**DESIGNATED SUBSTANCE AND  
HAZARDOUS MATERIALS SURVEY REPORT  
AT  
FENBROOK INSTITUTION  
OPERATED BY CORRECTIONAL SERVICE OF CANADA  
GRAVENHURST, ONTARIO**

File No.KB9465-00

March 29, 2011

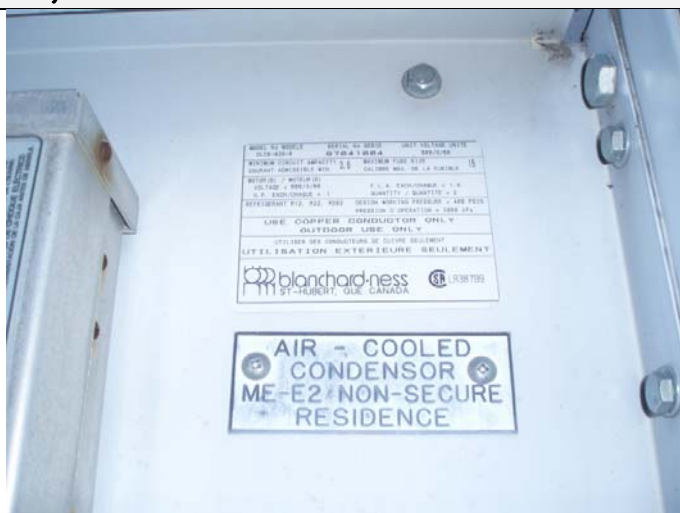
Cedar Building - roof

No	Cedar	"R-12, R-22 R502" on rooftop nameplates, however actual refrigerant housed in chiller unit in building is R134a, according to staff.	"R-12, R-22 R502" on rooftop nameplates, however actual refrigerant housed in chiller unit in building, according to staff, is R134a (not an ozone-	<p>Appears to be in good operating condition, no reported leaks, live monitoring from Nova Building. All maintained by licensed refrigerant contractors.</p> <p>Frequency of leak tests for equipment in Granite and Horizon Buildings has exceeded 12 months in the past, and may have occurred for this equipment (records not viewed).</p> <p>Recorded log information for the chiller in the</p>	<p>The facility should ensure the contractor completes leak testing of units containing R-134A within 12 months, and that a record/service log be maintained whenever the system is serviced, leak-tested or charged (see See Environmental Conditions and Operations Audit Report section 2.2.4).</p>

**Detailed recommendations (from Section 2.2) and Cost Estimate for Compliance:**

HVAC contractor shall update labelling on rooftop condensers promptly, to reflect actual refrigerant (current labelling does not show R-134a as refrigerant)

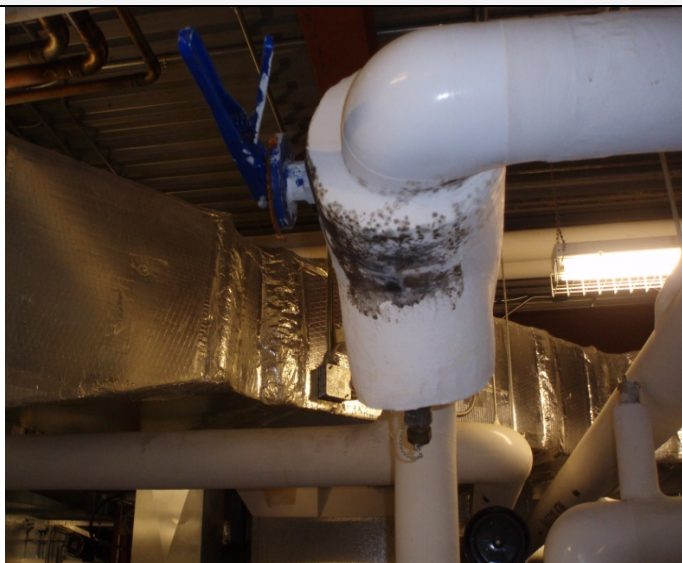
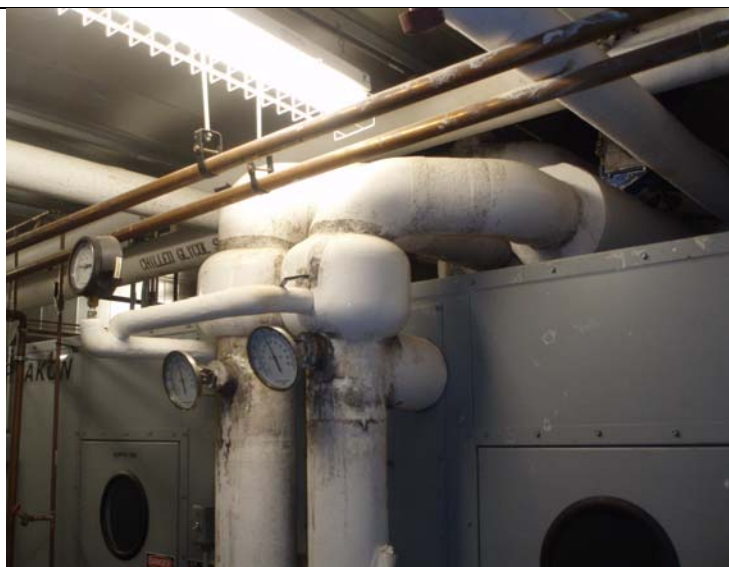
Aurora, Borealis,  
Driftwood (not including  
ongoing program at  
Edgewood, Falcon,  
Granite, Horizon)

DRIFTWOOD Mechanical Room	Mould growth on some pipe insulation. Possibly caused by water leak/damage or condensation. Accessible to maintenance personnel.	Approximately 1.0 m2 in total	Visible mould growth

**Detailed recommendations (from Section 2.2) and Cost Estimate for Compliance:**

Mould remediation should be carried out using the Canadian Constuction Association “*Guidelines for Mould Remediation for the Canadian Construction Industry*” (doc 82-2004) under Small-Scale Mould Growth (Less than 1 m<sup>2</sup>). Key requirements from this document are paraphrased below:

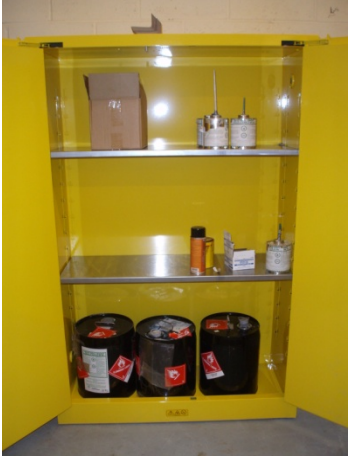
<p>Driftwood Building – D-173 Flammable storage cabinet containing Vinyl Cement</p>

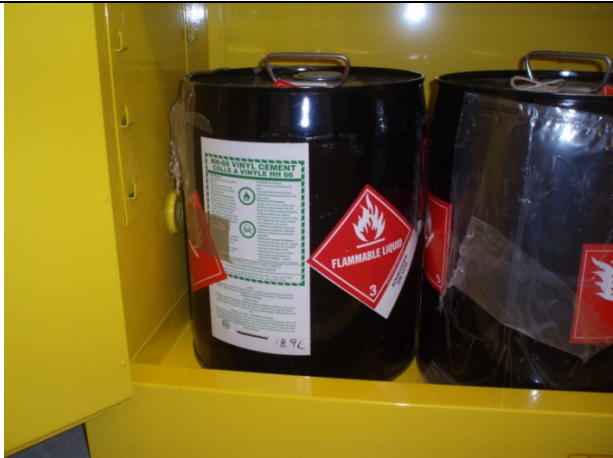
<p>Driftwood Building – D-173 Flammable storage cabinet containing Vinyl Cement</p>

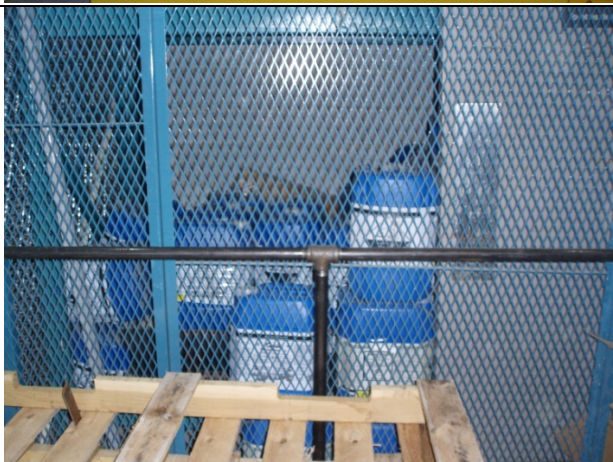
<p>Driftwood Building – D-137 12% Swish Chlorine Bleach storage. Stored on Containment tray behind locked fence.</p>

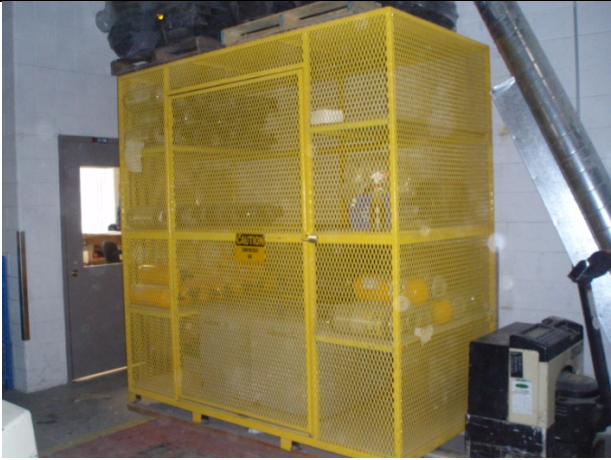
<p>Driftwood Building – D-137 Hazardous Material Storage</p>

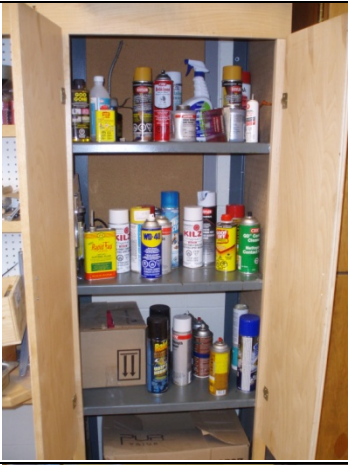
<p>Driftwood Building – D145 Chemical Storage</p>

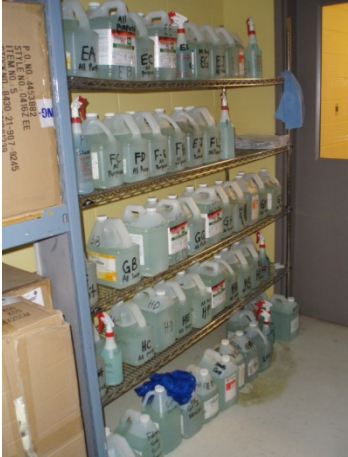
<p>Driftwood Building – D177 All purpose Cleaner storage</p>

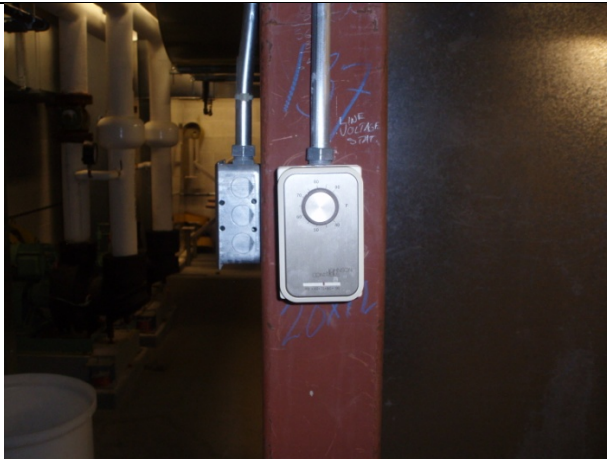
Typical thermostat-  
Potential source of  
mercury

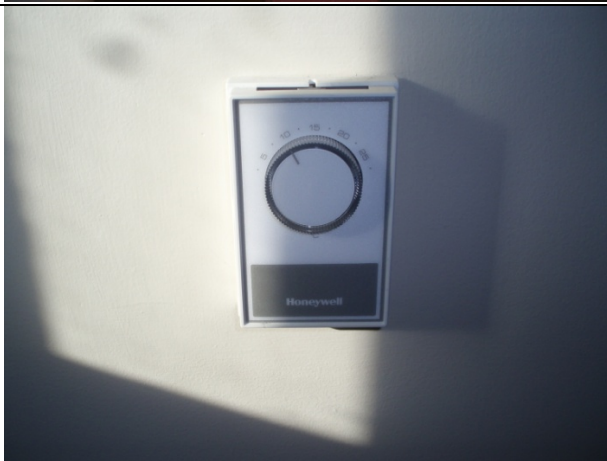
Typical thermostat -  
Potential source of  
mercury

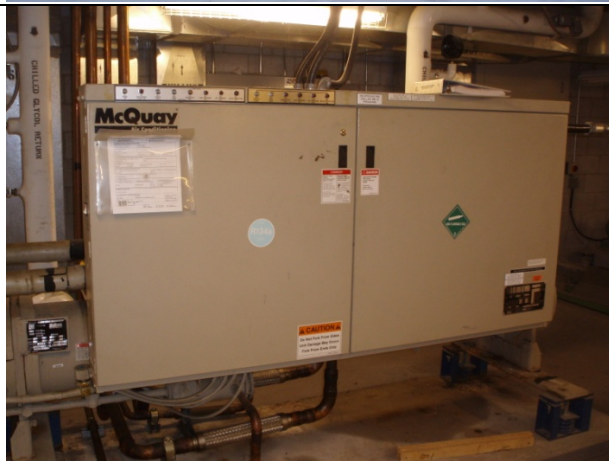
HVAC room –  
refrigeration equipment  
containing R134A

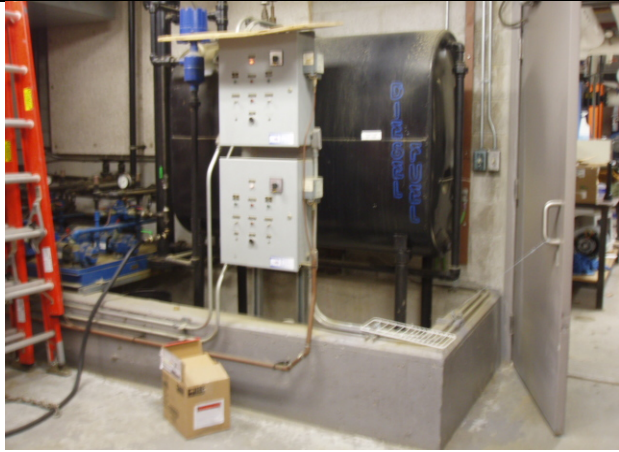
A photograph showing a large, dark-colored diesel day tank installed within a concrete secondary containment structure. The tank is surrounded by various pipes, valves, and electrical control panels. A red ladder is visible on the left side of the frame.	<p>Nova Building – Diesel day tank in concrete secondary containment</p>

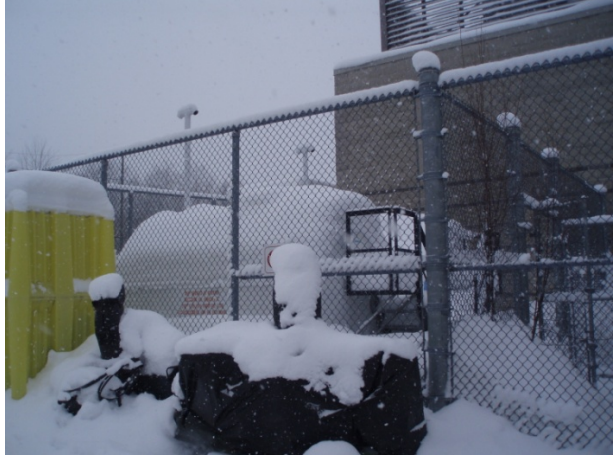
A photograph showing the exterior of the Nova Building, featuring several large, white, aboveground diesel storage tanks. The tanks are situated behind a chain-link fence, and the ground is covered in snow, indicating a winter setting.	<p>Nova Building – exterior diesel aboveground storage tanks</p>
