Repairs on Echo Sailboats

Provide materials and labour to do repairs on ten (10) Echo sailboats as described in the attached sheets. The work shall be done in the contractor's workshop.

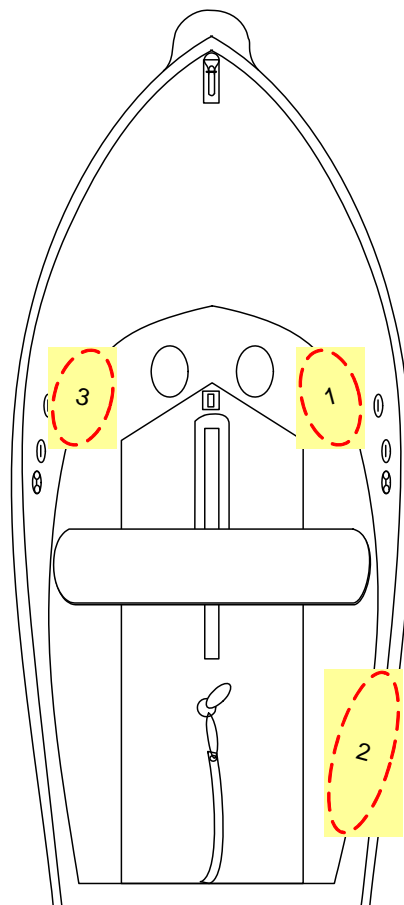
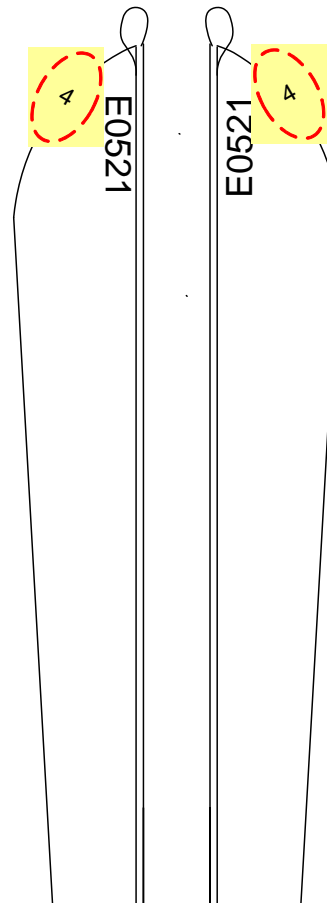
1. Gelcoat separation on starboard deck
2. Gelcoat crack on the aft starboard tank (sand and seal before painting)
- 3.
4. Fibreglass repair on bow
5. Paint entire interior
6. Paint bow repair

Numéro du voilier	Numéro de série	Remarques
E0521	QXW053461405	1. Écartèle Gelcoat sur pontage coté tribord
Location	SEN Enclos	2. Fissure gelcoat sur caisson arrière coté tribord (sabler et sceller avant de peindre)
WO number		3.
1020 D #		4. Réparation fibre de verre à l'étrave
Réfection	2013	5. Peinture complète intérieure
		6. Peinture sur réparation à l'étrave

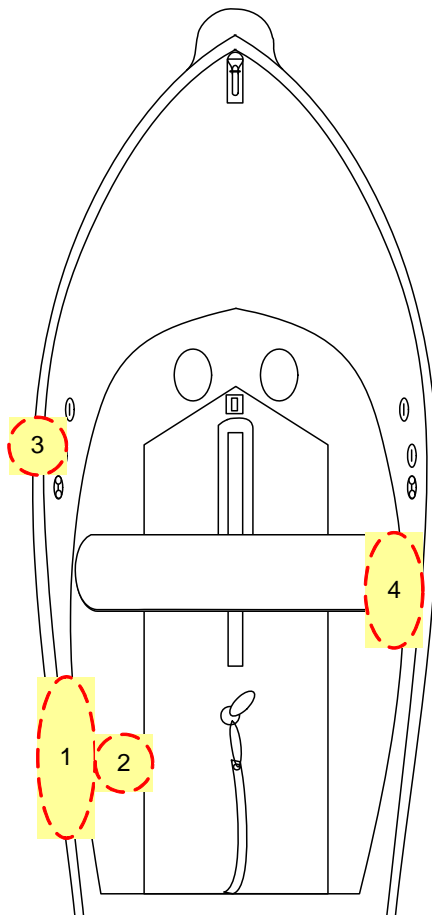
1. Repair crack on aft port gunwale;
2. Repair crack on aft starboard tank;
3. Gelcoat separation on port gunwale;
4. Repair crack on starboard tank near the thwart;
5. Repair fibreglass on hull below centreboard; and
6. Paint entire interior/exterior.

Numéro du voilier	Numéro de série	Remarques
E0619	QXW05403F505	<ol style="list-style-type: none"> 1. Réparer fissure sur plât-bord coté babord arrière 2. Réparer fissure sur caisson coté tribord arrière 3. Écartème de gelcoat sur plât-bord coté babord 4. Réparer fissure sur caisson coté tribord près du traversin 5. Réparations Fibre de verre sur coque sous dériveur 6. Peinture complète int/ext
Location	SEN Enclos	
WO number		
1020 D #	Contracteur 2012	
Réfection	2013

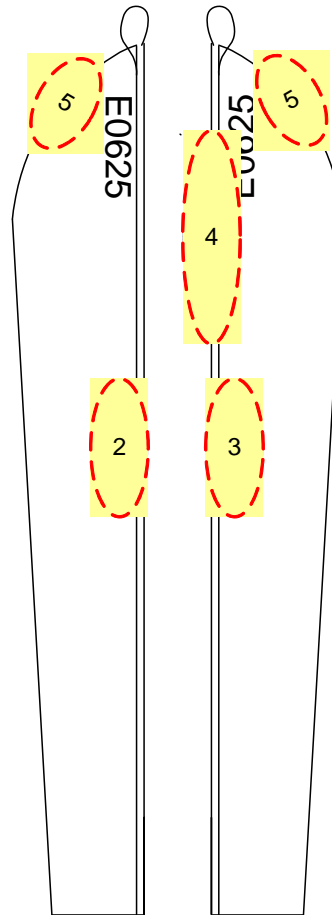
1. Repair gelcoat separation on aft transom;
2. Repair cracks below port gunwale;
3. Repair cracks below starboard gunwale;
4. Re-glue starboard gunwale guard;
5. Repair fibreglass on bow; and
6. Paint entire interior/exterior.

Numéro du voilier	Numéro de série	Remarques
E0625	QXN05406E505	1. Réparer écartèle de gelcoat sur tableau arrière
Location	SEN Enclos	2. Réparer fissures sous le plât-bord coté Babord
WO number		3. Réparer fissures sous le plât-bord coté Tribord
1020 D #		4. Recoller protecteur de plât-bord coté tribord
Réfection	2013	5. Réparer fibre de verre sur étrave
		6. Peinture int/ext complète

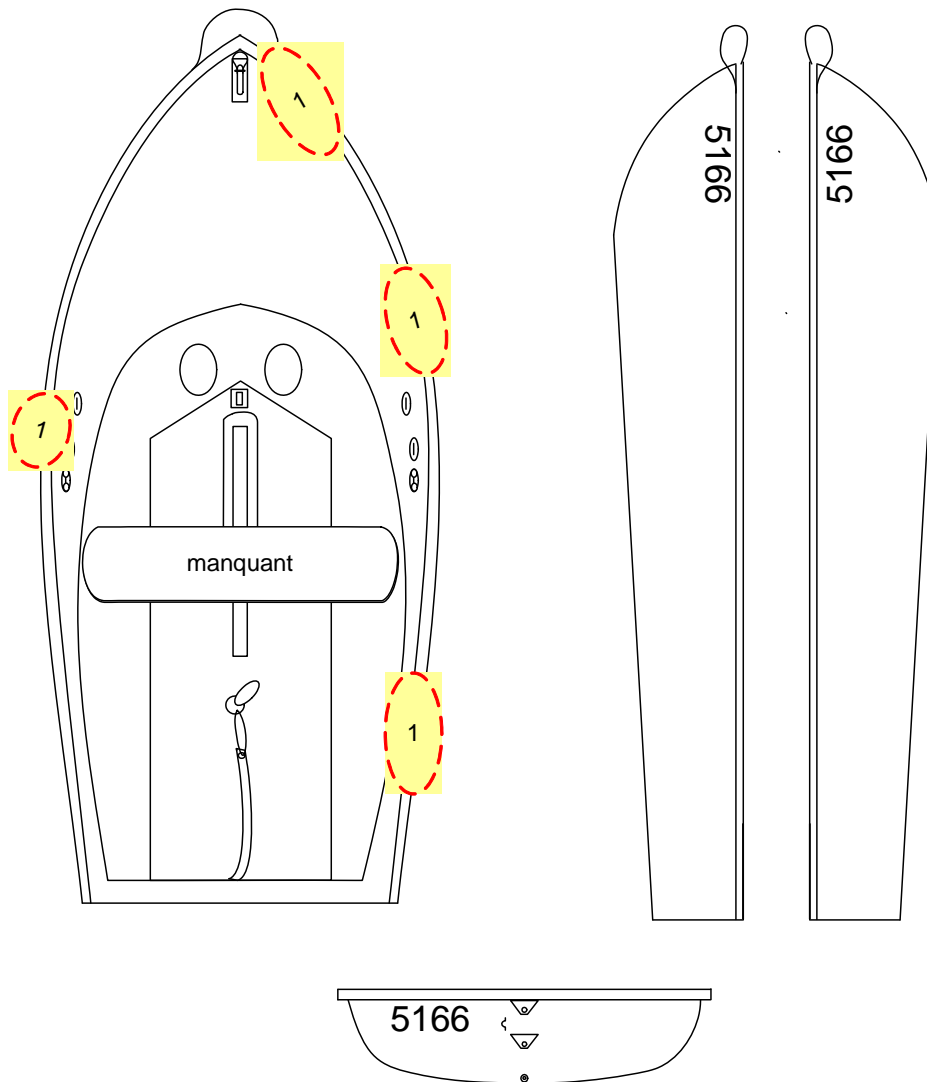
1. Repair several fractures/old repairs on port and starboard gunwale and deck;

Numéro du voilier	Numéro de série	Remarques
5166	CLW05166H202	1. Réparer plusieurs bris /vieilles réparations sur pontage et plât-bord coté babôrd et tribord 2. Sabler et préparer la surface pour la peinture 3. Peinture complète int/ext
Location	SEN Enclos	
WO number		
1020 D #		
Réfection	2013

Peinture complète nécessaire

2. Sand and prepare the surface for painting; and
3. Paint entire interior/exterior.

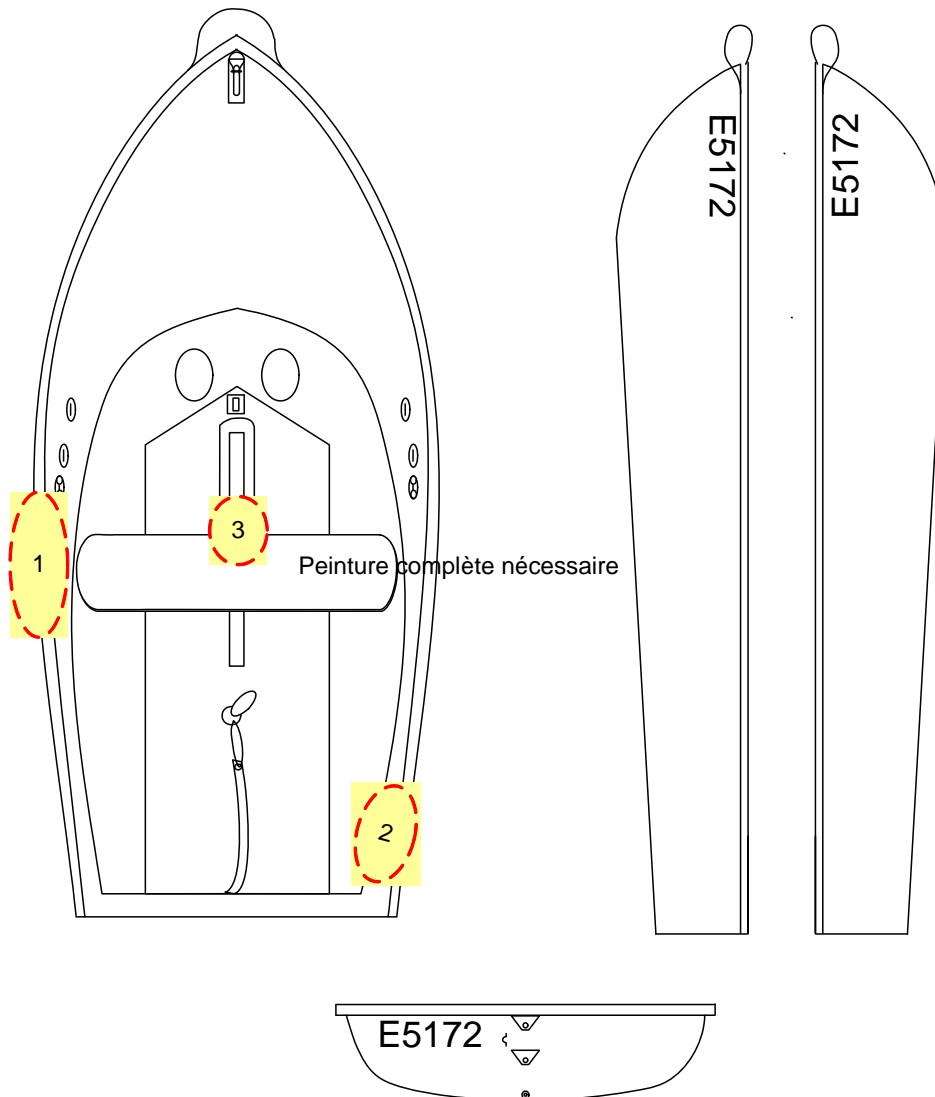
E5172

1. Repair fibreglass on port gunwale
2. Repair cracks in gelcoat on aft starboard tank
3. Repairs to centreboard trunk
4. Sand and prepare surface for painting
5. Paint entire interior/exterior

Numéro du voilier	Numéro de série	Remarques
5172	CLW05172H202	1. Réparer fibre de verre sur plât-bord coté babord 2. Réparer fissures dans gelcoat sur caisson tribord arrière 3. Réparation sur puit de dérive 4. Sabler et préparer la surface pour la peinture 5 Peinture complète int/ext
Location	SEN Enclos	
WO number		
1020 D #		
Réfection	2013

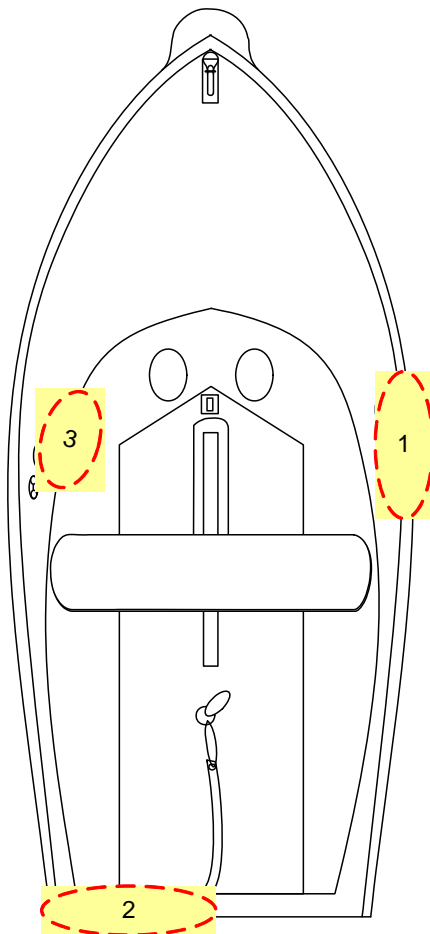
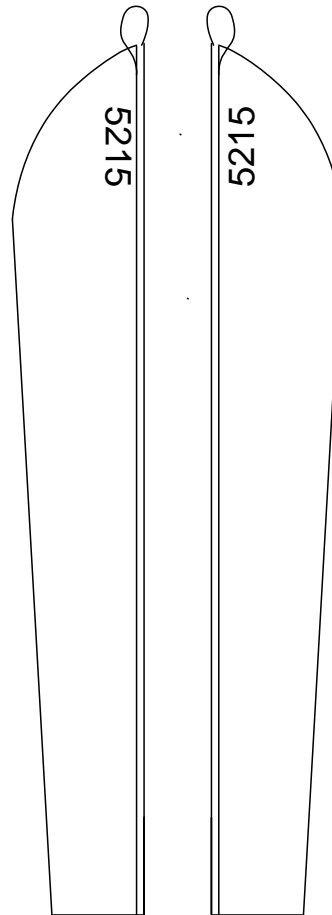
1. Fibreglass on starboard deck
2. Repair gelcoat separation on aft transom
3. Repair cracks on port deck
4. Sand and prepare surface for painting
5. Paint entire interior/exterior

Numéro du voilier	Numéro de série	Remarques
5215	CLW05215J203	<ol style="list-style-type: none"> 1. Fibre de verre sur pontage coté tribord 2. Réparer écartèles de gelcoat sur tableau arrière 3. Réparer fissures sur pontage coté babord 4. Sabler et préparer la surface pour la peinture 5. Peinture complète int/ext
Location	SEN Enclos	
WO number		
1020 D #		
Réfection	2013
