**CCGS Terry Fox  
Port Side Shell Renewals  
Between Main Deck and Foc'sle Deck  
I.W.O Frames 132 - 138**

Issued  
June 2012

**Project Number** 2363

## Terry Fox Damage Survey June 2012

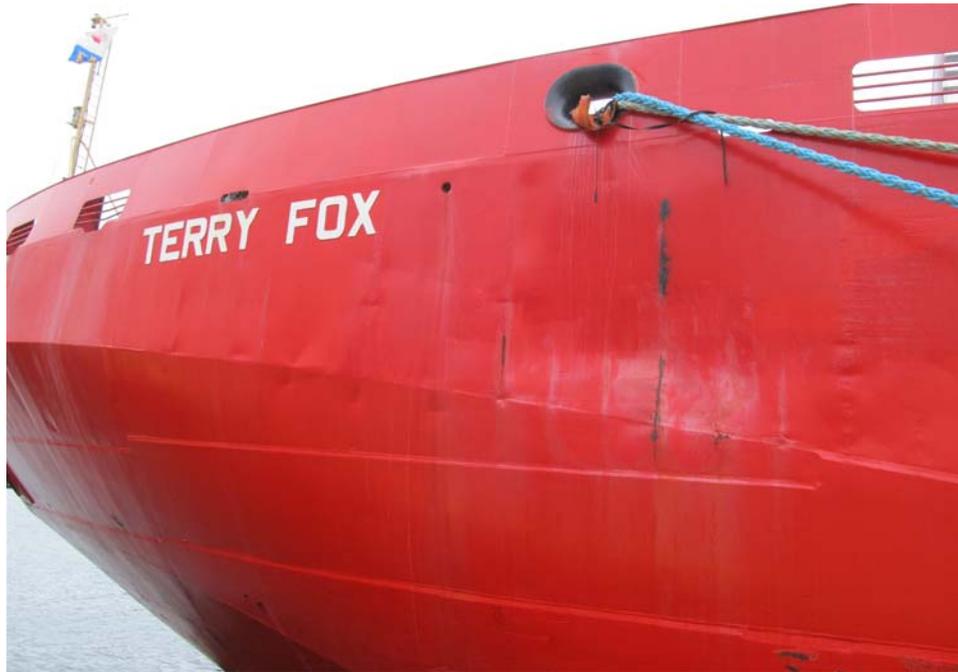
**Port Side Damage - Exterior View**

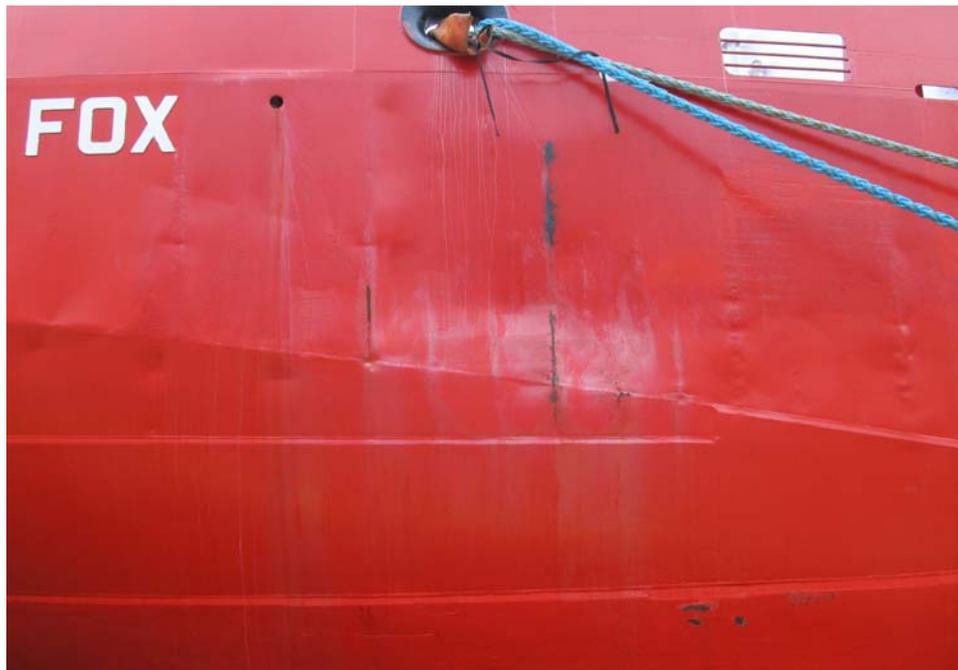
**Port Side Damage - Exterior View**

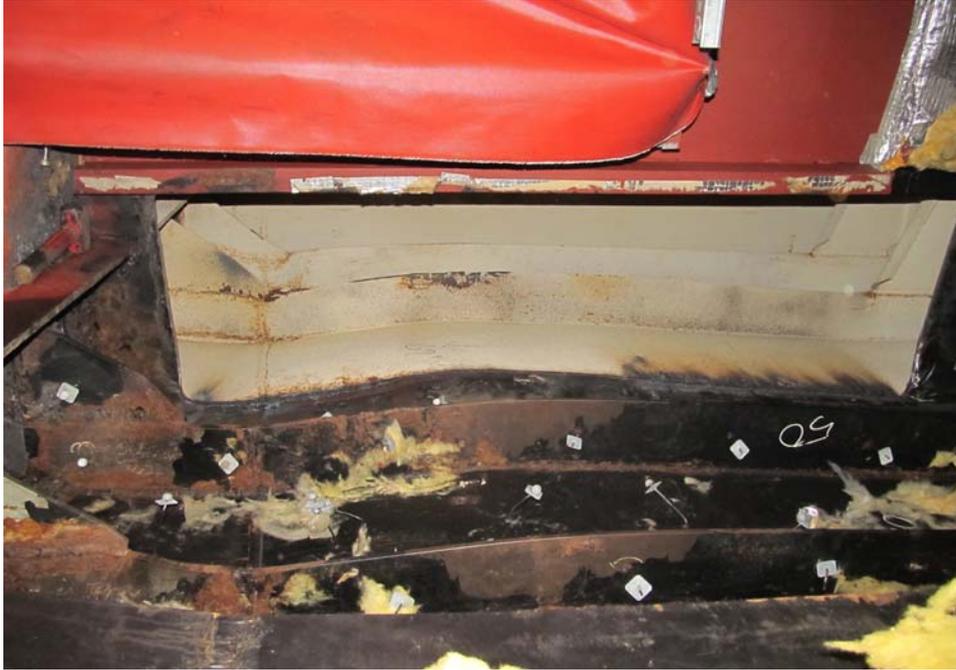
**View of damaged area looking aft**

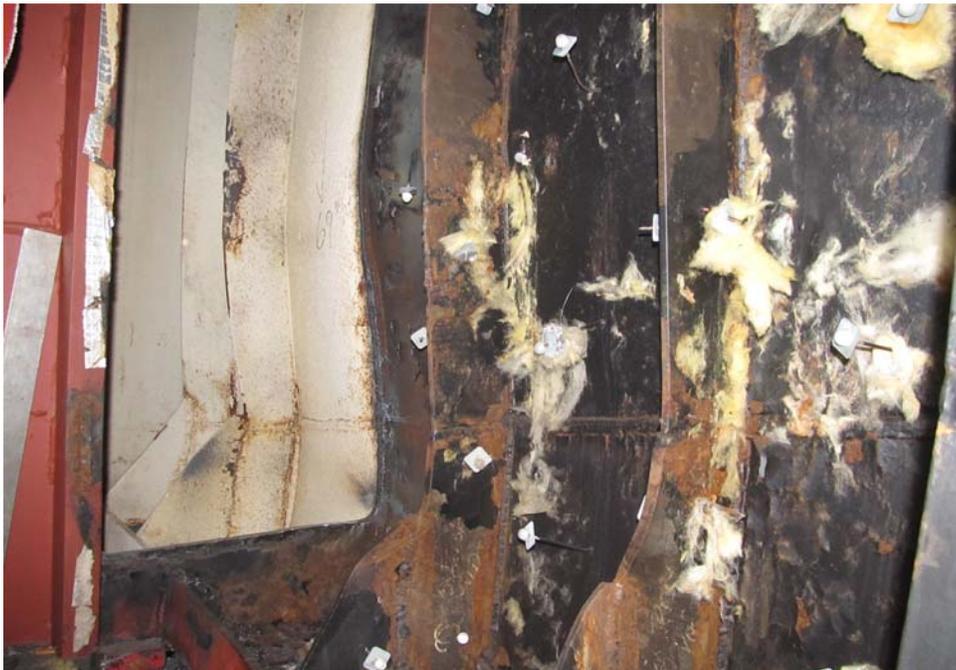
**View of damaged area looking aft**

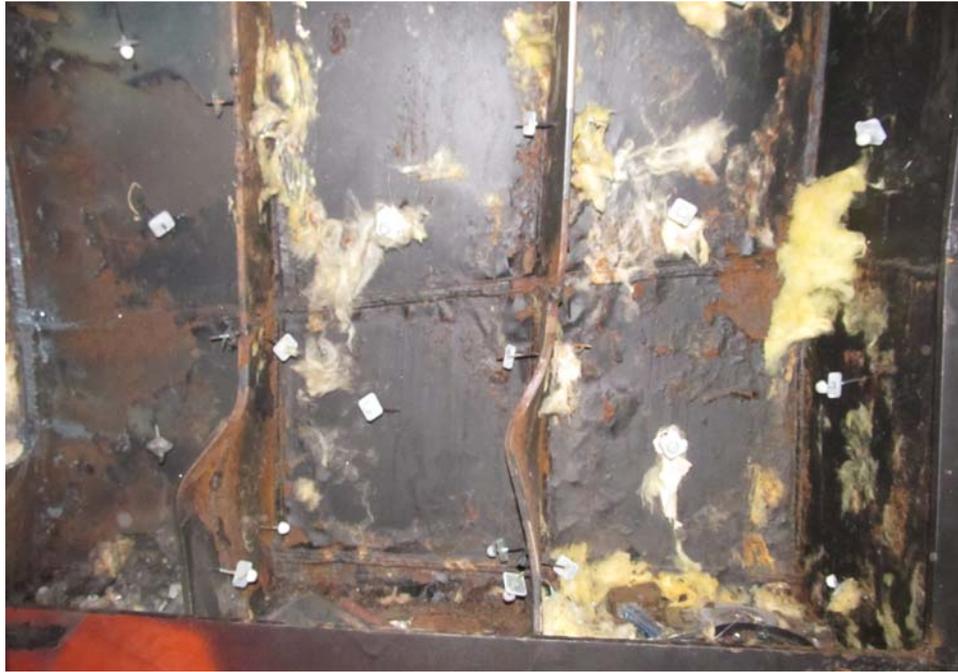
**Damaged frames, brackets**

- 2) The intermediate frame 133, 134, 136 and 137 shall be renewed completely from the top of the stringer to the underside of the Foc'sle Deck including the upper and lower brackets. The intermediate frames above the knuckle are 150 x 10mm flat bar and below the knuckle are 150 x 13mm flat bar. The lower brackets on top of the stringer are 350 x 200 x 10mm plate. The upper brackets located at the underside of the Foc'sle Deck are 300 x 550 x 10mm with 75mm flanges. The stringer and frames below shall remain intact. The frame spacing in this area is 400mm.

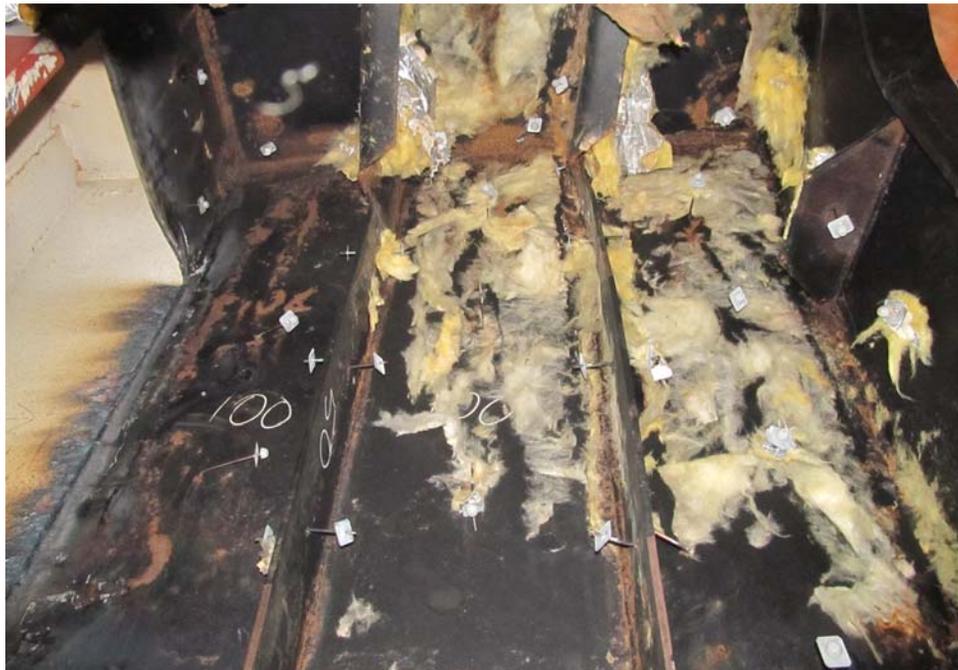
**Damaged frames, brackets forward of bulkhead at frame 35**

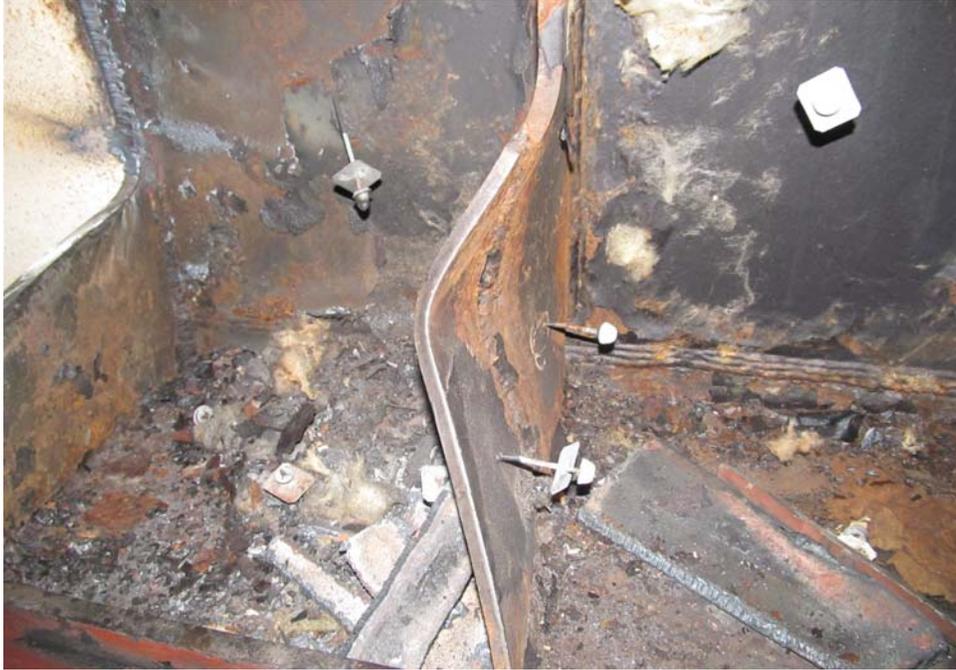
**Typical tripped bracket**

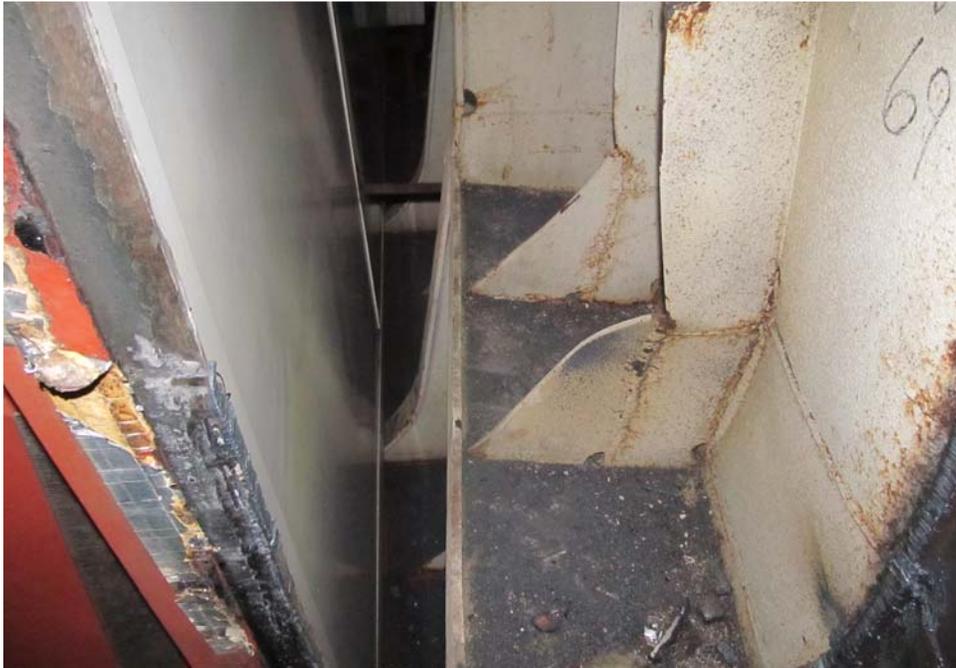
**Damaged frames, brackets aft of bulkhead**

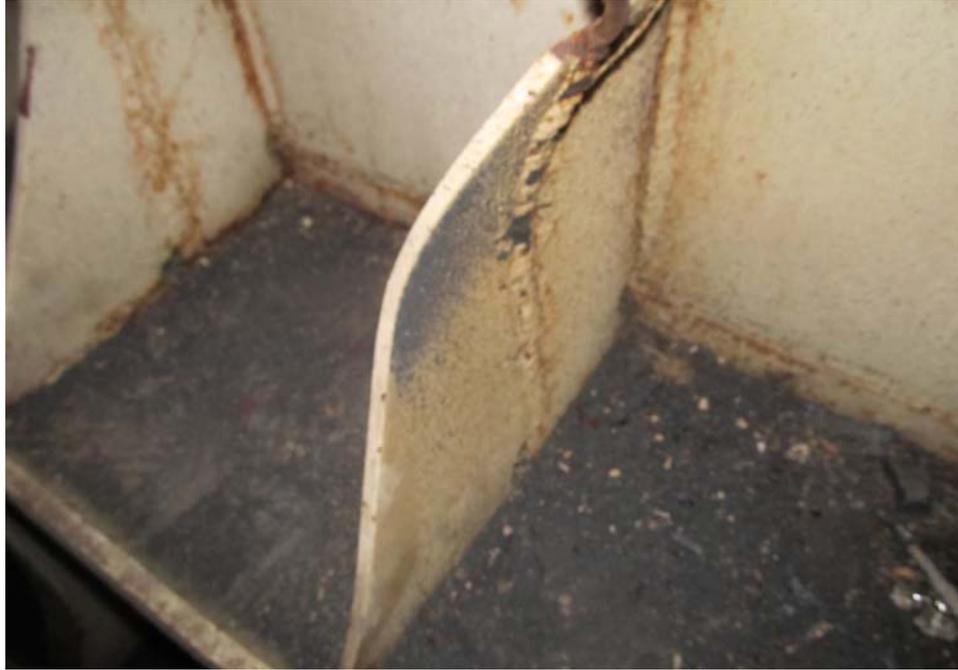
**Typical tripped bracket**

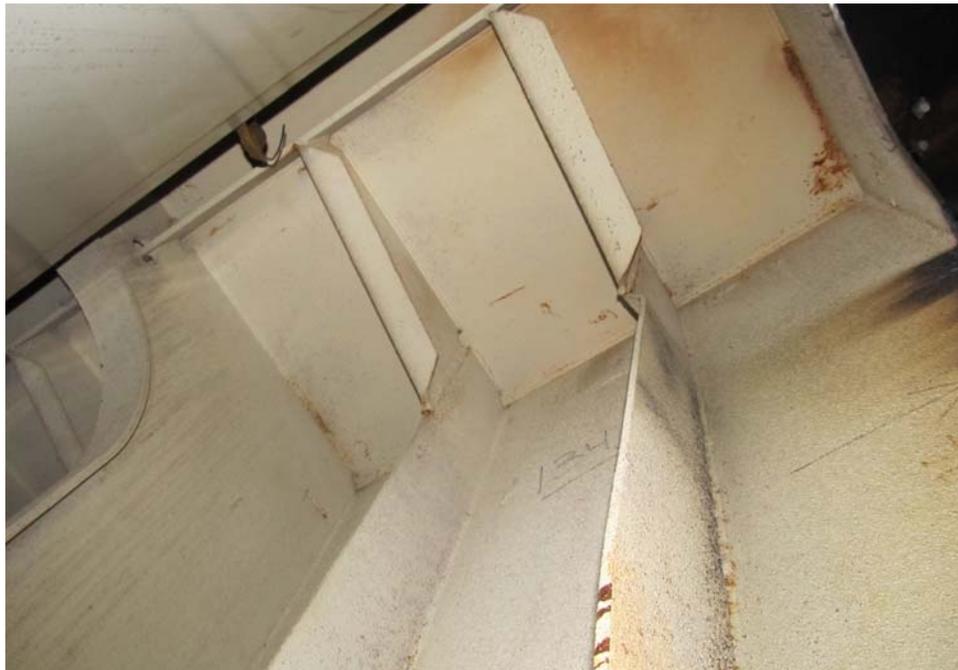
**Damaged frames, brackets aft of bulkhead**
