Designated Substances Survey (DSS) of the Fuel Transfer Building (FTB) at Cambridge Bay Airport, Nunavut

Final Report

November 16, 2012
Pacific Ref: 13476 R01

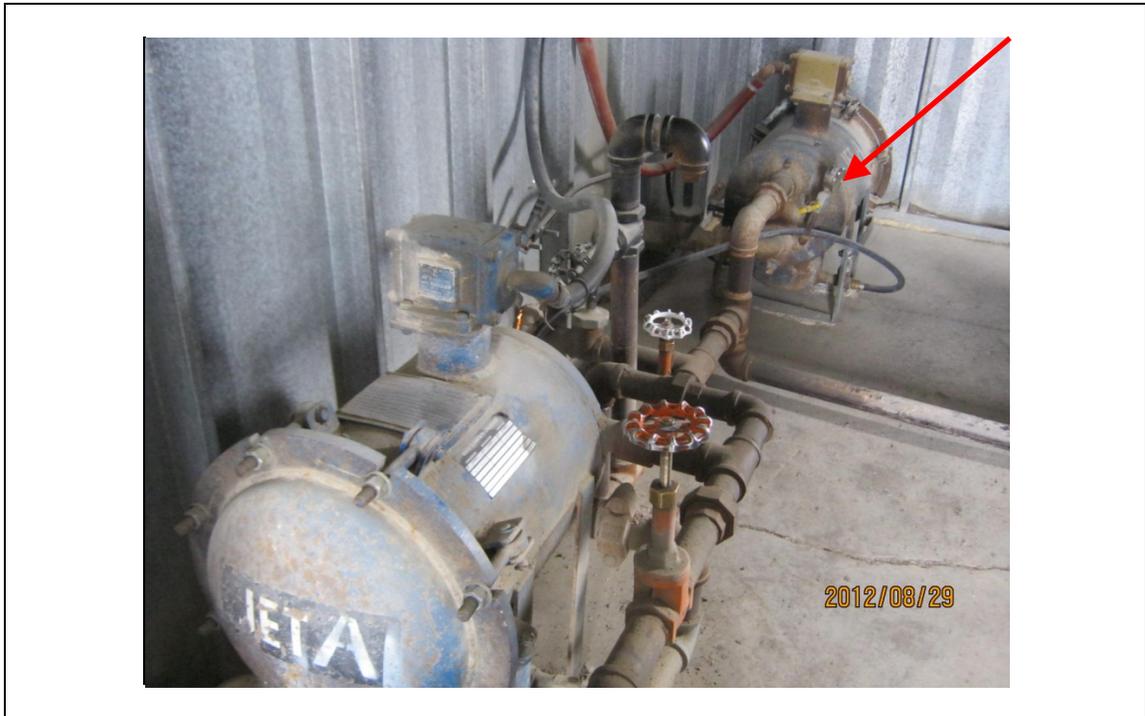
Photo 1	Date: Aug 29, 2012	Location: FTB, Interior
Description: Fueling equipment stored in the FTB as indicated by red arrow.

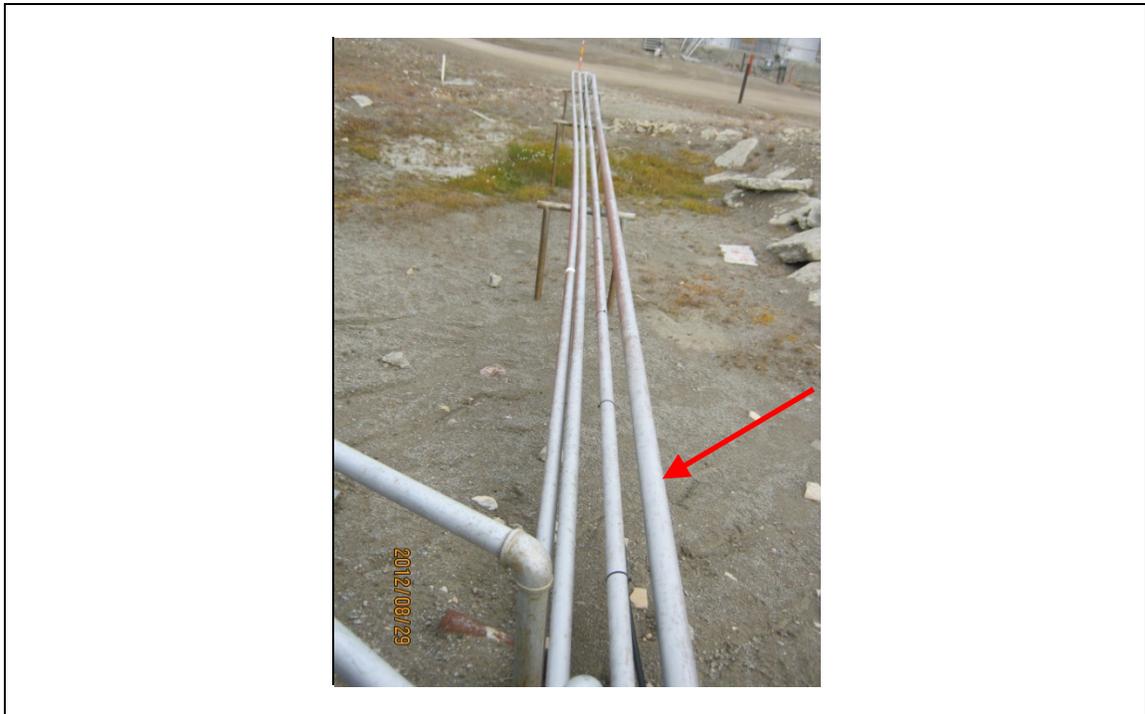
Lead at levels in excess of the guidelines contained within the Government of Nunavut Definition of Lead Containing Paint was detected in the silver paint applied to the fuel lines (Sample 13476 – L1) extending from the FTB (Photo 2). Refer to Table 2 below and the attached laboratory sample results in Appendix B.

Sample Number	Sample Location	Lead ($\mu\text{g/g}$)
13476 – L1	Exterior – Fuel Lines – Silver Paint	<u>27,600</u>
13476 – L2	Exterior – Light Pole – Yellow Paint	275
Government of Nunavut Definition of Lead Containing Paint		500

The limit of lead leachate in the Hazardous Constituents Controlled Under Leachate Test and Regulated Limits is 5.0 mg/L as stated in the Interprovincial Movement of Hazardous Waste and Hazardous Recyclable Material Regulations. Sample number 13476 – T1 was determined to be **non-leachable**. Refer to Table 3 and the attached laboratory sample results in Appendix B.

Lead-based silver paint (as defined by the Government of Nunavut Definition of Lead Containing Paint) was identified on the fuel line piping. However; it was determined that the paint was non-leachable as defined by Environment Canada's Interprovincial Movement of Hazardous Waste and Hazardous Recyclable Material Regulation and therefore can be accepted at most scrap metal waste facilities provided the receiving facility is advised of the presence of the lead-based paint. The required removal of small areas of lead-based paint to facilitate handling and transport of this piping has been discussed in Section 6.0 Rationale. The amount of double-bagged sealed contaminated waste generated will be approximately 15kg.

Photo 2	Date: Aug 29, 2012	Location: FTB, Exterior Facing South
Description: Lead containing silver paint on fuel lines as indicated by red arrow.

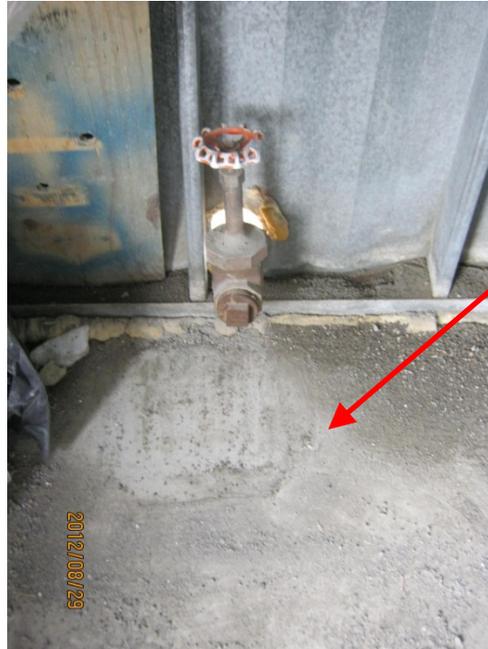
Sample 13476 – SW1 collected from the concrete floor of the FTB, below the capped Avgas pipe (Photo 3), contains lead in excess of the WorkSafeBC standard $200\mu\text{g}/\text{ft}^2$ for industrial settings (this standard is derived from the United States Environmental Protection Agency (USEPA) standard for industrial settings and is most commonly used). Therefore all the surface dust on the concrete floor of the FTB should be considered lead-containing as per the following reasoning;

Sample Number	Sample Location	Lead in Floor Dust ($\mu\text{g}/\text{ft}^2$)
13476 – SW1	Interior – Floor Below Avgas Valve	<u>763</u>
USEPA Standard		200

Approximate quantity of floor area to be cleaned is 160ft^2 . Contaminated waste generated will be approximately 20kg. Amount of concrete to be demolished and removed is approximately 1.525m^3 (3,530kg). The concrete floor was observed to be unsealed, i.e. no surface coatings. When the concrete has been cleaned to achieve the desired result of $<200\mu\text{g}/\text{ft}^2$ the concrete can then be disposed of as regular demolition waste.

Photo 3	Date: Aug 29, 2012	Location: FTB, Interior
Description: Lead containing dust on the concrete floor as indicated by red arrow

Surface dust on the FTB concrete floor was also determined to be lead-containing. The concrete floor was observed to be unsealed. The lead containing dust should be removed using HEPA equipped vacuums and the use of Personal Protective Equipment (disposable coveralls, steel-toed rubber boots, and respiratory protection equipped with HEPA filter cartridges). The dust should be removed from site by sealing it and used coveralls, used HEPA filter cartridges and polyethylene drop sheets by double-bagging in waste bags designed for the purpose and disposed of through the same carrier, as Hazardous Waste. This remediation process is expected to generate no more than 20kg's of double-bagged, sealed waste.

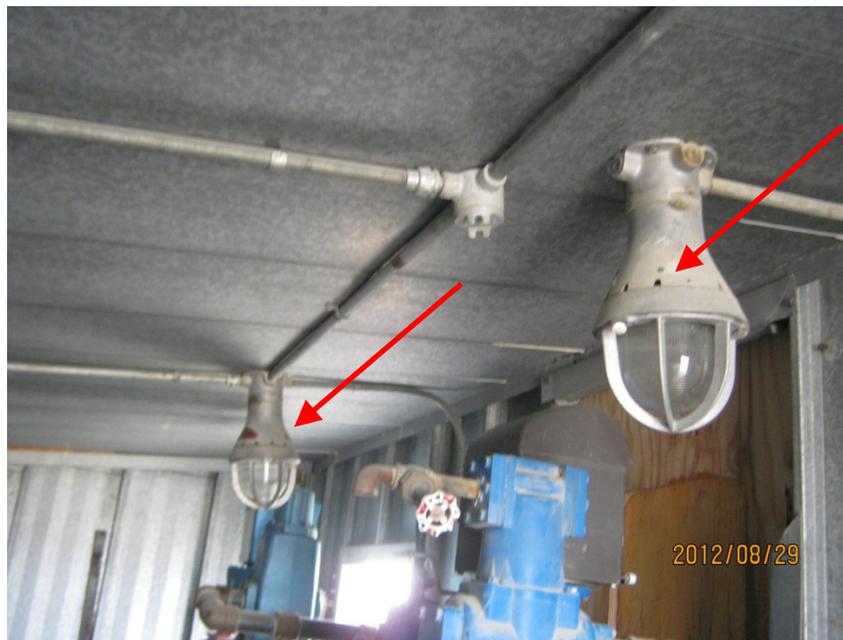
Two lamps suspected of being mercury vapour lamps were observed in the FTB (Photo 4). At the time of the investigation the lamp casings could not be removed to inspect the light bulbs and no clear label indicating the presence of mercury in the bulbs was observed. The mercury

contained within the mercury lamps is classified as a Special Waste material and must be disposed of in accordance with Federal regulations. The mercury can be recovered from the lamps at a licensed facility, and recycled. Lamps may also be carefully salvaged and removed and re-used in other locations until the end of their lifespan.

Photo 4	Date: Aug 29, 2012	Location: FTB, Interior
Description: Suspected mercury lamps as indicated by red arrows

Two suspected mercury lamps were observed inside the FTB. Prior to the demolition of the building the lamps should be salvaged, removed, and stored for reuse. No fluorescent light fixtures were observed within the building.
