Public Works and Government Services Canada
Northern Contaminated Sites Program

Remedial Action Plan Aklavik, Northwest Territories RCMP Housing Unit – Fuel Spill

AECOM
17007 – 107th Avenue
Edmonton, AB, Canada T5S 1G3
www.aecom.com

March 23, 2012

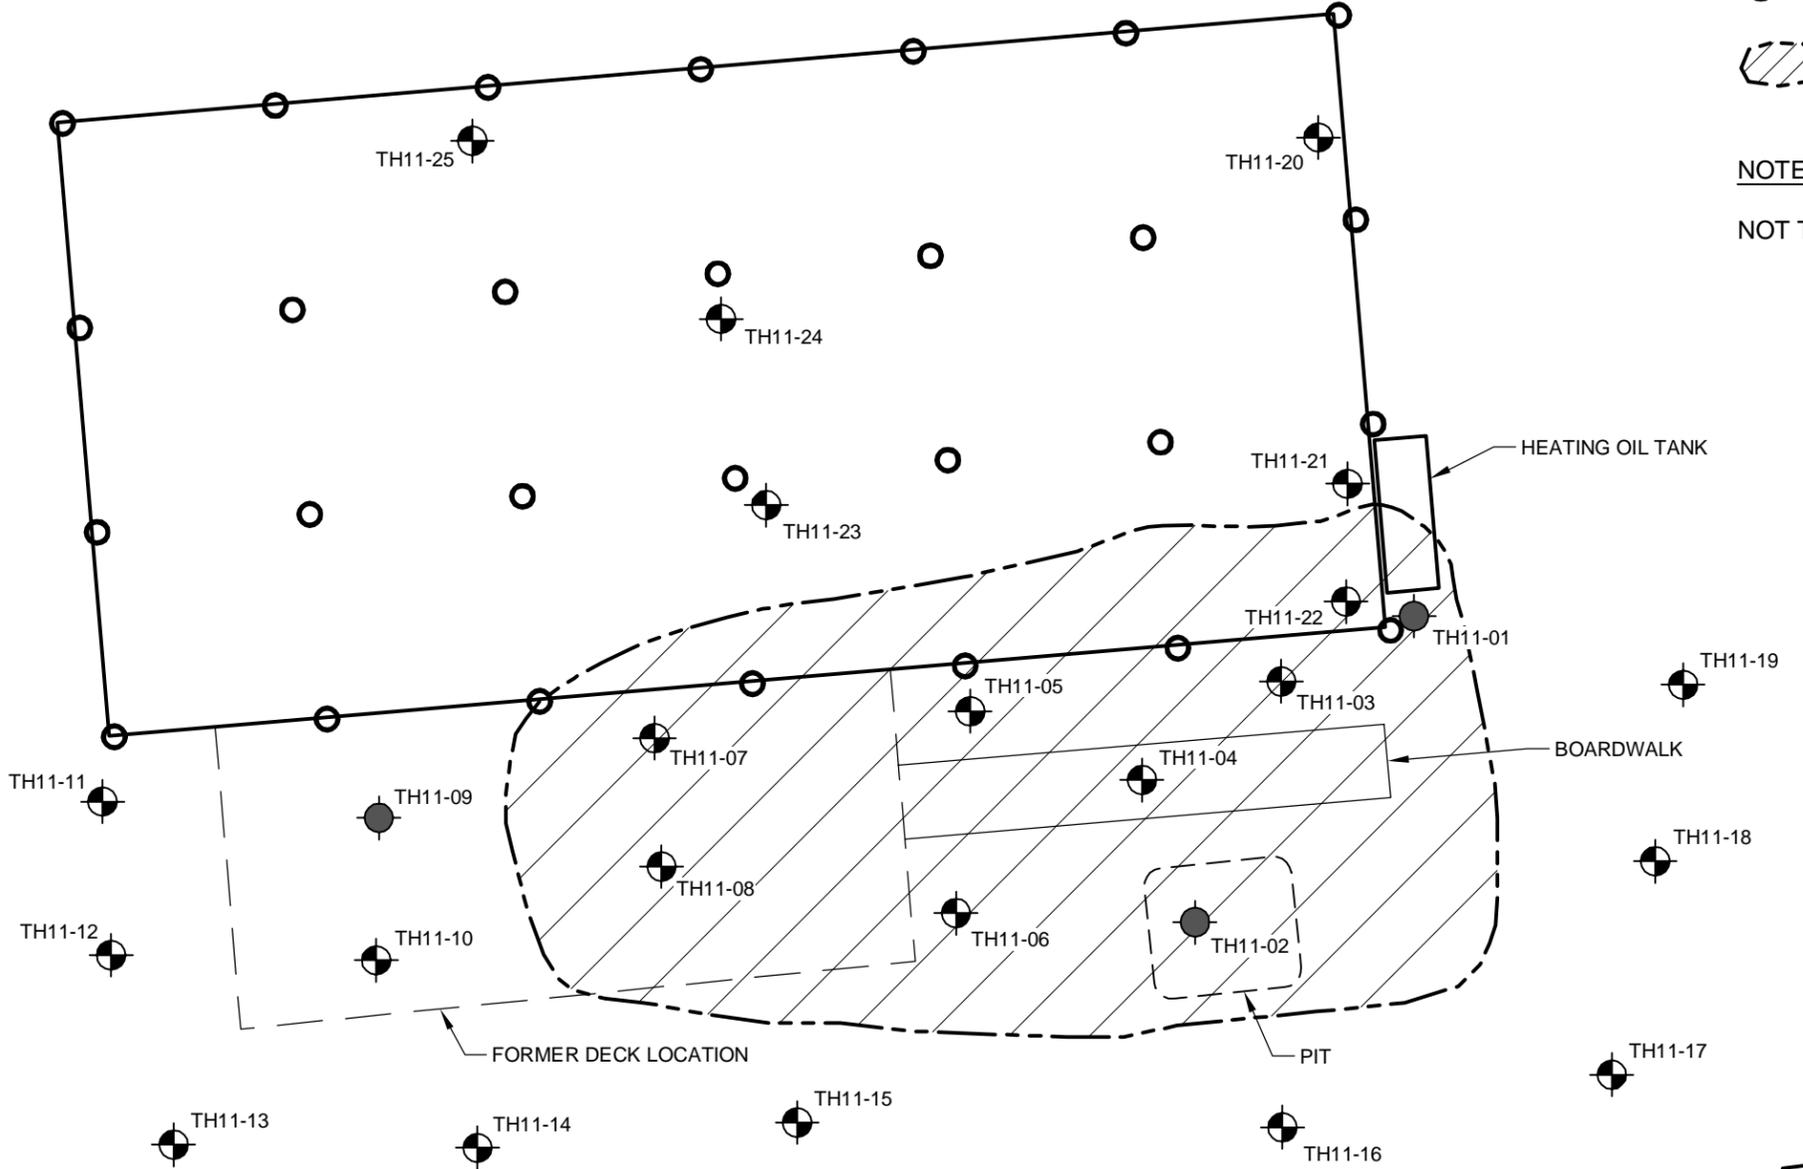
Samples from both the surface and permafrost depths at TH11-02 exceeded CCME guidelines for toluene, ethylbenzene, xylenes and F2 PHC, while only the deep sample (1.3 mBGS) had an exceedance for benzene and F1 PHC. Due to the depth of contamination extending to permafrost in TH11-01 and TH11-02, it is conservatively assumed that the depth of contamination in the impacted area extends to permafrost across the entire impacted area. Based on the location of the delineation boreholes, there is approximately 180 cubic metres (m³) of contaminated soils at this location. Figure 3 in Appendix A shows the approximate extent of soil contamination above CCME criteria.

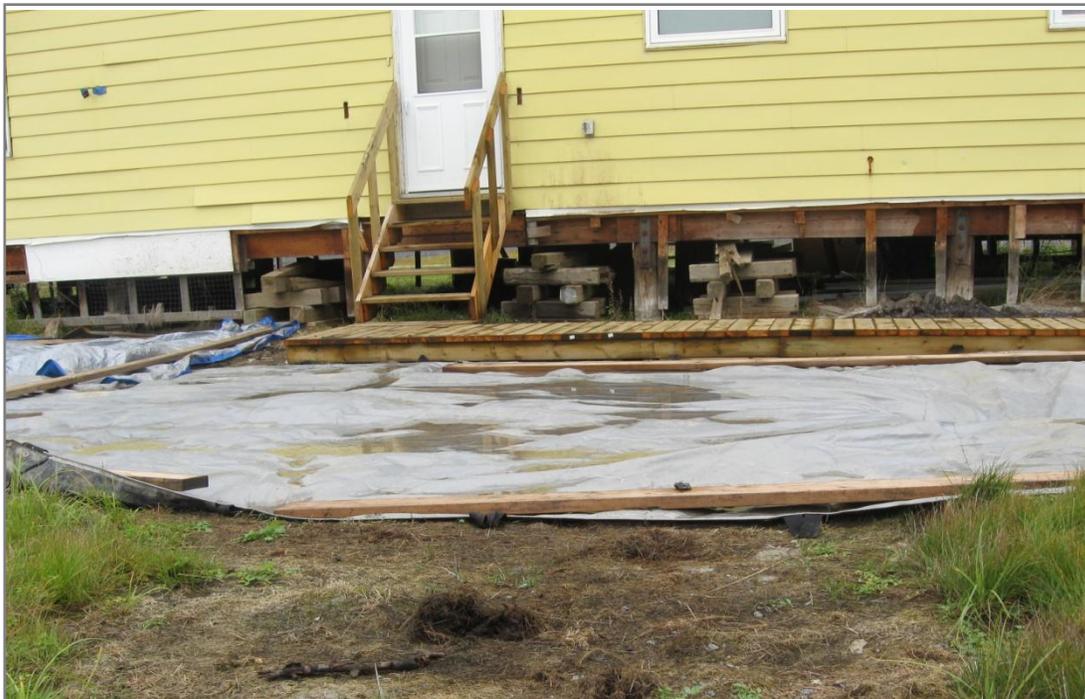
Photograph 1. Facing north over south end of house. Tarps held down by boards over the contamination zone. ↑

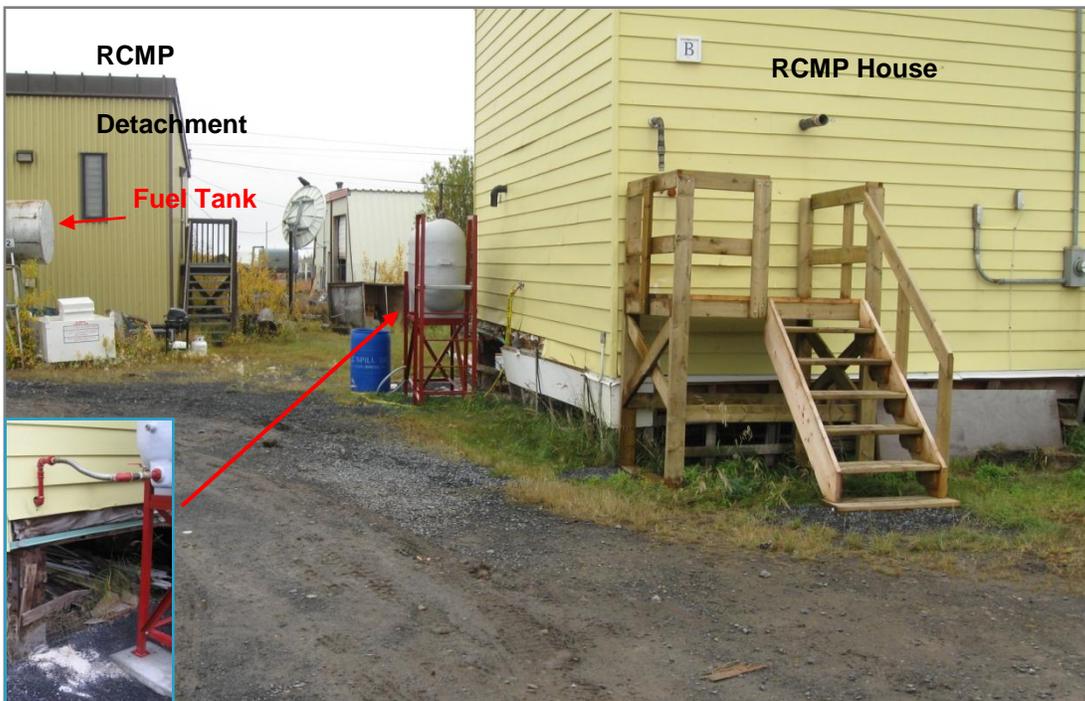
A fuel tank was noted affiliated with the adjacent RCMP detachment east of the subject property. Samples in the vicinity of this tank (TH11-17 and TH11-19) did not lead to any field observations of suspected impact relating to either the heating oil spill or the fuel tank.

Photograph 2. View facing south over east side of house. Heating oil tank inset. Note additional fuel tank adjacent to RCMP detachment. ↑

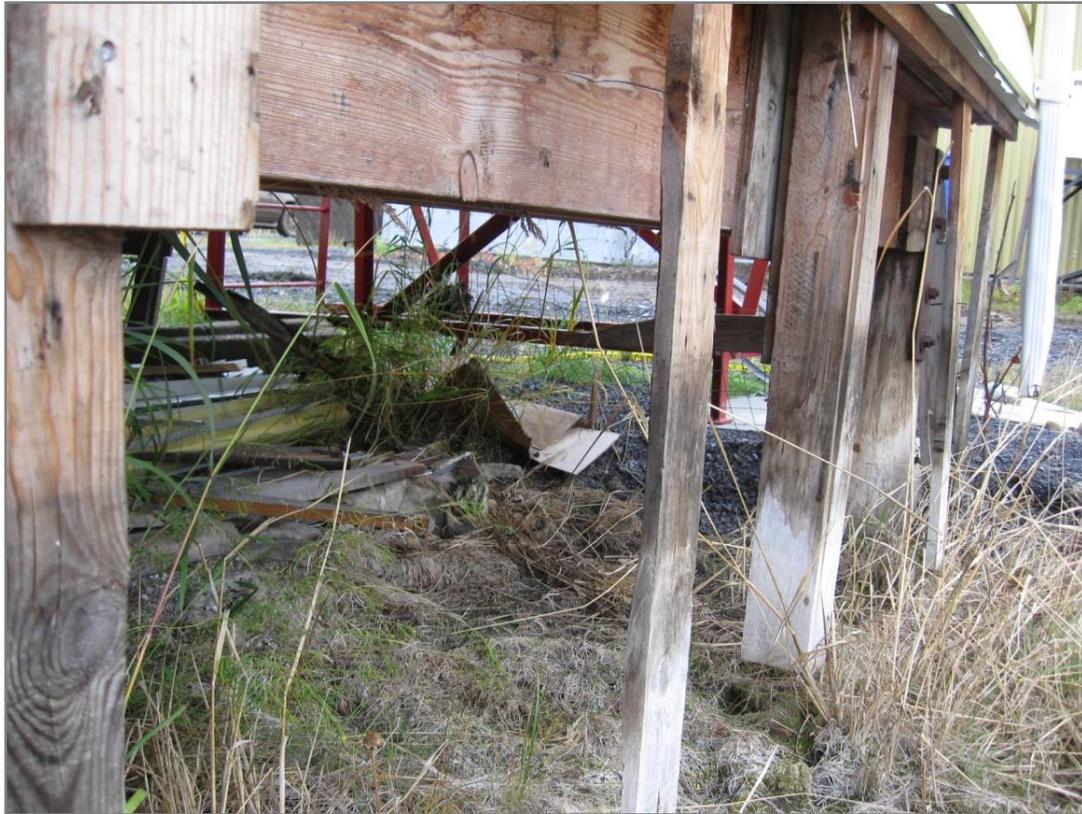
Samples from beneath the house were analyzed for PHC concentrations and the shallow sample from TH11-22 (immediately southwest of the tank) exhibited exceedances of ethylbenzene and F2 under the guidelines for the CCME guidelines for fine-grained soil on residential properties. The sample from 0.3 mBGS came back within CCME guidelines. For the remainder of the samples from beneath the house, volatile PHC constituents were below detectable limits, but detectable concentrations for F2 to F4 were noted. It should be noted that the soil beneath the house had a high organic content, which could account for a portion of the F3 values.

Photograph 3. View beneath southeast corner of house (TH11-22 obtained at this location). ↑

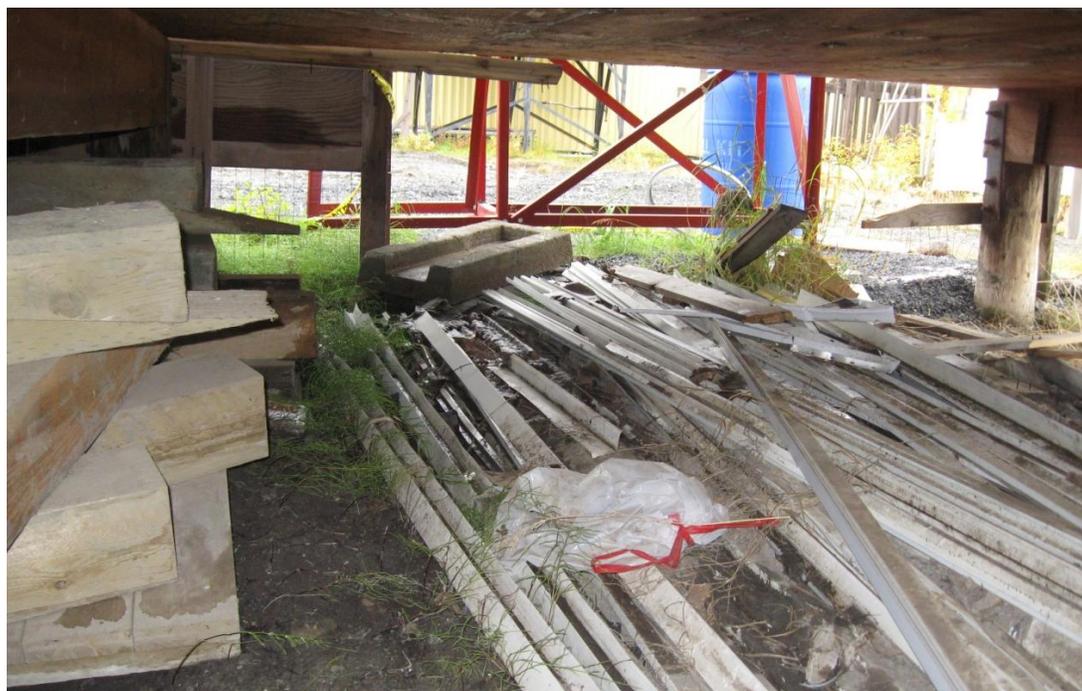
Photograph 4. Building materials stockpiled beneath southeast corner of house. ↑

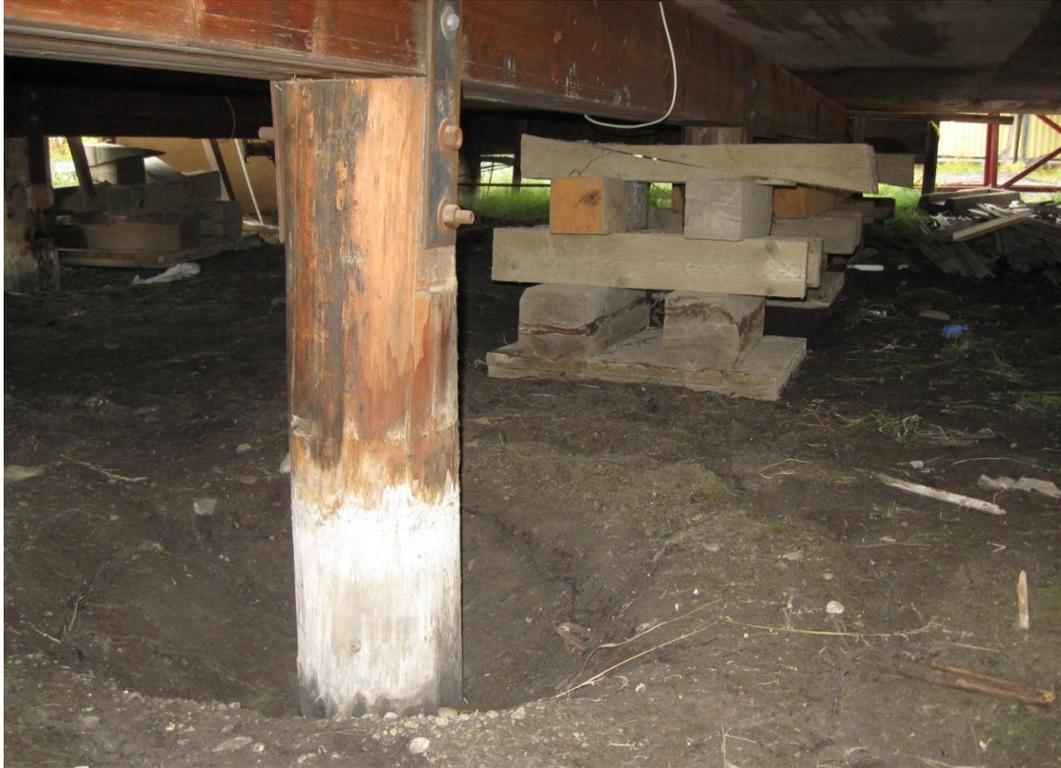
Photograph 5. House piles with erosion wells and cracked soil. ↑

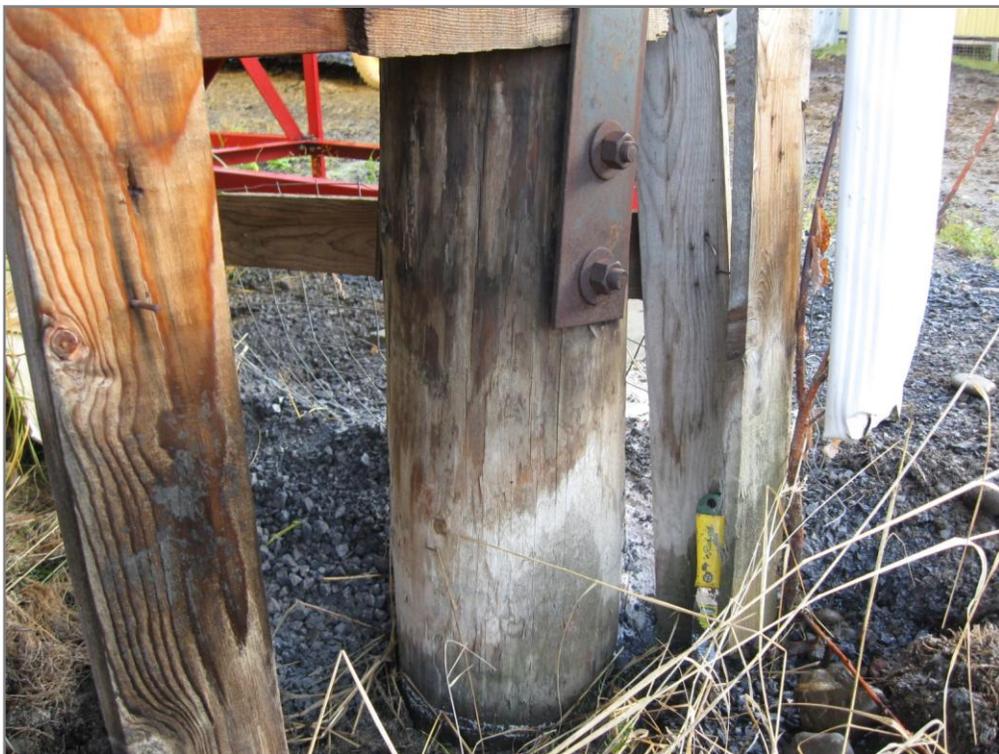
Field observations below the building identified that some piles were observed to have potentially adsorbed some of the heating oil (inconsistent colouration – i.e. not all creosote treated). Wood shavings from one pile and the wooden cribbing located near the heating oil tank were collected and analyzed for BTEX and F1-F4 hydrocarbon fractions. Table 3 in Appendix C presents that analytical data from the analyzed wood samples.

Photograph 6. Southeast pile and cribbing where wood shaving sample obtained. ↑

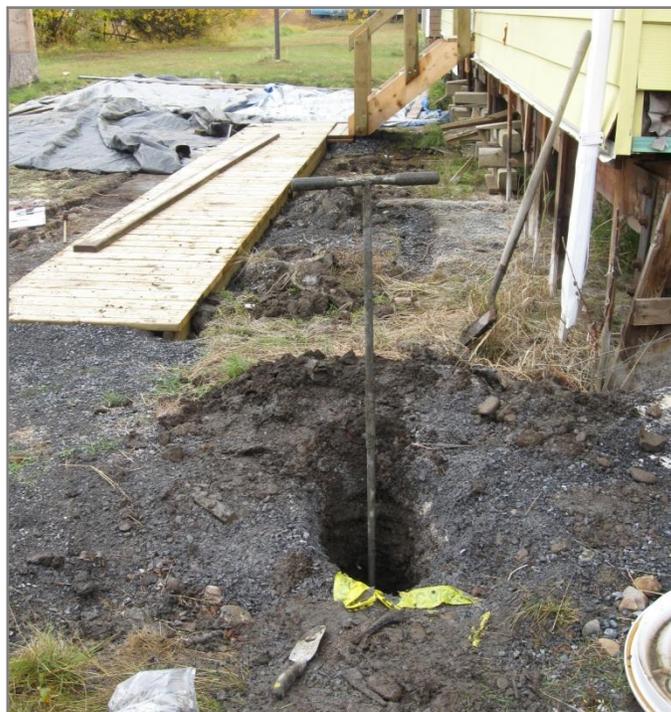
Although odours were detected from TH11-01 at both depths and a PHC sheen was noted on groundwater, the soil results indicated exceedances of toluene and ethylbenzene only from the sample at 1.35 mBGS. The sample from 0.4 mBGS was within CCME guidelines.

Photograph 7. TH11-01 testpit completed immediately south of tank. ↑

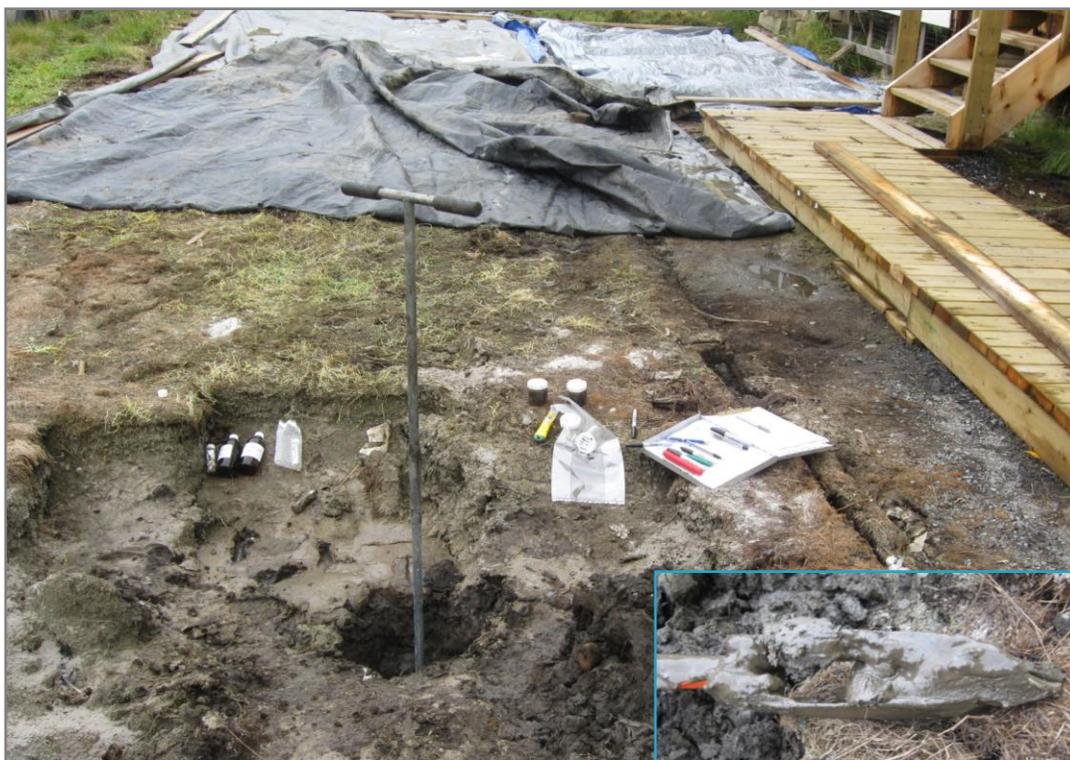
Samples from both the surface and permafrost depths at TH11-02 (the pit) exceeded CCME guidelines for toluene, ethylbenzene, xylenes and F2 PHC, while only the deep sample (1.3 mBGS) had an exceedance for benzene and F1 PHC.

Photograph 8. TH11-02 location; view facing west over south end of house. PHC sheen on soil at depth of water (inset). ↑

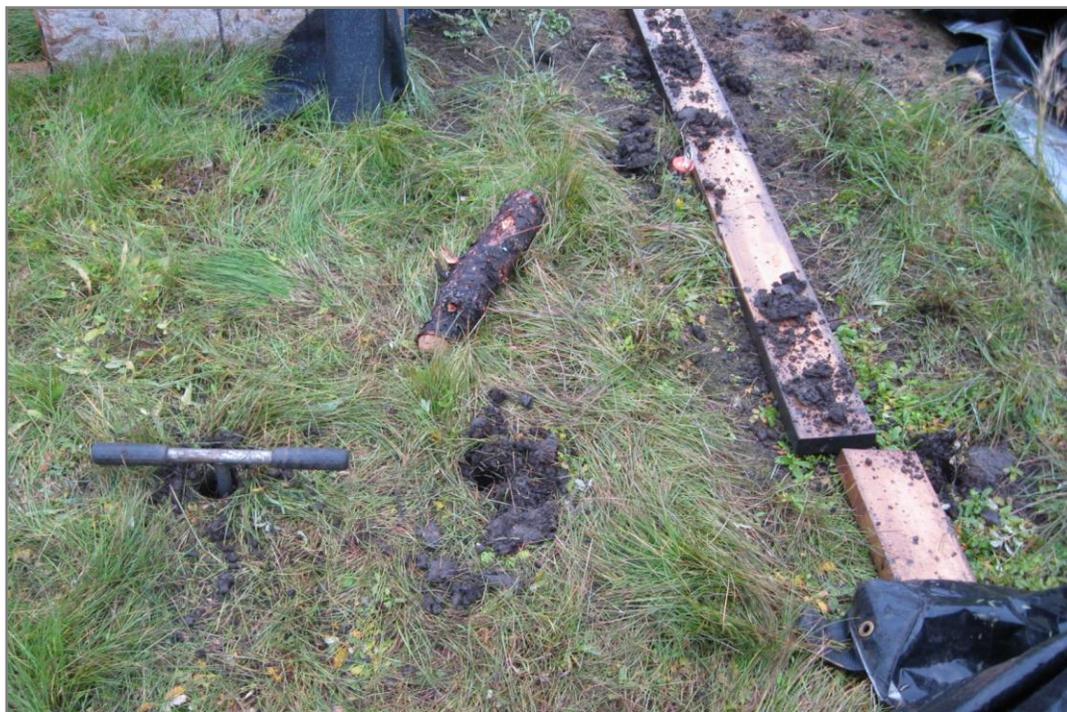
Photograph 9. Location of TH11-11 on west side of lot; permafrost reached at approximately 1 mBGS. ↑

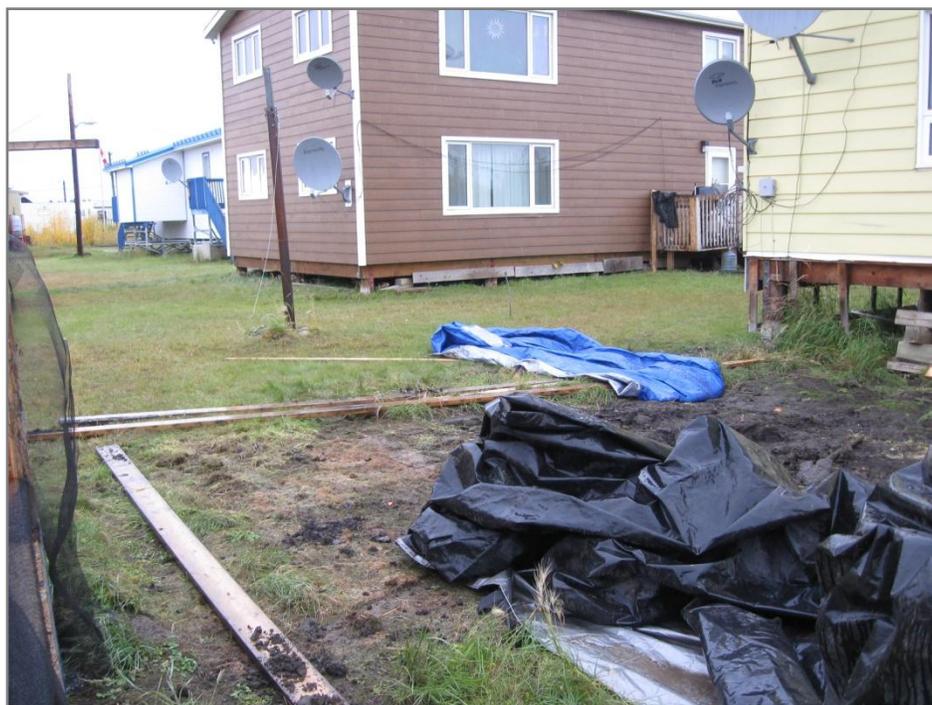
Photograph 10. View facing northwest over southwest corner of lot. Note close proximity to adjacent house and indentation in ground surface in front of the clothesline pole; this delineates the property line. ↑

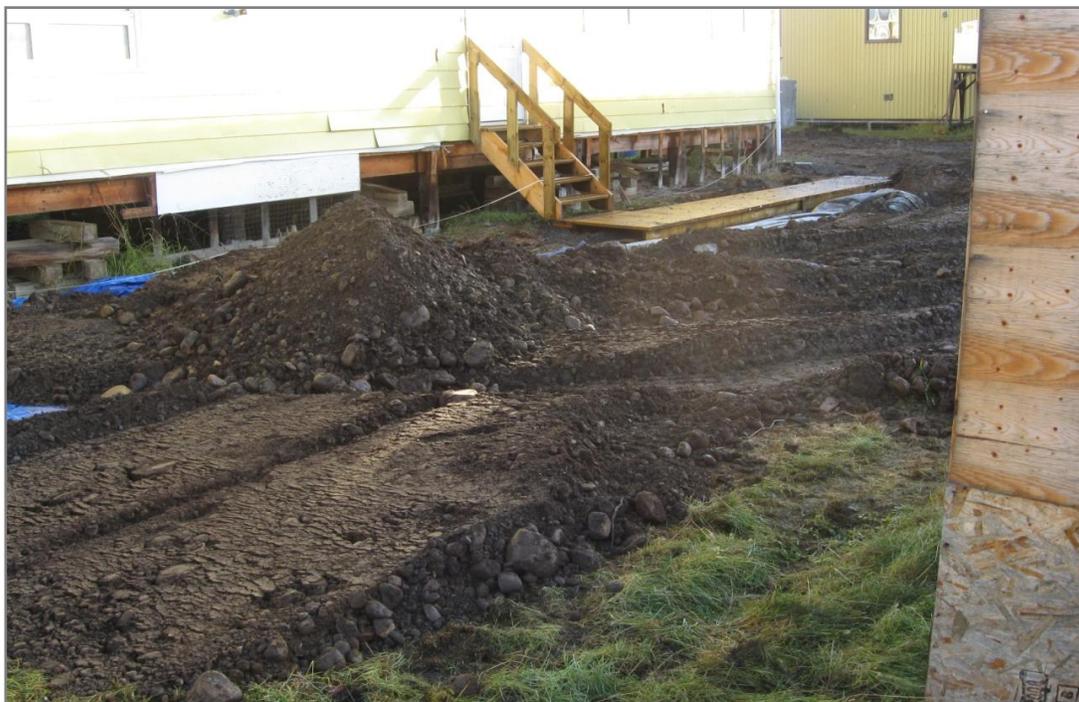
Photograph 11. View facing northeast over cover placement in progress. ↑

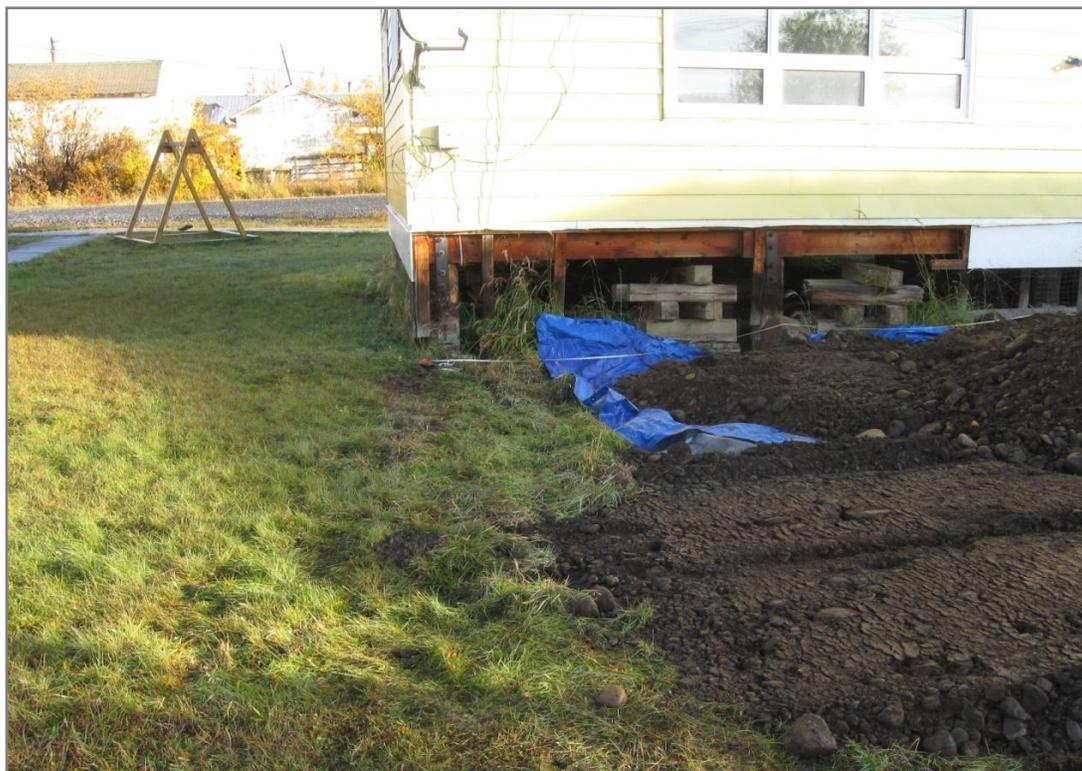
Photograph 12. View facing north over west side of property during cover placement in progress. Cover eventually placed to full extent of west side of property line. ↑

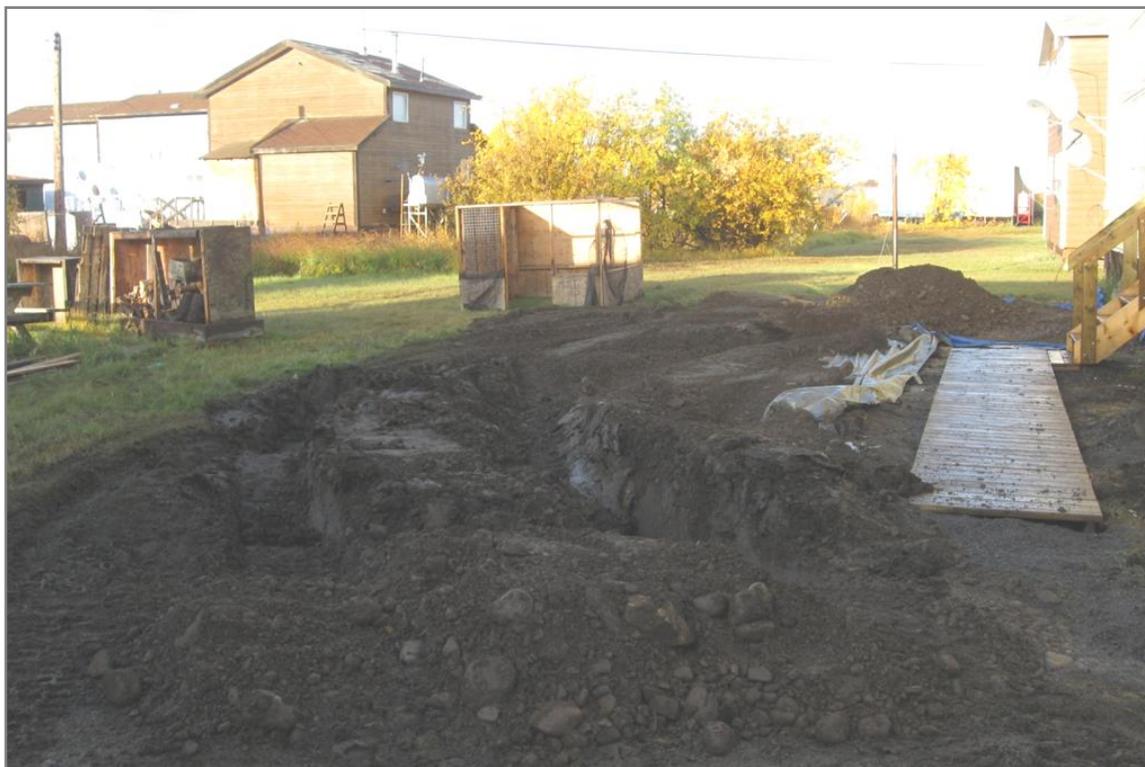
Photograph 13. Ruts remaining from initial attempts to place cover material. Silty soil conditions resulted in heavy equipment getting stuck. ↑

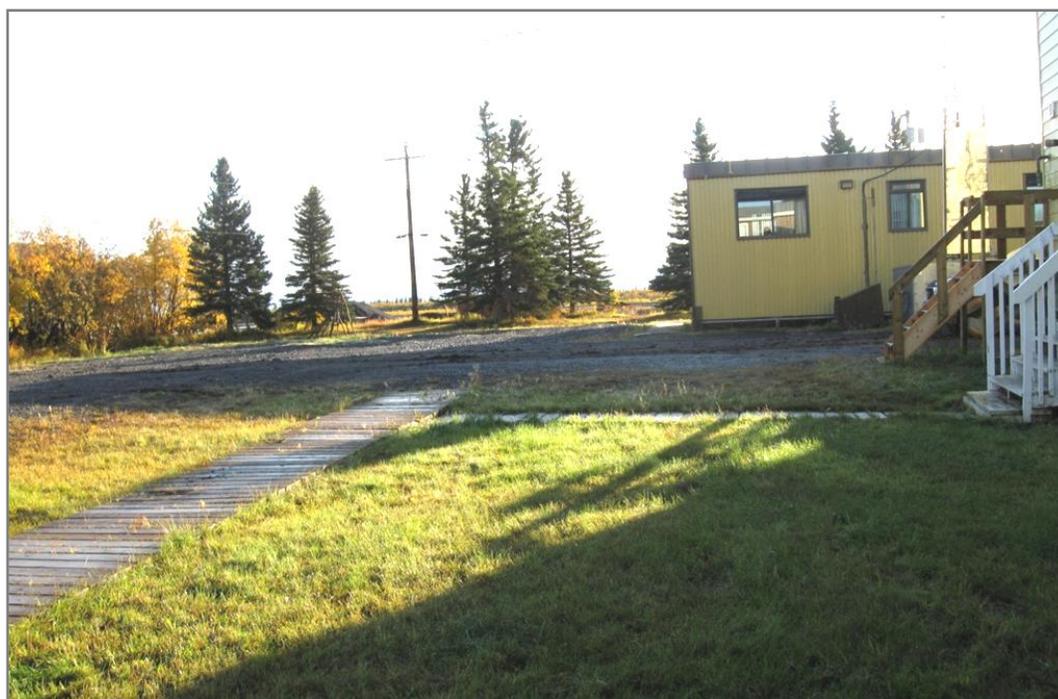
Photograph 14. View facing east over north side of lot; view facing RCMP detachment building. ↑
