PRIORITIZED ROCK SLOPE STABILIZATION WORK

Mt. Revelstoke National Park & Glacier National Park

INSPECTION OF HIGH PRIORITY ROCK AND SOIL SLOPES MOUNT REVELSTOKE NATIONAL PARK TRANS CANADA HIGHWAY MEADOWS IN THE SKY PARKWAY NELS NELSEN ROAD

INSPECTION OF HIGH PRIORITY ROCK AND SOIL SLOPES GLACIER NATIONAL PARK TRANSCANADA HIGHWAY

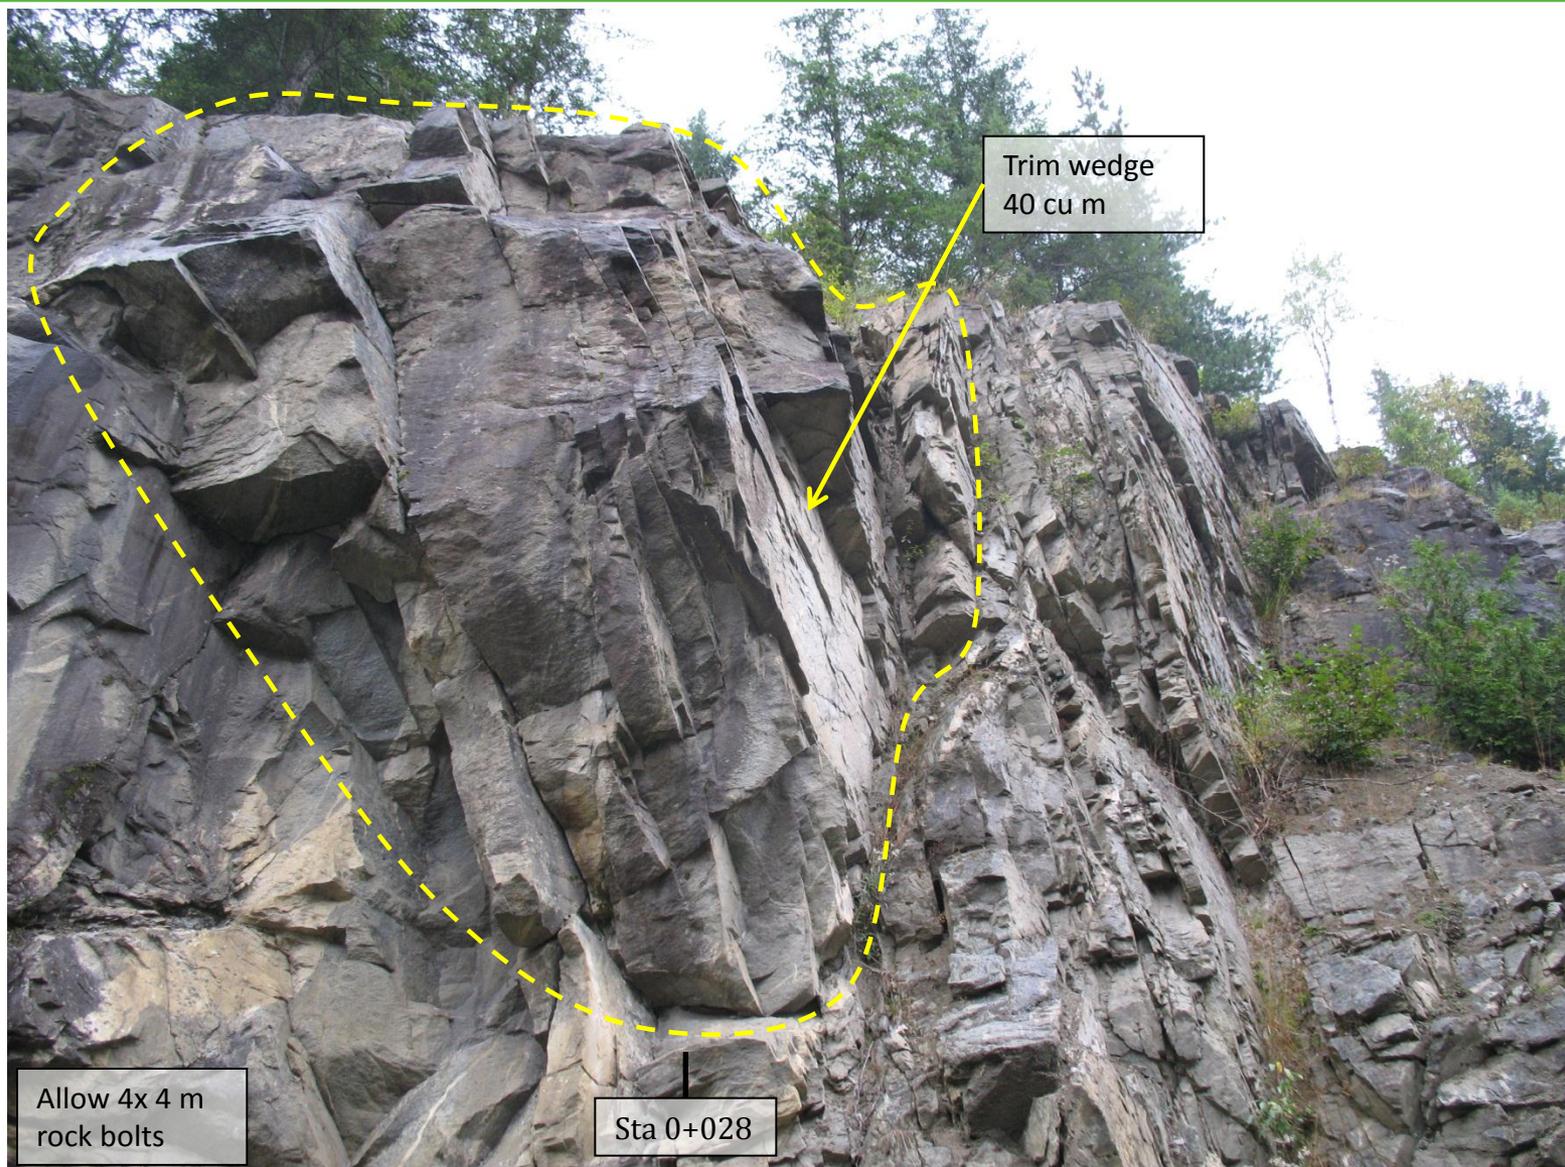
Sta 0+028

EBA's site inspectors noted a large wedge at Sta 0+028. This wedge is starting to show signs of dilation. The wedge should be removed by trim blasting. Another wedge was noted at Sta 0+061. The base of this wedge has suffered historical blast damage. Trees are growing out of the back joint of the wedge, and eventually they will lever the block from the face. The ditch beneath this wedge is 4.75 m wide and is unlikely to contain the wedge if it was to fail as a single block.

Trim wedge
40 cu m

Allow 4x 4 m
rock bolts

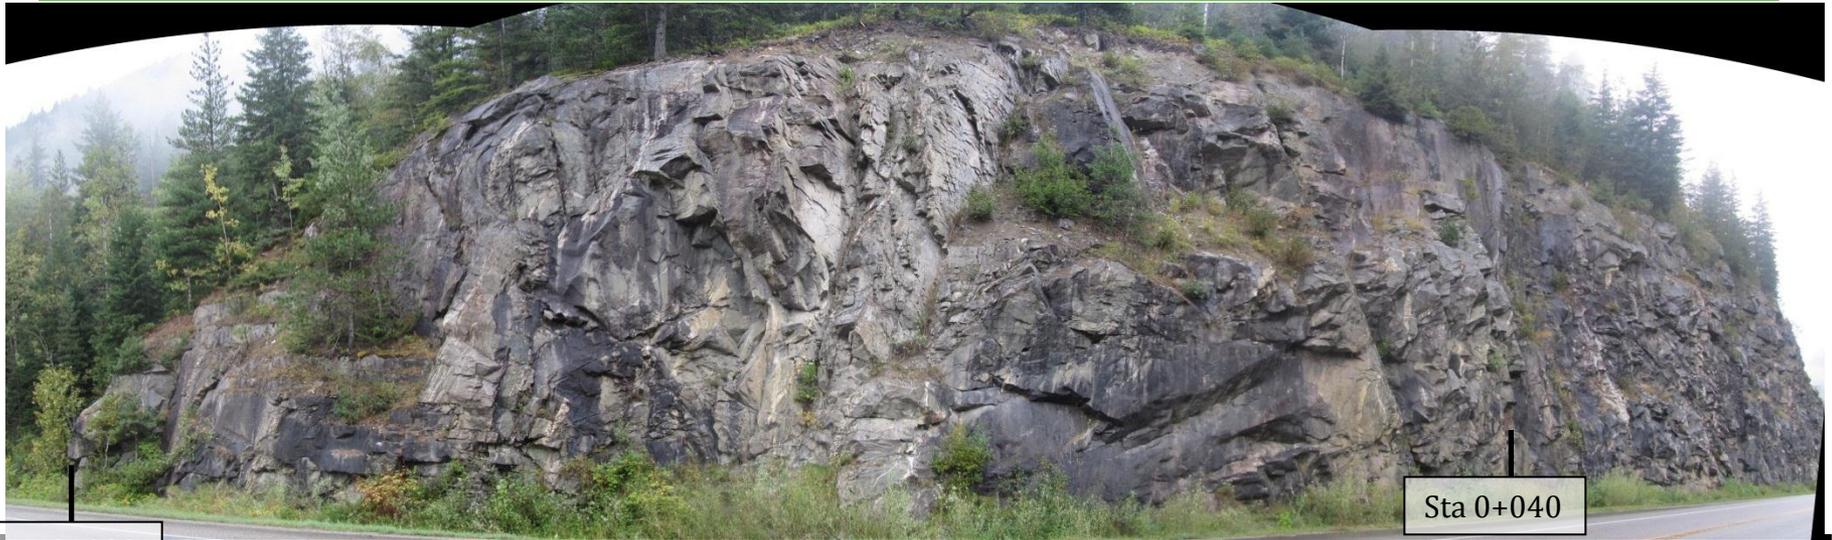
Detached blocks
Typical trim location

Scale
75 hrs
Allow 30 cu m
trim blasting of
overhangs and
wedges

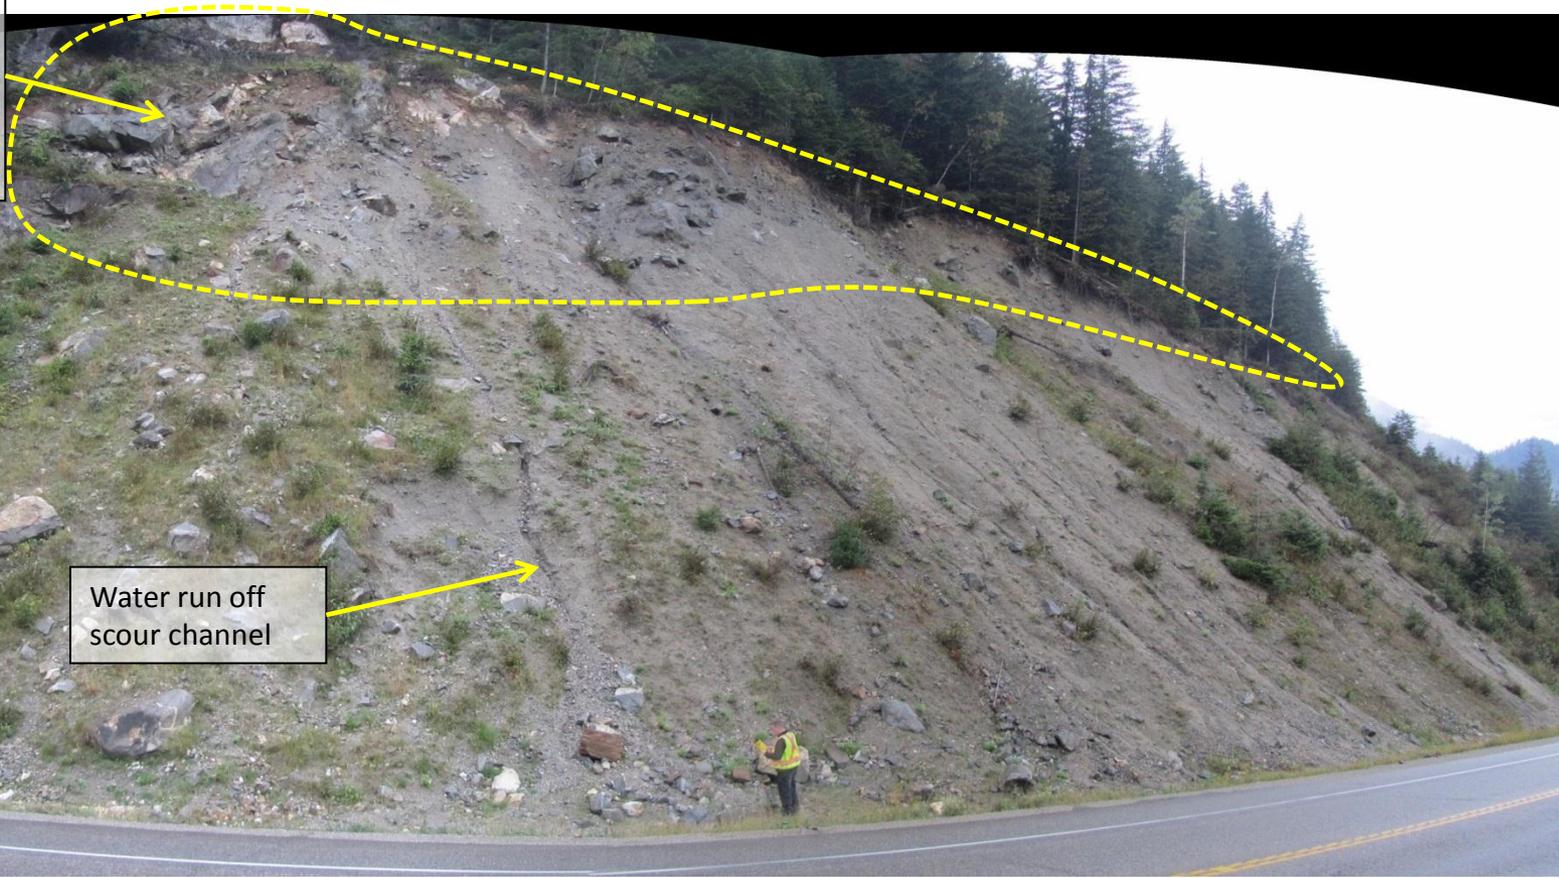
Sta 0+000

Water run off
scour channel

Surface water runoff has created a few scour channels in the accumulation of winter gravel found in the ditch. When the ditch undergoes improvement, care should be taken to avoid undermining the shoulder of the highway.
