Western and Northern Canada
Johnson Lake Dams
(Banff National Park)
2012 Engineering Inspection Report

Jim Reeves, P.Eng, MASc
Civil Engineer – Western and Northern Canada

September 1, 2012

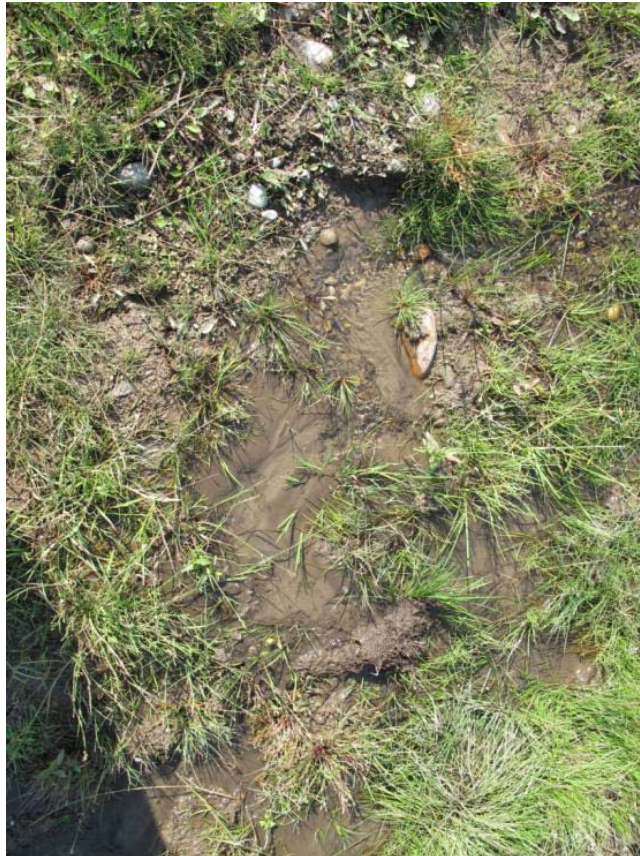
Photo 11

Vegetation (Photo 11): High standing coniferous trees were observed on the downstream embankment on either side of the creek. Vegetation types can either reinforce or compromise the dam's structure. Coniferous trees can have an aggressive weed like root network characterized by fine roots which run horizontally about 75 – 125 mm beneath the soil with an associated tap root. Tap roots some trees have been observed to reach depths of 15 – 20 m. Research has been ongoing observing the impacts of vegetation on dam stability. Coniferous trees can have root systems that can reinforce the dam's structural integrity as long as the tree is kept healthy over the life cycle period of the dam. Rotting root systems can result in preferential flow paths resulting in piping.

Vegetation: Maintain existing low growing grassy vegetation. Regular mowing operations are essential to facilitate inspection when monitoring cracking, animal burrows, surface erosion, and seepage. Newly established saplings should be removed as their roots systems have not yet established themselves to a depth of compromising the dam's structure. Existing high standing trees should be considered for removal as part of a dam recapitalization project.

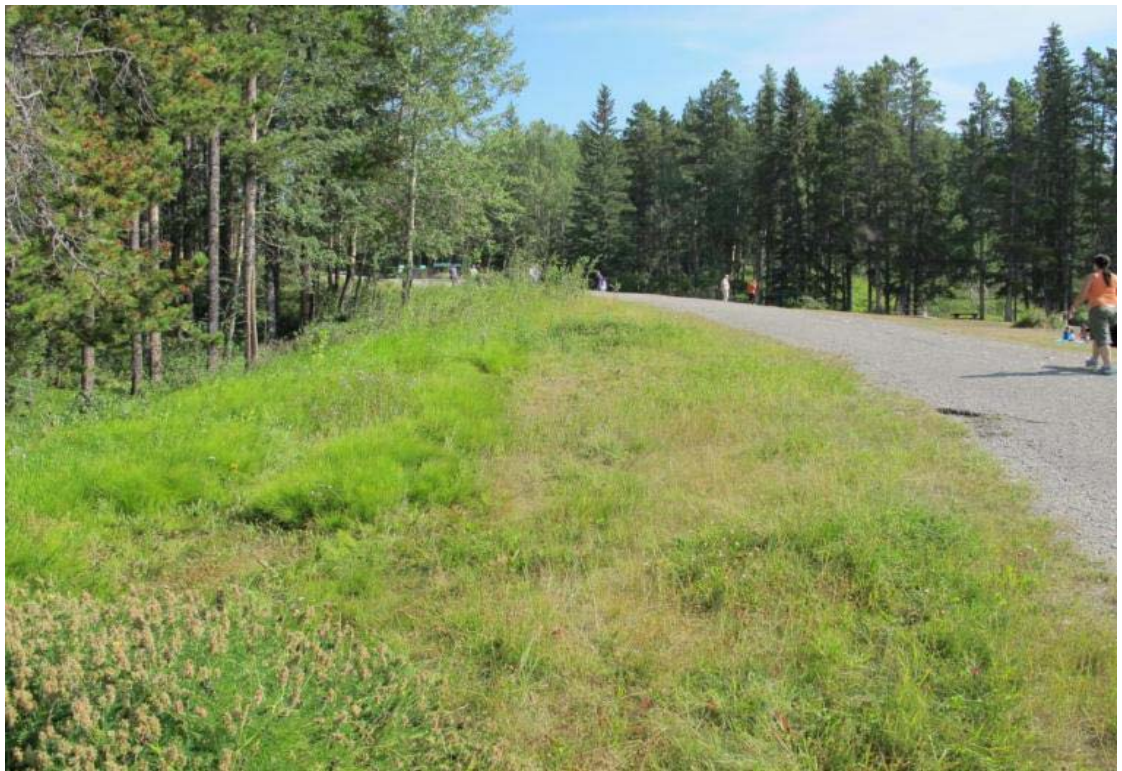
Photo 16 West Dam - Downstream bank looking north

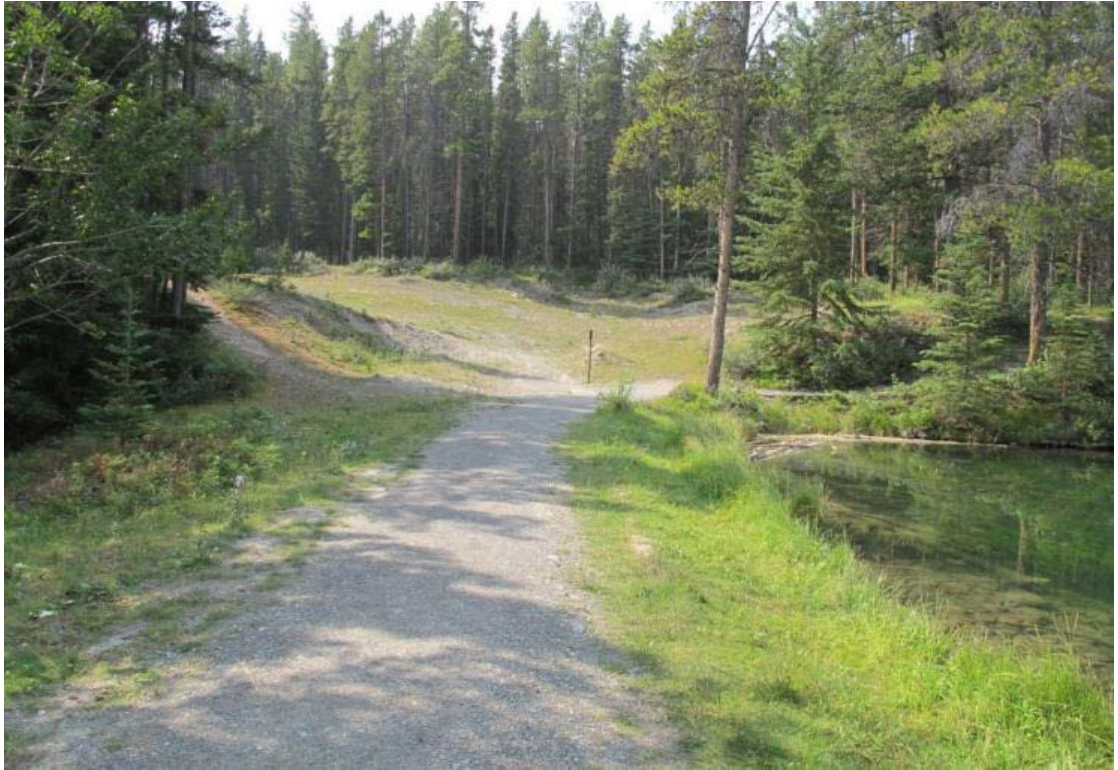
Embankment Erosion (Photos18): There is a localized area of wave erosion on the upstream embankment mid-dam. Flagstone has been placed to serve as riprap to mitigate ongoing deterioration by absorbing and deflecting wave energy. The spacing of the stone helps trap the water and mitigate erosion of the unprotected embankment. Some flagstone has been undermined and has migrated down the embankment to a point of being less effective. The crest of the dam has noticeably narrowed as a result of the erosion.

Photo 18 East Dam - Looking towards west abutment

Embankment Erosion: Bank hardening should be re-established. The depth of the bank hardening material perpendicular to the embankment should a minimum of two layers of the previously used flagstone. The flagstone should be constructed over a layer of geotextile filter cloth overlaying a layer of gravel. A maximum of a 1:2 slope should be used with the flagstone placed as to not incur any toe erosion and downward movement of the bank hardening material.

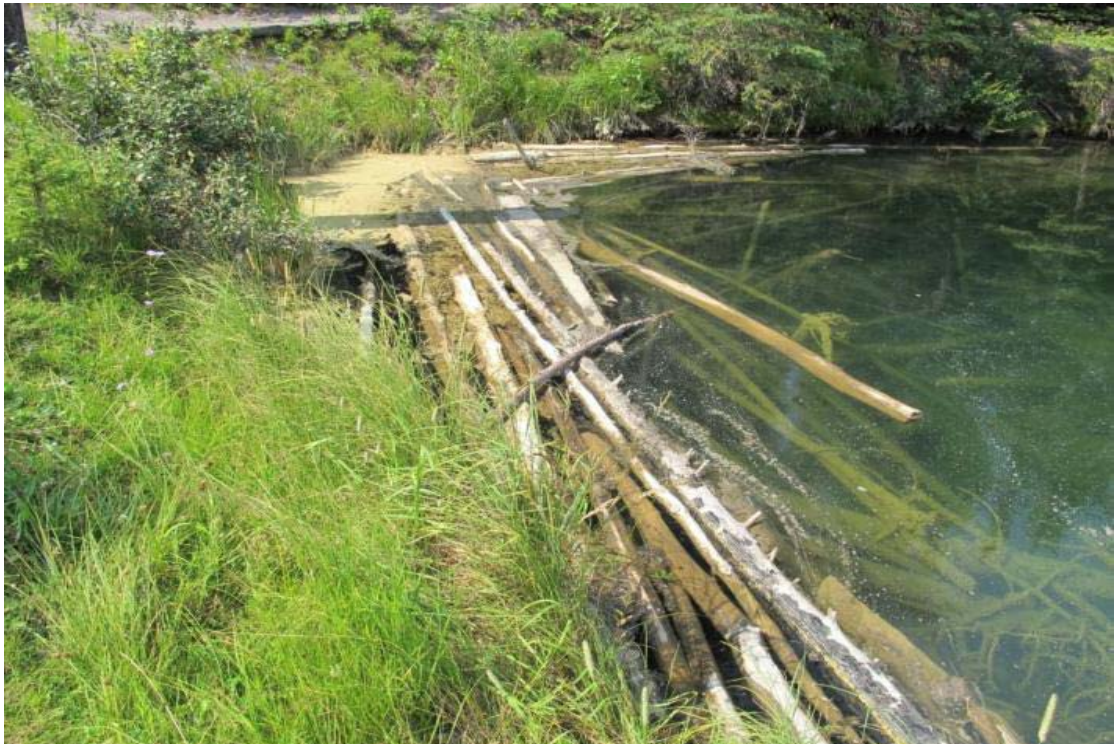
Photo 19 East Dam - Debris accumulating at west end of dam

Debris: Existing deadfall does not appear to pose a threat to the dam at this time. As part of the maintenance cycle the debris should be removed

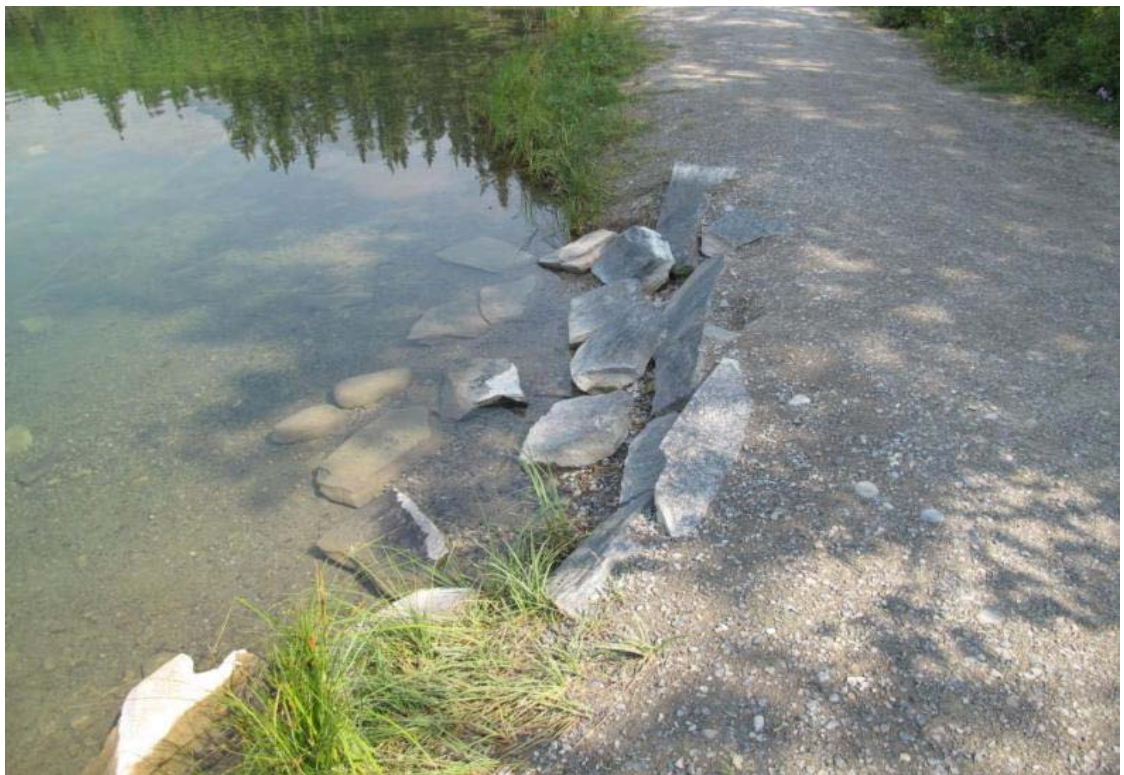
Photo 21

Overtopping (Photo 21): A 0.1 m² square, 7 m long concrete beam has been placed on the top of the embankment just east of the location of the shrubs. The beam appears to have been placed to mitigate damage caused by overtopping. Overtopping has eroded the dam crest and downstream embankment carrying dam material to the toe of the embankment. Maintenance material has been placed to reestablish the crest of the dam. Ongoing overtopping has eroded the maintenance material displacing it to the downstream embankment and toe. Minimum freeboard measurements were found to be 120 mm.

Overtopping: Freeboard design heights vary depending on the dam materials resistance to waves and overtopping, wind velocity and effective fetch, reservoir depth and potential settlement of the dam crest. Observed effects of overtopping suggest the dam crest needs to be regraded to an elevation which incorporates a minimum of a 0.3 m freeboard or drawdown the reservoir to an elevation that will attain a minimum of a 0.3 m freeboard.

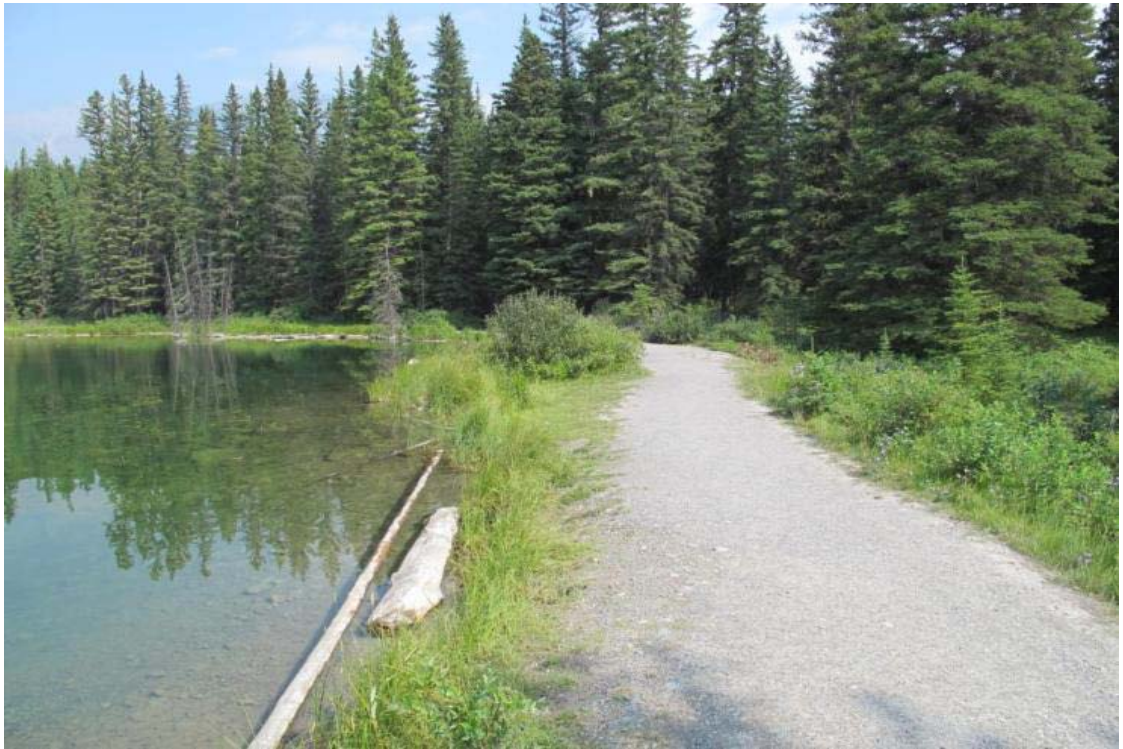
Vegetation (Photos 22): High standing deciduous trees (Poplar) were observed on the downstream embankment at the west end of the dam. Vegetation types can either reinforce or compromise the dam's structure. Poplars have an aggressive weed like root network characterized by pencil like strands with a woody bark that run horizontally about 75 – 125 mm beneath the soil. Tree root systems may compromise the dam's structure either through overturning leading to large root-soil plates or when root systems rot result in preferential flow paths resulting in piping.

Photo 22 East Dam - Looking towards east abutment

Vegetation: Maintain existing low growing grassy vegetation. Regular mowing operations are essential to facilitate inspection when monitoring cracking, animal burrows, surface erosion, and seepage. Newly established saplings should be removed as their roots systems have not yet established themselves to a depth of compromising the dam's structure. Existing high standing trees should be considered for removal as part of a dam recapitalization project.

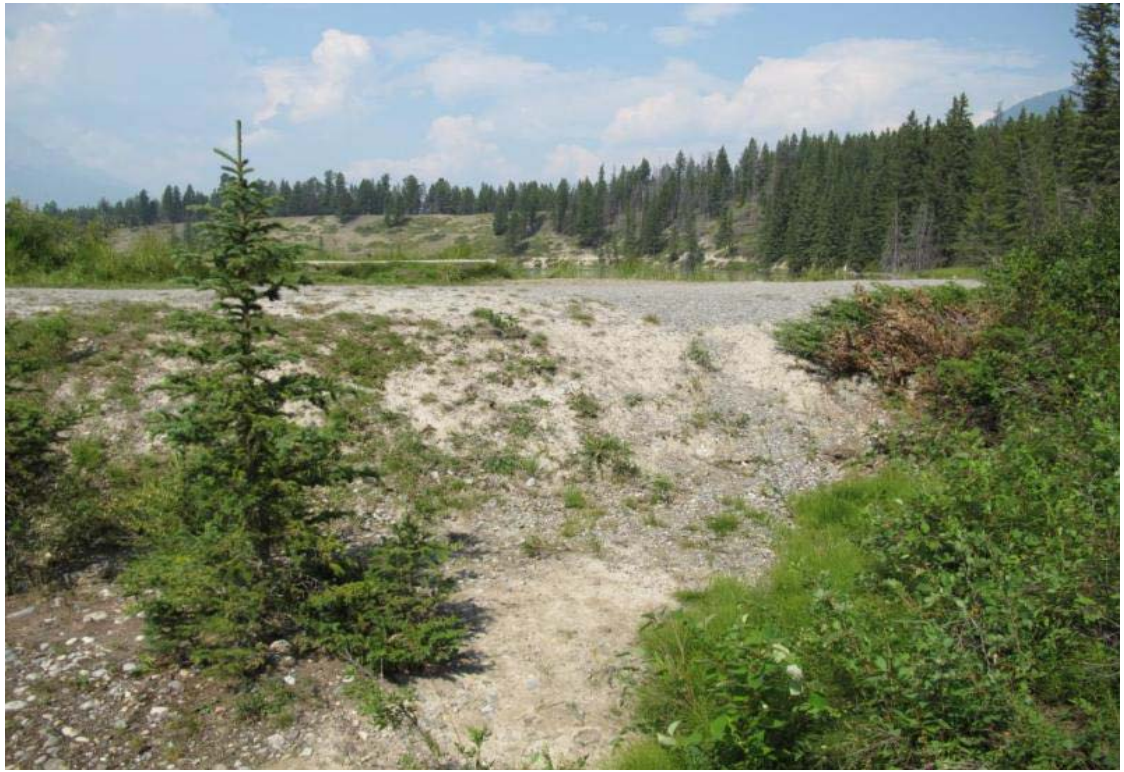
Failure Scarp (Photos 25): There is a notable curved scarp located on the downstream embankment at the west end of the dam. The scarp is approximately 7m in length and 150 mm at its deepest point. Located down slope of the scarp were zones of bulging. The combination of the scarps geometry and two ground movements (vertical displacement and bulging) are indications of a slope failure. There is insufficient information to determine whether the failure is rotational or translational. Failures of this type can occur slowly or suddenly and are the result of either a loss in soil strength or a change in the embankment geometry. A major contributor to a loss in soil strength is a change in effective stress caused by increased pore water pressures.

Rutting (Photo 25): Uniformly spaced rutting was noted at the west end of the dam. This implies that vehicles with narrow wheel bases had traversed the dam's crest. Rutting indicates an insufficient degree of compaction of the dam's crest material to support the intended loading. After further investigation it was discovered that the Field Unit had mobilized construction equipment to the site to support maintenance operations.

Photo 25 East Dam - Evidence of overtopping

Failure Scarp: Lacking the information detailing the soil qualities at the observed location of the scarp it is difficult to determine proper mitigating measures. It is recommended that a toe berm be established at the location of the scarp to limit future movement until a formal Dam Safety Review can be done.

Rutting: Rutting is a sign that vehicles for which the dam was not designed to support had traversed the dam.

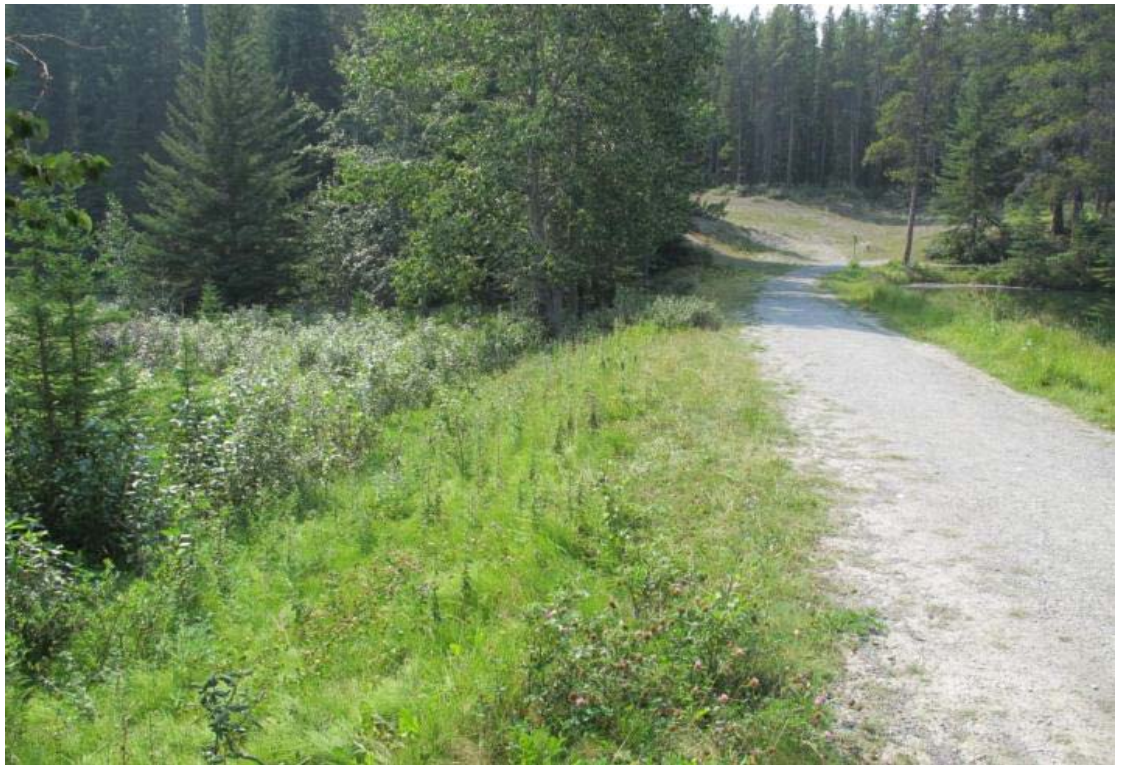
Photo 27 East Dam - West end vegetation on downstream bank
