# KING MOUNTAIN TRAIL RESTORATION GATINEAU PARK

SUMMARY OF ISSUES AND PROPOSED INTERVENTIONS

The current document focuses on the King Mountain Trail (approximate length 1.8 km), located in the southern part of Gatineau Park. A summary analysis of the issues is presented, as well as their associated proposed interventions.

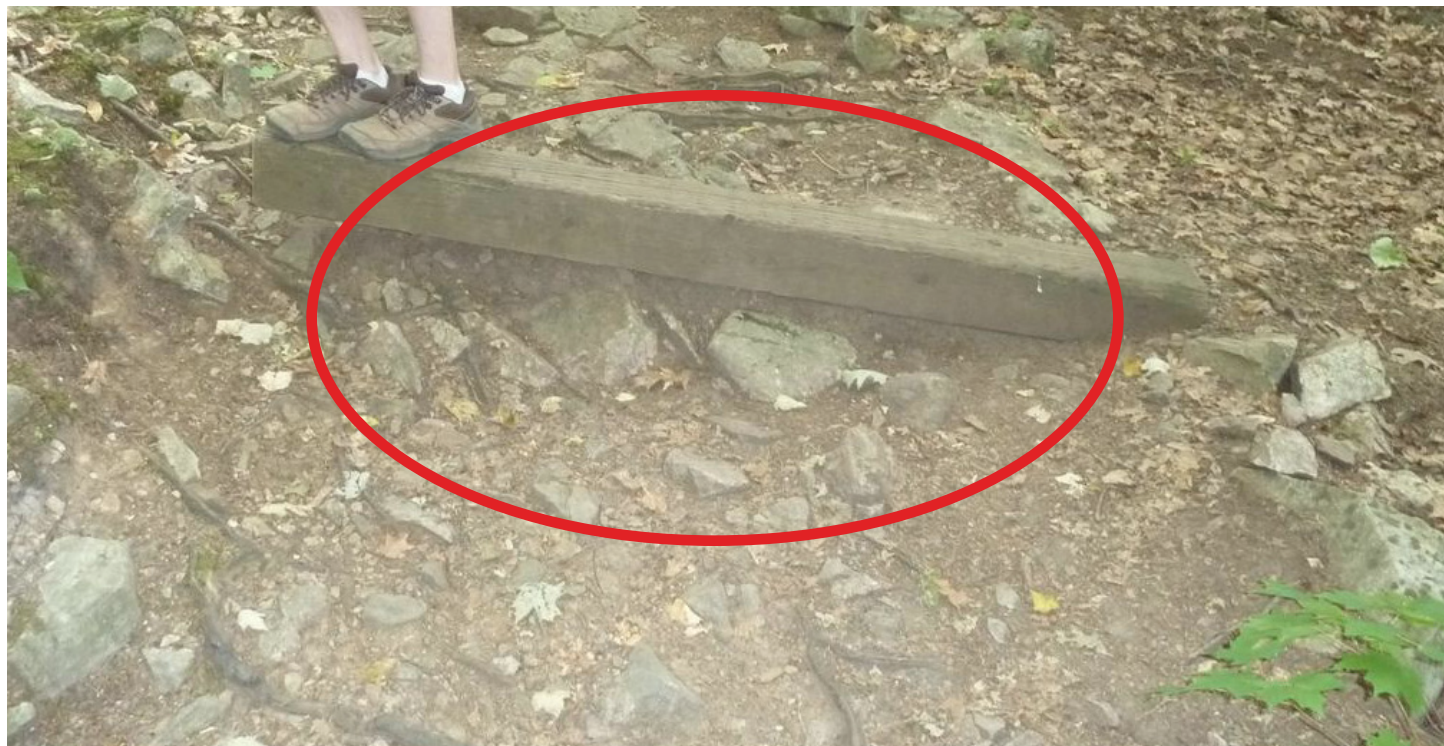
- An unnecessary square timber step in the center of the trail

- Clear the path of unnecessary obstacles and recuperate the square timber for use with other interventions
- Recuperate nearby existing natural stones to level the ground

- **A-3** Remove the simple timber and level the surface with existing materials found on the site. Recuperate the existing timber if possible, otherwise dispose off-site.

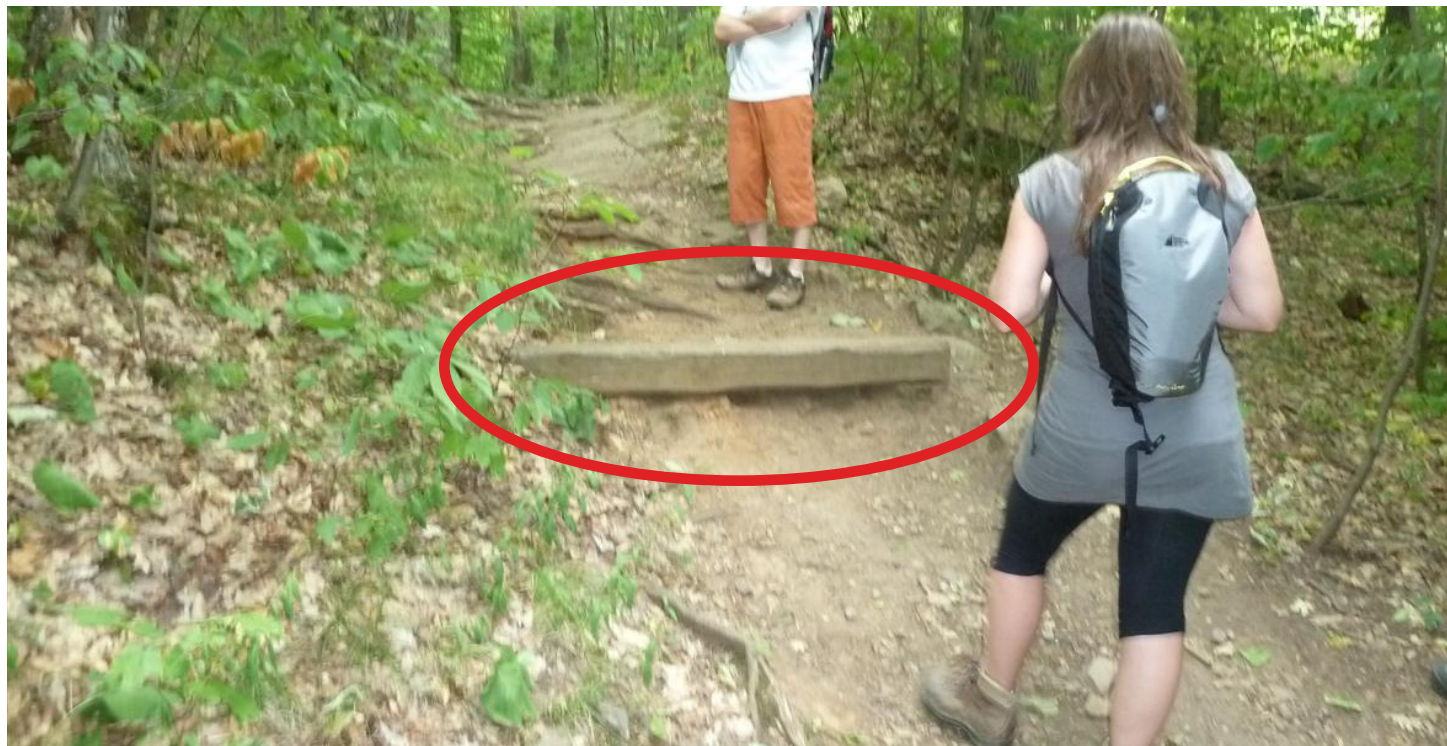
- An unstable square timber step
- Indications of erosion caused by surface runoff

- Stabilise the timber to create a step

**D-2** Remove the existing timber and install a step. Recuperate the existing timber if possible, otherwise dispose off-site.

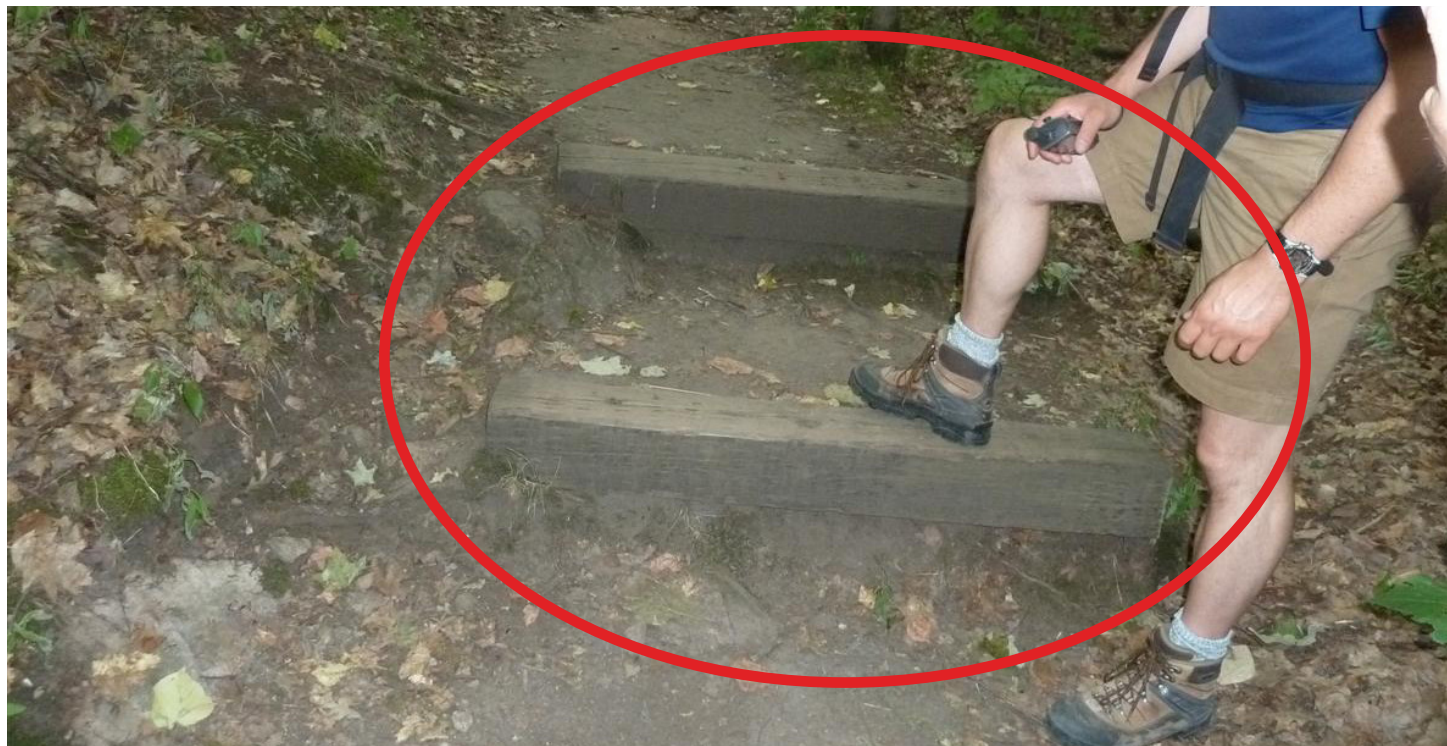
- Two square timber steps are unstable and too high
- Indications of erosion caused by surface runoff

- Stabilise the timbers to create steps and adjust their levels

**D-2** Remove the existing timber and install a step. Recuperate the existing timber if possible, otherwise dispose off-site.

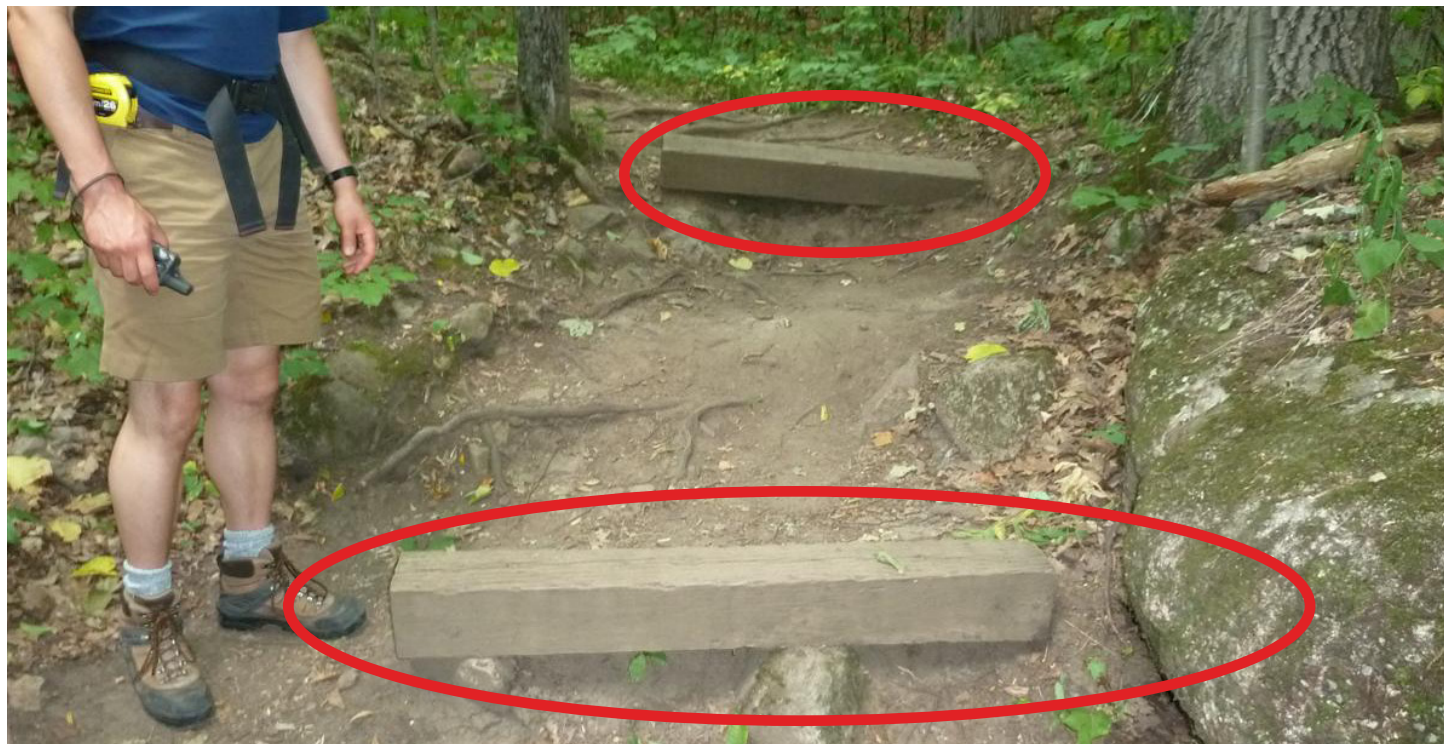
- Three square timber steps are unstable and too high
- Indications of erosion caused by surface runoff

- Stabilise the timbers to create steps and adjust their levels

**D-2** Remove the existing timber and install a step. Recuperate the existing timber if possible, otherwise dispose off-site.

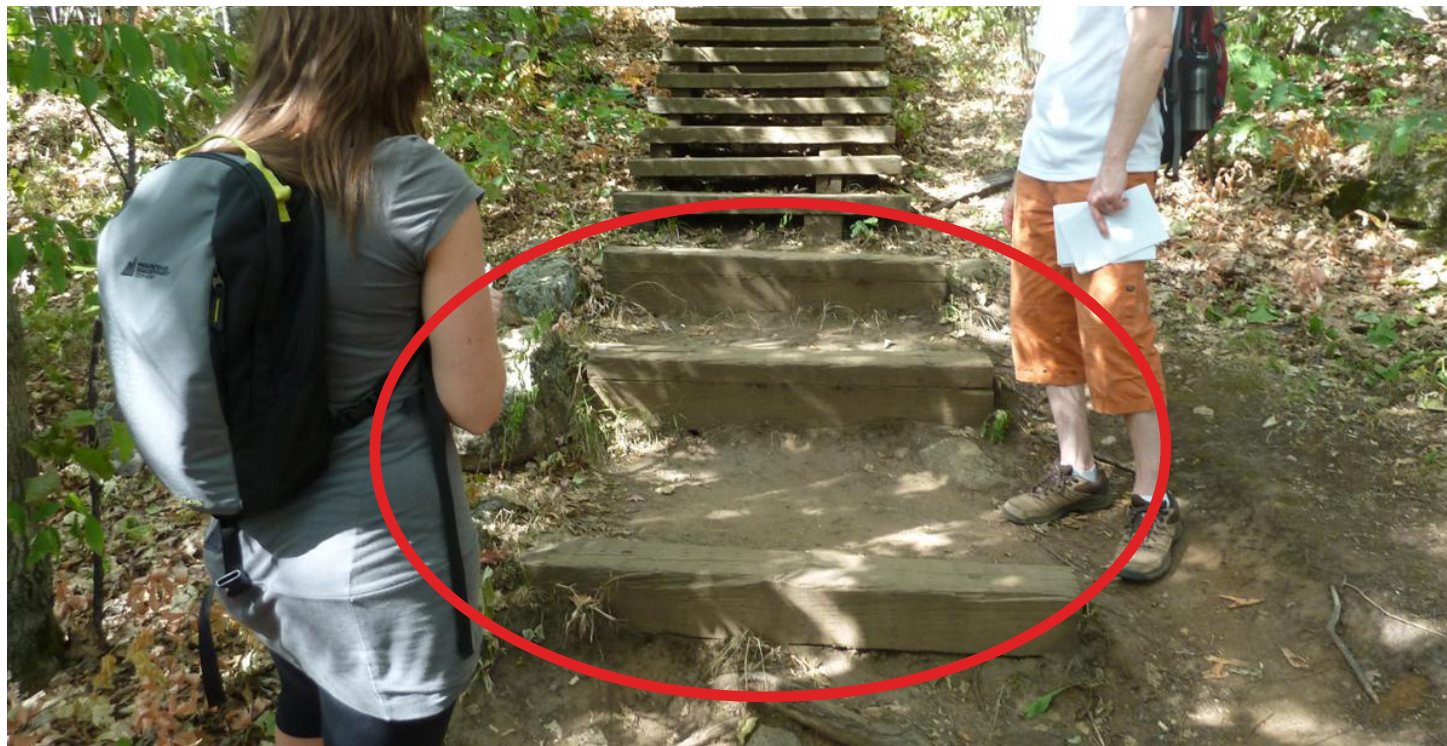
- Three square timber steps are unstable and too high

- Remove 3 timbers to create a continuous elevated staircase with a landing

- D-1 Remove the existing timbers and install an elevated staircase with a landing

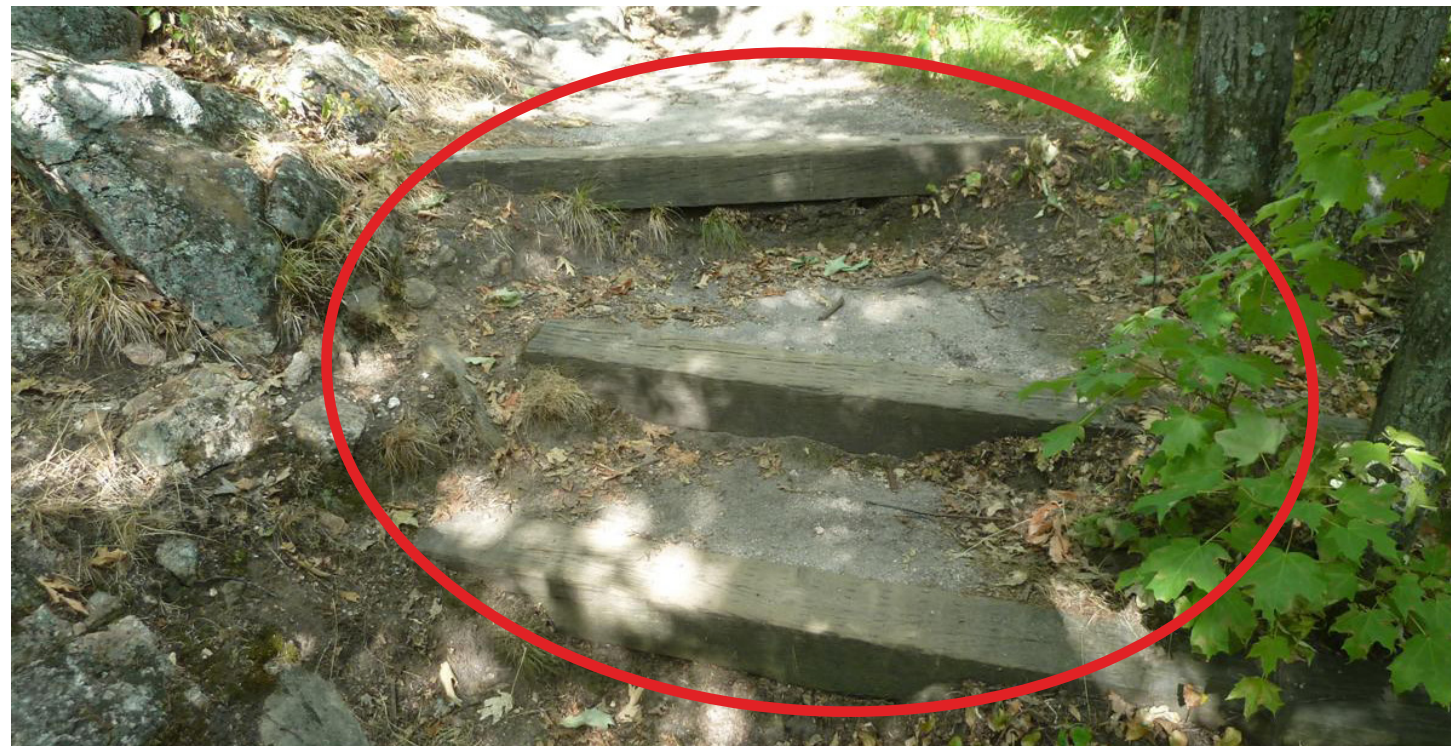
- Three square timber steps are unstable and too high
- Indications of erosion caused by surface runoff

- Remove 3 timbers to create a continuous elevated staircase

- D-1 Remove the existing timbers and install an elevated staircase with a landing

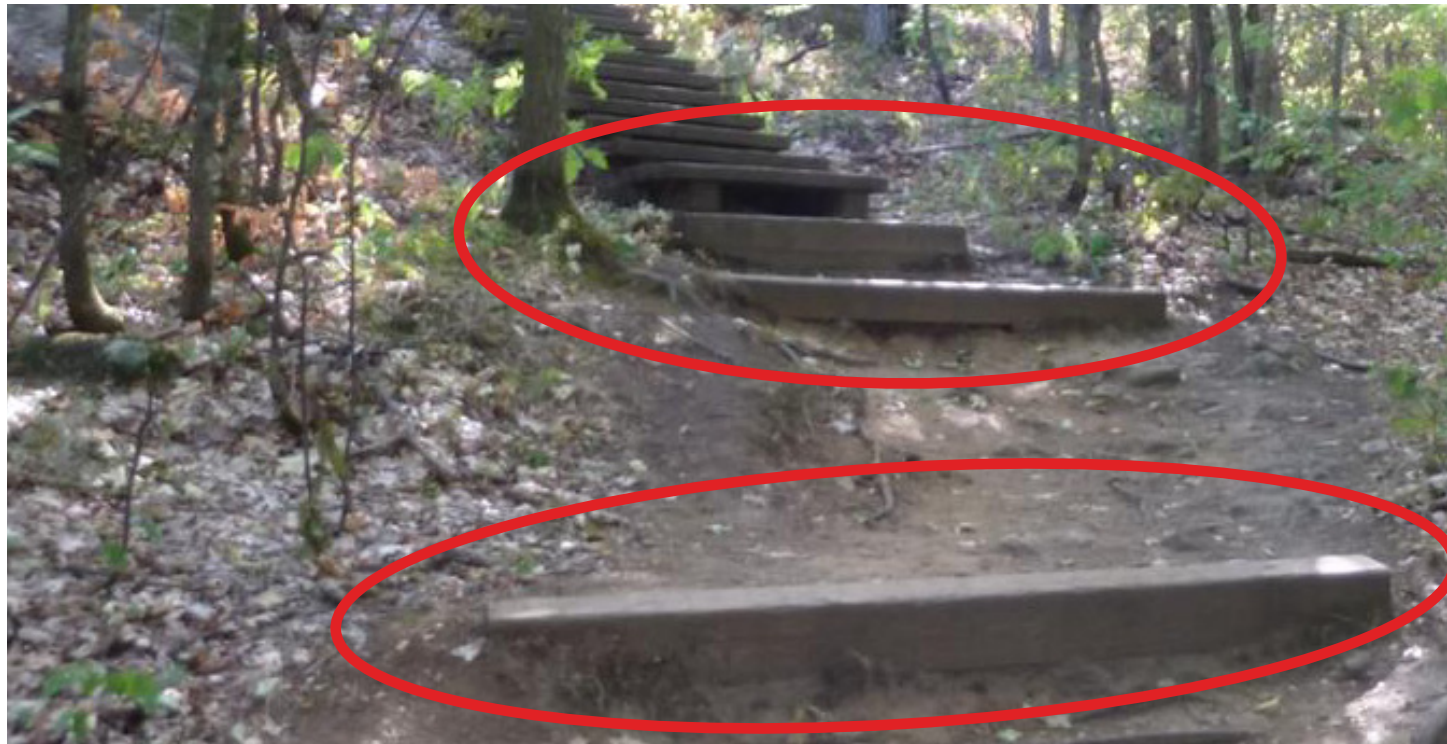
- Two square timber steps, at the bottom of the stairs, are unstable and too high
- One square timber step is unstable and too high : located after the stairs
- Indications of erosion caused by surface runoff

- Remove the 2 steps to create a continuous elevated staircase
- Stabilise the timbers to create steps and adjust their levels
- Lengthen the existing staircase to protect the path

- D-1 Remove the existing timbers and install an elevated staircase (allow for approximately 2 landings)
- D-2 Remove the existing timber and install a step. Recupérate the existing timber if possible, otherwise dispose off-site.

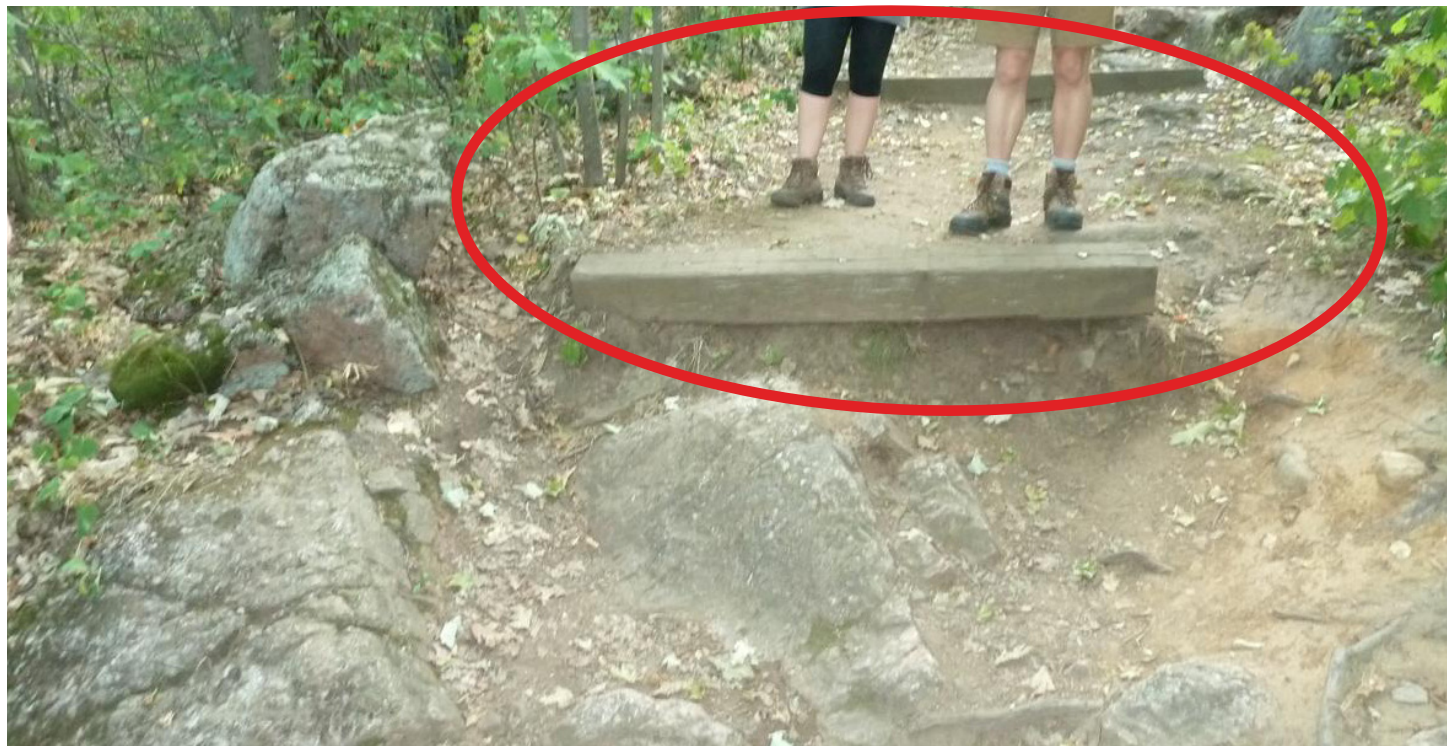
- Two square timber steps, at the center of the trail, are unstable and unnecessary
- Indications of erosion caused by surface runoff

- Remove the 2 timbers, leveling the trail and placing the existing stones to create a safe route of passage
- Install the timbers to create steps and adjust their levels

- **C-1** Fill the central portion of the trail, raising the area with granite stone dust mix, 0-19 mm dia., compacted with plate tamper. Align the natural stones to delineate the edges of the path to take.
- **D-2** Remove existing timbers and install the steps. Recupérate the existing timbers if possible, otherwise dispose off-site.

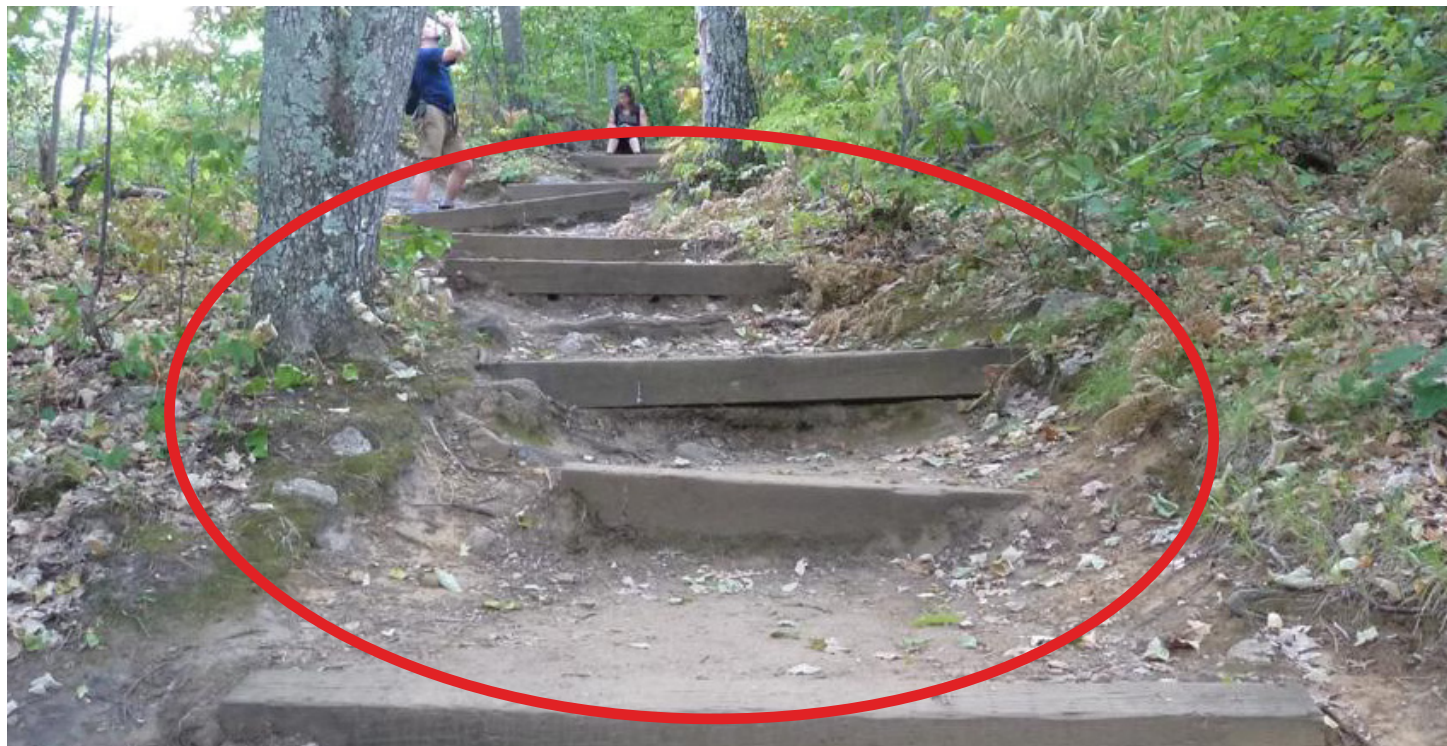
- About 12 square timber steps, in the center of the trail, are unstable
- Indications of erosion caused by surface runoff

- Remove the timbers to create a continuous elevated staircase
- Recuperate the square timbers for use in other interventions

- D-1 Remove the existing timbers and install an elevated staircase (allow for approximately 8 landings, 1.5 metres long)

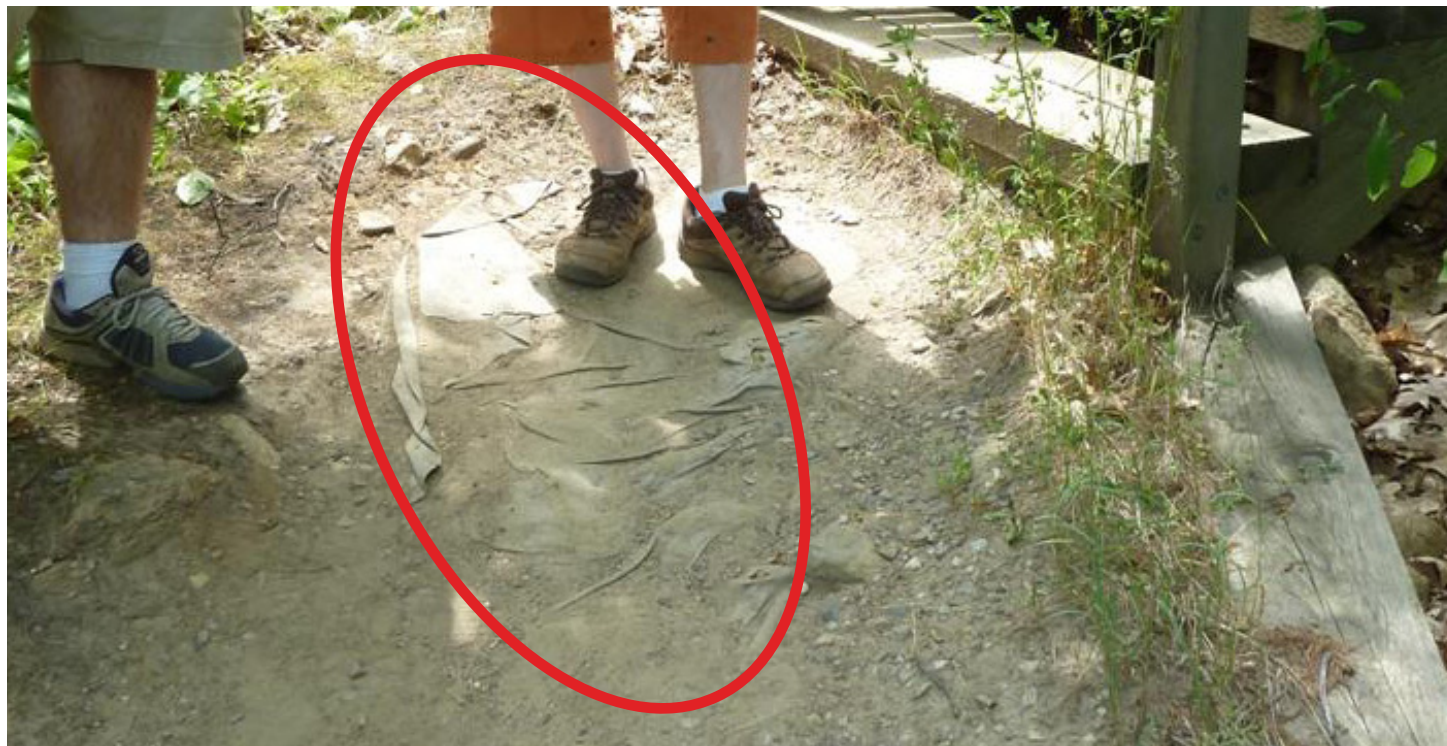
- Visible geotextile caused by : steep slope and the gravel mix is washing off the surface
- The staircase of this portion does not have a handrail and is steep

- Keep the path safe by cutting the excess geotextile and levelling the trail as needed
- Install a handrail for the portion of the existing staircase

- **C-1** Remove the geotextile and level the material on-site. As needed, fill with granite stone dust mix, 0-19 mm dia., compacted with plate tamper.
- **D-3** Install handrail for existing staircase

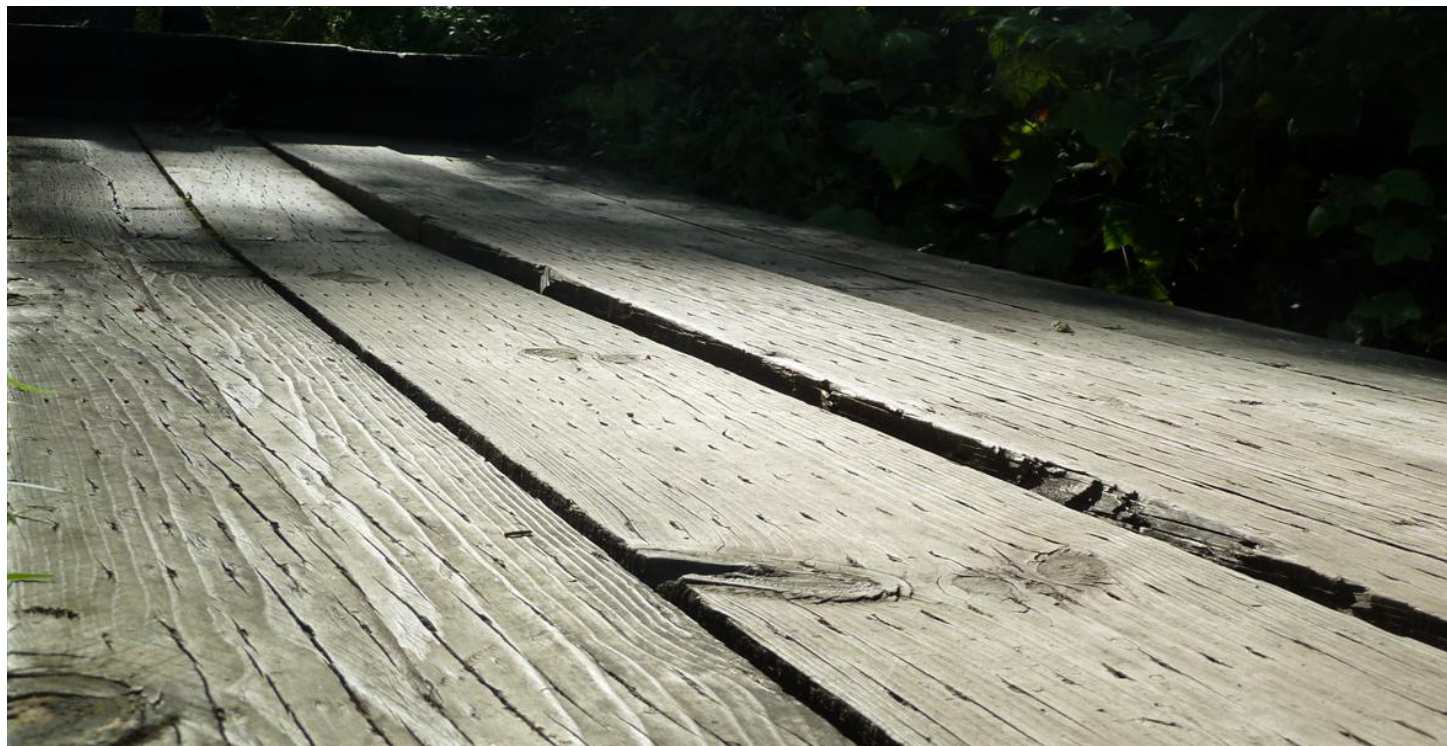
- A square timber on the boardwalk is too high

- Replace the timber to create safe passage

- Adjust the elevated timber on the existing boardwalk as shown in the previous picture

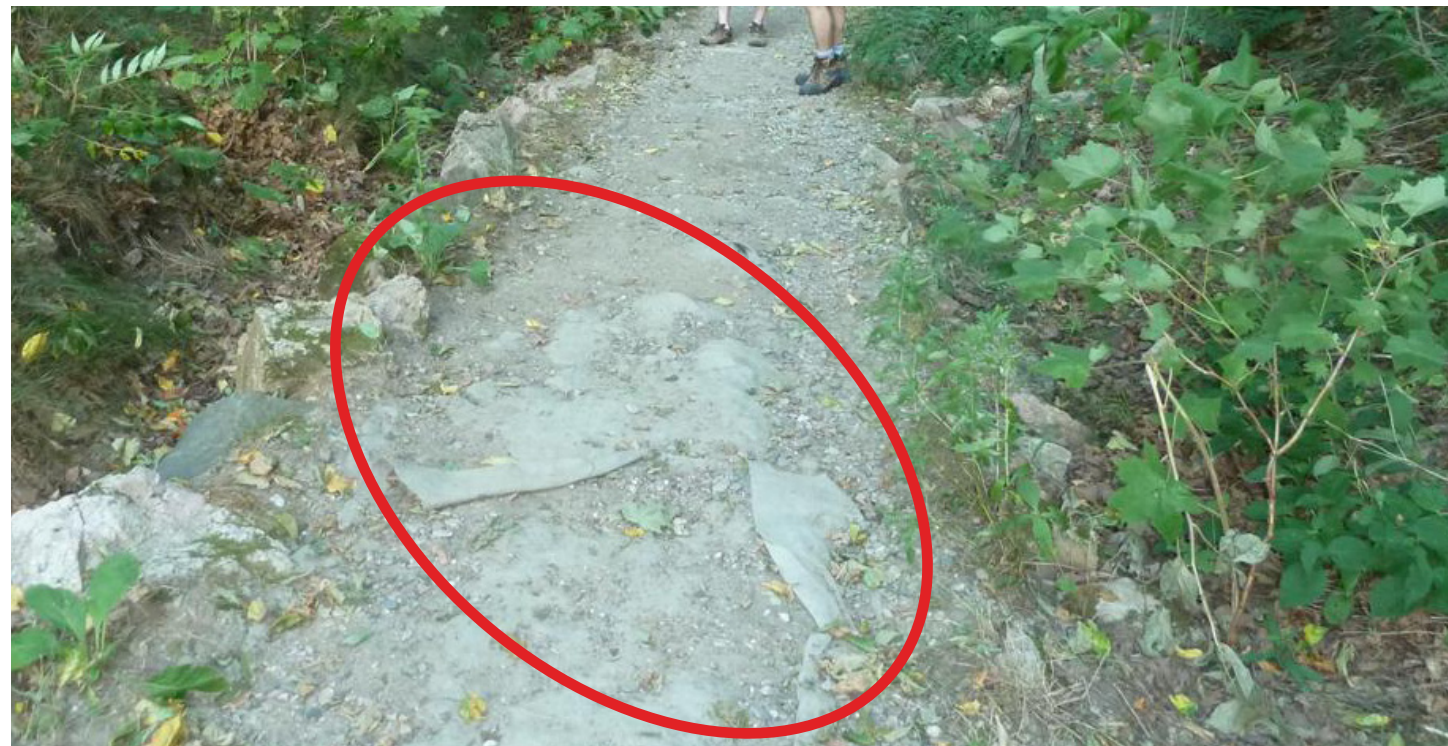
- Long trail with steep slope showing geotextile caused by the washing away of gravel

- Remove the geotextile and realign the water drainage
- Intervene at the source and direct the water to the lowest grade point, preventing it from running along the length of the path
- Focus interventions on three zones of the trail to optimize water captation

- B-1 Install cross drains along the trail (3 interventions)
- C-1 Fill the central portion of the trail with granite stone dust mix, 0-19 mm dia., compacted with plate tamper, after having removed the geotextile
