Pre-renovation Hazardous Building Materials Survey Report

Combined Services Building Sandspit Airport Sandspit, BC

September 21, 2011

PHH ARC Project No. 12166C

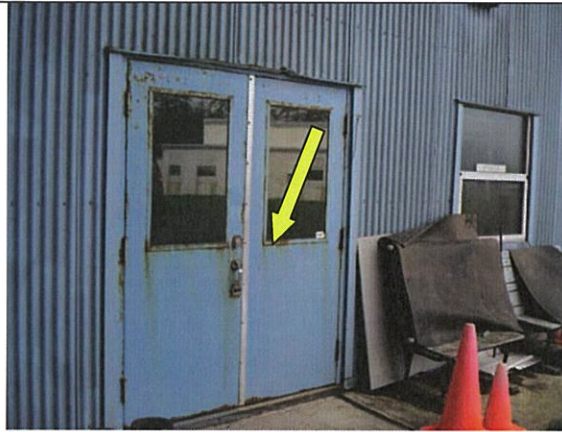
Typical asbestos-containing black window putty applied to glazing of the exterior man doors.

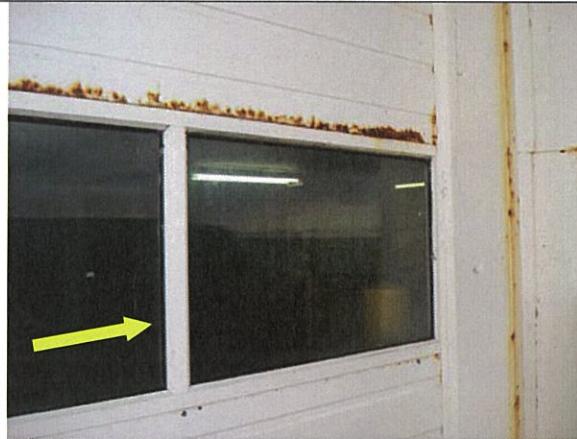
Typical asbestos-containing black window putty applied to glazing of the exterior overhead sectional doors.

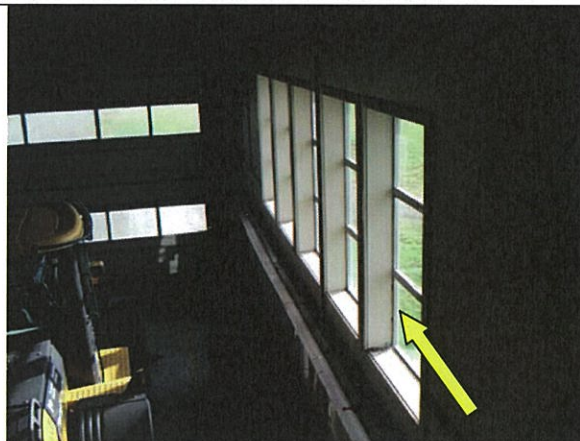
Typical asbestos-containing black window putty applied to the glazing of windows on the North and South facades
