APPENDIX 5
WATER ACCESS

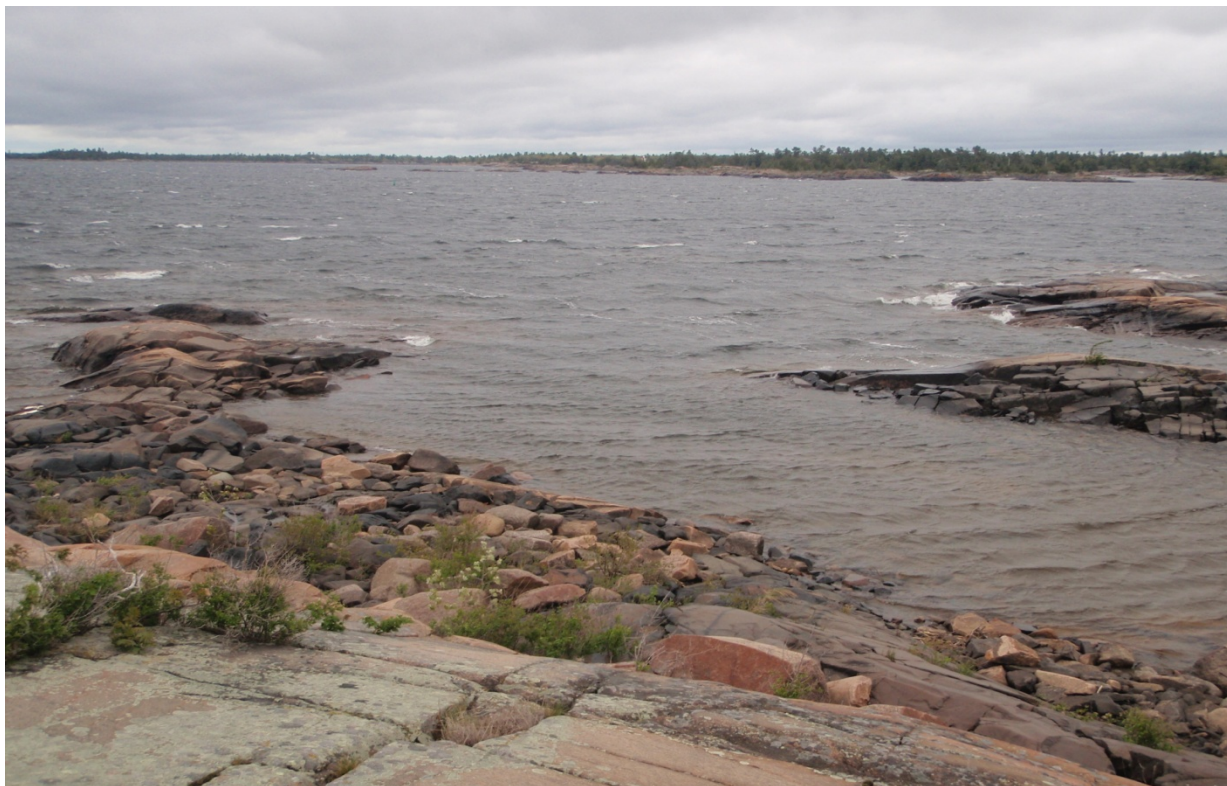
Photo 1: Looking north – Light Tower building is to the right outside of photo frame.

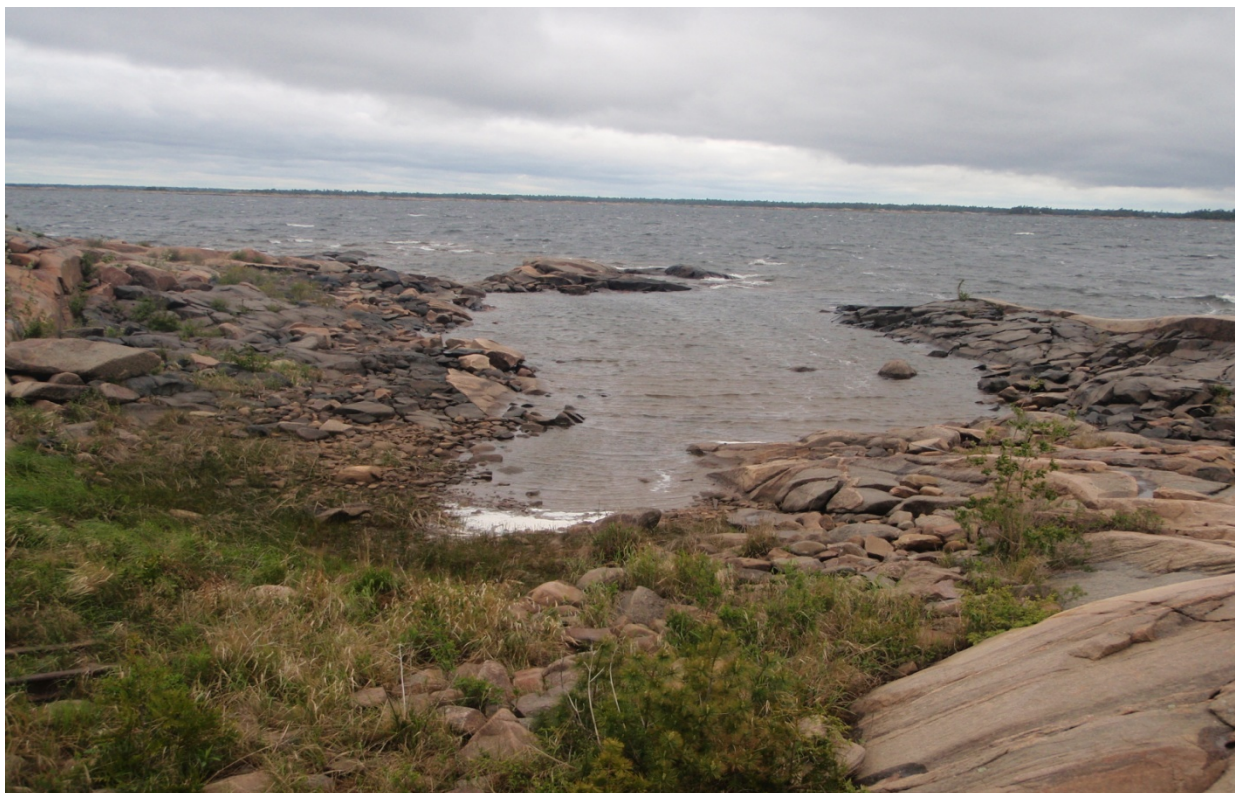
Photo 2: Looking north – showing possible landing slip. Same location as shown in Photo 1 above.

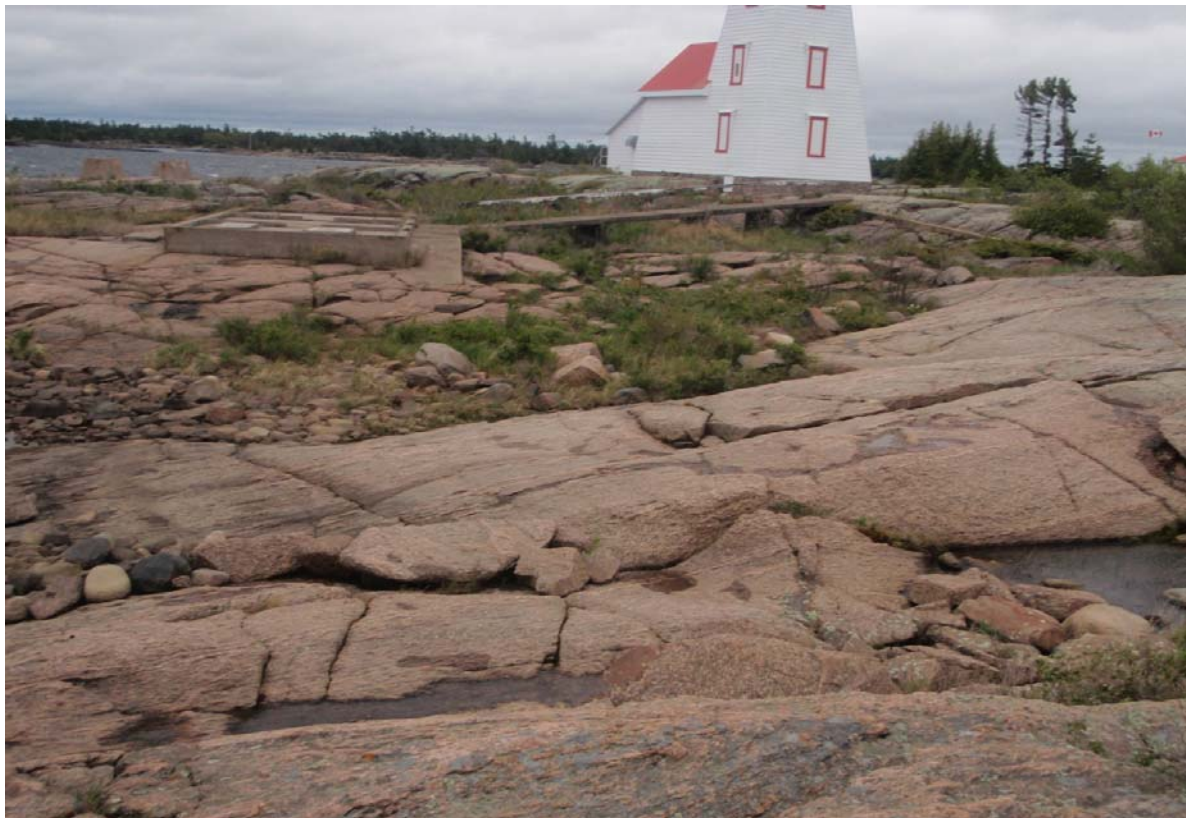
Photo 3: Looking north-east towards the Light Tower building. Remains of former concrete dock.
