APPENDIX 5
SITE PHOTOGRAPHS

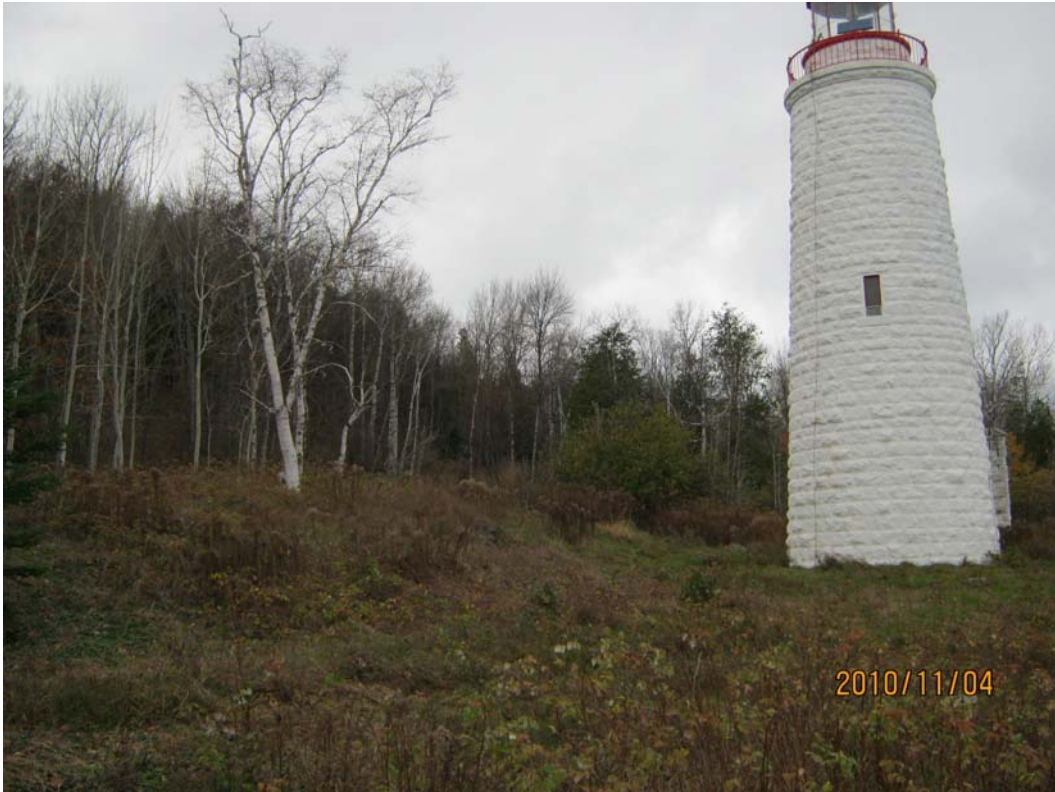
Photograph No.1 – View of light tower facing northwest.

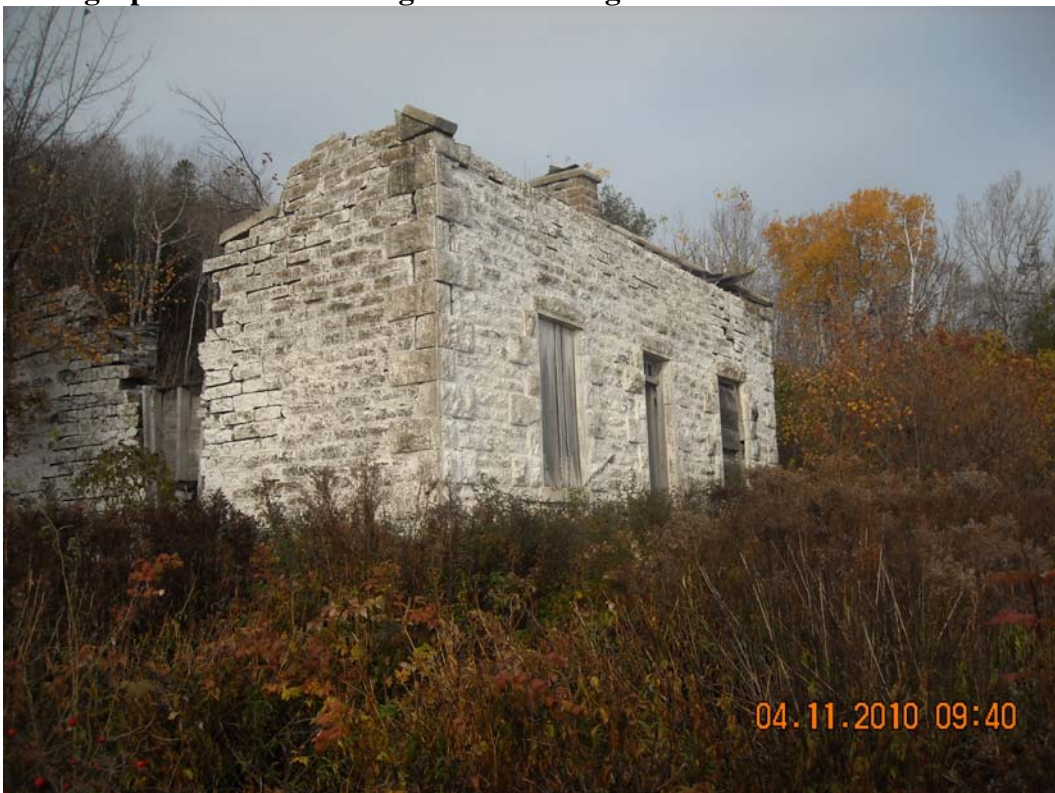
Photograph No.2 – View of former light keepers dwelling facing northwest.

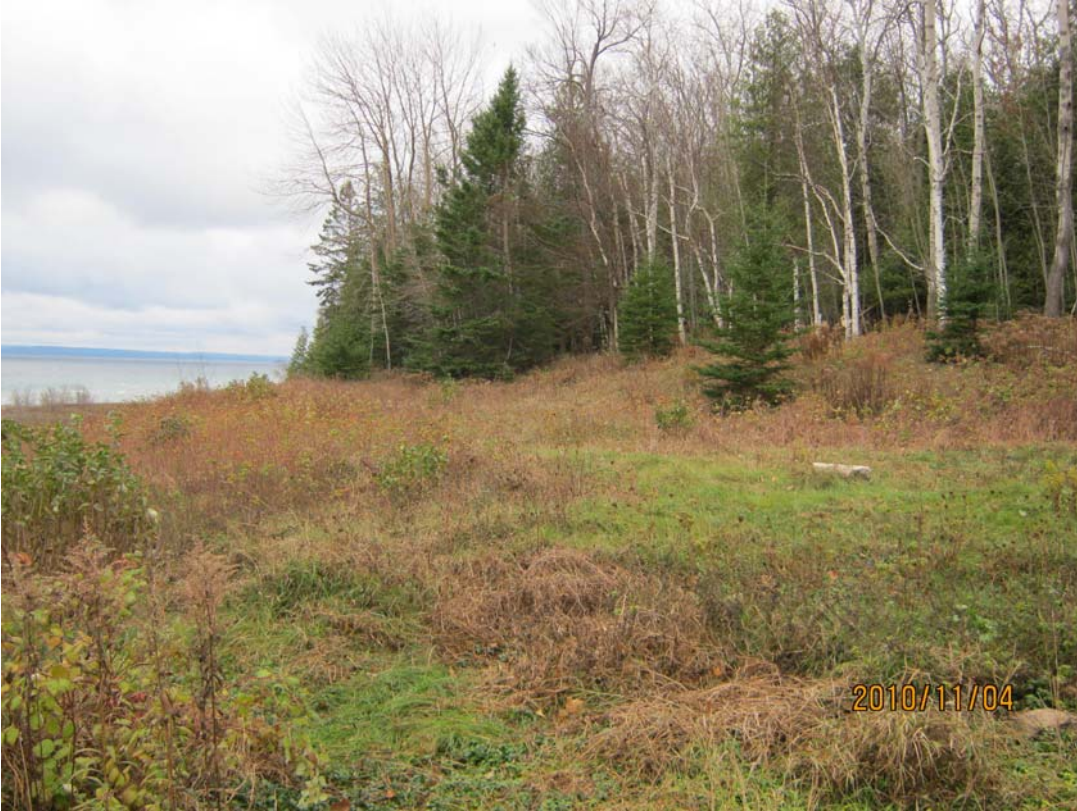
Photograph No.3 – View of flat area south of light tower.

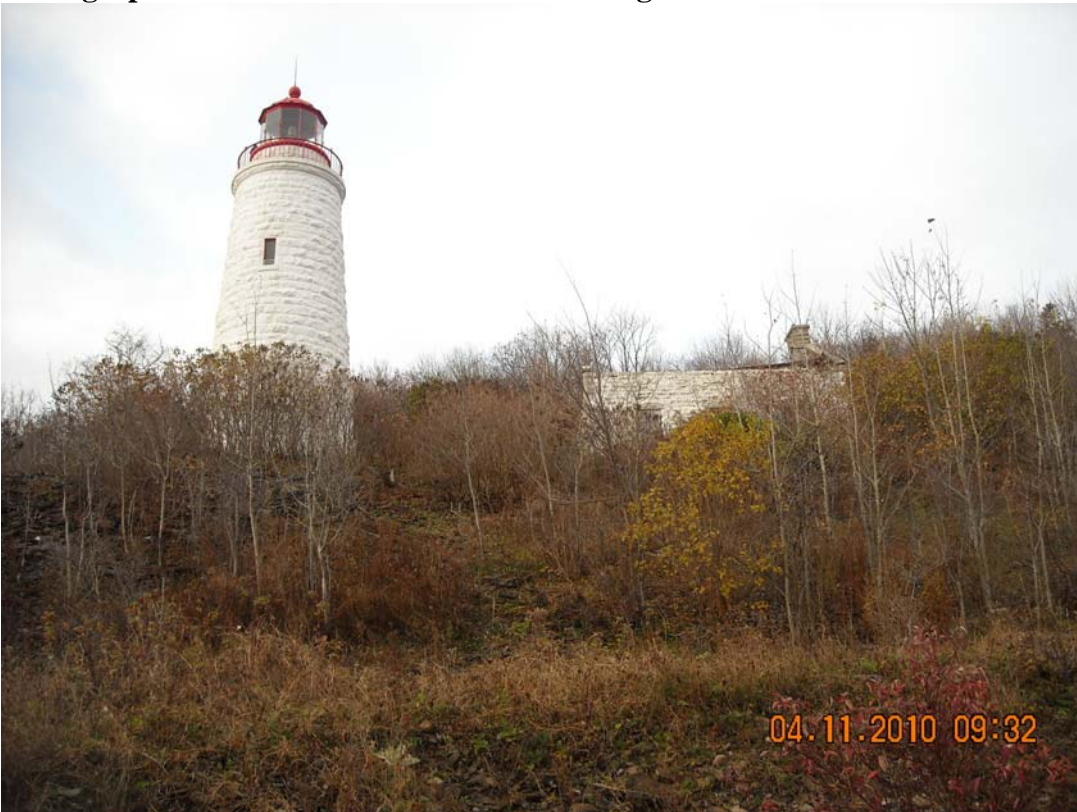
Photograph No.4 – View of light tower and former light keeper dwelling facing west from base of slope.

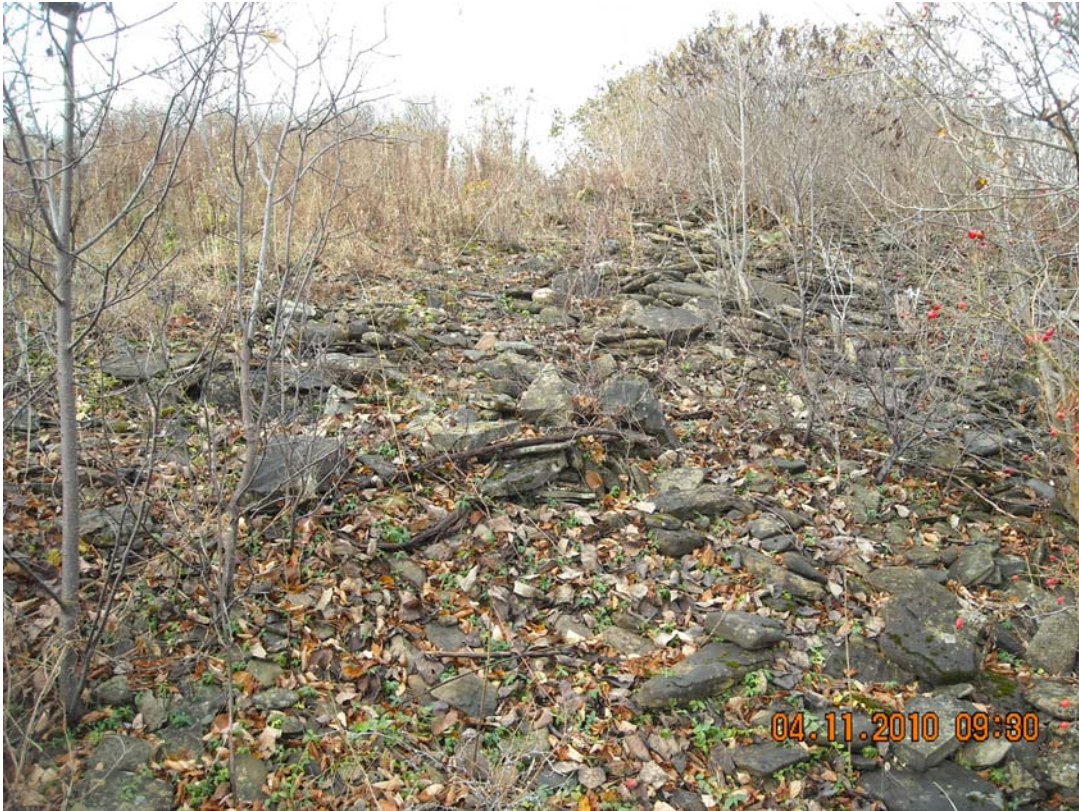
Photograph No.5 – View of shale and vegetation half-way down slope facing west.

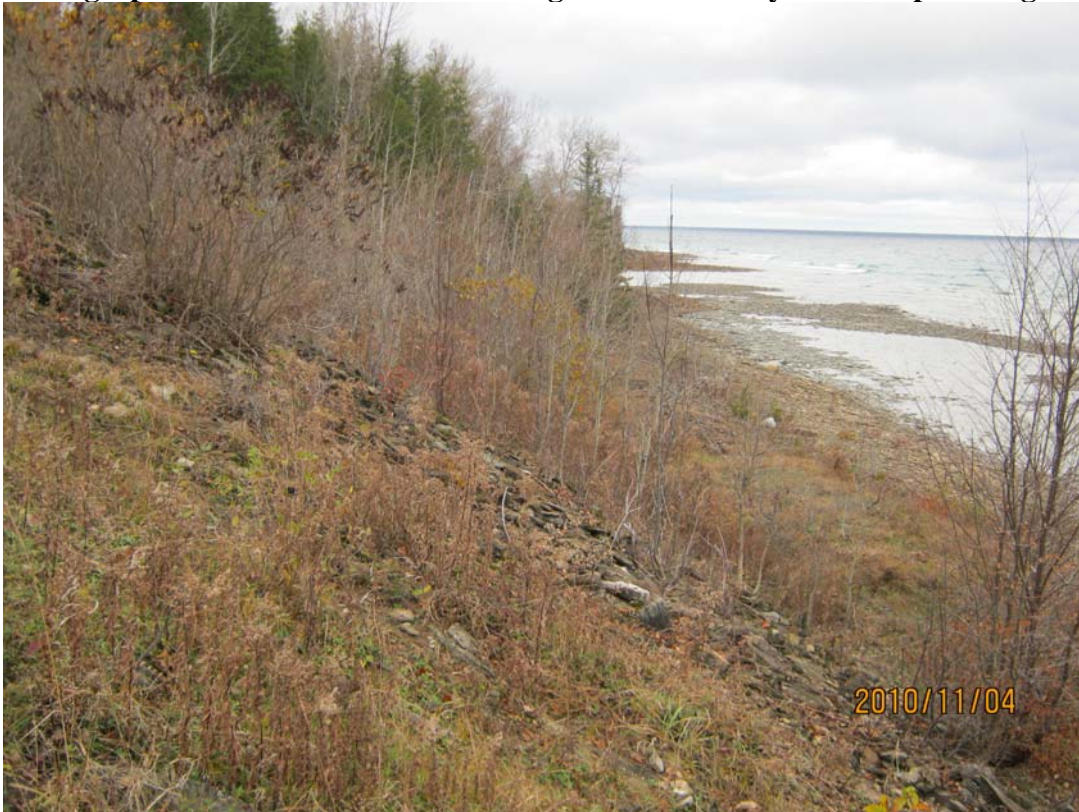
Photograph No.6 – View of slope facing north.

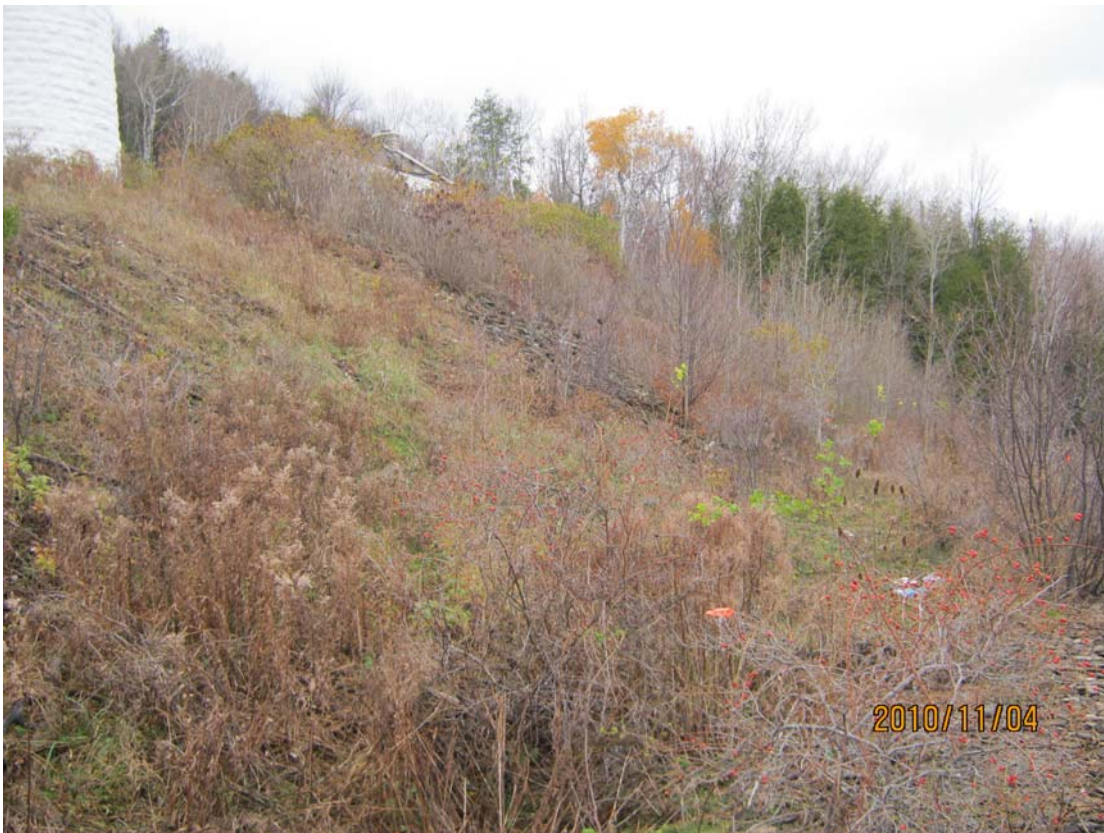
Photograph No.7 – View of slope facing north-northwest

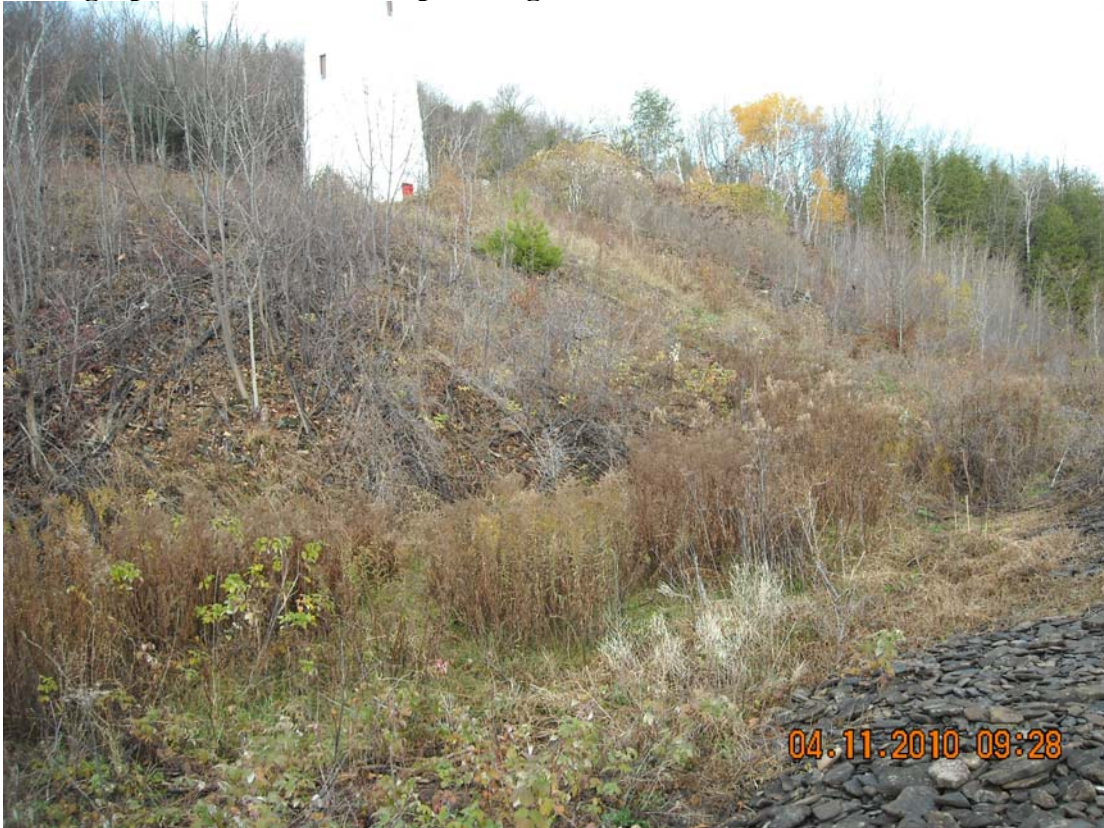
Photograph No.8 – View of slope facing north-northwest

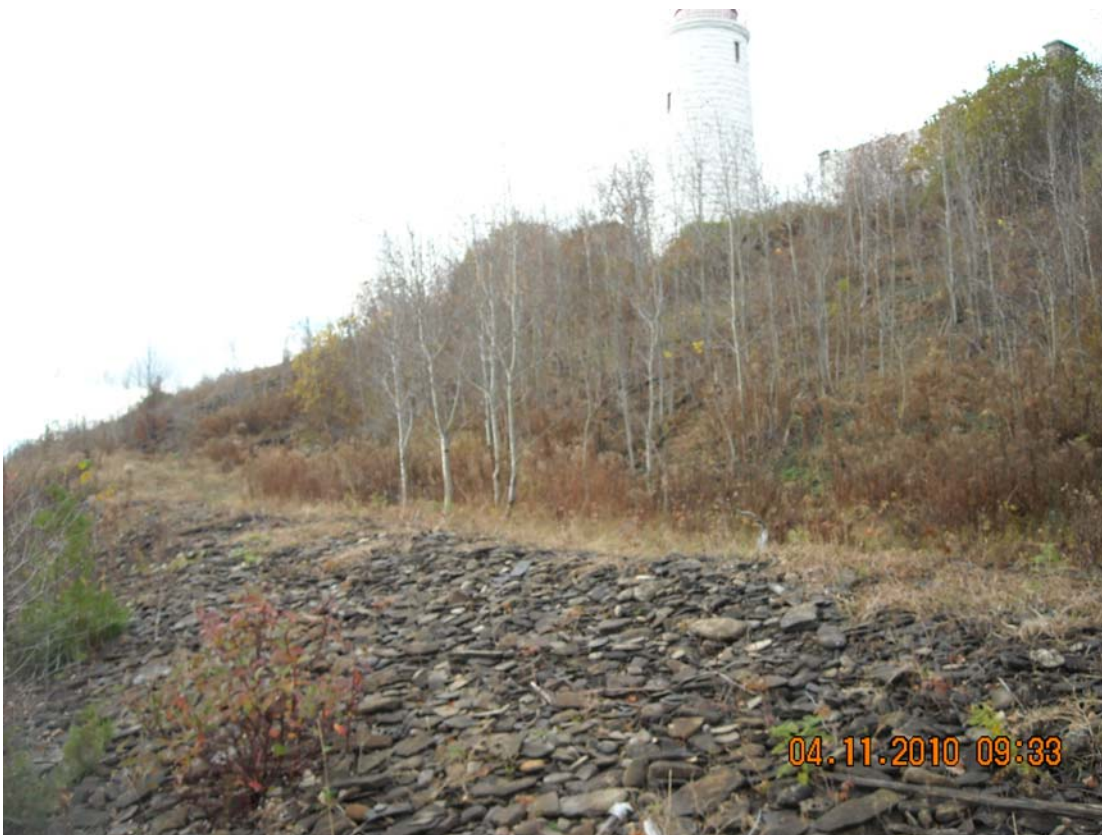
Photograph No.9 – View of cobble shoreline facing south-southwest.

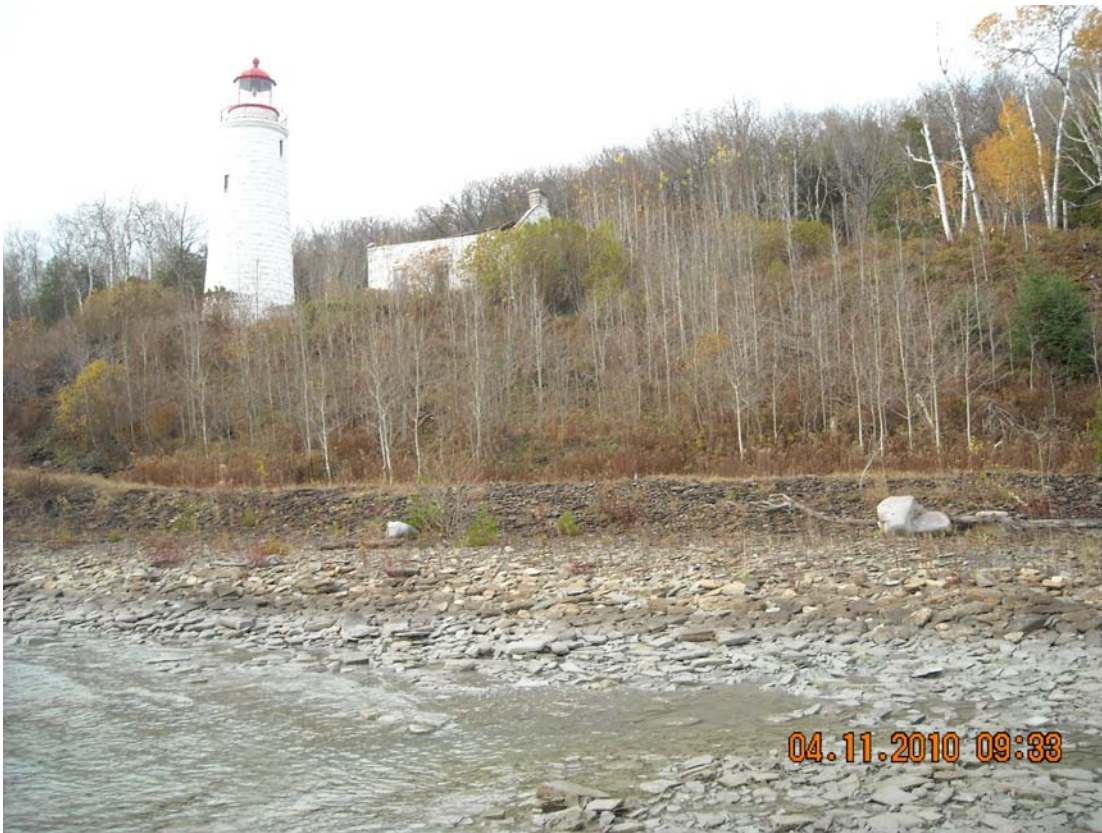
Photograph No. 11 – View of site facing southwest.

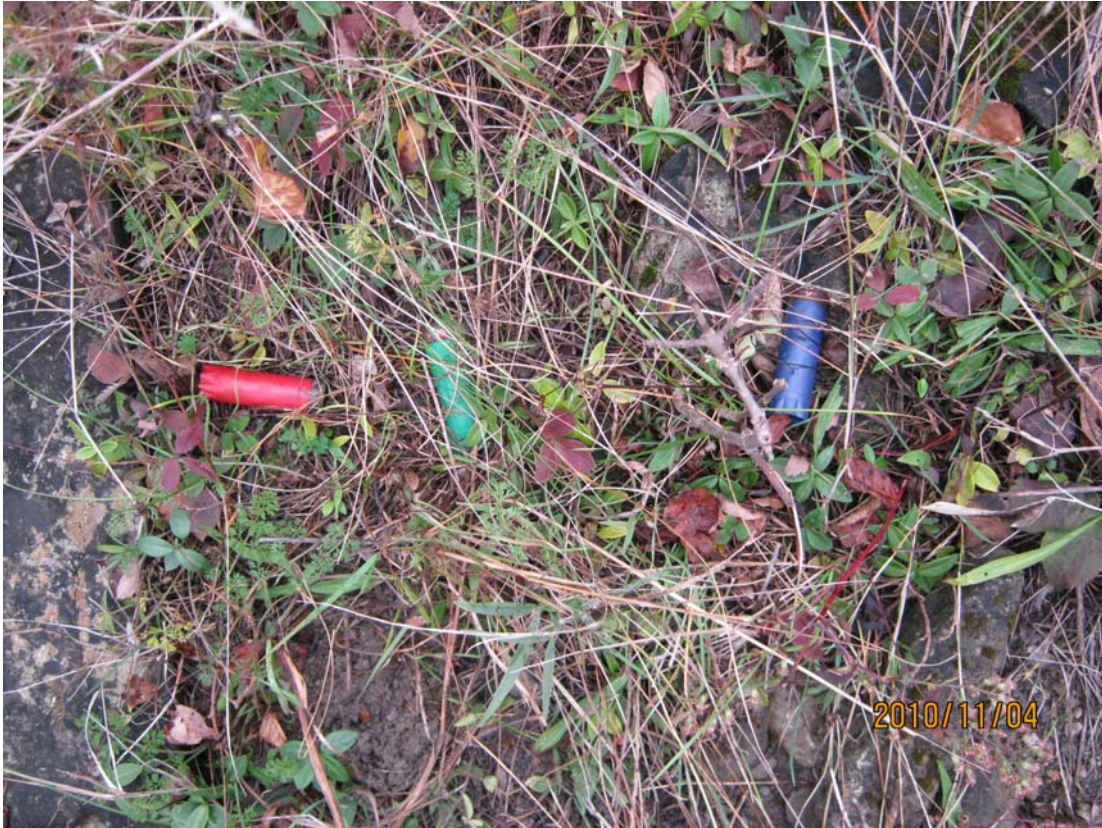
Photograph No.12 – View of spend shell casings along footpath towards shoreline.
