**Public Works Government Service Canada (PWGSC)**

**Project Number: R.041804.001**

**Big Chaudiere Dam  
Geotechnical Study Report  
August 2011**

**KGS**  
**GROUP**  
**CONSULTING**  
**ENGINEERS**

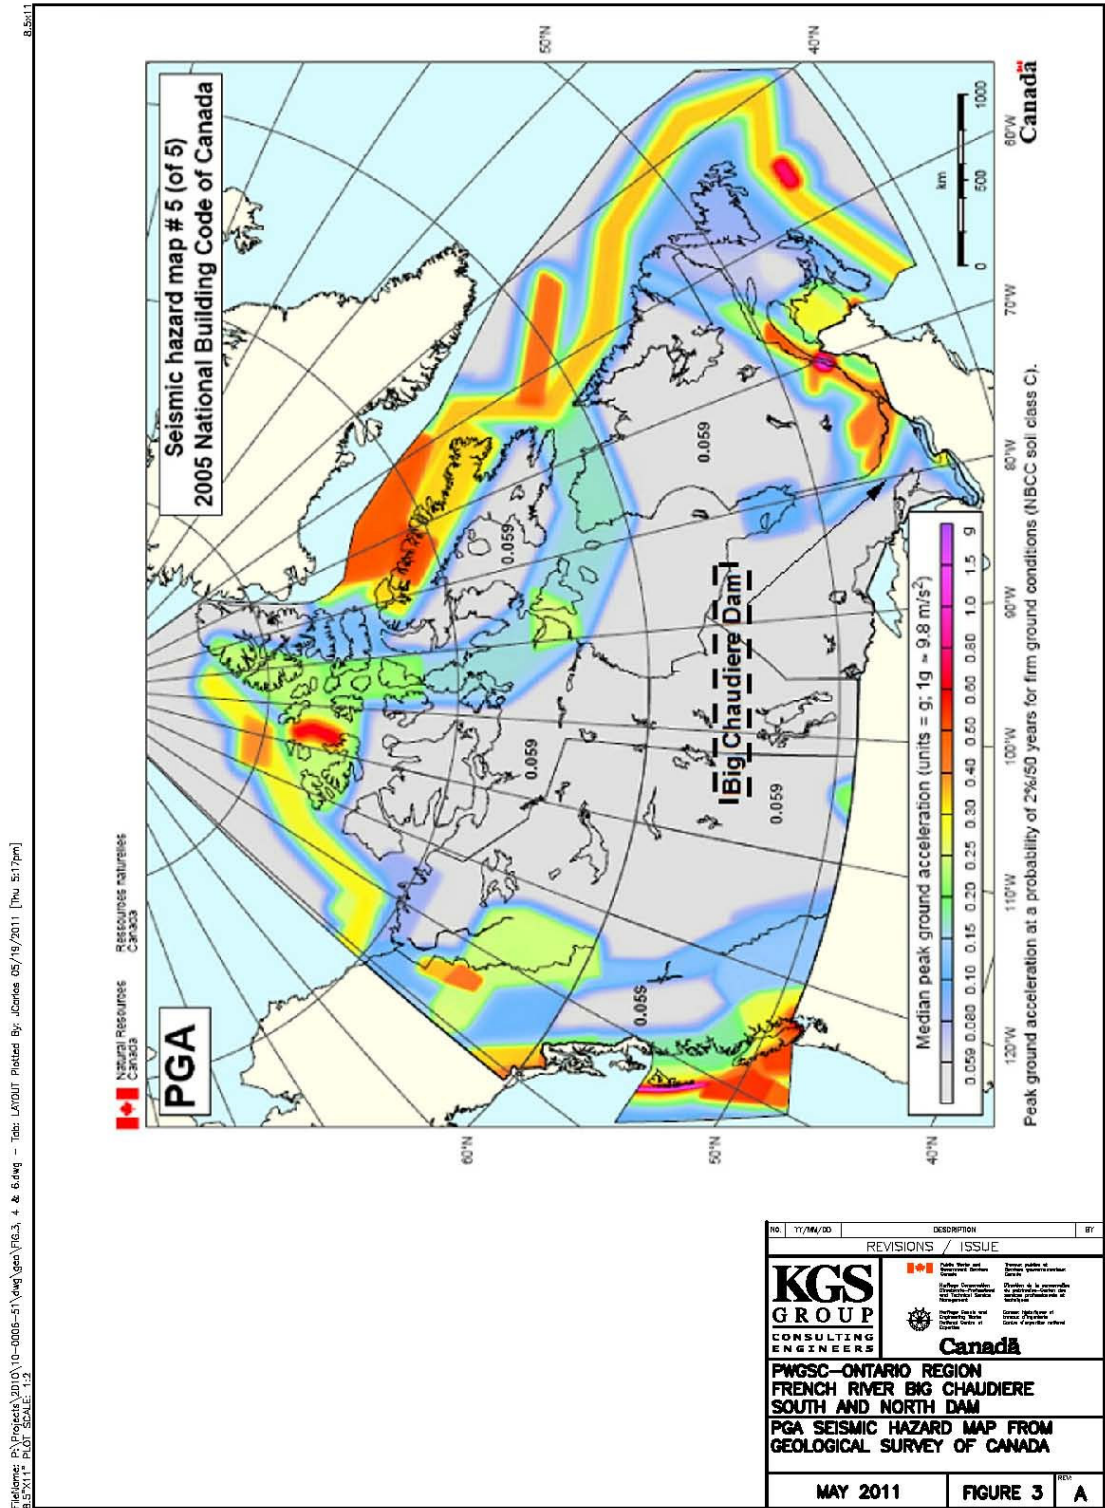
**FIGURE 3:** PGS Seismic Hazard From Geological Survey of Canada.

The seismic hazard map of median peak ground acceleration (PGA) values from the Geological Survey of Canada (GSC) is shown on **Figure 3**. Based on the seismicity zoning map, the Big Chaudiere Dam is located within an area of relatively low seismicity (i.e. approximately <0.15 g).

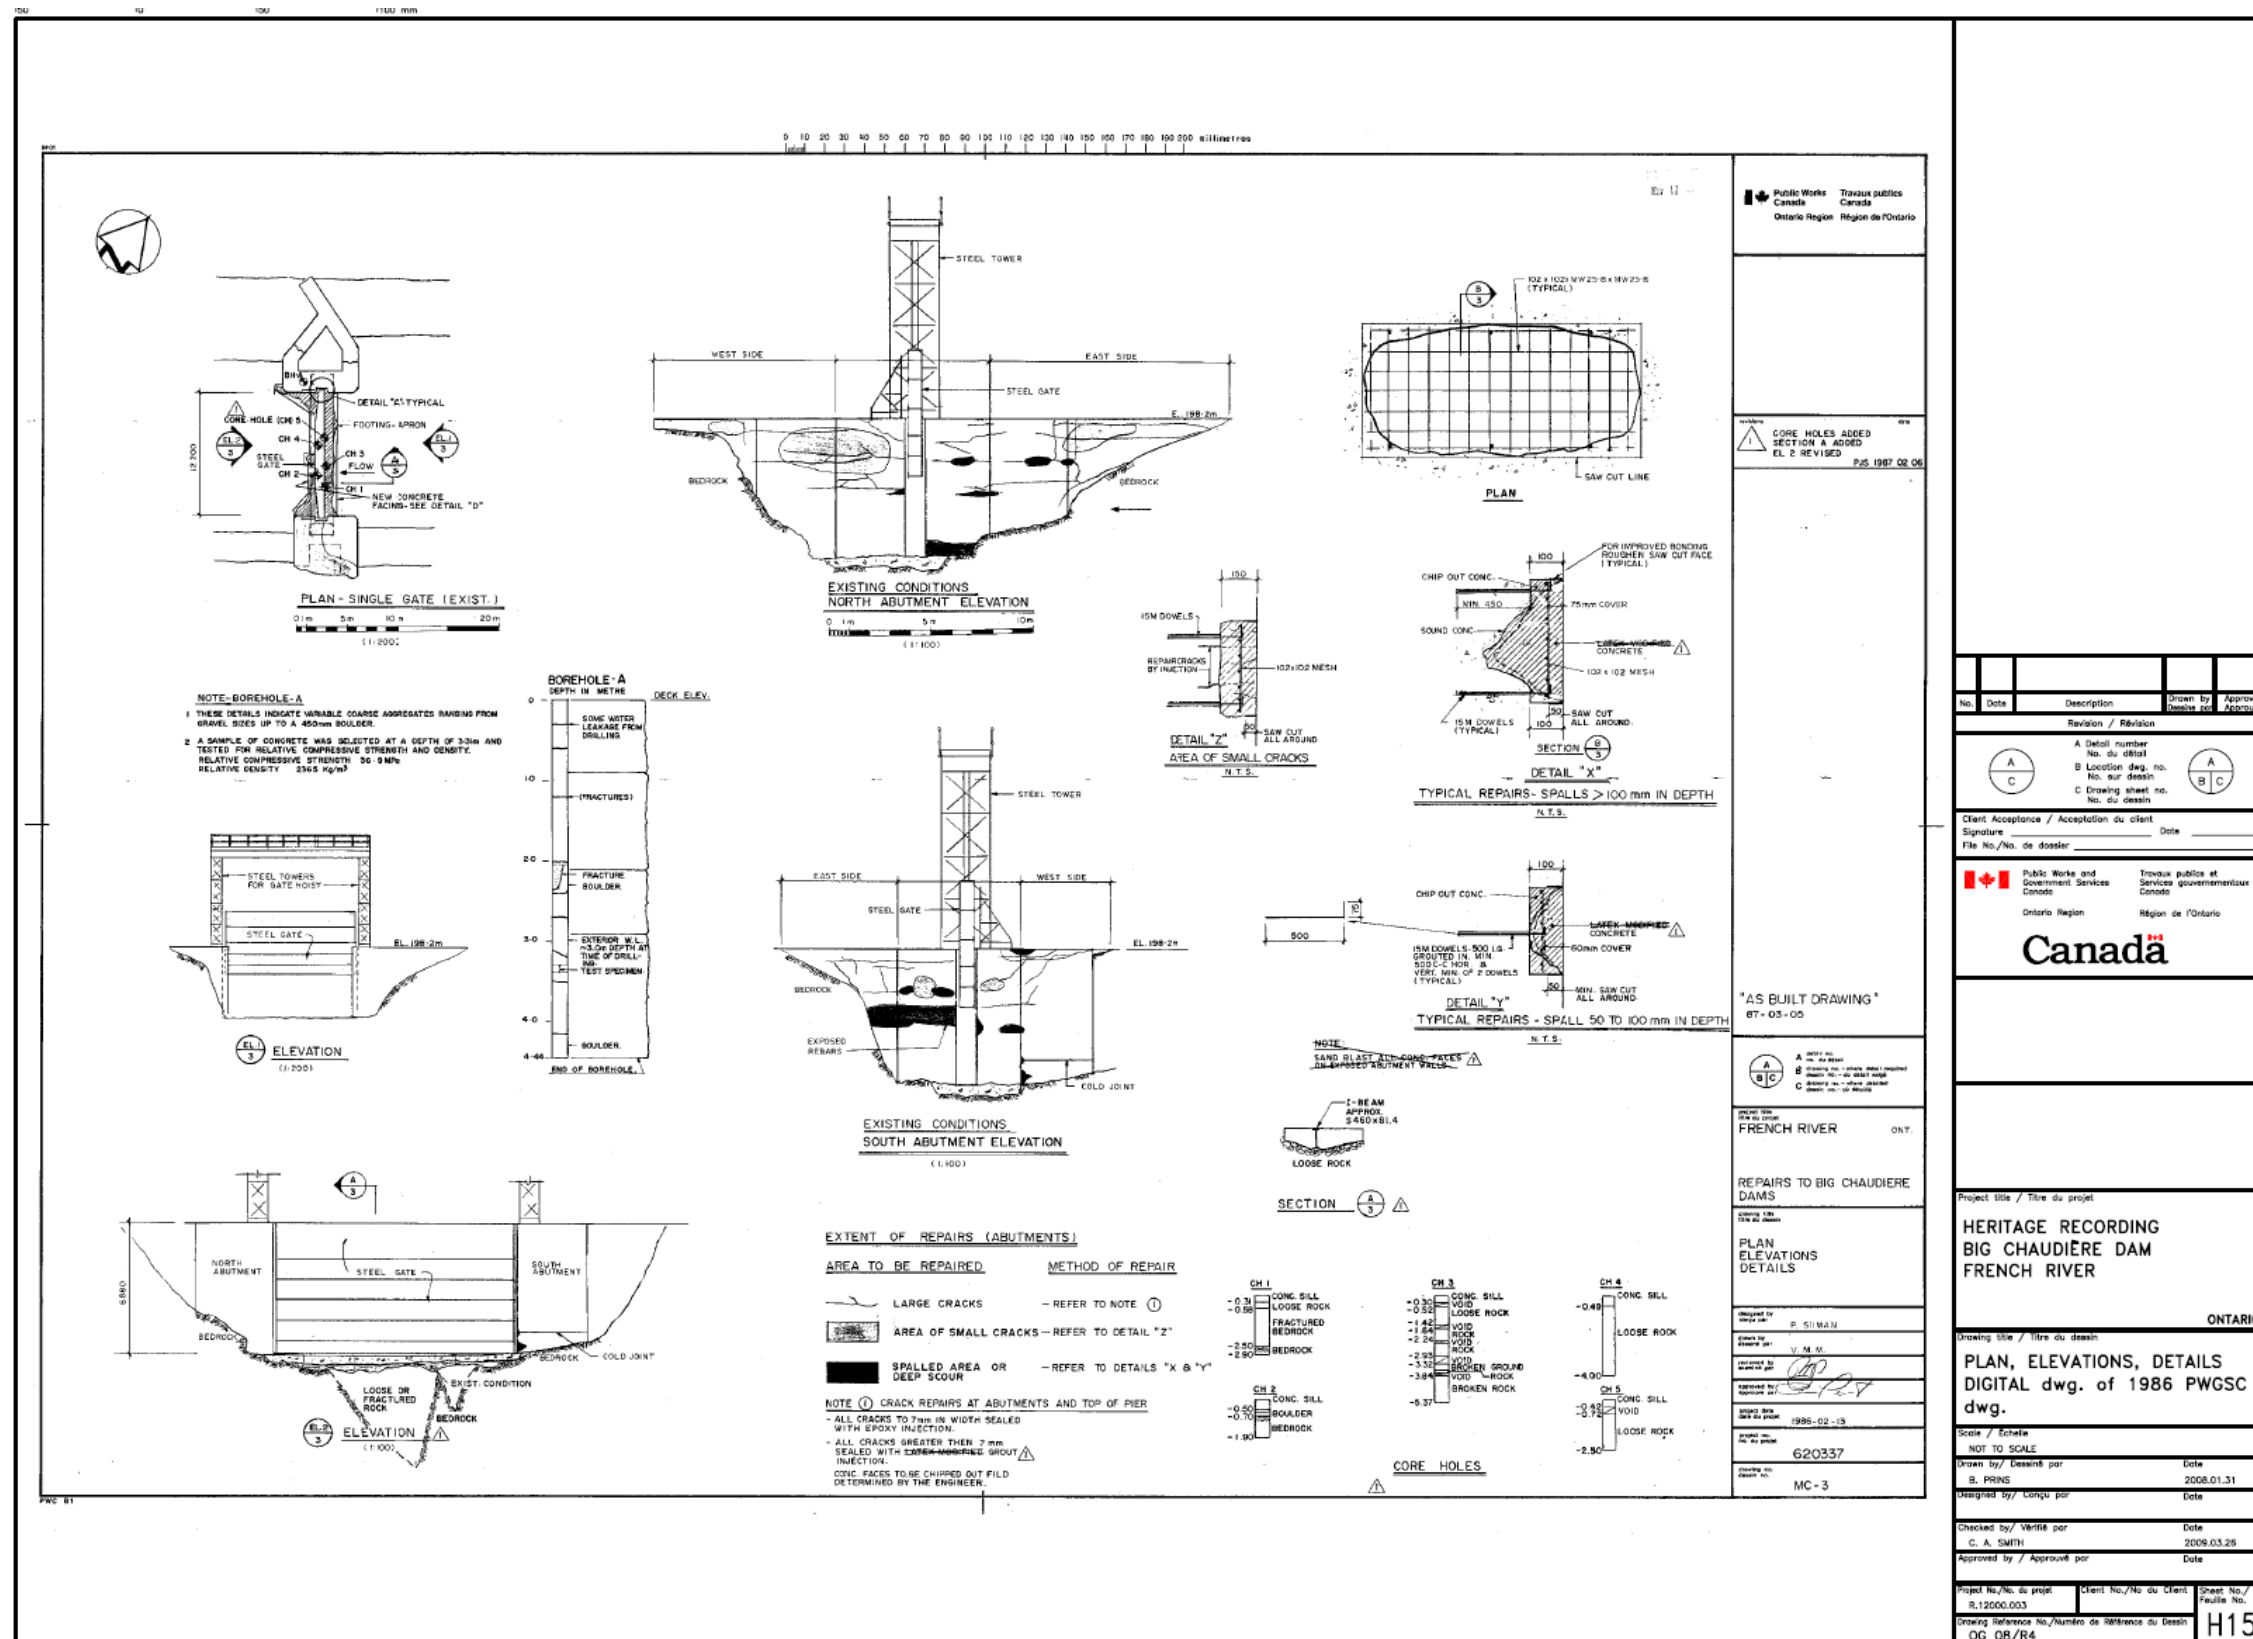
The proposed work for the South Channel Dam involved repairs to the concrete and steel gate. In order to evaluate the overall concrete condition, some investigation boreholes were advanced in the north concrete abutment and sill areas. Core samples of the concrete and foundation materials were obtained. One borehole (BH-A) was drilled through the north concrete abutment and five boreholes (CH-1 to CH-5) were drilled through the concrete sill of the South Channel Dam. The holes drilled through the sill were advanced while the steel gate was out and being repaired. The borehole locations, summary data and cross sections along with repair work carried out are shown on Dwg. No. MC-3 Project no. 620337, **Figure 4**.

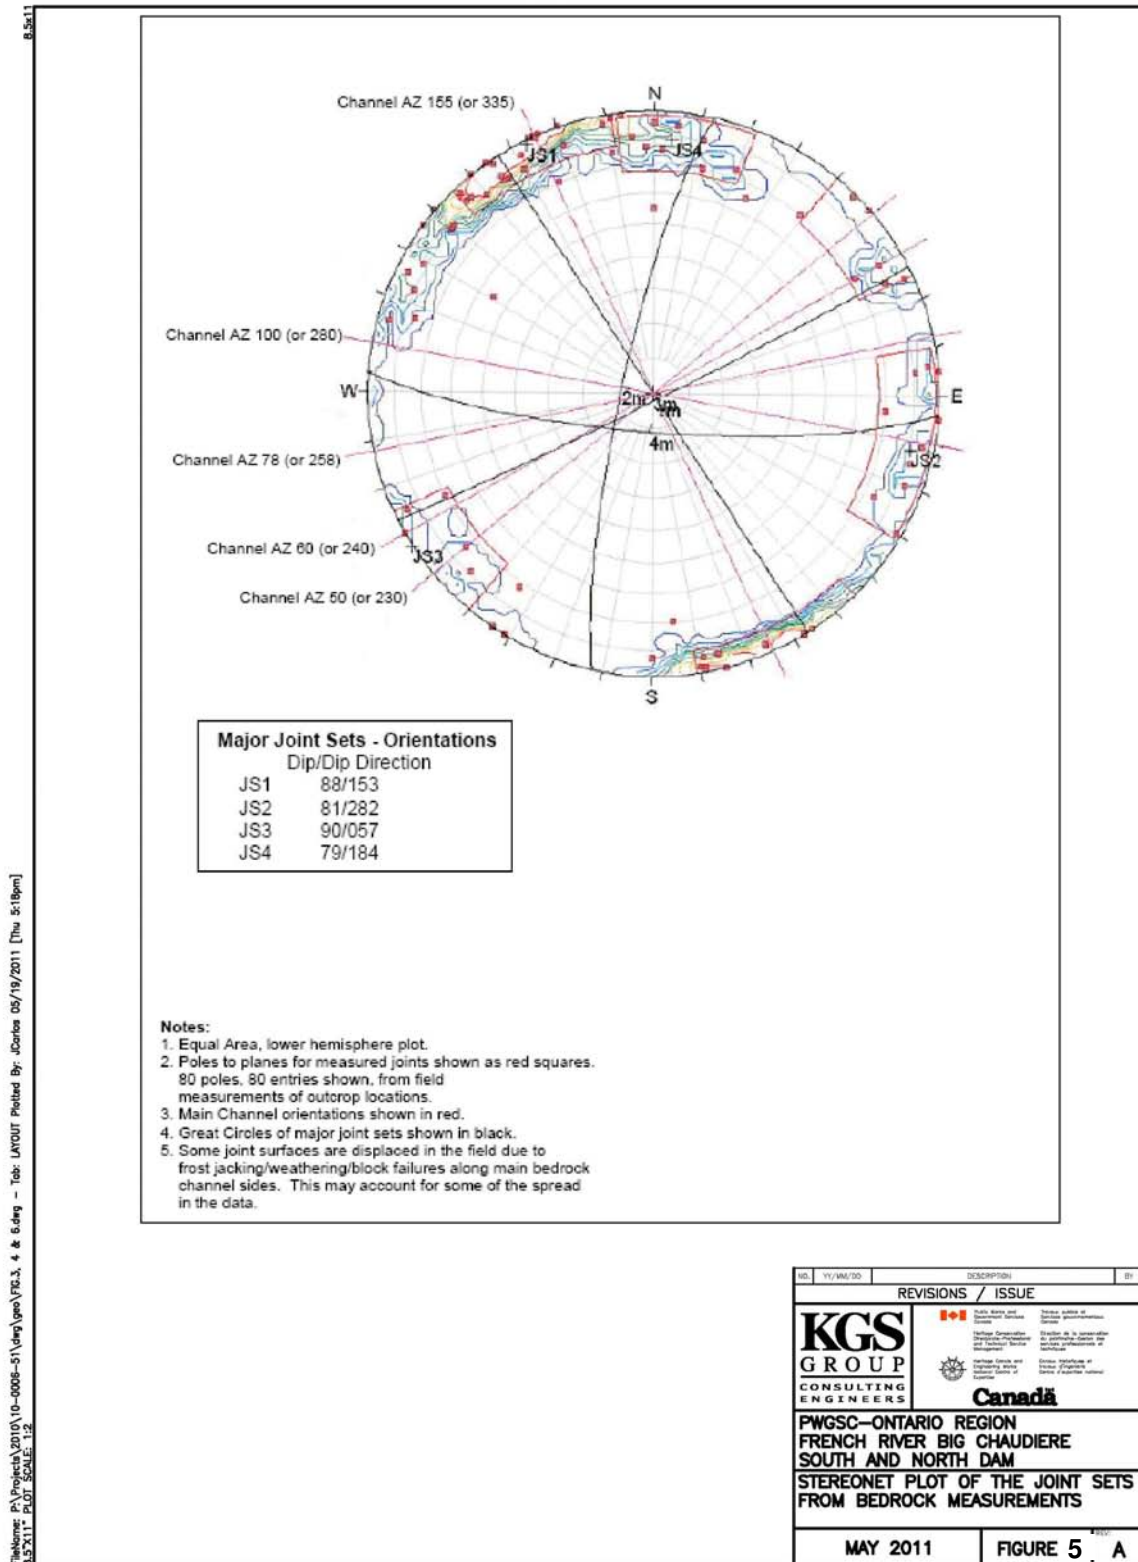
**FIGURE 5:** Stereonet Plot of the Joint Sets from Bedrock Measurements – Big Chaudiere Dam

Joint or discontinuity measurements taken at the site predominantly strike north-easterly to easterly, with steep (subvertical) dips to both the northwest and southeast. Joints with other orientations are present, but are less common. Small dyke structures are noted along the north and south edges of the south channel, striking at AZ 060°.

Many areas of the observed bedrock channel sides are failing by wedges moving out from the channel sidewalls, due to frost jacking/weathering, and generally due to the steep dips of the joint sets, often dipping into the channel wall (i.e. northward), which enhances the movement of rock slabs toward the open channels. The noticeable displacement (predominantly aperture widening) along joints present at the bedrock channel sides has likely added to the spread in some of the orientation data, as presented on the DIPS plot.

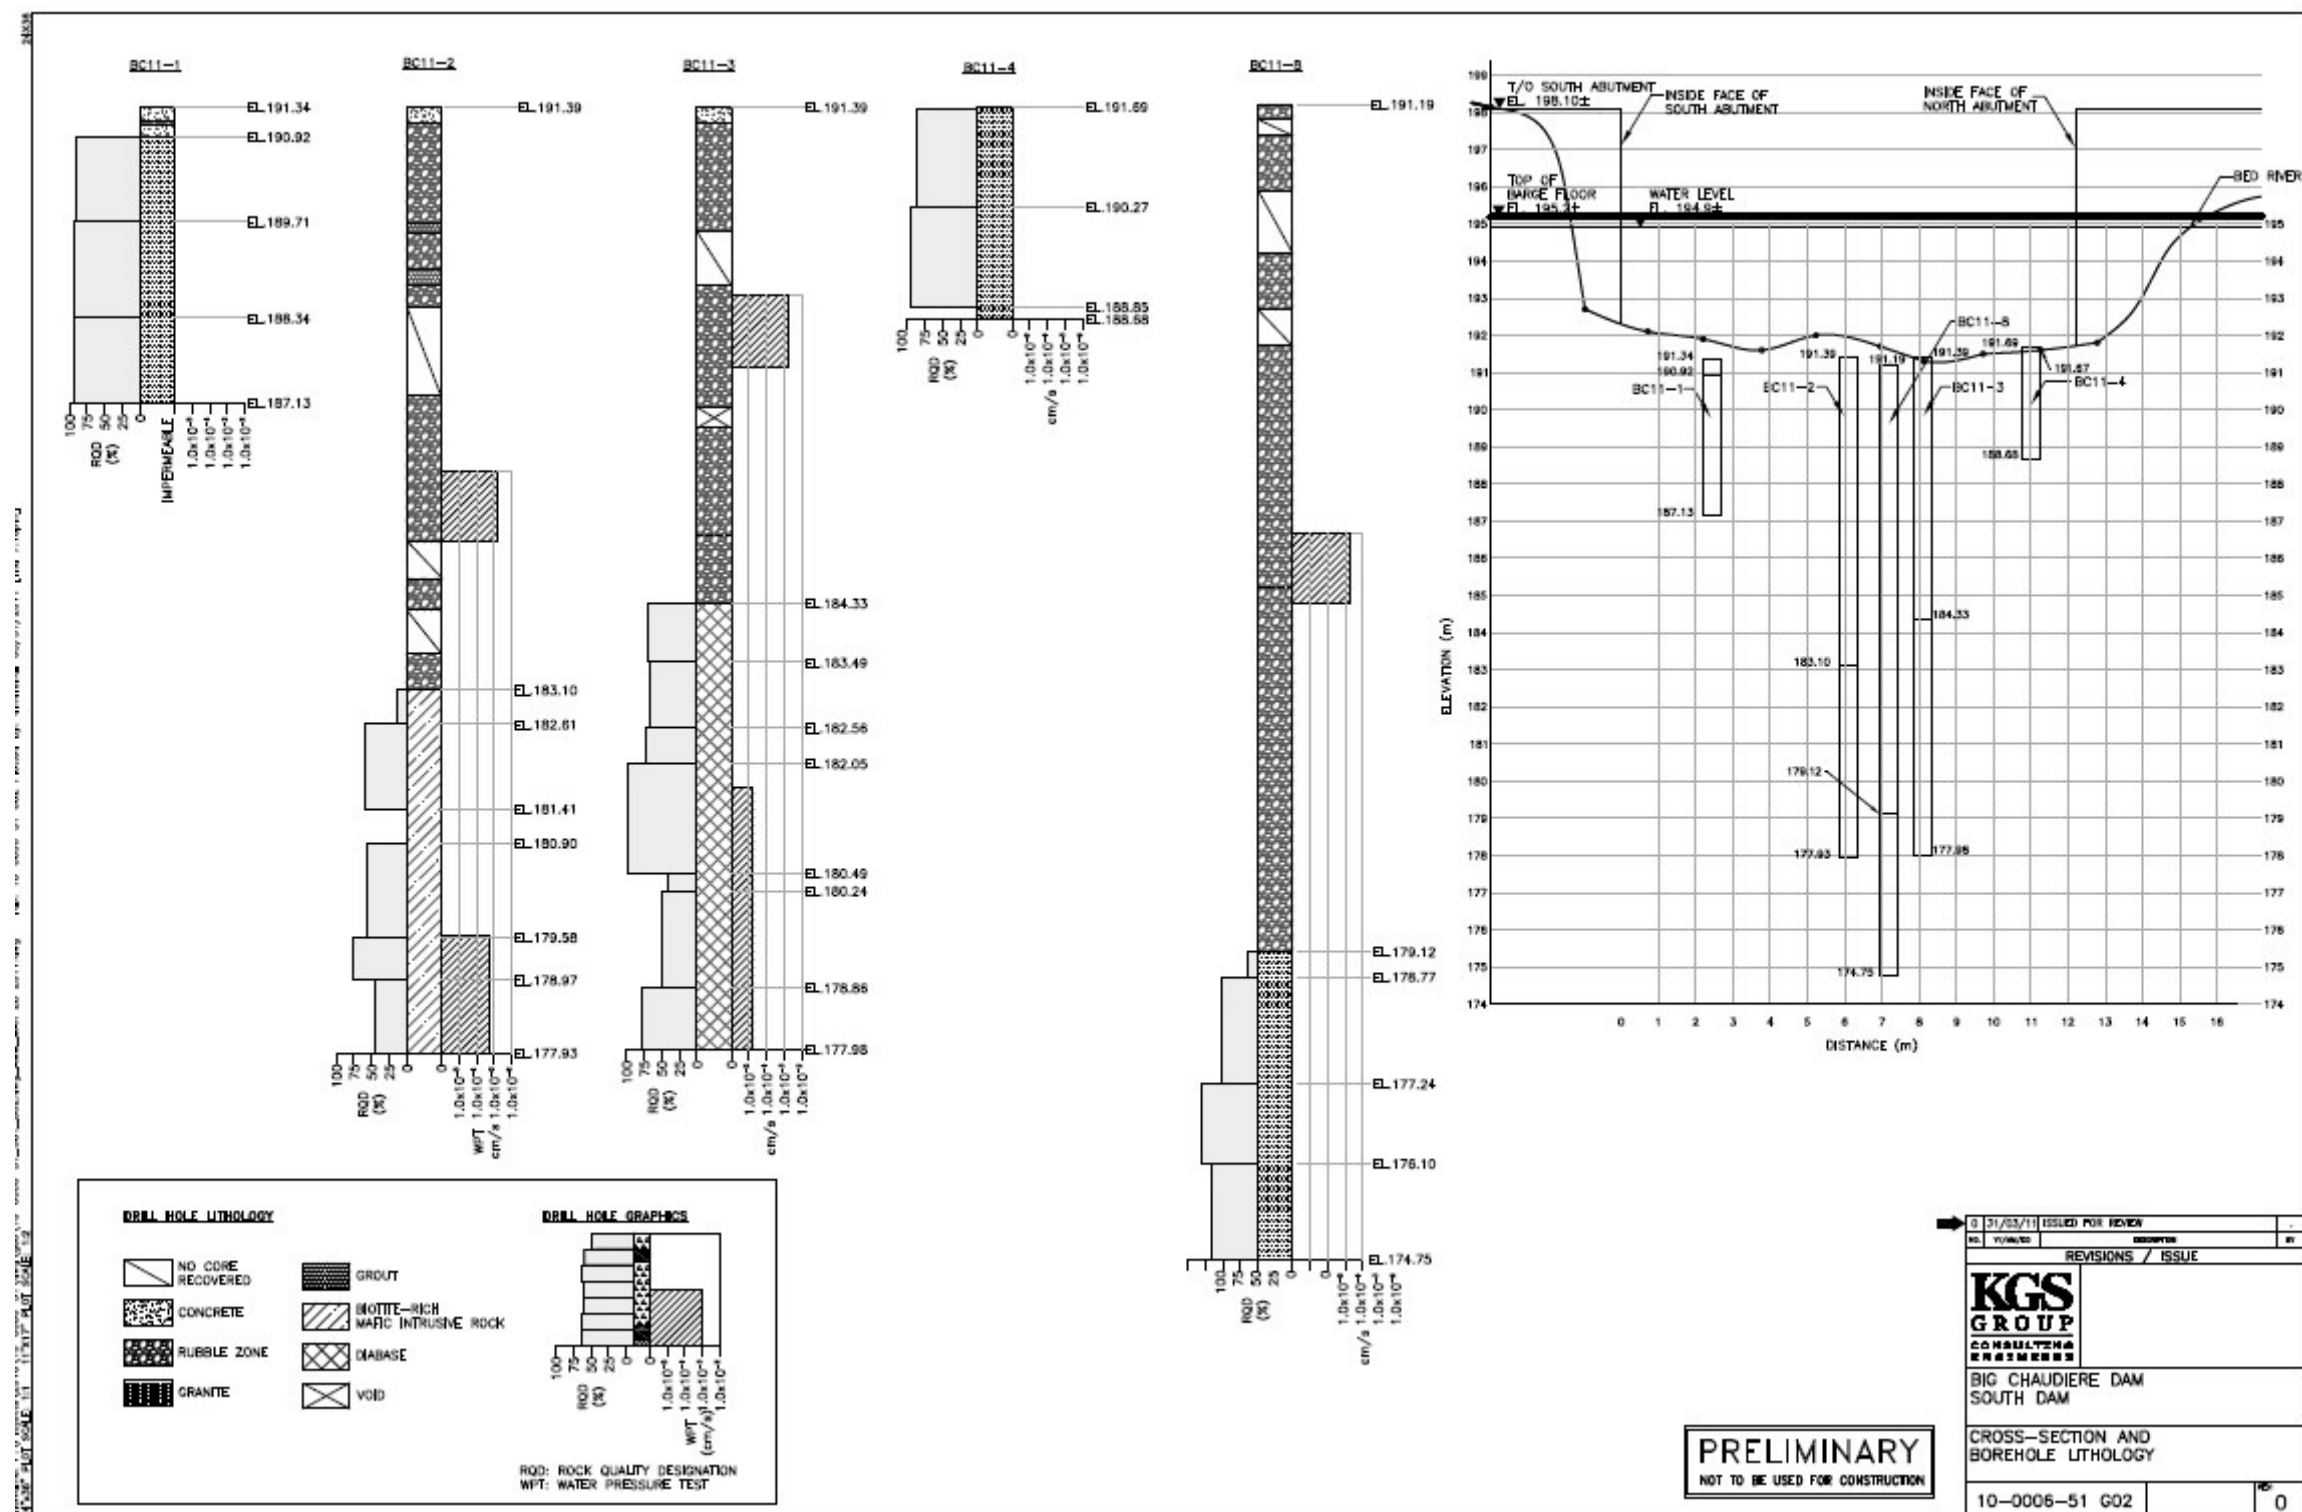
FIGURE 9: Cross Section of River Bed upstream of South Channel Dam - Drilling Investigation Program 2011.

The borehole core samples and the seismic refraction survey confirms that there is a deep crevice within the bedrock that is completely filled with “rubble” (i.e., loose rockfill and granular material) on the upstream side of the South Channel Dam. The maximum depth of the “rubble” filled crevice is approximately 12 m.

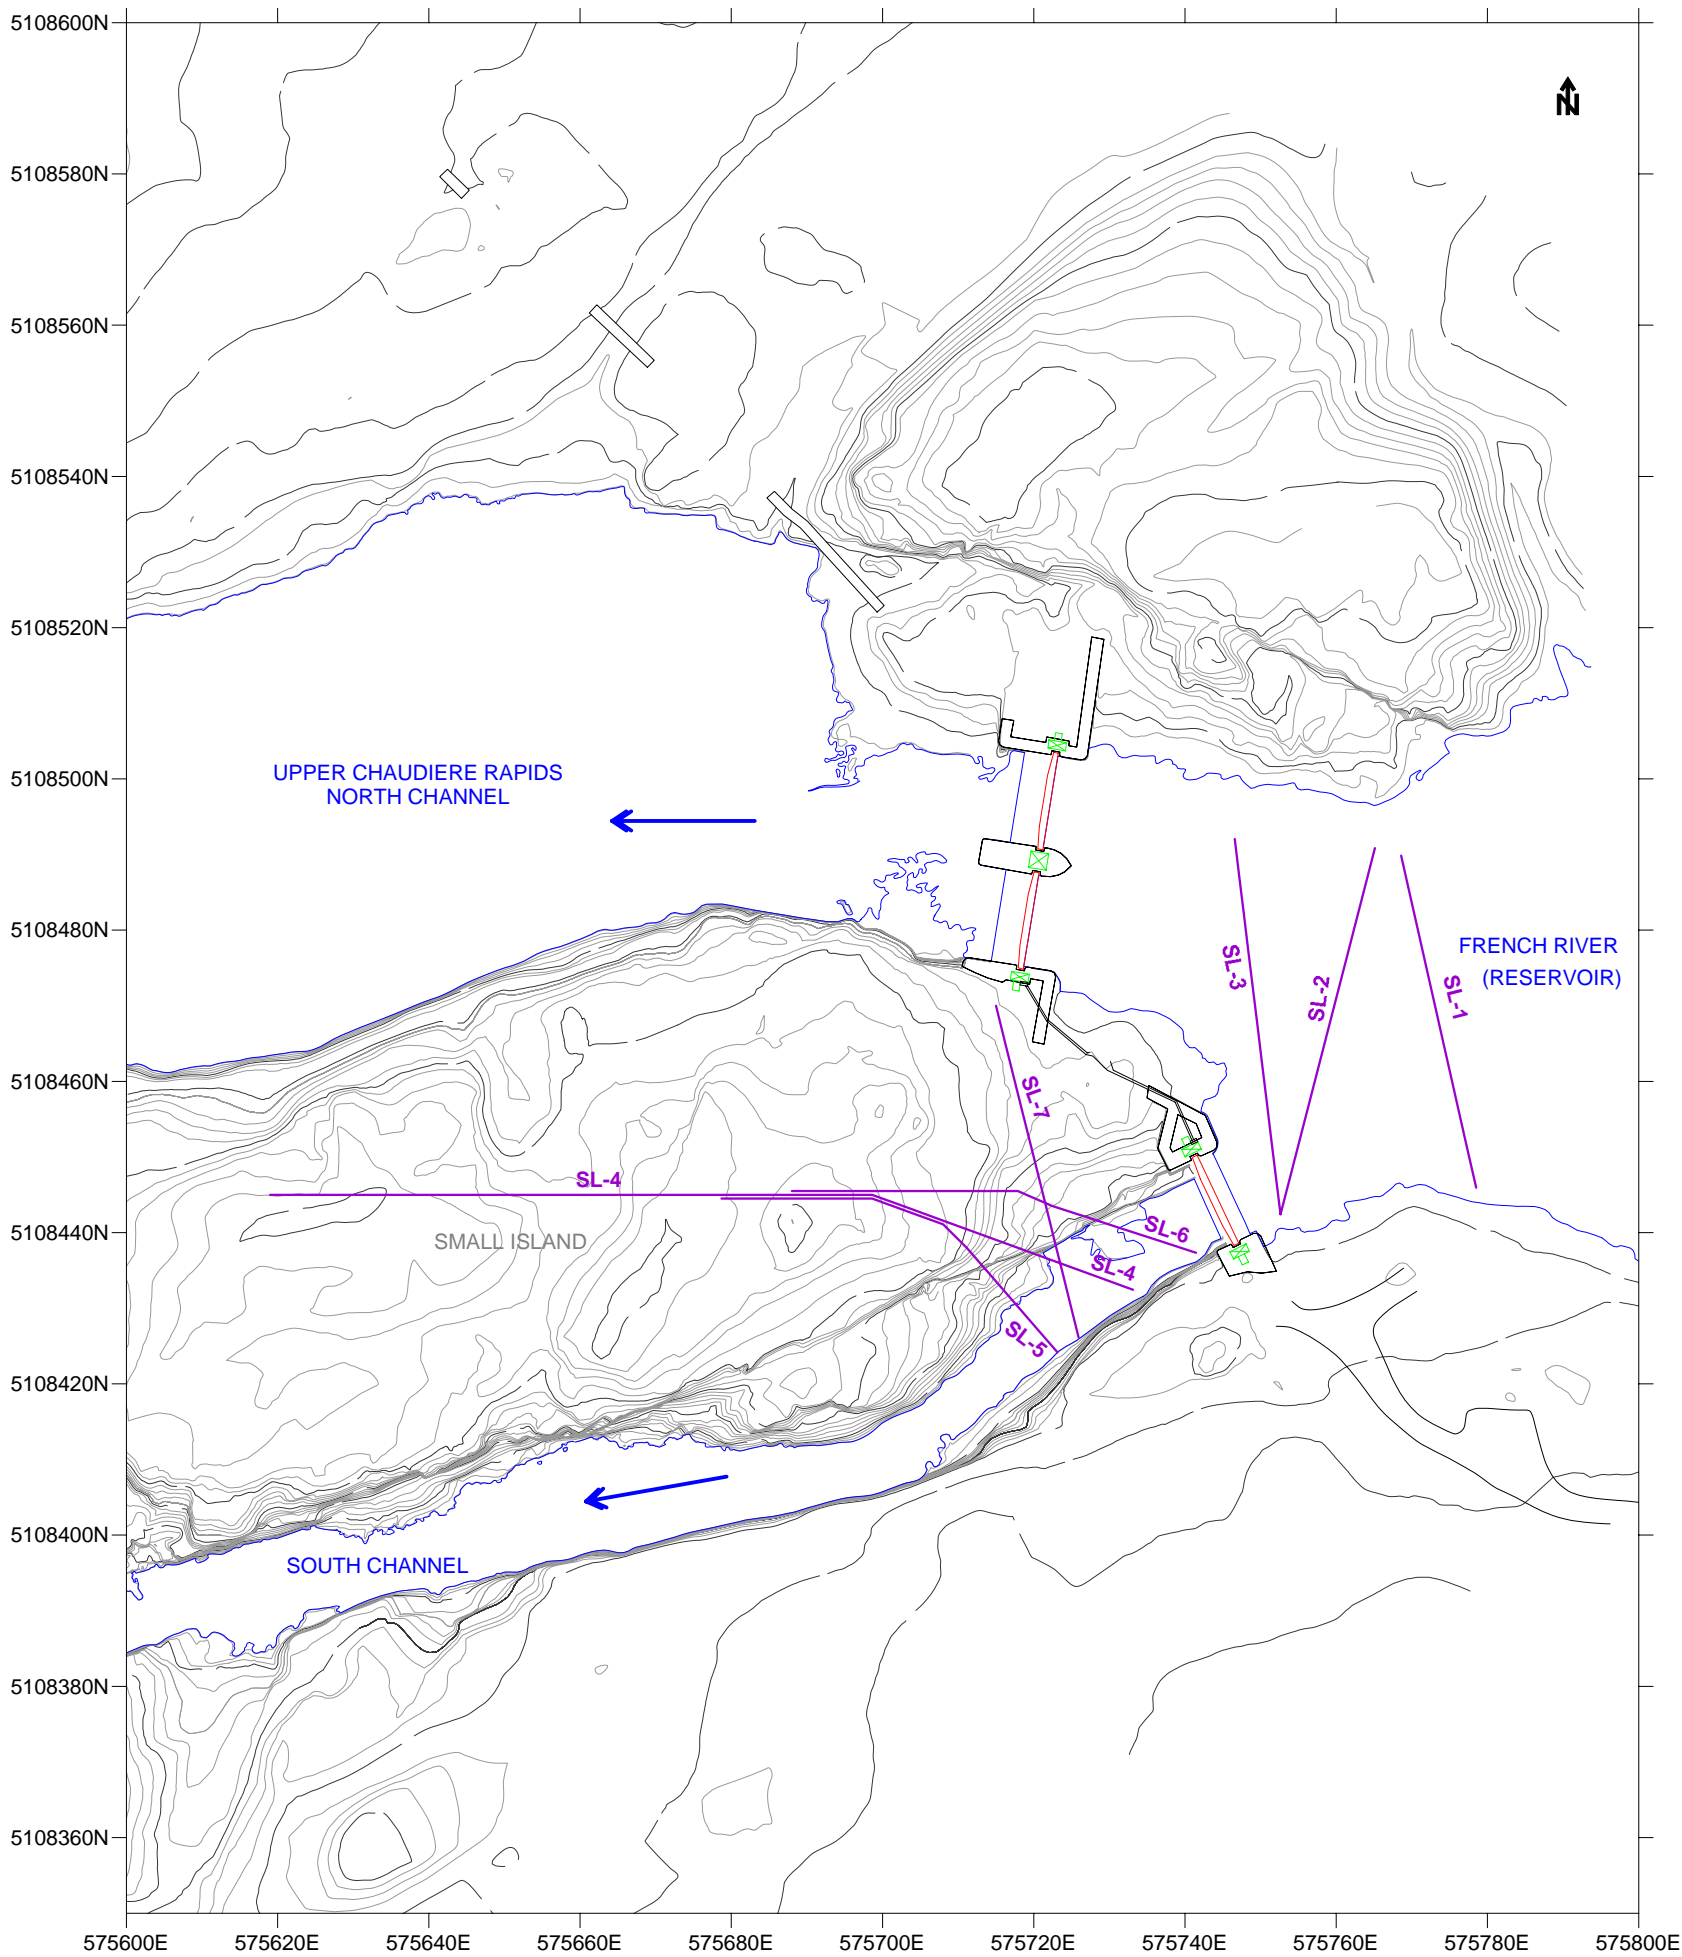
KGS GROUP CONSULTING ENGINEERS		
BIG CHAUDIERE DAM PROJECT		
SEISMIC REFRACTION SURVEY		
SITE PLAN		
FRONTIER GEOSCIENCES INC.		
DATE: OCT. 2010	SCALE 1:1,000	FIG. 2

The purpose of the seismic refraction survey was to determine geological conditions and the structural nature of the south channel of the French River. Specifically, structural weaknesses such as a fault, shear zone or sharp depression of the south channel and southern shore of French River were of interest. Seismic lines SL-1, SL-2, and SL-3 were conducted overwater on the upstream side of the Big Chaudiere Dam, extending across the French River. Seismic lines SL-4 through SL-7 were conducted on the downstream side of the dam, extending across the south channel of Upper Chaudiere rapids and onto Small Island. A Site Plan of the seismic lines and survey area is presented at a scale of 1:1,000 in Figure 2, of the Appendix.
