# Designated Substances Survey

Gatineau Park Facilities  
(PA# 95799, Gatineau Park Headquarters)

Prepared For:  
National Capital Commission  
40 Elgin Street, Ottawa ON K1P 1C7

Project No: OTEN00019509D  
Report date: February 2010

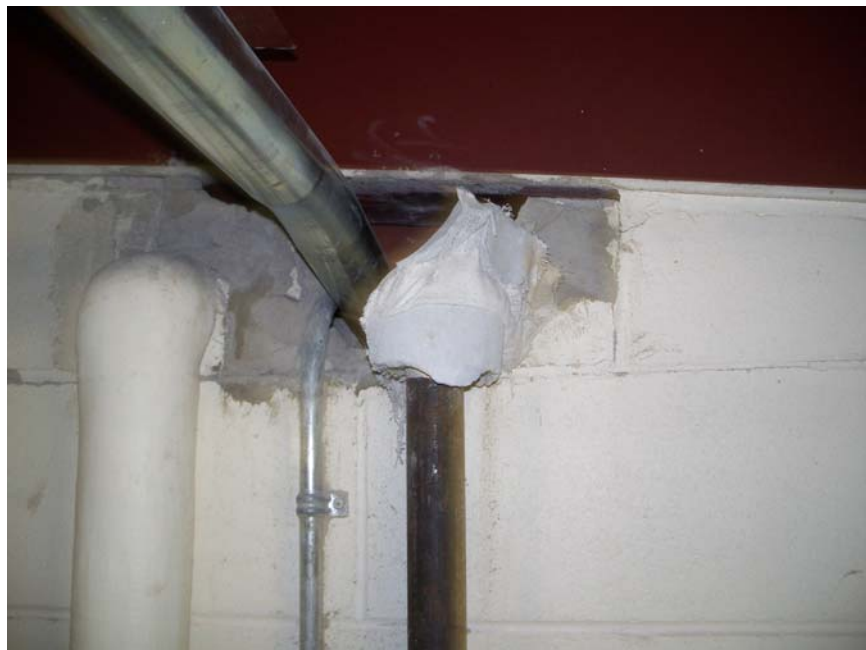
As part of the survey, **friable pipe (mud) elbows** within the garage/service portion of the building were identified to contain 36% chrysotile asbestos. The pipe elbows were located, but not limited to, within the mezzanine (2<sup>nd</sup> floor) storage rooms (i.e. map storage room), generator room, garage mezzanine. The majority of pipe elbows were identified to be in good condition but a limited number were identified be in poor condition. However, no debris was associated with the pipe elbows at the time of the site survey.

Based on initial estimates, approximately 30 to 60 asbestos mud elbows are located within the garage portion of the building. Based on the hazard ranking tree, a hazard ranking of 3 is associated with these materials as some are slightly damaged (some of the elbows) and are easily accessible to all staff. It is noted that a significantly damaged pipe elbow in the map storage room (Sampling location 3a should be repaired and/or removed) not withstanding any future plans for renovations.

**Photograph No. 2**  
Asbestos-containing mud elbows

The mud elbows identified within the main rooms of the building were determined to contain asbestos, and it is estimated that there are approximately 30 to 60 elbows. It is noted that a damaged elbow was identified in the 2<sup>nd</sup> floor map storage room and should be removed and/or repaired. Since the material is found on pipes, the material could likely be removed using Moderate Risk operations in accordance with Section 3.23.15 of R.Q.c.S-2.1,r.6) assuming a glove bag is used

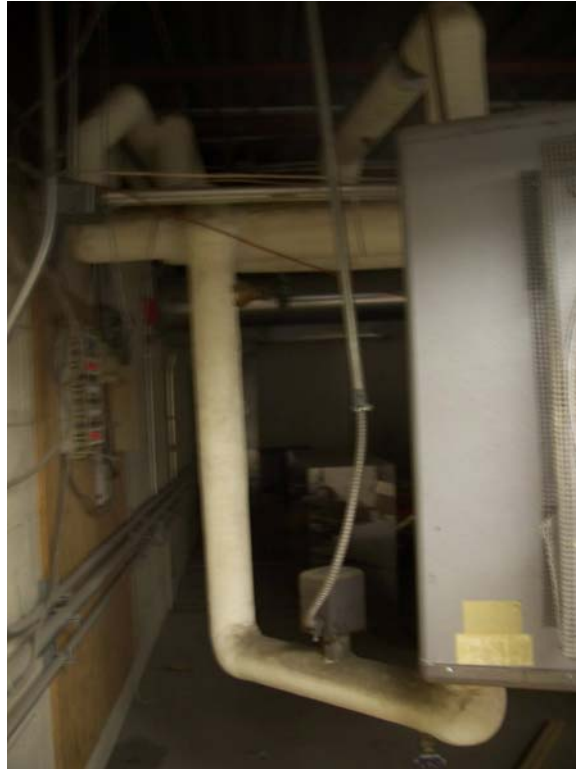
**Photograph No. 3**  
Additional ACM mud elbows on mezzanine

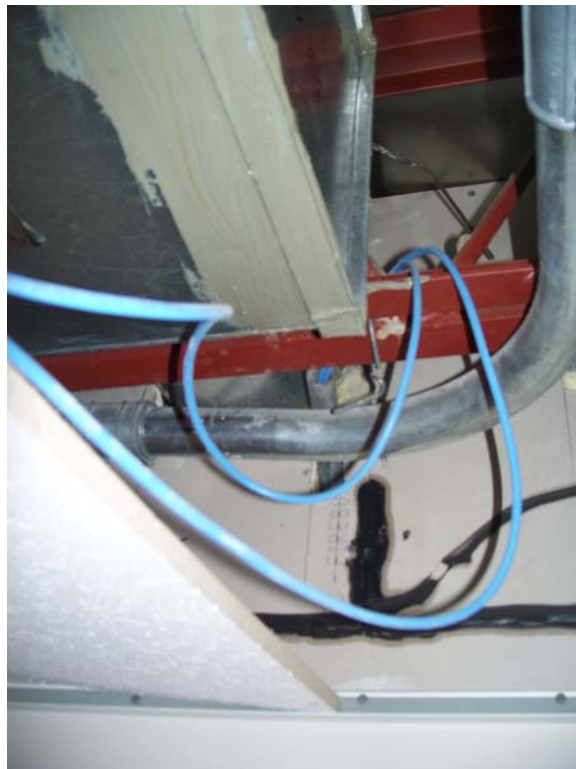
Black sealant (potential fire stop material) was sporadically identified within the subject building and was identified to contain 1% of chrysotile asbestos. The fire-sealant was predominantly identified within joints/seams/cracks between the drywall walls and / or drywall/concrete seams. The material is described as a sticky adhesive material.

Estimates with regards to the quantity of the material are difficult at this time given that the material is located sporadically and only in limited areas. However, given that the material is non-friable, a hazard ranking of 7 is associated with the material as it is unlikely to release air-born fibres and it is located above ceiling tiles.

**Photograph No. 4**  
Asbestos-containing black sealant

The fire sealant identified was non-friable and generally in good condition. The quantity was limited to seams between drywall and concrete. As a result, if the material is to be removed, a Low Risk removal operation would be required as per Section 3.23.14.1 of R.Q.c.S-2.1,r.6)

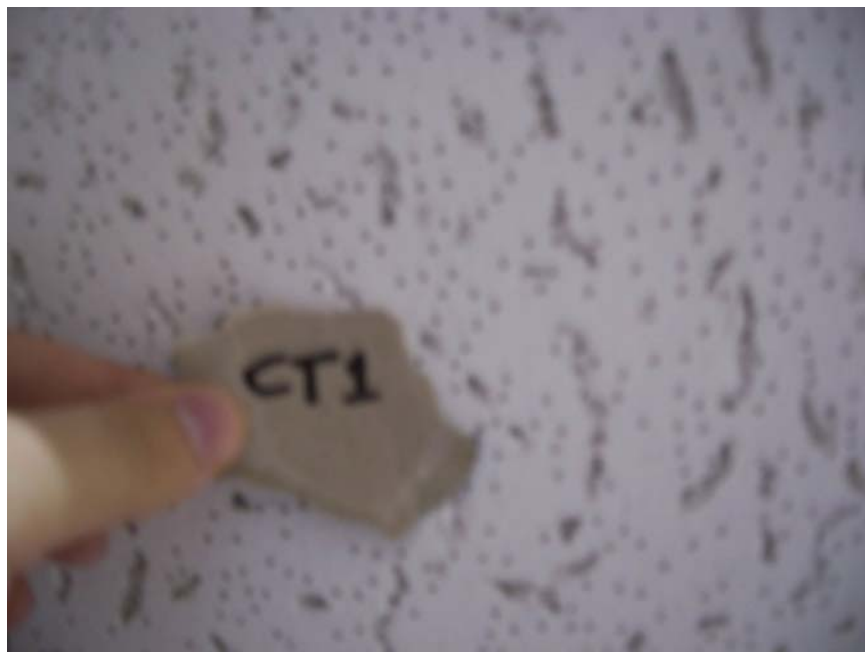
**Photograph No. 5**  
CT1 ceiling tile (non-asbestos)

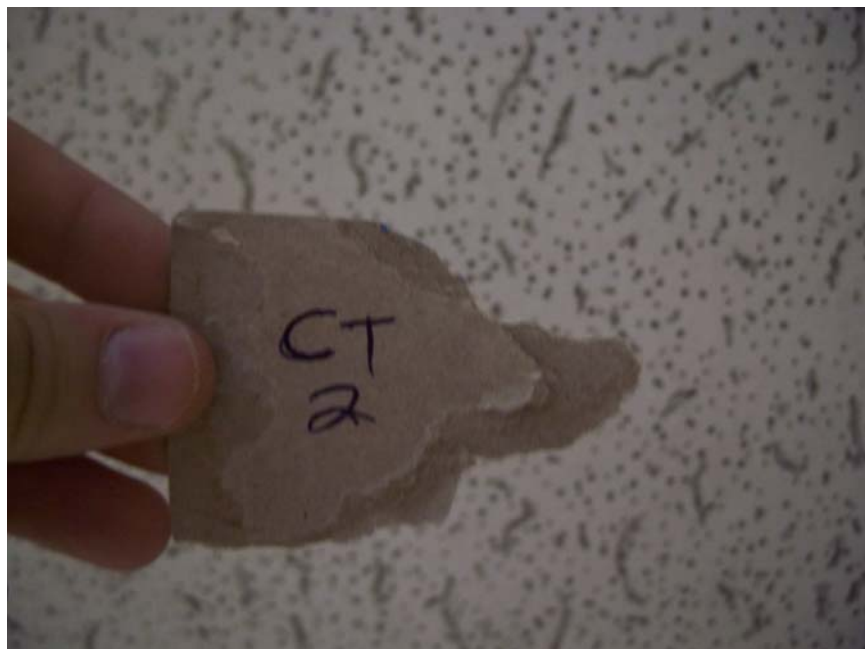
**Photograph No. 6**  
CT2 ceiling tile (non-asbestos)

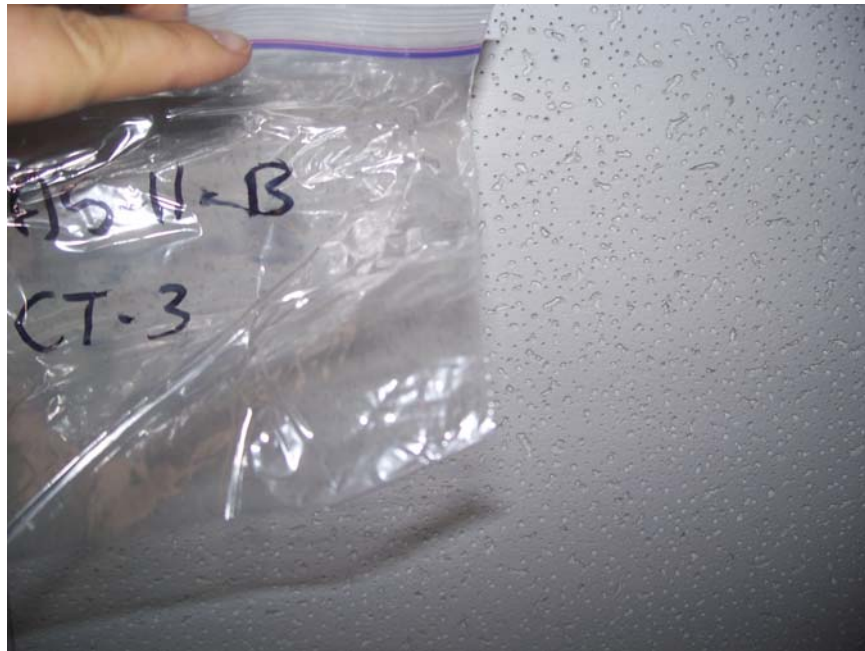
**Photograph No. 7**  
CT3 ceiling tile (non-asbestos)

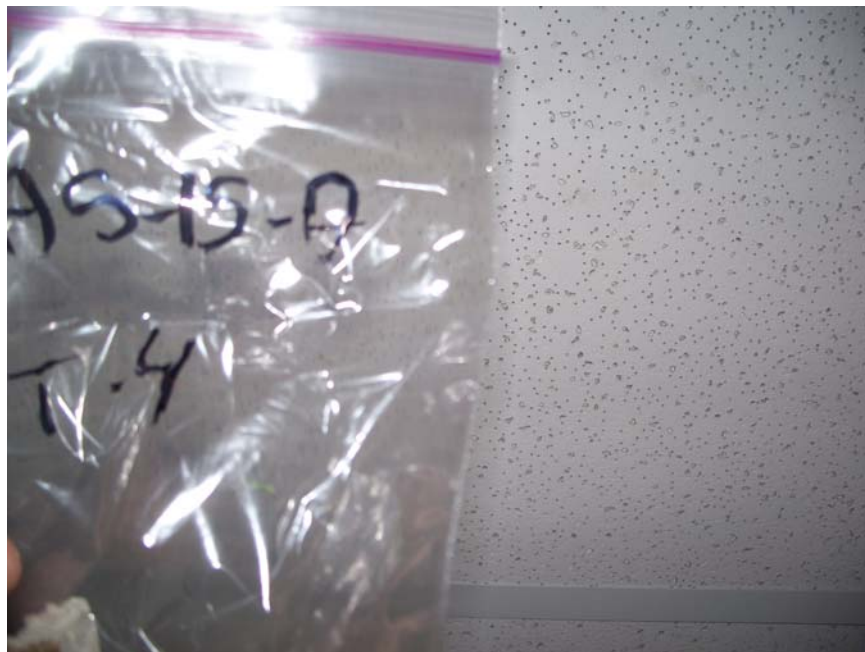
**Photograph No. 8**  
CT4 ceiling tile (non-asbestos)

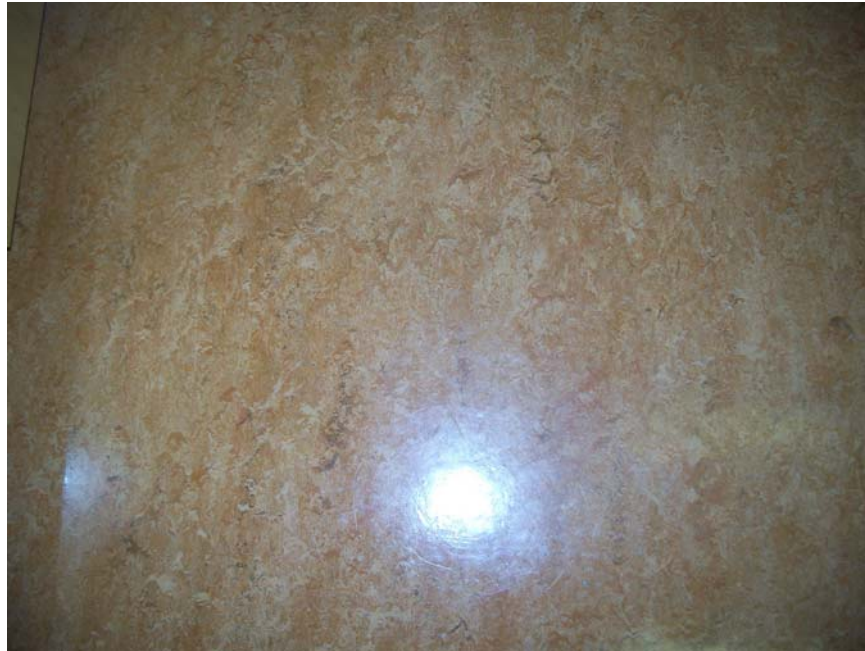
**Photograph No. 9**  
FT3 seamless floor (non-asbestos)

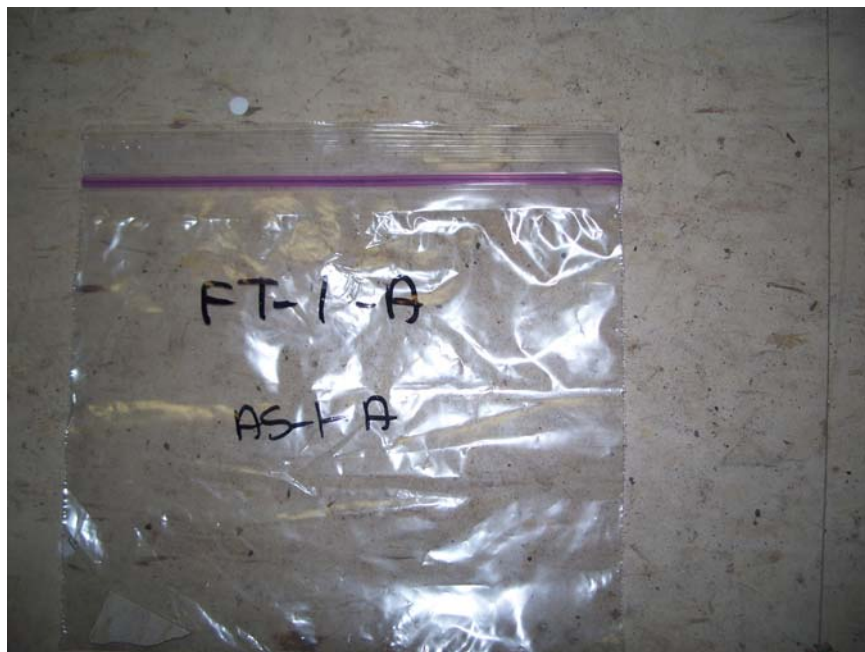
**Photograph No. 10**  
FT1 floor tile (non-asbestos)

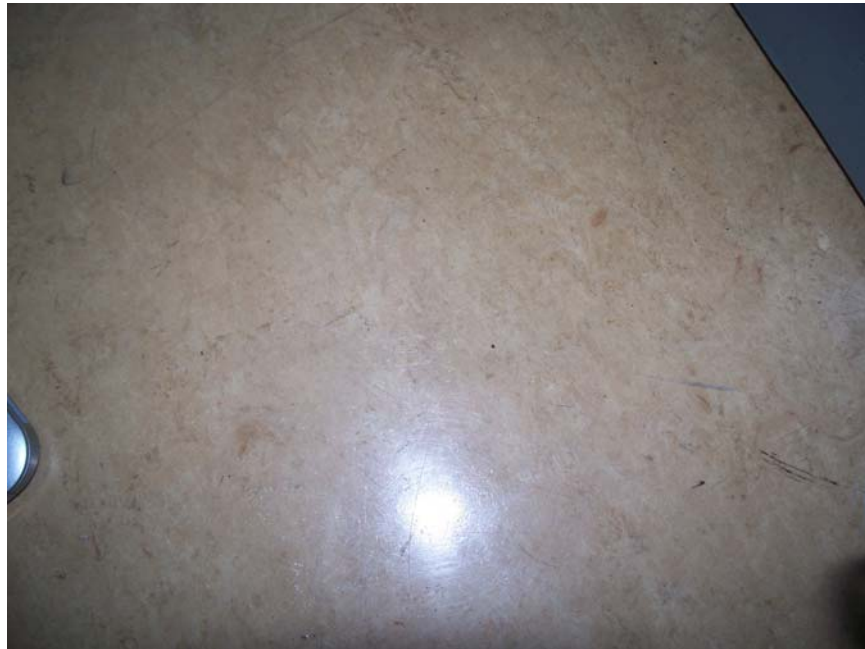
**Photograph No. 11**  
FT2 seamless flooring (non-asbestos)

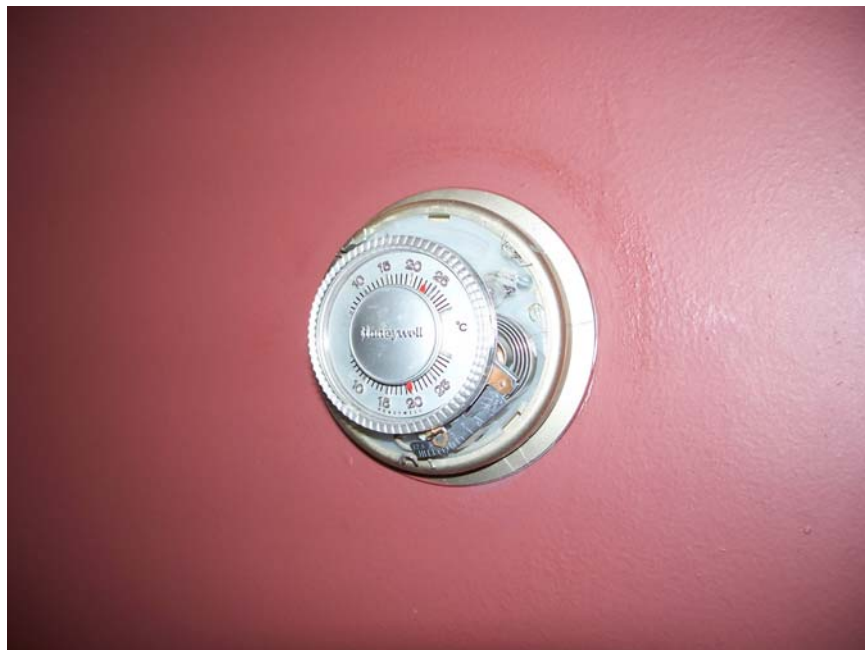
Three of the thermostats observed within the subject building were identified to contain mercury. Approximately five of the thermostats were observed to be locked and Trow could not review the contents of the thermostats. All remaining thermostats were identified to be electronically controlled.

**Photograph No. 12**  
Mercury thermostat identified in offices.

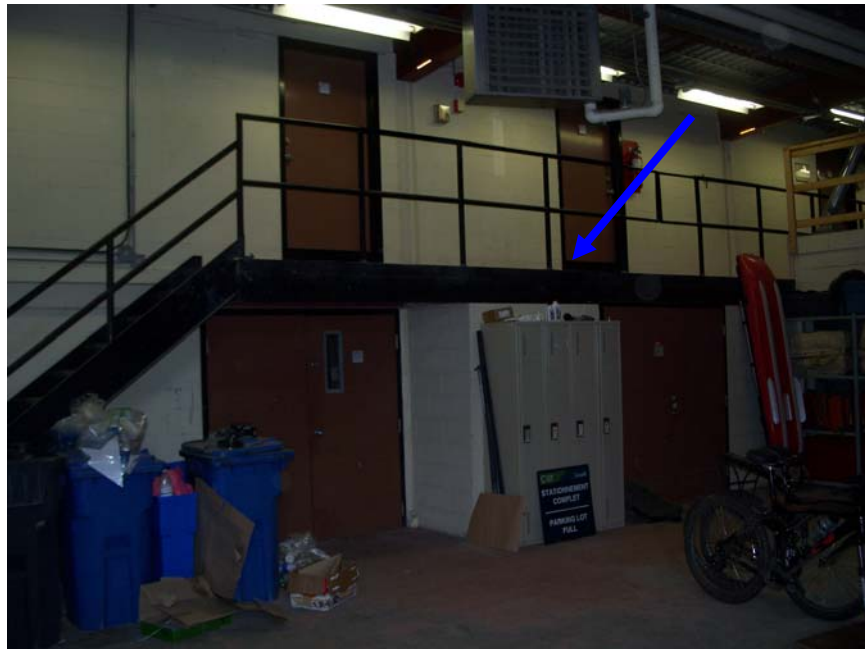
It is noted that the lead-based paint applications were identified on railing/columns and some doors but were not identified on any of the walls within the building. It is also noted that the lead-based paints (i.e. black and red paint) were identified to be in fair to good condition with no significant peeling and/or flaking. As a result, there is no immediate concern regarding exposure to the painted surfaces. Refer to Section 5.1.2 for recommendations when handling the material.

**Photograph No. 13**

Commonly identified fluorescent lights and lead-based black paint.

For all painted surfaces above the applicable criteria, necessary protective equipment should be worn to reduce the risk of lead-dust inhalation to any workers when the buildings are being demolished. Activities involving abrasion or sanding of painted surfaces should be minimized. Appropriate personal protective equipment (i.e., respirators, gloves and eye protection) should be worn when undertaking any such activities.
