Reference: Maligne River Fifth Bridge Engineering Assessment
Jasper National Park

Re: Hydrotechnical Assessment and Conceptual Design for the Maligne Canyon Fifth Bridge over the Maligne River at 06-36-045-01-W6M

ISL ENGINEERING AND LAND SERVICES LTD.			
SITE PHOTOGRAPHS			
MALIGNE RIVER 5TH BRIDGE (SW-36-045-01-W6M)			
DESIGN: M. WOOD	DRAWN: N. DYER	FIGURE 2	
CHECK: D. COOPER	DATUM: UTM NAD83-Z11

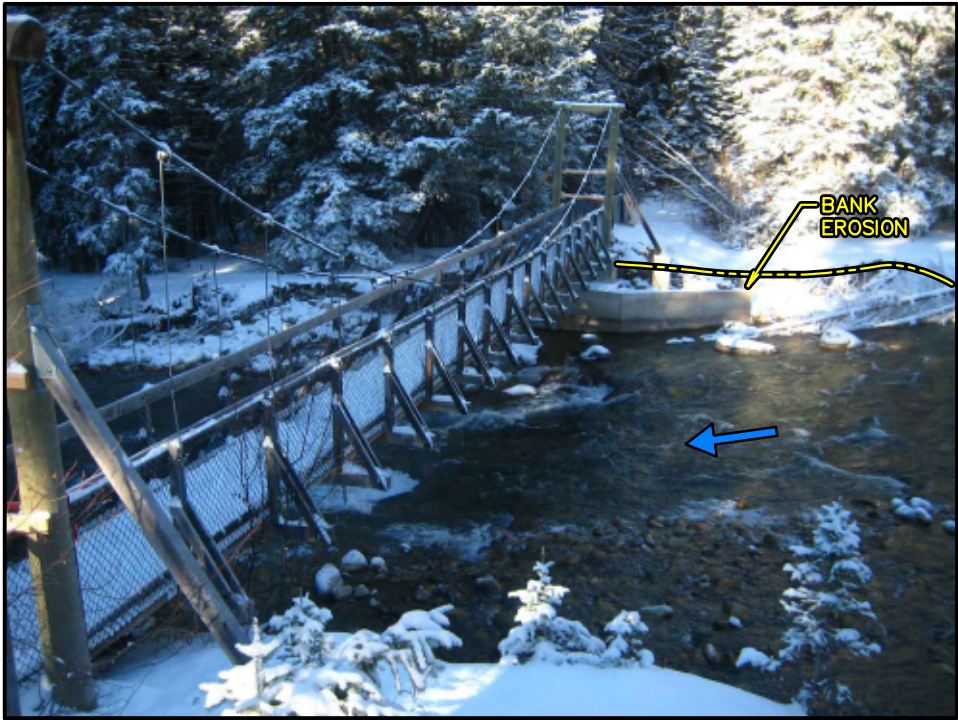
1. View of Existing Pedestrian Bridge (Looking Northwest).

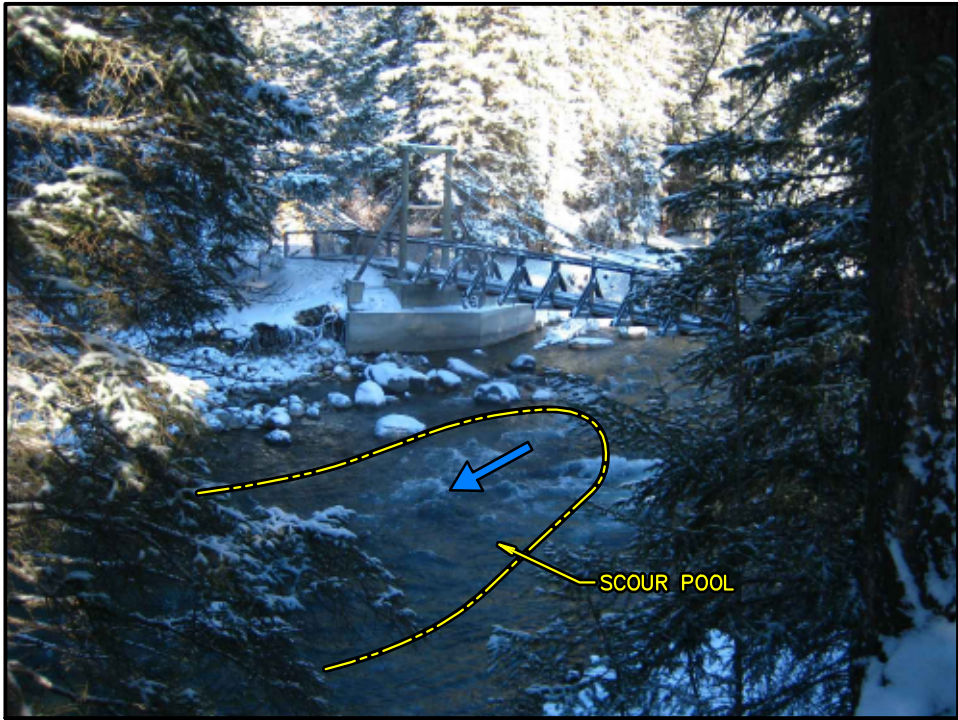
2. Upstream View of Existing Pedestrian Bridge (Looking Northwest).

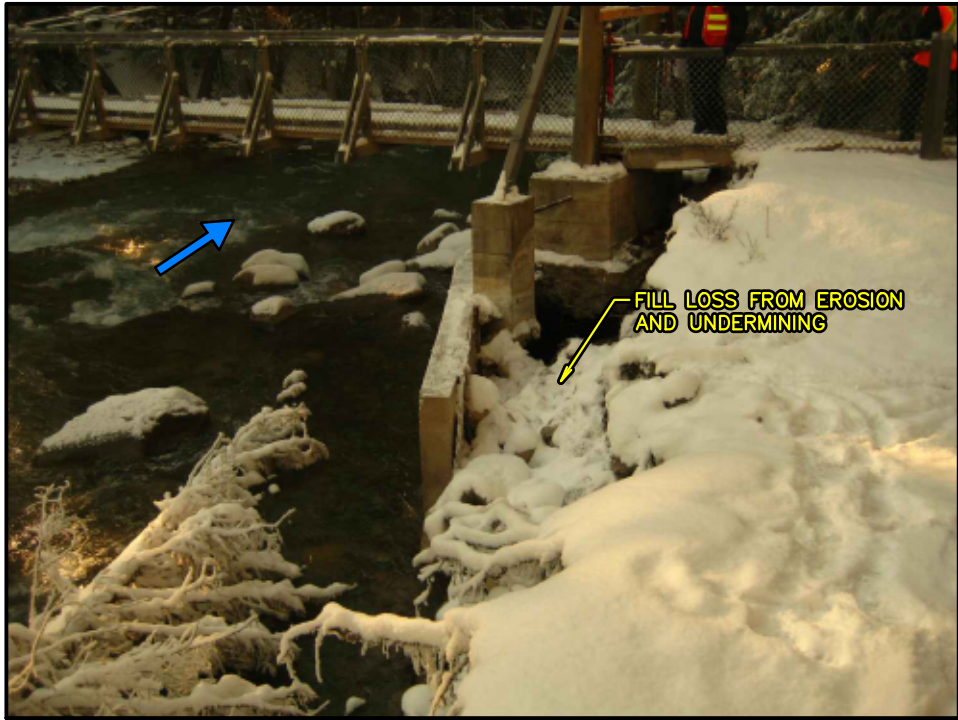
The left bank abutment appeared to be in good condition with only minor scour of the foundation at the downstream edge. The right bank displayed considerable damage and the bridge superstructure had undergone some rotation in the clockwise direction when observed from the right bank. Deformation and damage to the right bank approaches and handrails was also observed.

The right bank is 2.0 m high and vertical to undercut due to the thalweg's position along its toe. The undercutting has likely become more pronounced as recent erosion has washed out approximately 2 m of the bank in 2012. It is believed that the progression of this erosion is driven by deposition on the left side of the channel as shown in Photo 6 of Figure 2. The root structure of the mature conifers in the right overbank provides some degree of resistance to the erosion. This erosion will continue to progress at a slow rate with future development of the point bar. Hydraulic modelling (described later in this report) suggests that the right bank just barely overtops during the 100-year flood. Though the bank is low, the overbank flood depths estimated using the hydraulic model, and the presence of the slightly elevated pathway that runs back into the floodplain, suggests that the potential for full scale channel switching to the north side is low.

3. View of Existing Right Abutment. Note Fill Loss Behind Abutment Wall.

It would be necessary to remove and reconstruct the right-bank concrete abutment and amour it with class 1 rock rip rap. The existing dead man on both banks would likely be re-used. The bridge span extension is required to accommodate the channel migration. The south abutment will require class 1 rock rip rap slope protection due to potential future erosion. The low chord of the existing bridge is required to be raised by 0.31m from its current elevation due to its susceptibility to damage from debris during the 1:100 year flood.

bridge. The details of the proposed armouring are provided in Figure 5. It is recommended that the existing concrete wall at the right abutment be removed to allow for proper placement of the armouring while minimizing the encroachment into the channel.

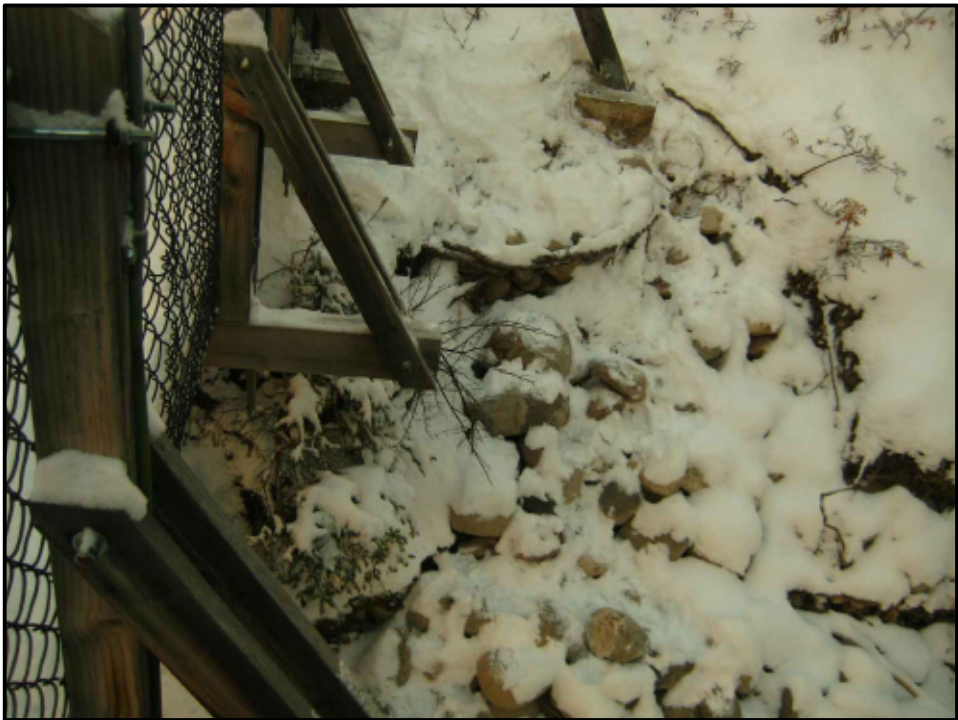
The left (south) bank is 4 m high and slopes at 1:1 H:V. It is well vegetated with only minor localized erosion. This local erosion is most apparent at the trimline and around portions of the south abutment. The left bank does not overtop during flood. The erosion on the left bank has not compromised the south abutment but any future erosion likely would.

4. Minor Erosion on Downstream Side of Left Abutment.

The south abutment, pending the structural analysis required by design, would probably be removed, redesigned and replaced to accommodate the forces induced by the new bridge superstructure. Class 1 rock riprap slope protection on both abutments is also required to avoid potential future erosion.

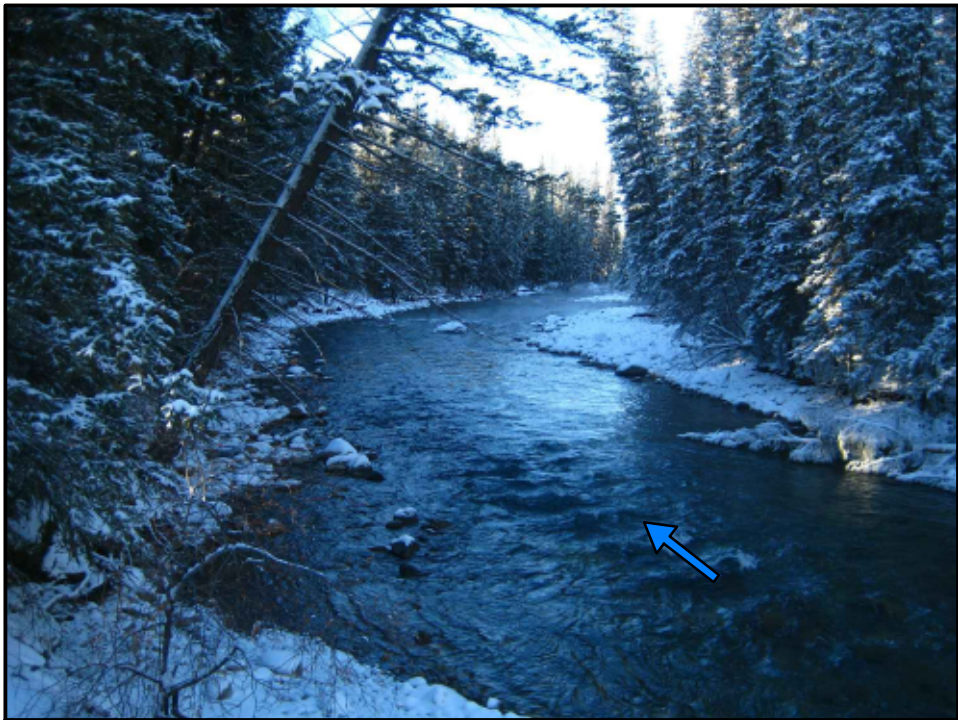
5. Downstream View of Maligne River (Looking East from Left Abutment).

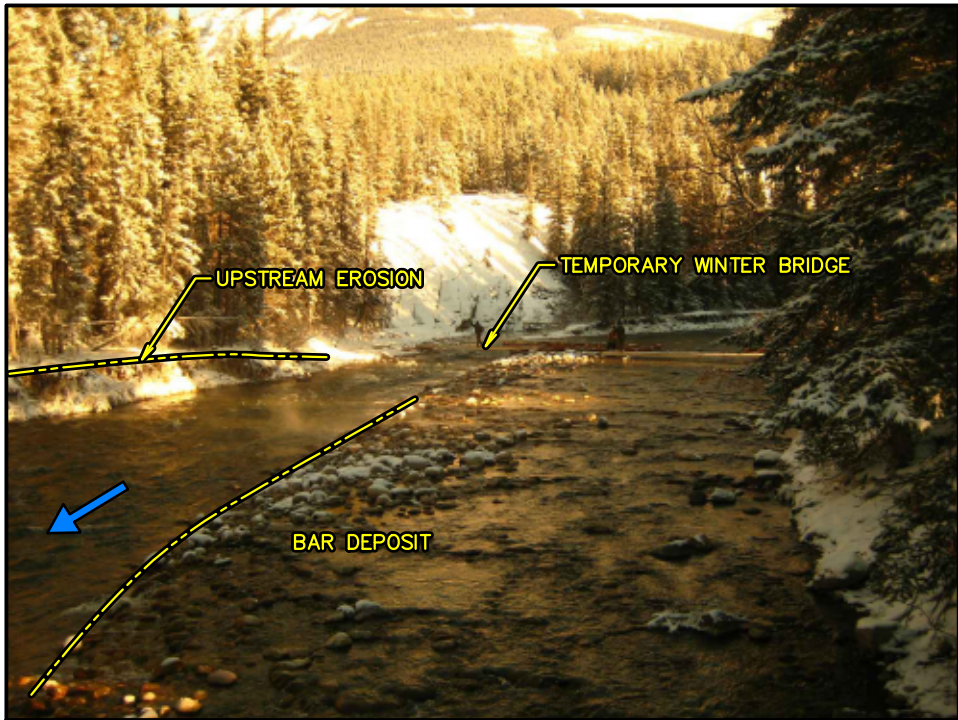
6. Upstream View of Maligne River (Looking from East).
