APPENDIX 5

SITE PHOTOGRAPHS – WATER ACCESS

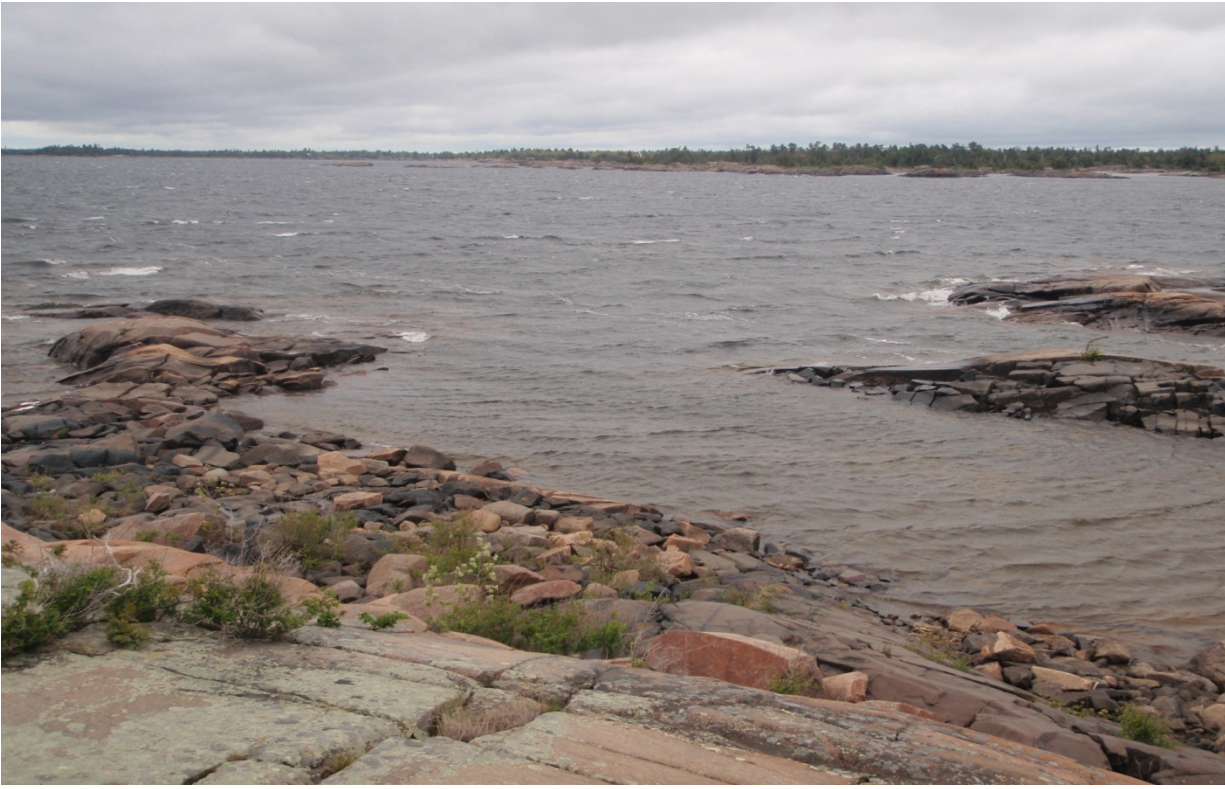
Photo 1: Looking north – Light Tower building is to the right outside of photo frame.

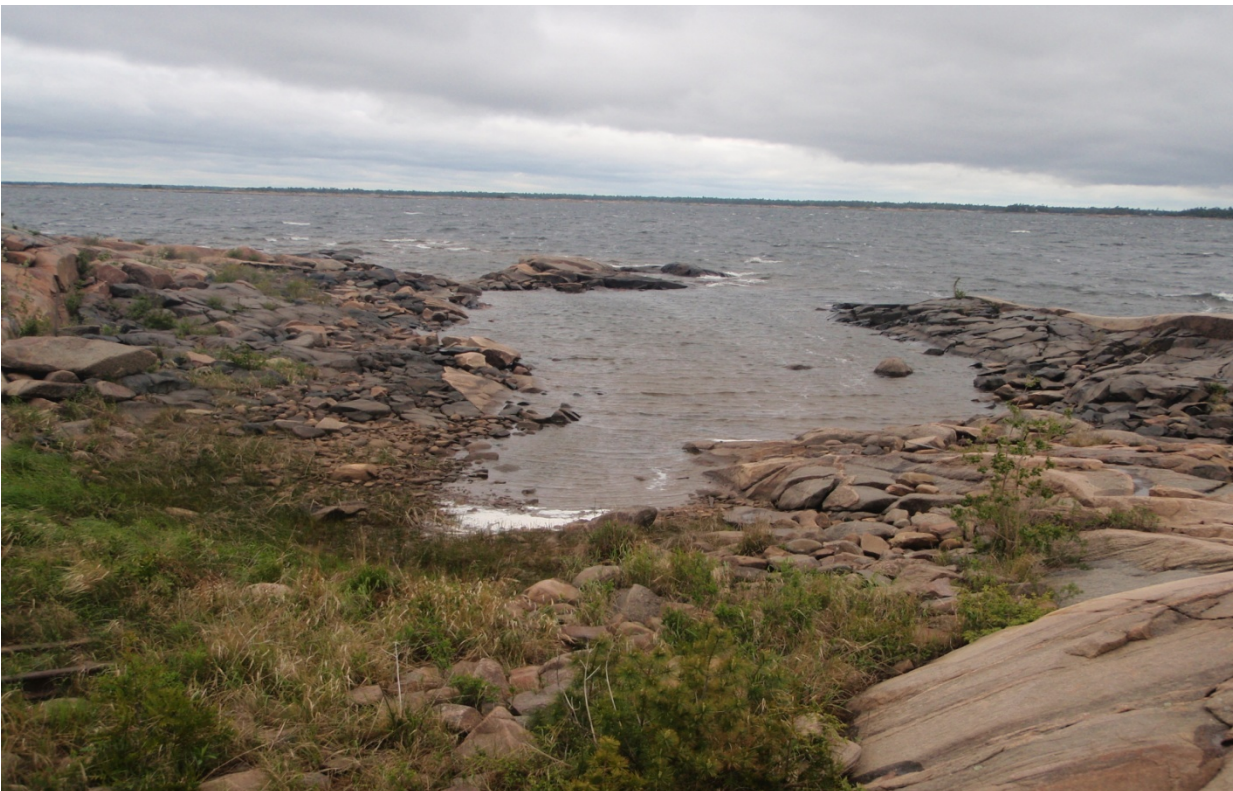
Photo 2: Looking north – showing possible landing slip. Same location as shown in Photo 1 above.

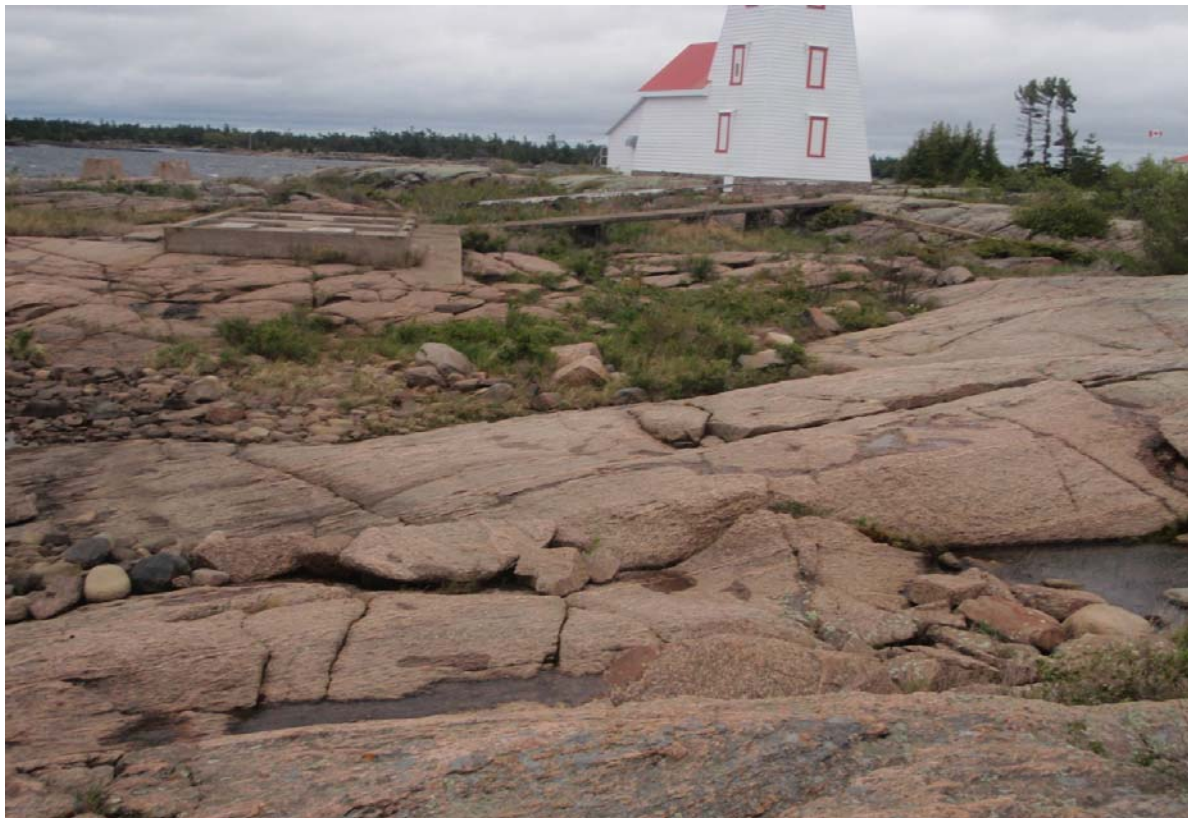
Photo 3: Looking north-east towards the Light Tower building. Remains of former concrete dock.

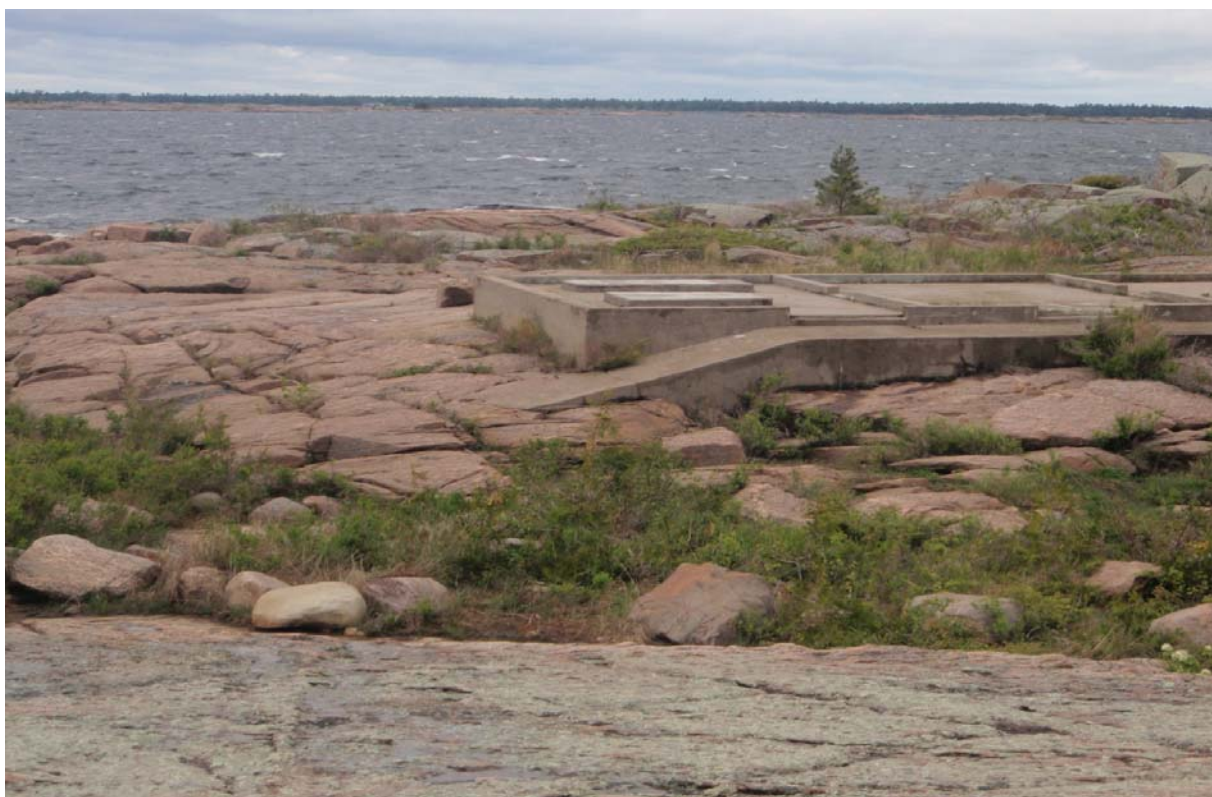
Photo 4: Closer view of remains of former concrete dock.

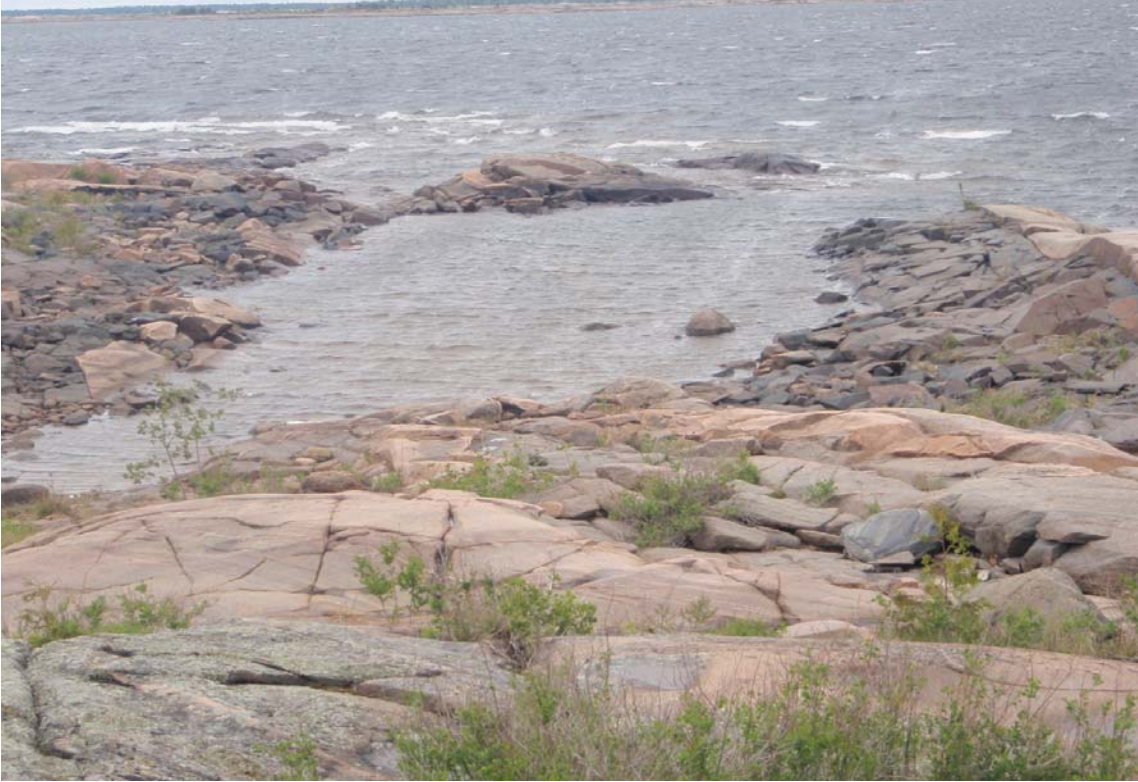
Photo 5: Looking north-west at possible landing slip.

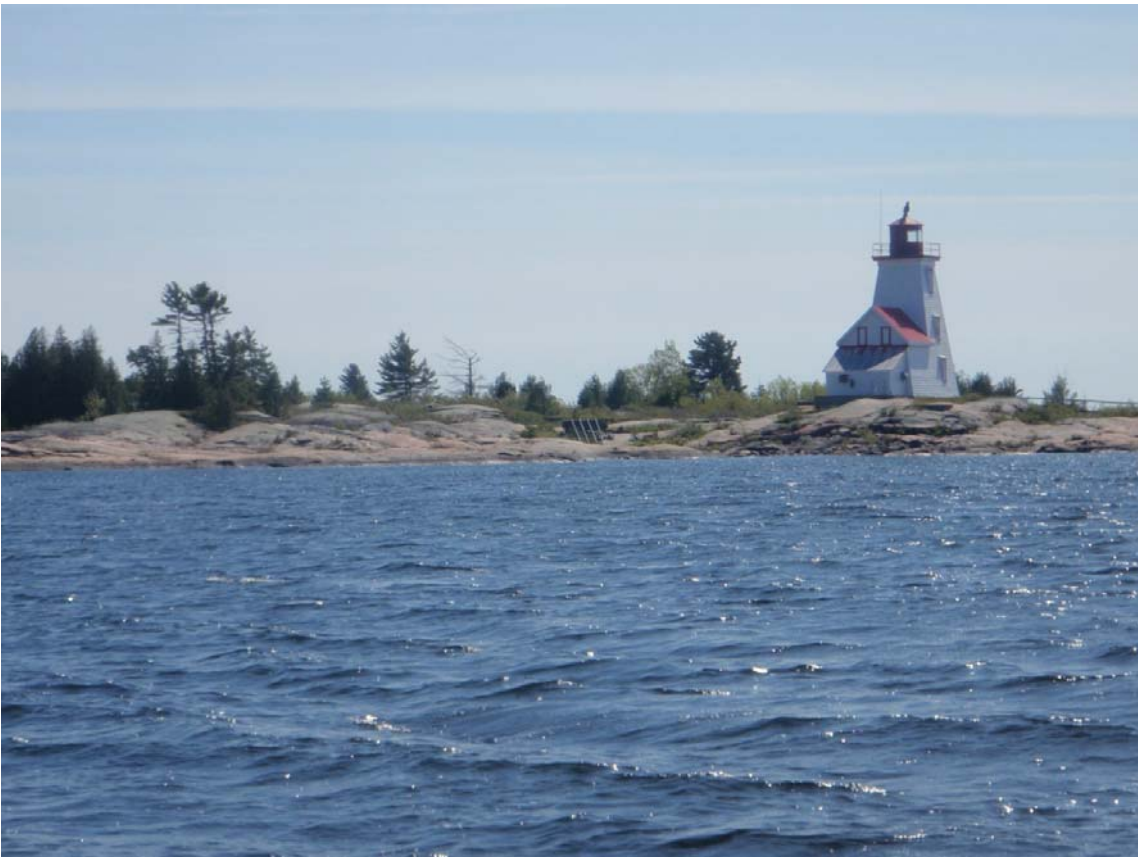
Photo 6: Looking south towards the site. Shore conditions on the north side of the island.
