Royal Canadian Mounted Police

Inspection Report on Firing Ranges

D Division

Final Report: January 8, 2013

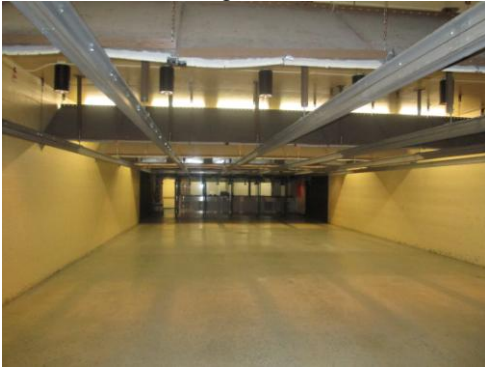
View over the Range

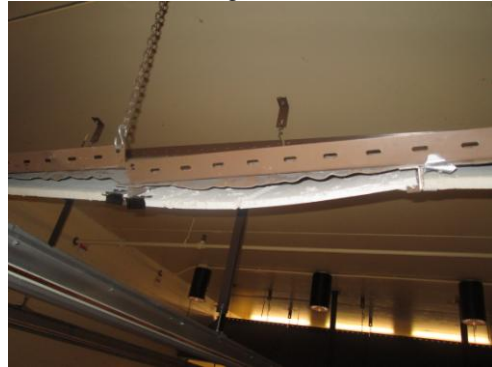
Other/Special :	The ceiling baffles/deflectors are so damaged that are high risk for the shooting training personnel
-----------------	---

Back side of damaged baffles

Overall the range is in poor condition and is not equipped with the required facilities (ammo storage, a proper corridor, cleaning area, etc.). The ceiling baffles are to be replaced immediately with 8mm thick 1T100 armour steel plates. The current ceiling baffles do not meet the regulation standards and have excessive damage.

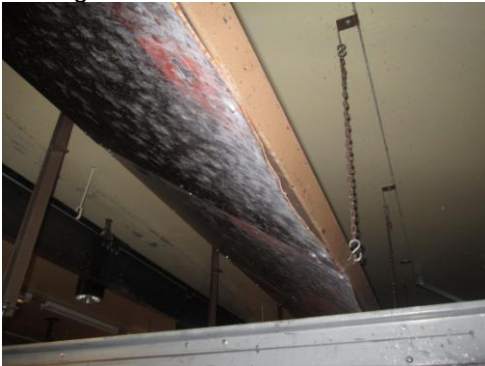
Ceiling :	Concrete protected by damaged original 3mm baffles
-----------	---

Damaged Baffles

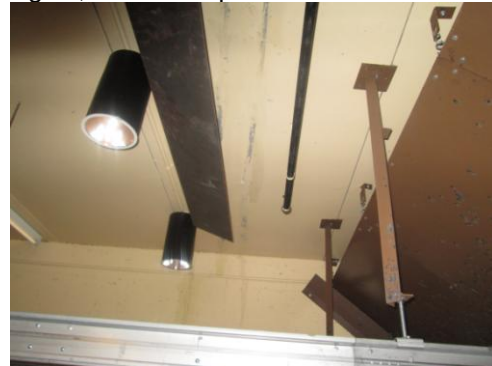
Lighting :	Partially protected in need of improvement
------------	---

Lights, Baffles & Sprinklers

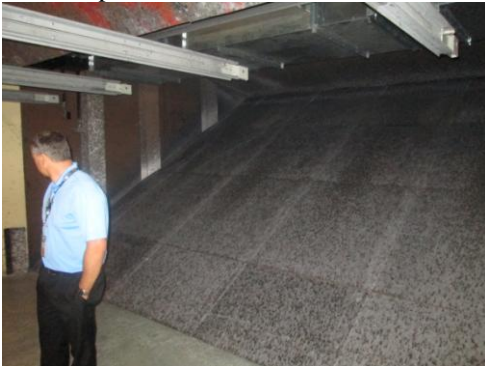
Back Stop

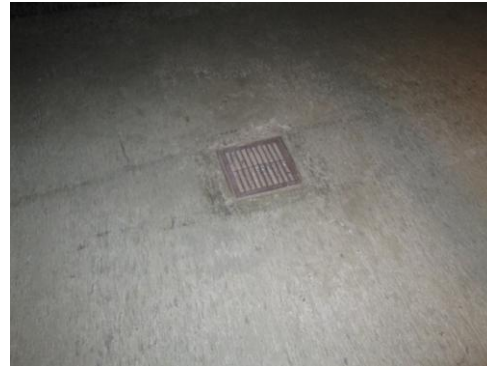
Floor Drains

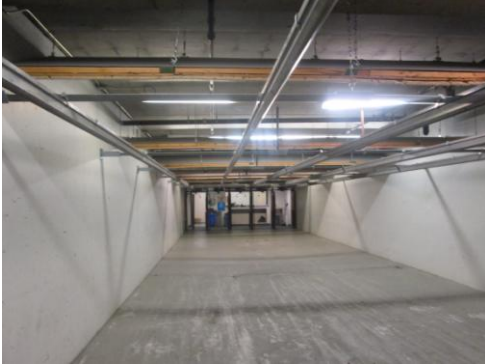
Rear View of the Range

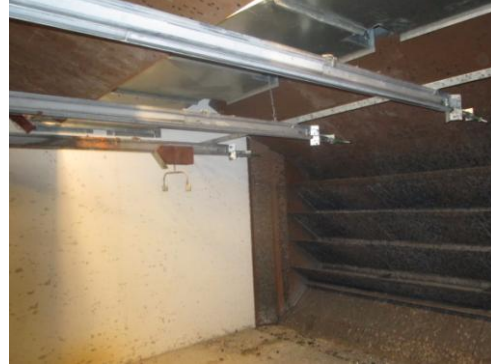
Bullet trap

- The Venetian steel plated back stop must be either completely refurbished or replaced.
- Develop maintenance and cleaning schedules for the range.

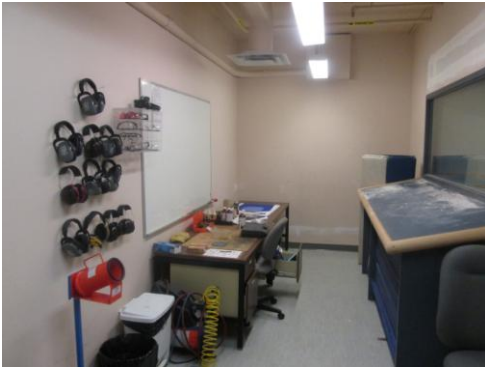
Combined Room

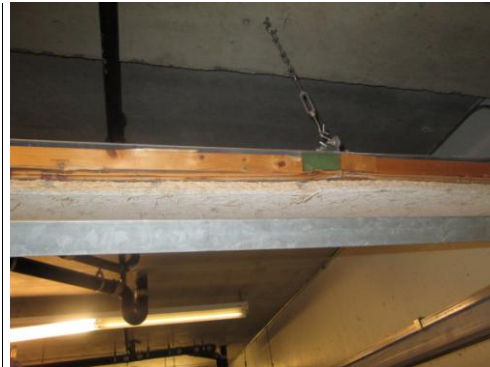
Baffle Structure

- The 4mm thick steel baffles with ¾" thick plywood and acoustic boards must be redesigned to protect all of the lights, sprinkler system and piping within the firing range.

- The current steel plates are to be replaced with 8mm thick 1T100 armour steel and all bolts, nuts and 90 degree edges found on steel within the range are to be bevelled to the appropriate angles for ballistic use.

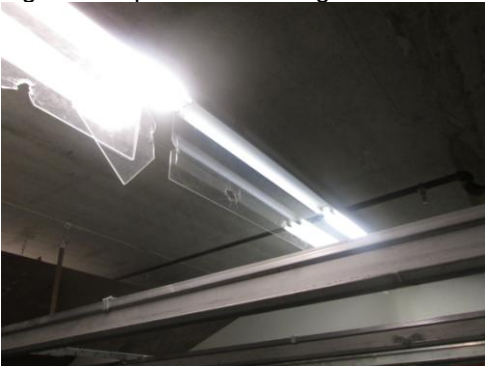
Lights with protective Plexiglas

- The moveable overhead target holders must be either refurbished or replaced with a new system.
- The lights must be redesigned and replaced by a new lighting system.

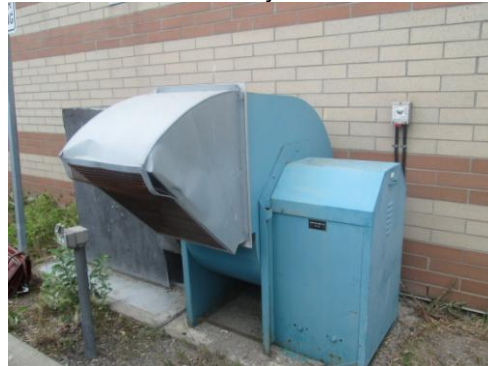
The firing range is located in the basement of the RCMP detachment. The range was built in the late 1980s and has lacked regular maintenance which is reflective of the condition of the range. The facility also lacks the appropriate space required for range operation. The ventilation system has not been properly maintained and as a result it is currently malfunctioning. The exhaust ventilation system is decommissioned, creating a positive air pressure inside the range. As a result of the improper ventilation system the metal, including the galvanized air ducts within the range are rusting.

Exhaust Ventilation System

- The ventilation system must be upgraded to meet the current standards. This includes the addition of a new intake and exhaust filtration system, replacement of the exhaust fan, balancing the system, etc.

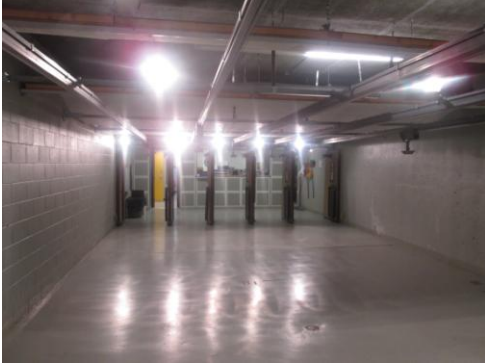
Rear View

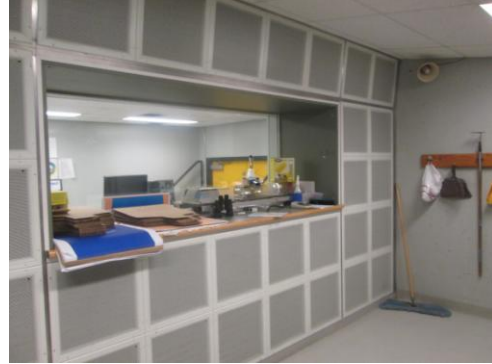
The firing range was constructed in 1997 and is located in the basement of the Dauphin detachment. Overall the range is in good condition and is well maintained minus the ventilation system which indicated positive air pressure within the range. The overhead deflectors/baffles are not constructed with 8mm thick 1T100 armour steel plates. However, they are well constructed with a combination of 4 and 5mm thick steel in combination with 5/8" (3/4") thick plywood. The design of the baffles reduces the risk of ricochet.

Air Inlets in the Range

It is recommended that the ventilation system be thoroughly inspected to avoid positive air pressure within the range. If found faulty the system is to be refurbished or replaced with a new system that meets the current standards. The system must be appropriately balanced and a maintenance and system balancing schedule is to be put in place.

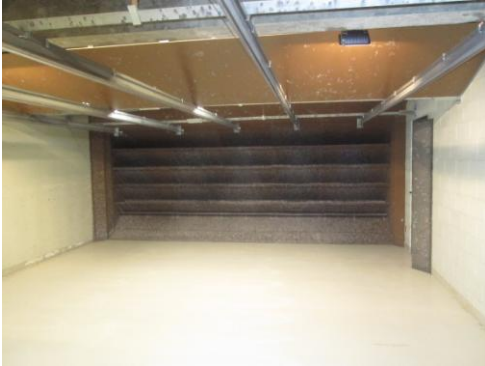
Back Stop

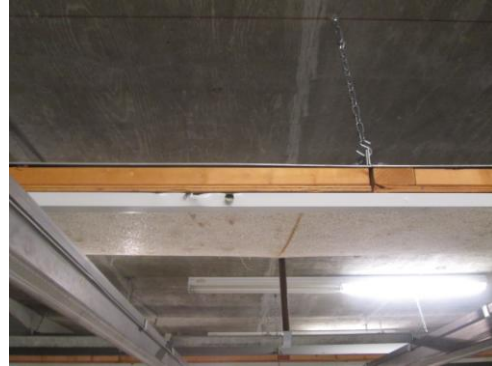
Steel baffles with plywood

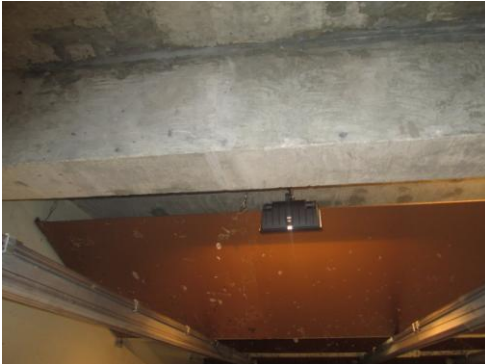
Steel plate Baffle

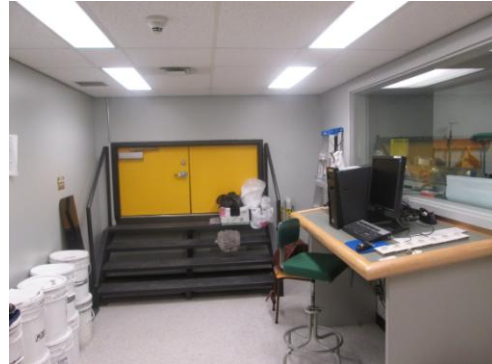
The range is lacking the required operational space and only has one combined room and storage for ammunition. The range is also very loud during firing and the acoustics need to be upgraded.

Combined Room
