PRE-DEMOLITION HAZARDOUS BUILDING MATERIALS ASSESSMENT

CSC's Mountain Institution
Buildings FB1 – FB9 and Manure Pits,
Sutherland and Humphries Road,
Agassiz, BC

FINAL REPORT

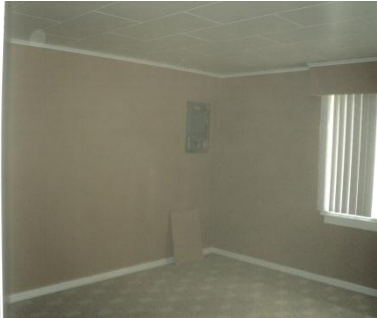
Identified ACM Description and Condition Information	Photo
Drywall joint compound – walls within Room 106, and may be present beneath wallpaper throughout.

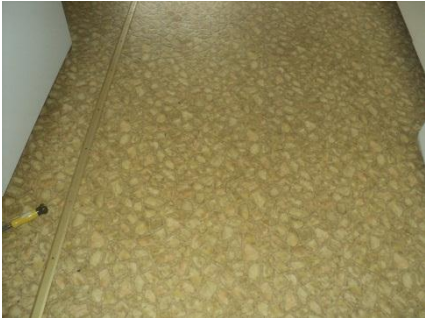
Vinyl sheet flooring – stones pattern, kitchen (Room 107).

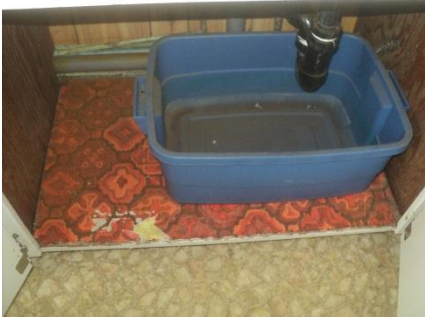
Identified ACM Description and Condition Information	Photo
Vinyl sheet flooring – red, in kitchen cabinets (Room 107)

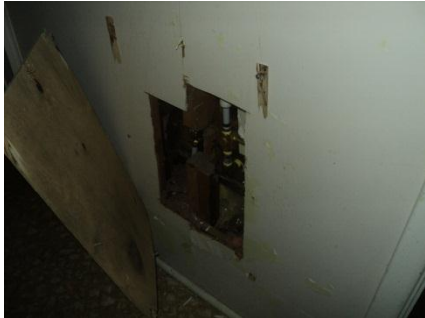
Identified LCP Description	Photo
White paint on the exterior walls of the building.	 
White / green (layered) paint on the interior walls.

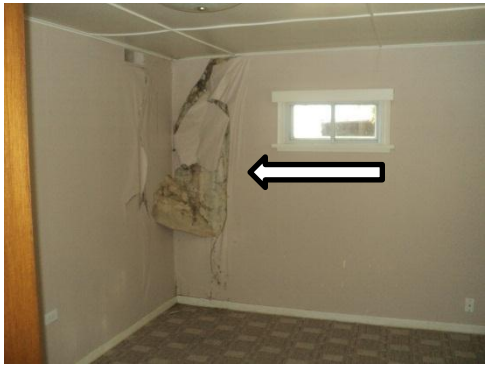
Identified Mould and/or Moisture Impacted Materials Description	Photo
Suspect mould and moisture damage was observed on the north and west walls of the northeast bedroom (Room 106).

When demolition within the subject building proceeds, it is expected that mould and/or moisture-impacted building materials will be removed and disposed of during that process. Due to the suspected presence of mould on building materials, and if those impacted materials are to be removed by hand, demolition workers should be notified of the presence of mould-impacted building materials and be provided with respiratory protection and/or other personal protective equipment (PPE) as deemed necessary for the work that they will be conducting.

As the impacted drywall materials are finished with asbestos-containing joint compound, the work procedures and PPE that will be required to address the asbestos will be sufficient in protecting workers and adjacent areas from exposure to mould.

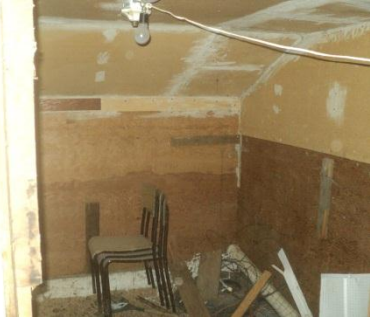
Identified ACM Description and Condition Information	Photo
Drywall joint compound – walls and ceiling within Room 102.

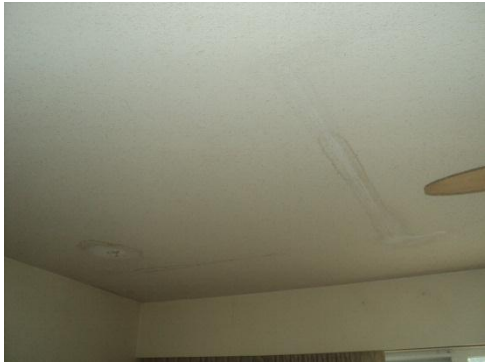
Identified Mould and/or Moisture Impacted Materials Description	Photo
Suspect mould and moisture damage was observed on the ceiling within Room 102.

When demolition within the subject building proceeds, it is expected that mould and/or moisture-impacted building materials will be removed and disposed of during that process. Due to the suspected presence of mould on building materials, and if those impacted materials are to be removed by hand, demolition workers should be notified of the presence of mould-impacted building materials and be provided with respiratory protection and/or other personal protective equipment (PPE) as deemed necessary for the work that they will be conducting.

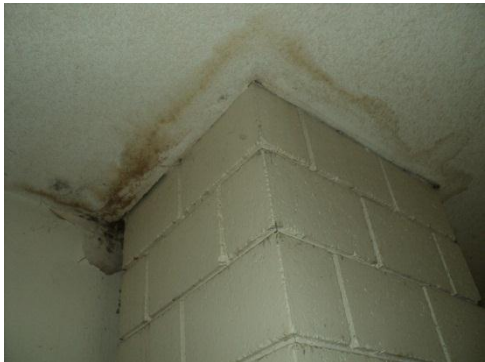
Suspect mould and moisture damage was observed on the ceiling within Room 111.

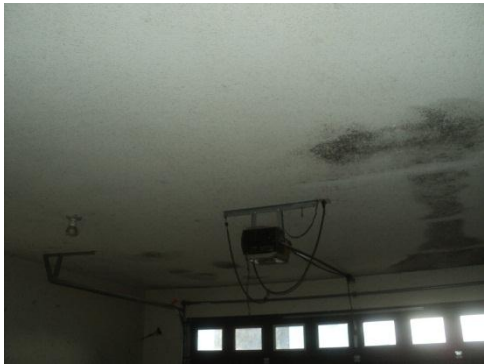
Identified Mould and/or Moisture Impacted Materials Description	Photo
<p>Suspect mould and moisture damage was observed on the ceiling within the garage (Room 114).</p>

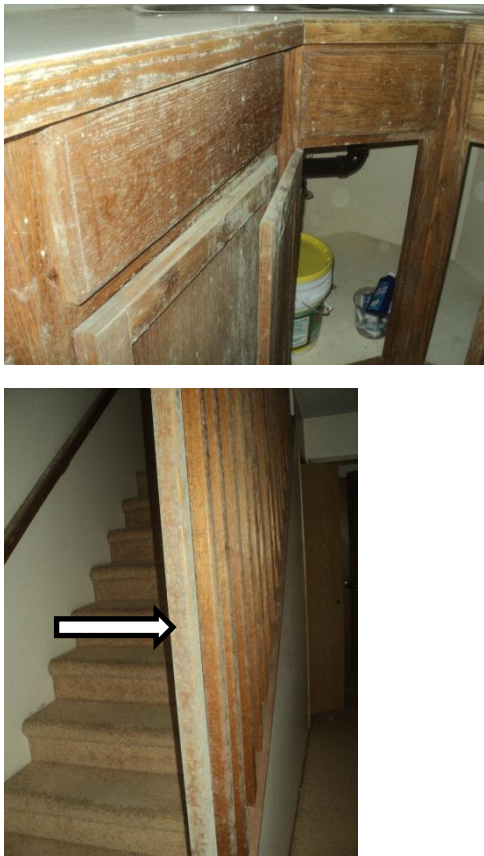
<p>In addition to the above areas that appeared to be impacted by specific moisture intrusion issues, suspect mould was observed on the majority of surfaces throughout, which appeared to be associated with overall interior humidity/condensation issues.</p>

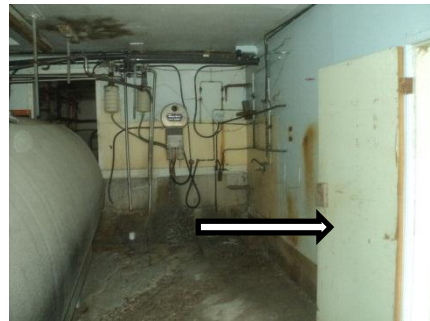
Identified LCP Description	Photo
Green paint on the interior door in Room 103.

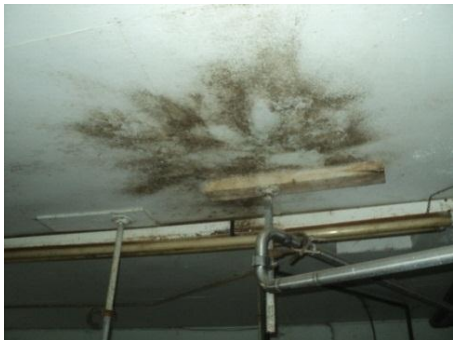
Identified Mould and/or Moisture Impacted Materials Description	Photo
Suspect mould was observed on the ceiling within Room 101.

When demolition within the subject building proceeds, it is expected that mould and/or moisture-impacted building materials will be removed and disposed of during that process. Due to the suspected presence of mould on building materials, and if those impacted materials are to be removed by hand, demolition workers should be notified of the presence of mould-impacted building materials and be provided with respiratory protection and/or other personal protective equipment (PPE) as deemed necessary for the work that they will be conducting.
