Title - Sujet Lead Paint Abatement	
Solicitation No. - N° de l'invitation E0225-141170/A	Amendment No. - N° modif. 001
Client Reference No. - N° de référence du client E0225-14-1170	Date 2013-10-02
GETS Reference No. - N° de référence de SEAG PW-\$PWA-123-5015	
File No. - N° de dossier PWA-3-70056 (123)	CCC No./N° CCC - FMS No./N° VME
Solicitation Closes - L'invitation prend fin at - à 02:00 PM on - le 2013-10-17	Time Zone Fuseau horaire Atlantic Daylight Saving Time ADT
F.O.B. - F.A.B. Plant-Usine: <input type="checkbox"/> Destination: <input checked="" type="checkbox"/> Other-Autre: <input type="checkbox"/>	
Address Enquiries to: - Adresser toutes questions à: Lockyer (PWA), Jeff	Buyer Id - Id de l'acheteur pwa123
Telephone No. - N° de téléphone (902) 496-5636 ()	FAX No. - N° de FAX (902) 496-5016
Destination - of Goods, Services, and Construction: Destination - des biens, services et construction:

**Re: Updated Risk Management Plan
Devil's Island Former Minor Shore Light, Halifax County, Nova Scotia**

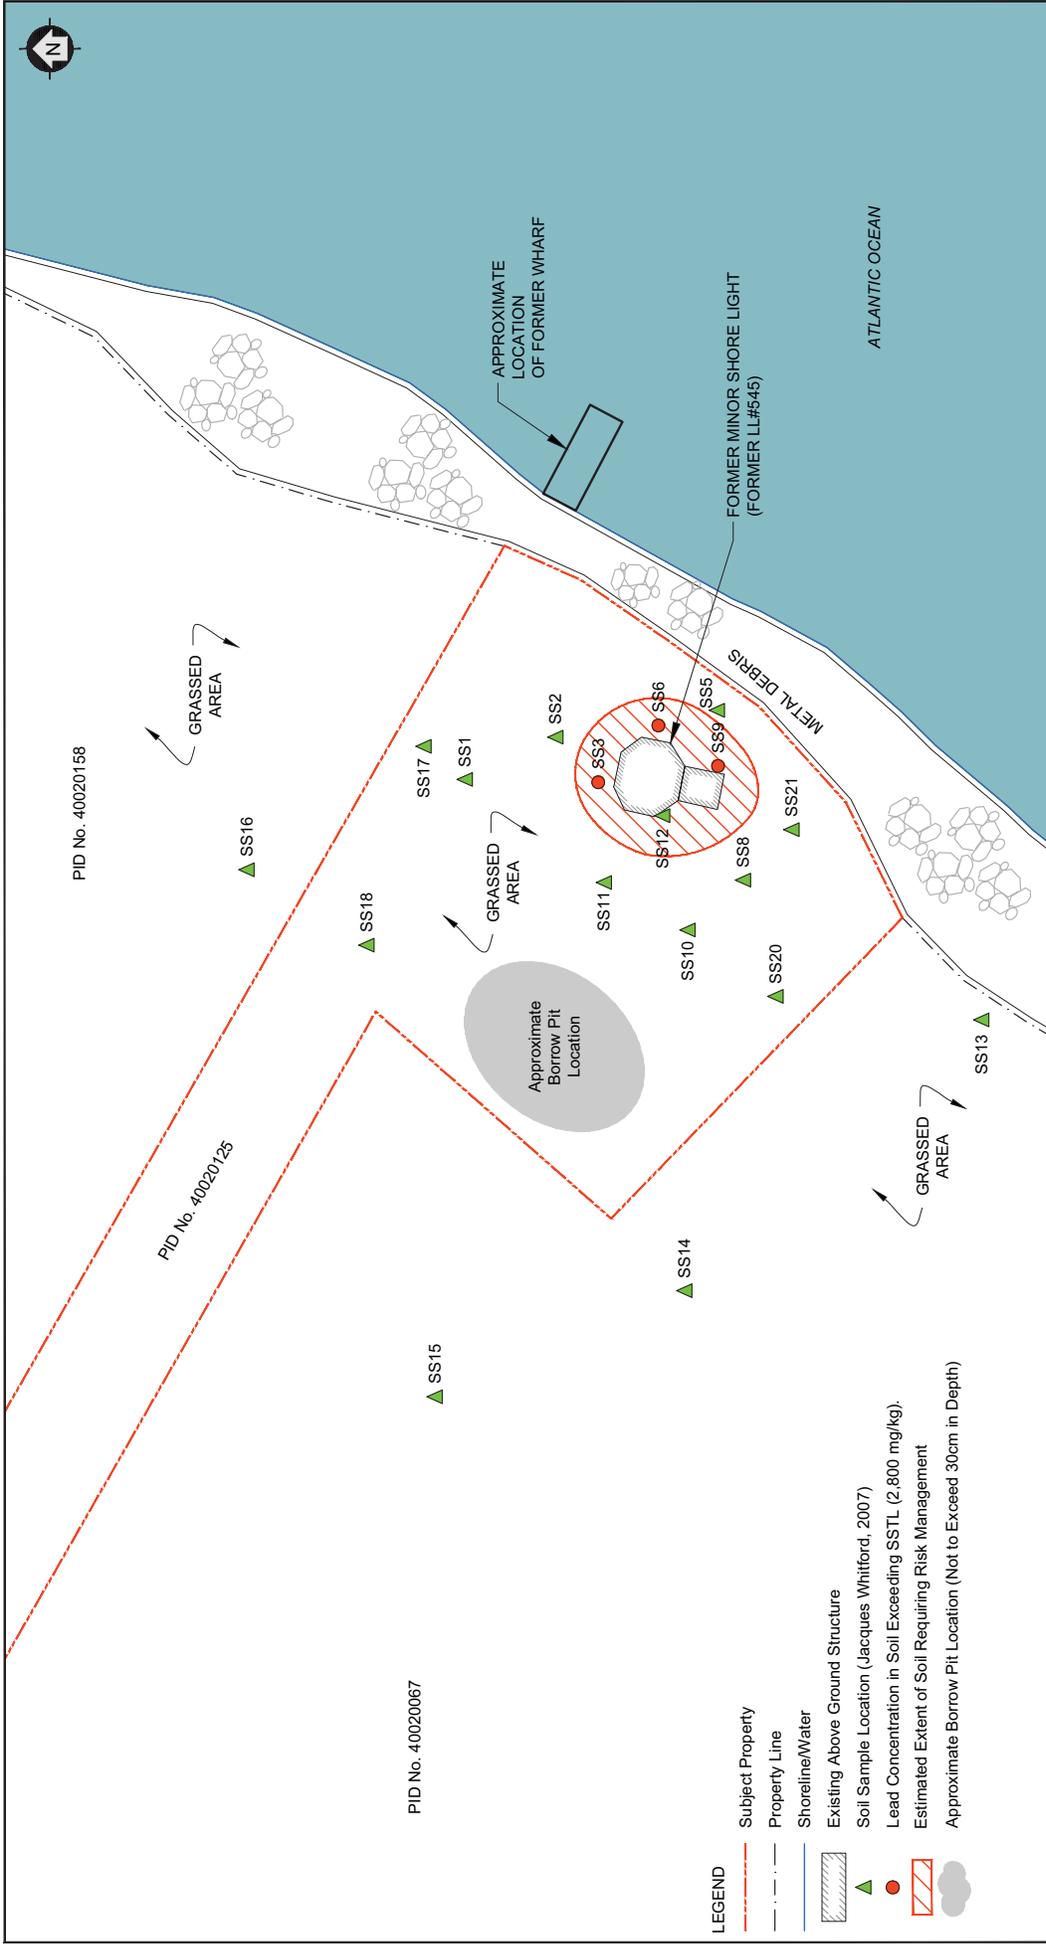
Soil Areas Requiring Risk Management
 Risk Management/Remedial Action Plan
 Devils Island Light Station, Halifax County, NS
 (LL# Former 545, DFRP# 02878, RPIS# MC00145)

Elevated concentrations (>SSTL) for lead are most likely related to flaking of lead based paint from the former MSL. To assess the potential benefits of undertaking risk management or remedial action in the immediate vicinity of the former MSL, the soil lead EPC has been recalculated, excluding the following samples, as illustrated on Figure 1, Appendix B:

- Impacted area within the dripline of the former MSL: SS3, SS6, SS9, and SS12.

The concentration of lead in soil at SS12 (dripline sample on the western side of the former MSL) did not exceed the revised SSTL. However, this sample has been excluded from the revised EPC calculation and it is recommended that remedial action undertaken should extend around the entire dripline of the former MSL.

As indicated, no unacceptable risks remain for site visitors assuming that the areas noted above and indicated on Figure 1 are risk managed and/or remediated. Based on the proposed remediated areas, no concentrations exceeding the revised SSTL (2,800 mg/kg) will be

The risk management at the former MSL includes the encapsulation of the area requiring risk management with geosynthetic liner secured with soil excavated from an on-site borrow pit, which could be excavated in the vicinity of samples SS18 and SS19 (i.e., areas of the site with sufficient soil volumes and soil lead concentrations lower than the SSTL). Dillon provided performance considerations for a liner/soil cover in their risk management plan. The main considerations identified by Dillon are summarized as follows:

- The geosynthetic should be woven/permeable to rain water and UV resistant;
- The leading edges of the geosynthetic should be embedded at least 150mm (6") into the ground;
- 100% of the surface of the geosynthetic should be covered with at least 150mm of soil to provide UV protection, erosion protection, and ballast;
- Seams in the geosynthetic liner will have a 500mm overlap;
- Soil shall be free of rocks or objects that may penetrate the underlying geosynthetic liner;
- Exposed soil shall be rolled/compacted and seeded with grass to stabilize it and prevent erosion. Temporary sediment control structures such as silt fencing, mulch, and hay bales may be required until the grass cover is established; and
- Based on the above performance criteria, a Terrafix® 800R or equivalent is recommended.

Because the foundation of the former MSL is elevated on blocks, additional considerations are as follows:

- Care should be taken to avoid ponding of water, especially beneath the former MSL as a result of the capping; and
- Because the borrow pit will not be backfilled, it should not exceed 30 cm in depth to avoid creating a tripping/falling hazard.
