**Maison Charron Rehabilitation – 164 Laurier
Street, Gatineau, Qc.
Tender File # AL1467
October 9, 2013
ADDENDUM NO: 1**

DESIGNATED SUBSTANCE SURVEY ASSET NO. 3669

**164 RUE LAURIER
GATINEAU, QUEBEC**

**NOVEMBER 2010
REF. NO. 072145 (6)**

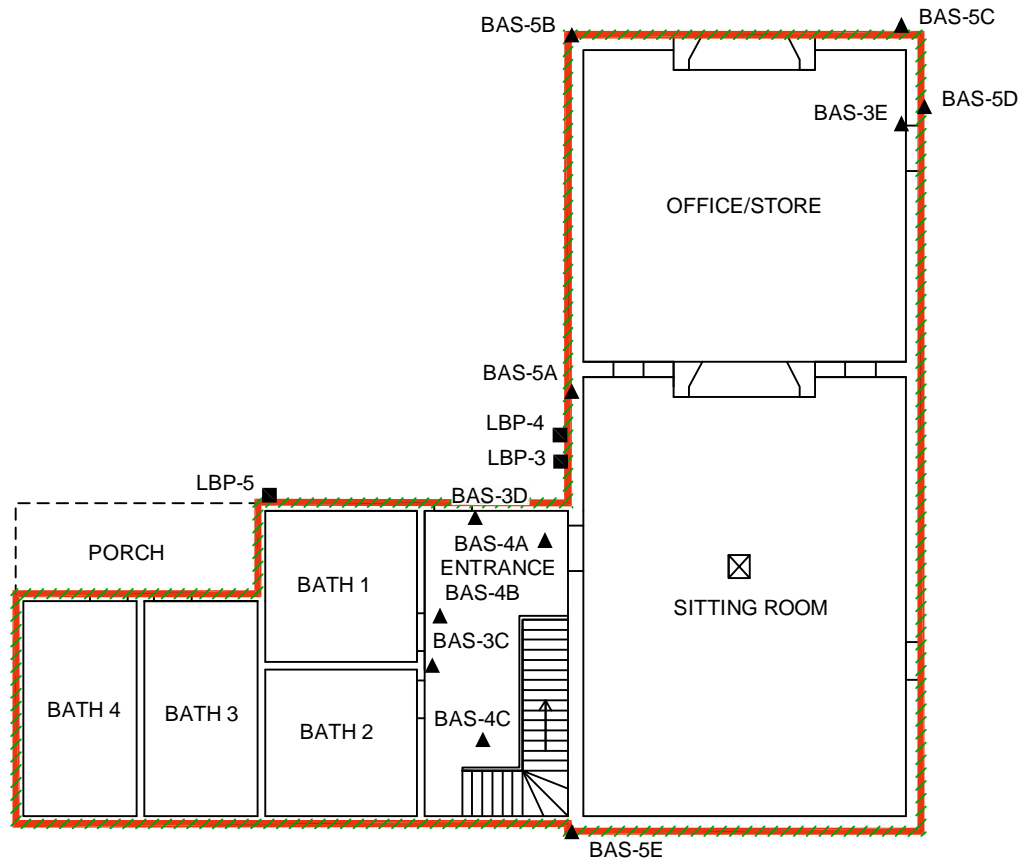
- ▲ BAS-5A BULK ASBESTOS SAMPLE LOCATION
- LBP-3 LEAD PAINT CHIP SAMPLE LOCATION
- /// LEAD CONTAINING PAINT - SHUTTERS
- LEAD CONTAINING PAINT - TRIM

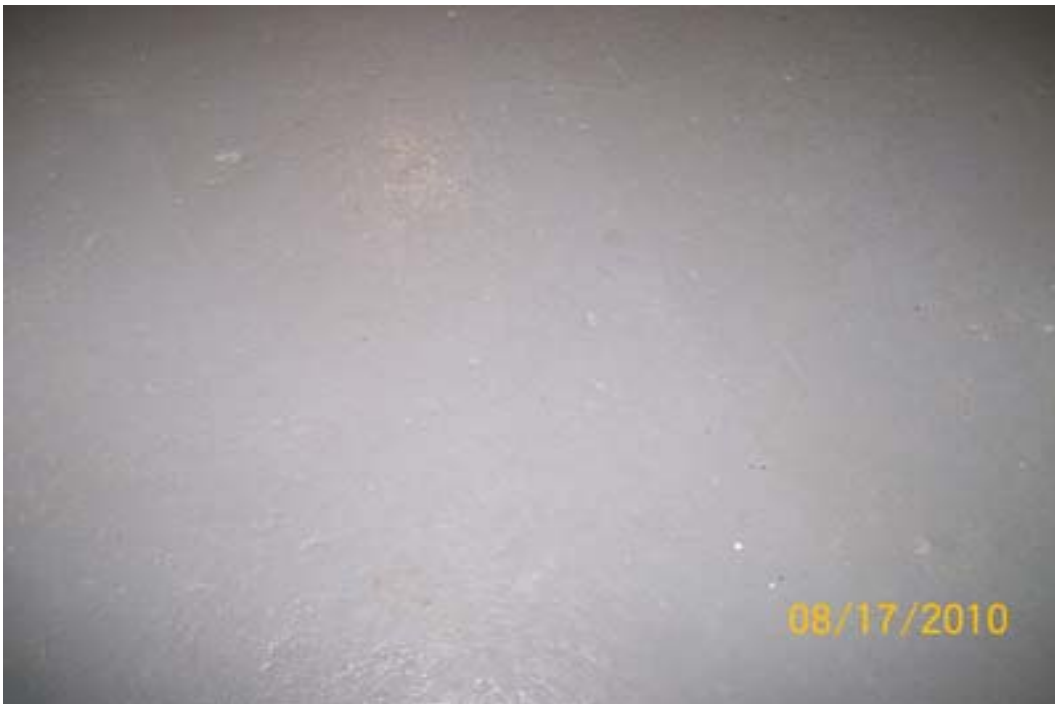
Photo No. 4: Grey paint, floor in basement, 3669-LBP-1.

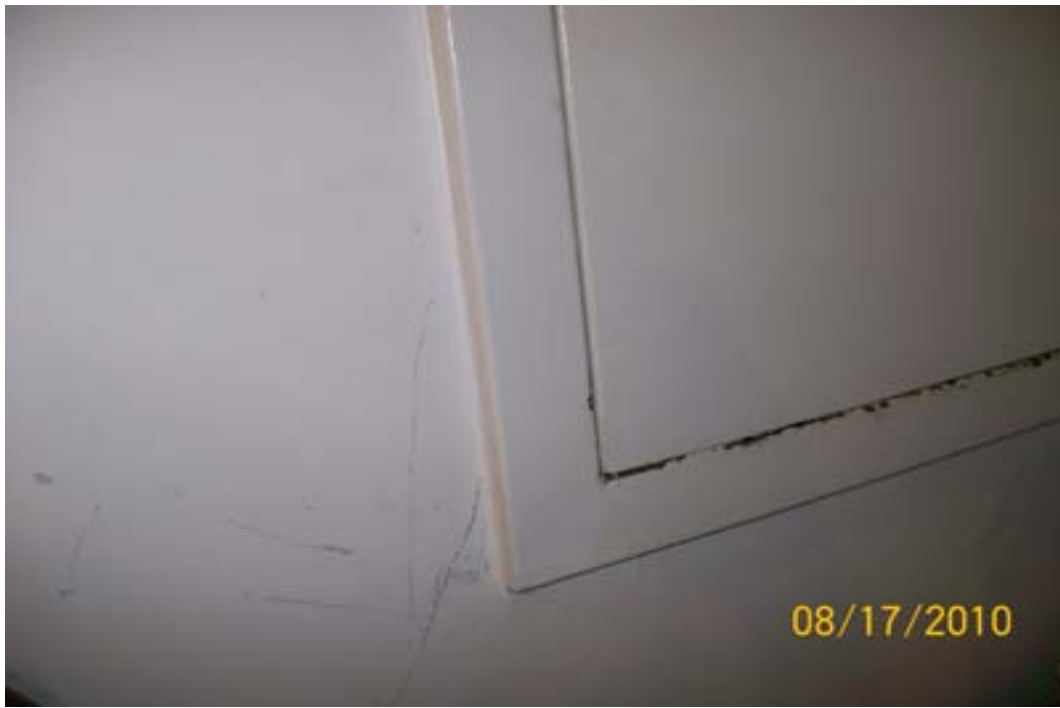
The lead based paint (LBP) survey conducted as part of the DSS indicated elevated lead concentrations in certain paint including the white interior wall/trim/ceiling paint, the white exterior trim paint, and the green exterior shutter paint. All of these painted surfaces were observed to be in good condition at the time of the Site inspection. Lead is also most likely present in solder of electrical equipment and plumbing fixtures, batteries in emergency lighting and alarms, and potentially in old metal pipes (no sample collected for lead analysis).

Photo No. 5: White paint, crawl space door, 3669-LBP-2.

5. The measures outlined in the Quebec regulation c. S-2.1, r.19-01, as well as the Guideline for Lead on Construction Projects (MOL, September 2004), should be implemented for proper PPE and to control potential lead dust hazard during any maintenance, renovation or demolition work which involves the disturbance of a painted surface or other lead-containing materials. No regulations currently exist in Quebec for the disposal of lead-containing paint (regular landfill disposal is acceptable). However, materials with high proportions of lead are considered a hazardous material (e.g., lead batteries) and must be handled, stored, transported and disposed in accordance with appropriate provincial and federal regulations. In addition, lead-containing waste with certain concentrations is regulated as a

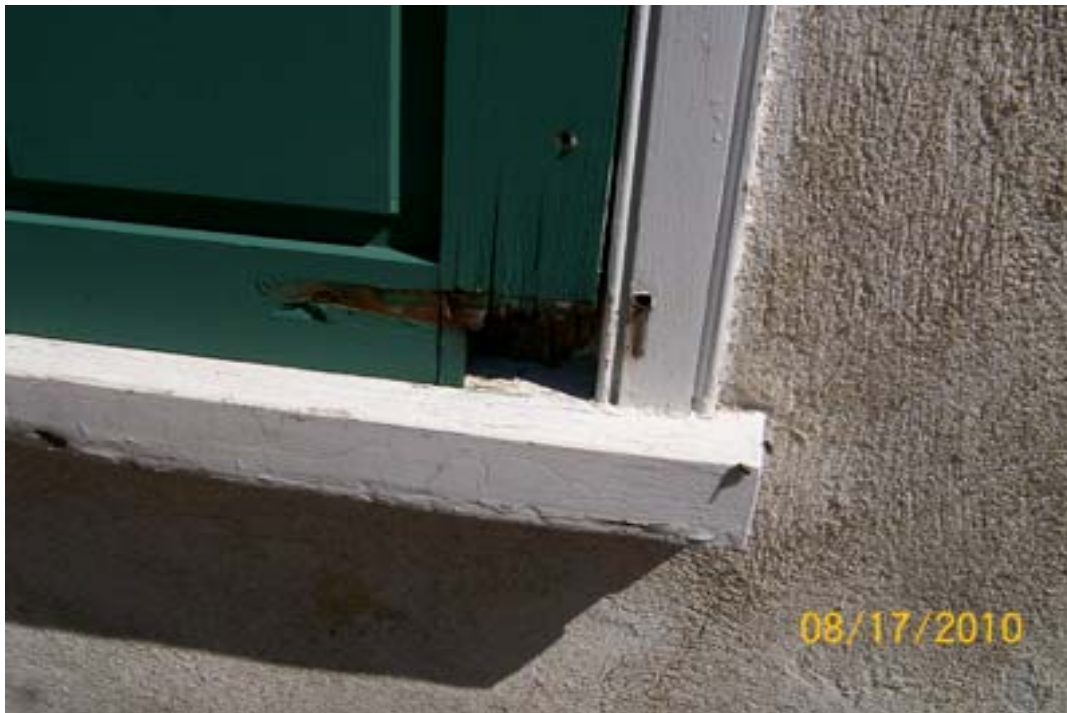
Photo No. 6: White paint, exterior window trim, 3669-LBP-3.

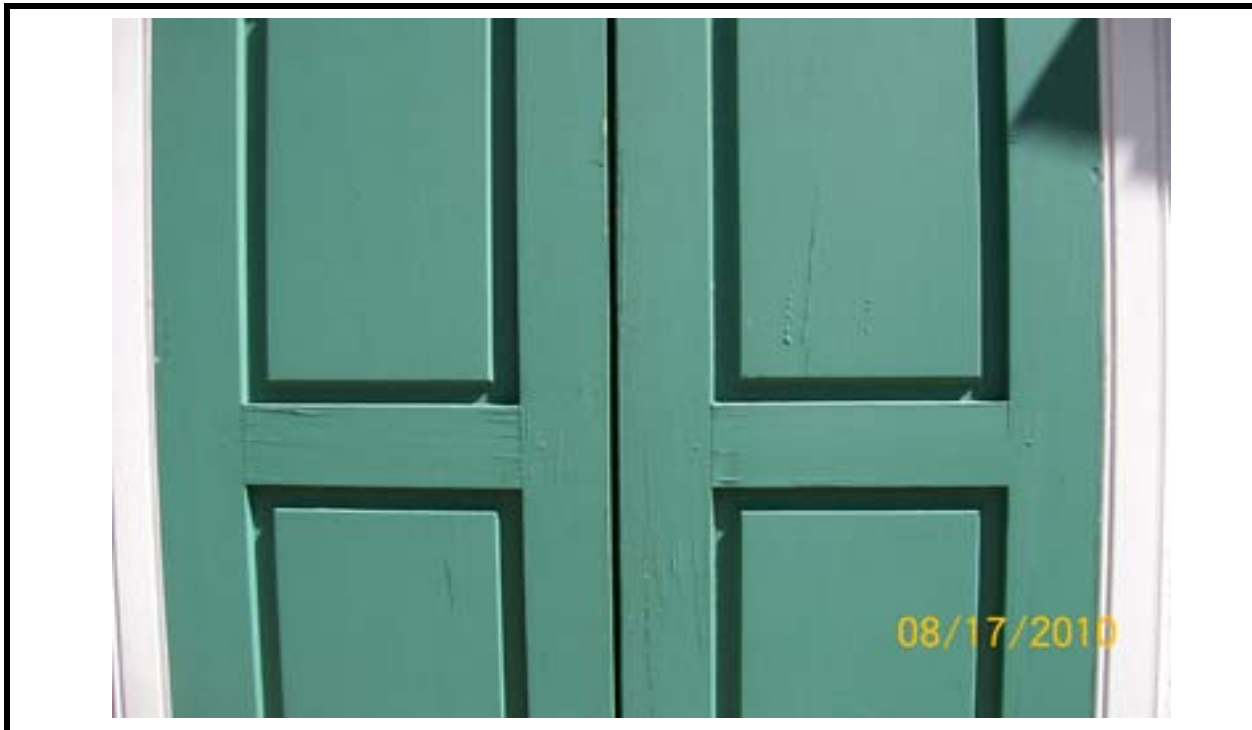
Photo No. 7: Green paint, exterior shutters, 3669-LBP-4.

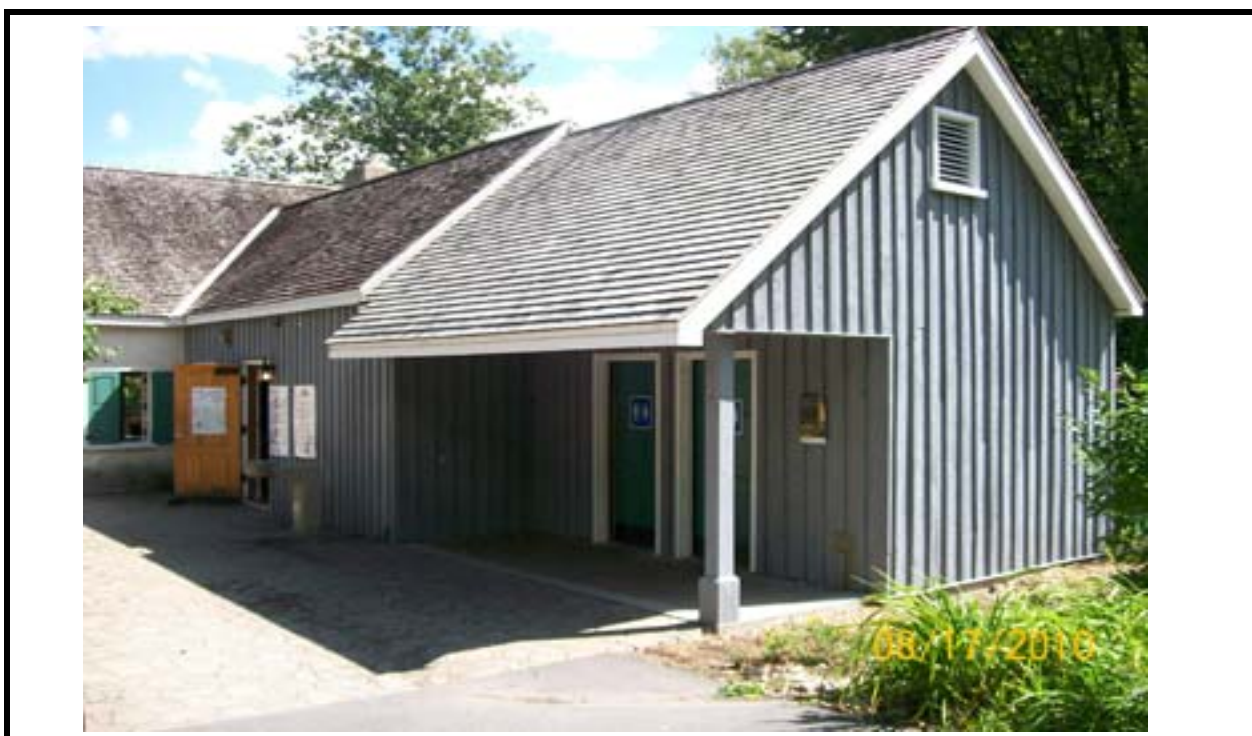
Photo No. 8: Grey paint, exterior wall, 3669-LBP-5.

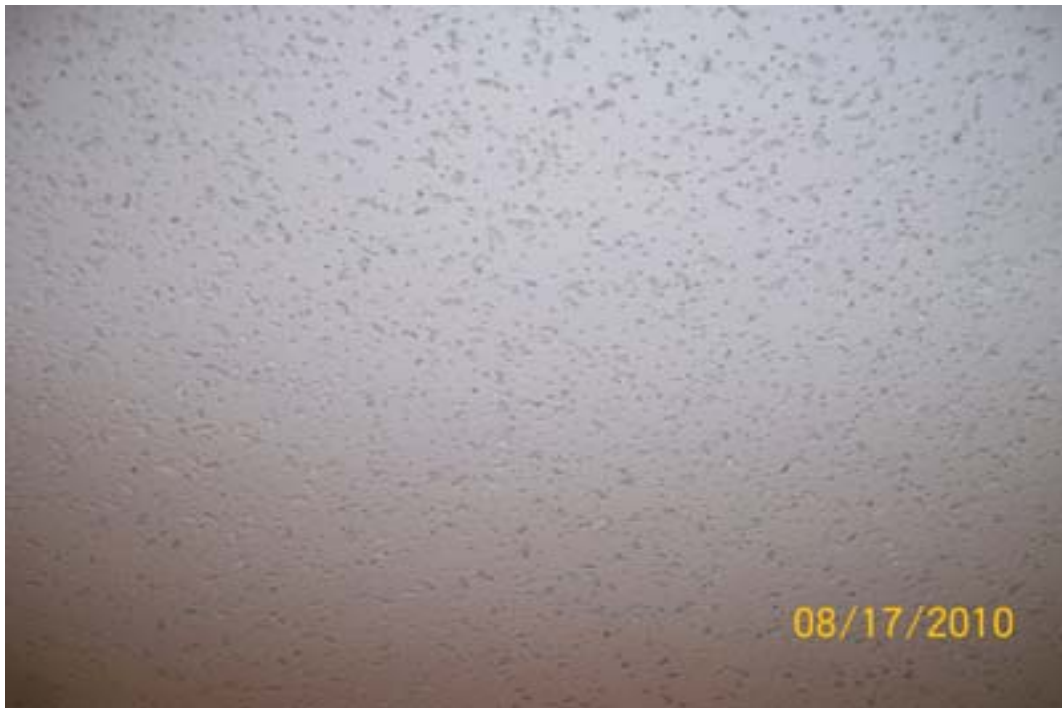
Photo No. 9: Speckled ceiling tile, storage room 1, 3669-BAS-1ABC.

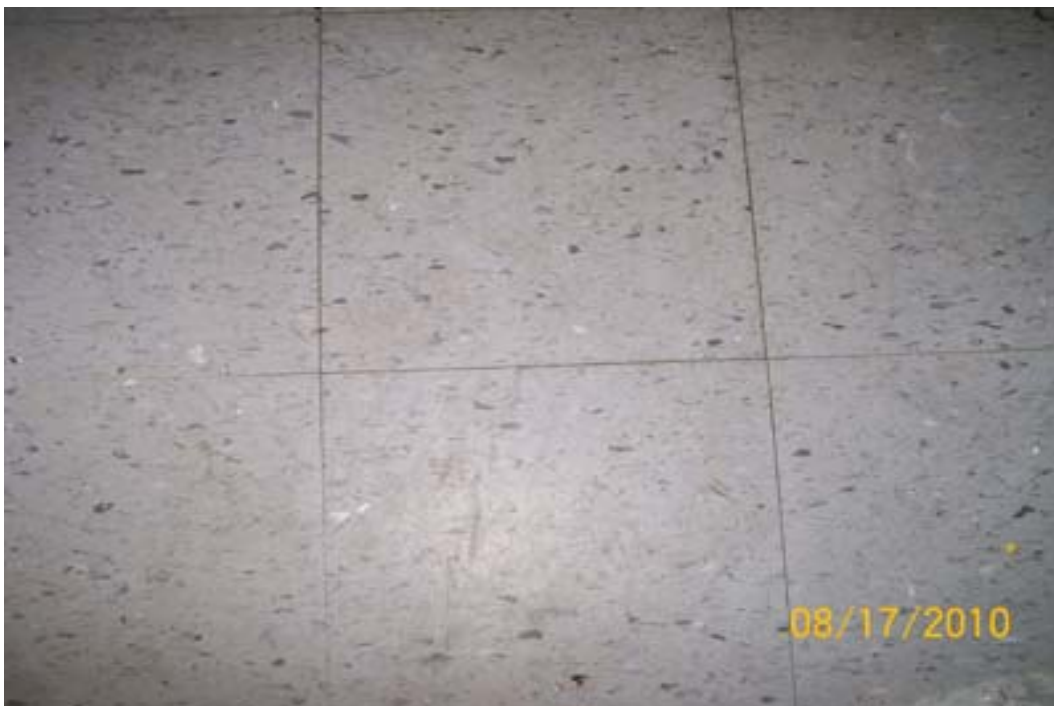
Photo No. 10: Grey vinyl floor tile, kitchen (basement), 3669-BAS-2ABC.

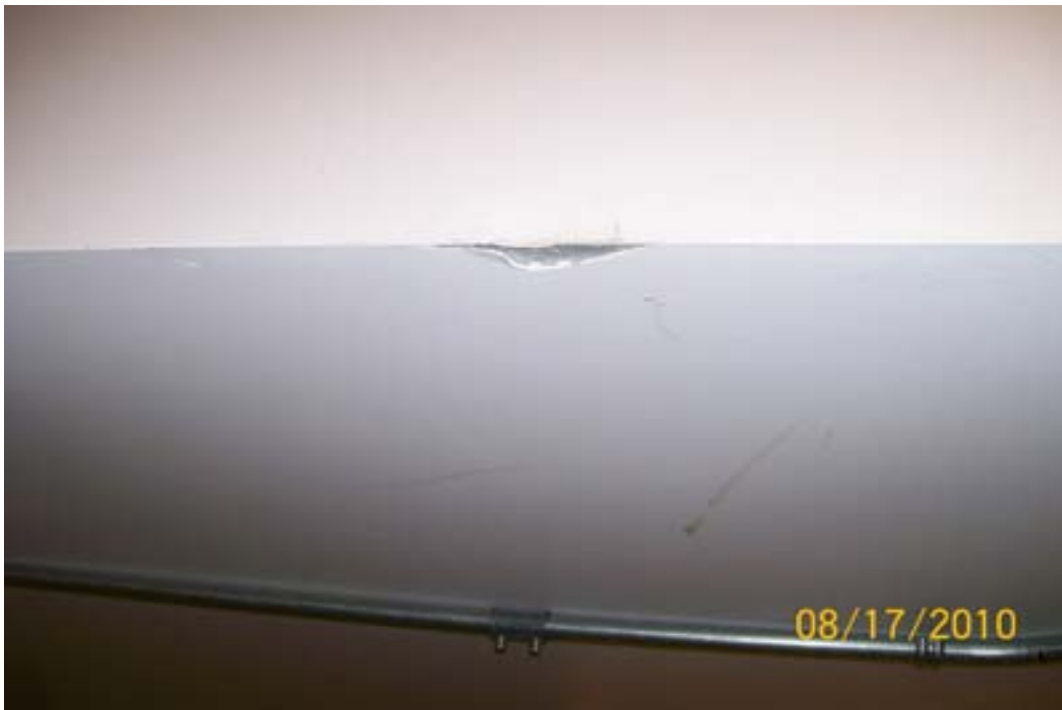
Photo No. 11: Drywall compound, basement storage 2, 3669-BAS-3A.

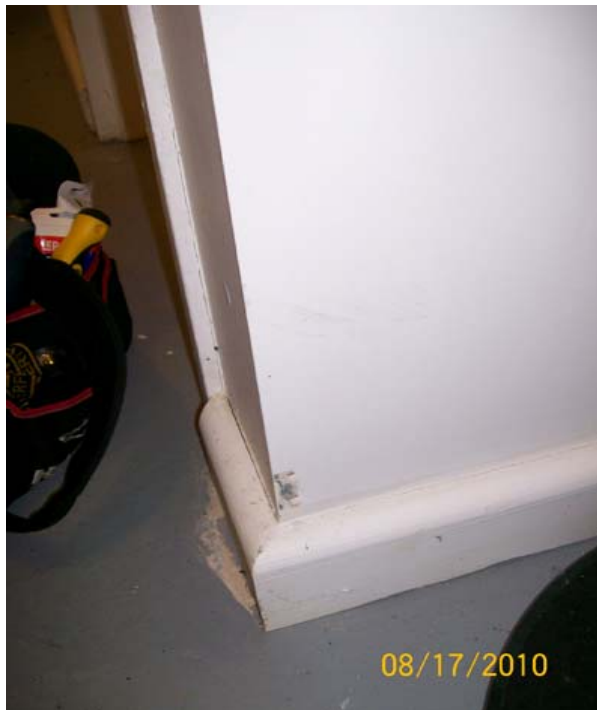
Photo No. 12: Drywall compound, basement hall, 3669-BAS-3B.

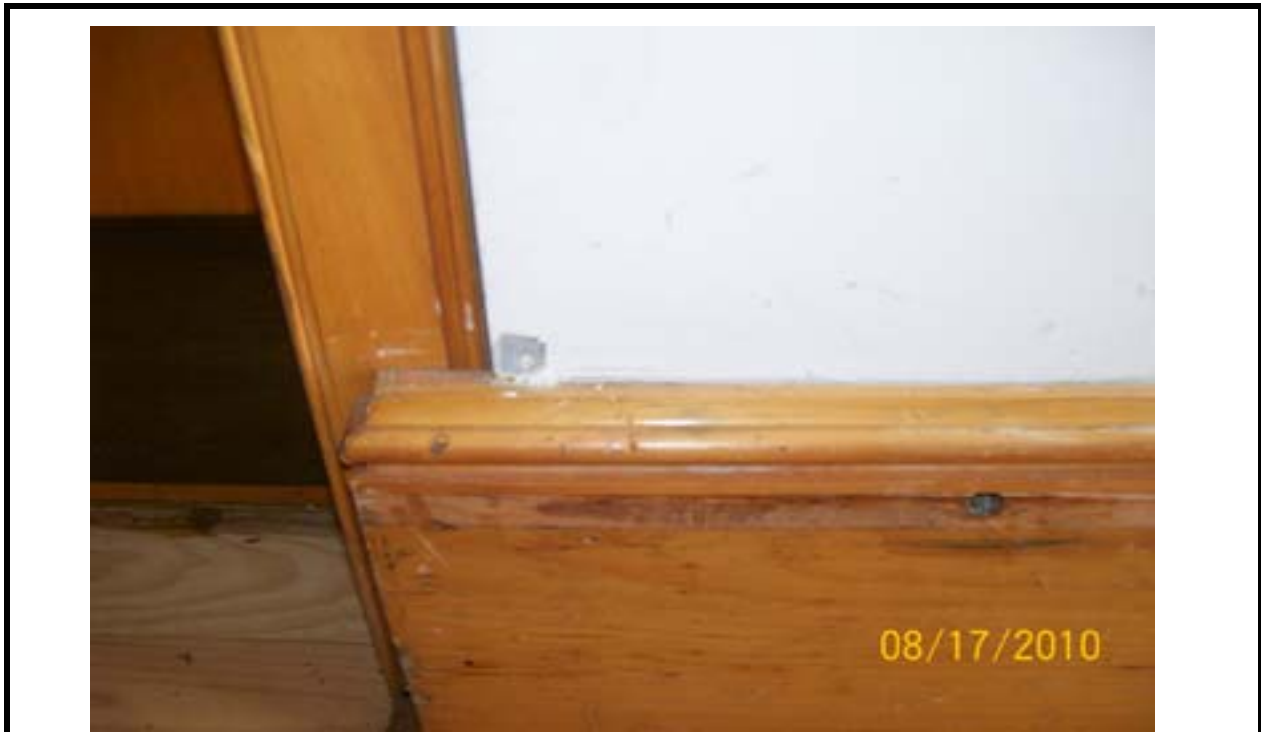
Photo No. 13: Drywall compound, entrance hall (ground floor), 3669-BAS-3C.

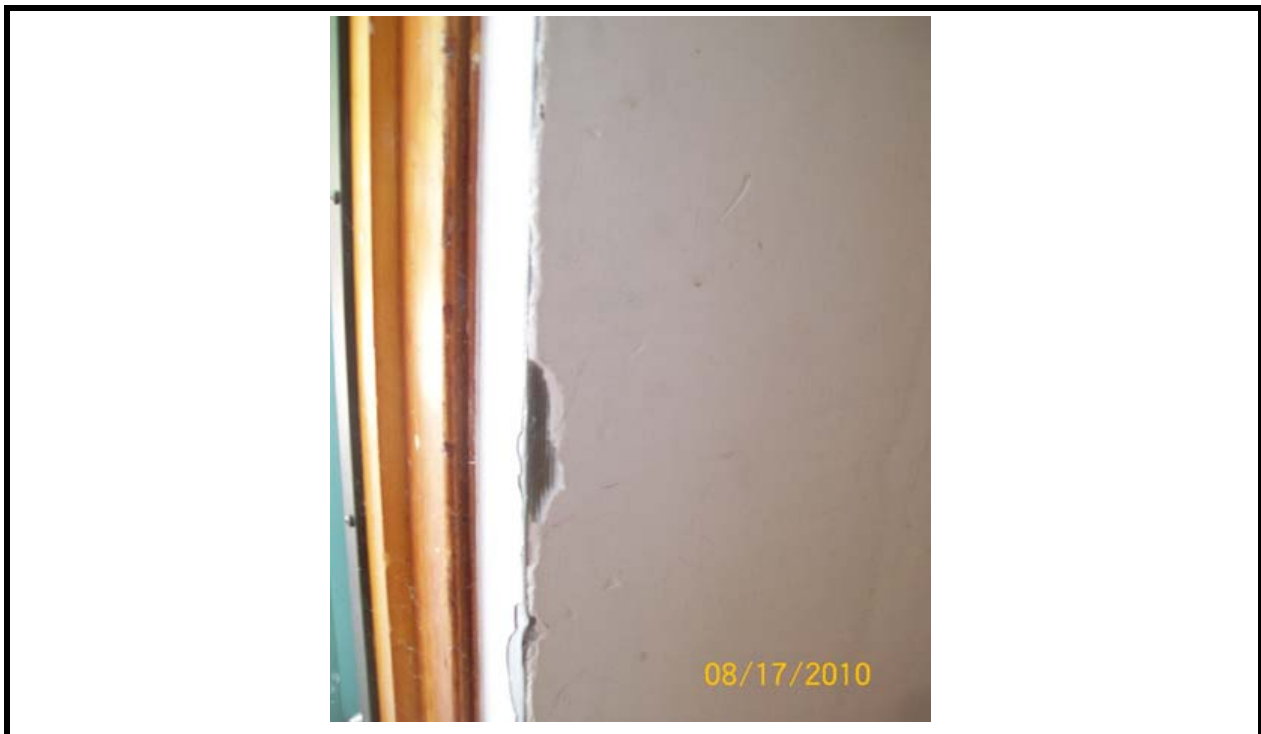
Photo No. 14: Drywall compound, entrance door (ground floor), 3669-BAS-3D.

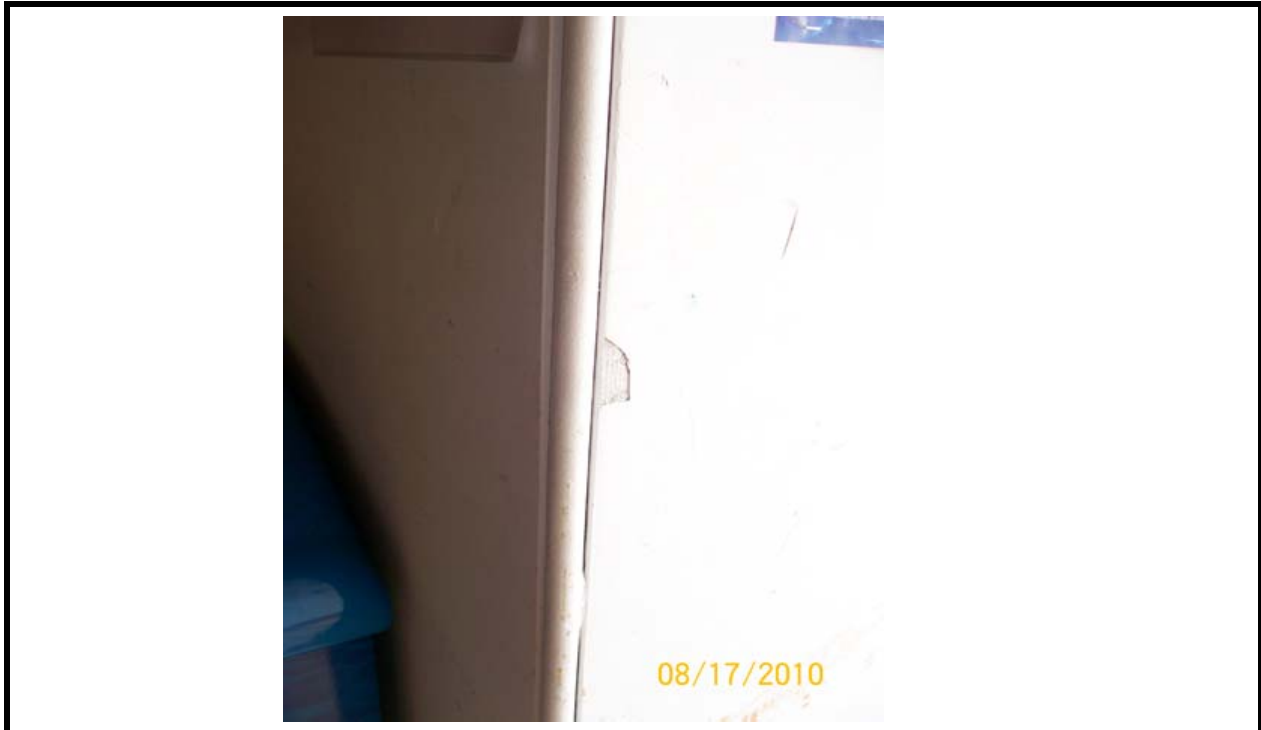
Photo No. 15: Drywall compound, office/storage (ground floor), 3669-BAS-3E.

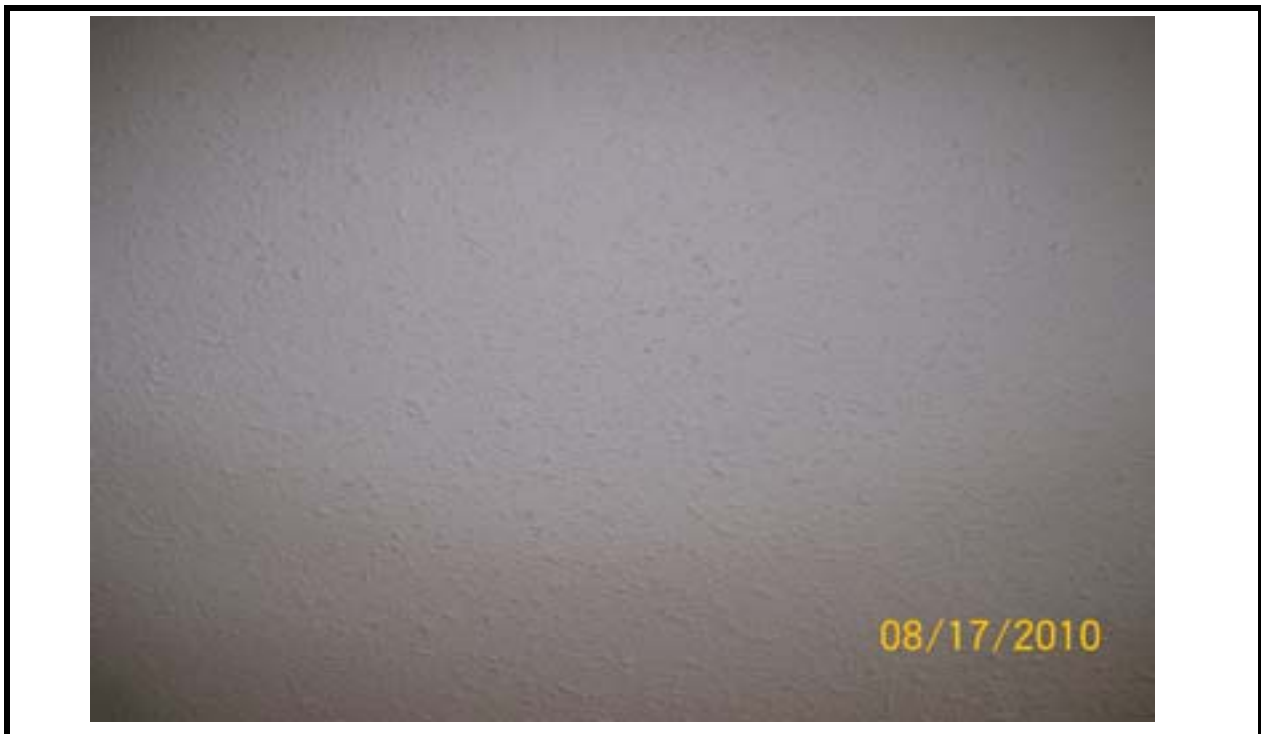
Photo No. 16: Stipple coat ceiling finish, entrance (ground floor), 3669-BAS-4ABC.

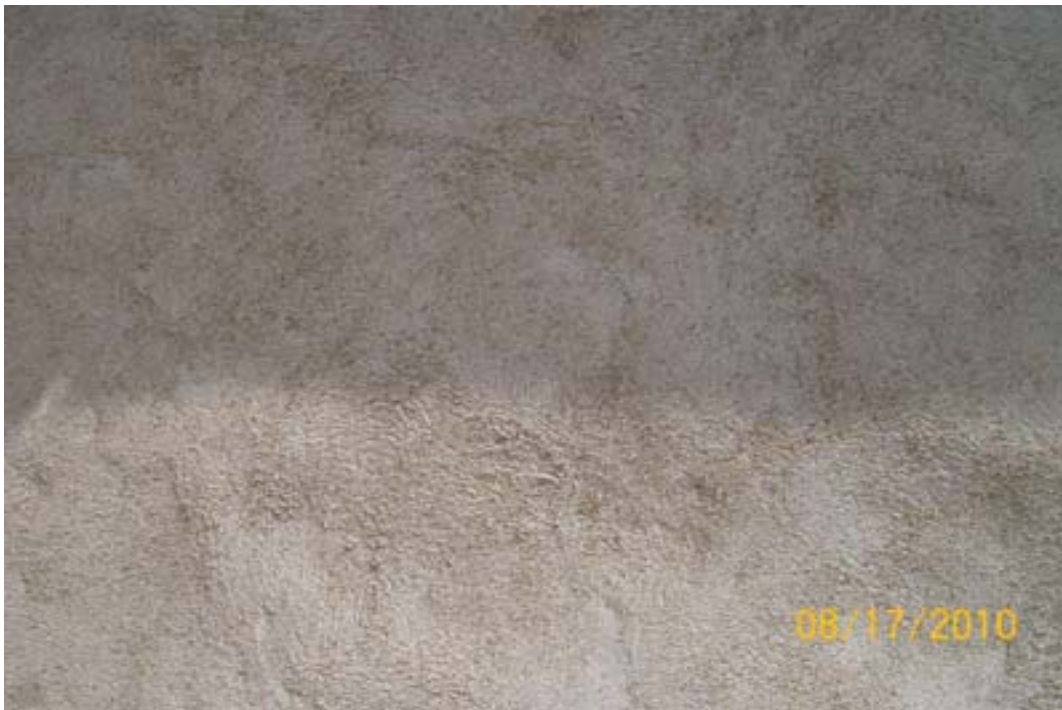
Photo No. 17: Textured finish, exterior wall, 3669-BAS-5ABCDE.

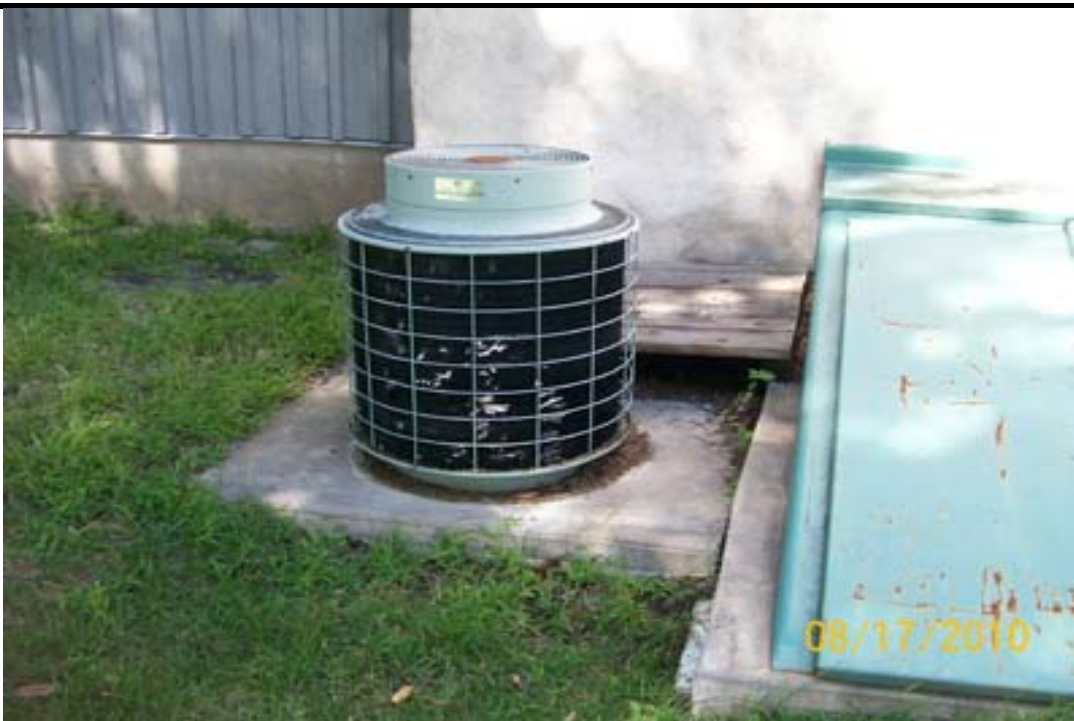
One exterior heat pump was present at the Site outside the south end of the building and may potentially contain ODS.

Photo No. 18: Heat pump, south side of building, potentially contains ODS.
