**DESIGNATED SUBSTANCE SURVEY
811-813 FIRST STREET EAST &
348 PRINCE ARTHUR STREET
CORNWALL, ONTARIO
FILE #: 9798-01-10749**

**PRODUCED FOR:
SEIZED PROPERTY MANAGEMENT DIRECTORATE
PUBLIC WORKS AND GOVERNMENT SERVICES CANADA**

**PRODUCED BY:
CONCENTRIC ASSOCIATES INTERNATIONAL INCORPORATED**

**DATE:
SEPTEMBER 20, 2012**

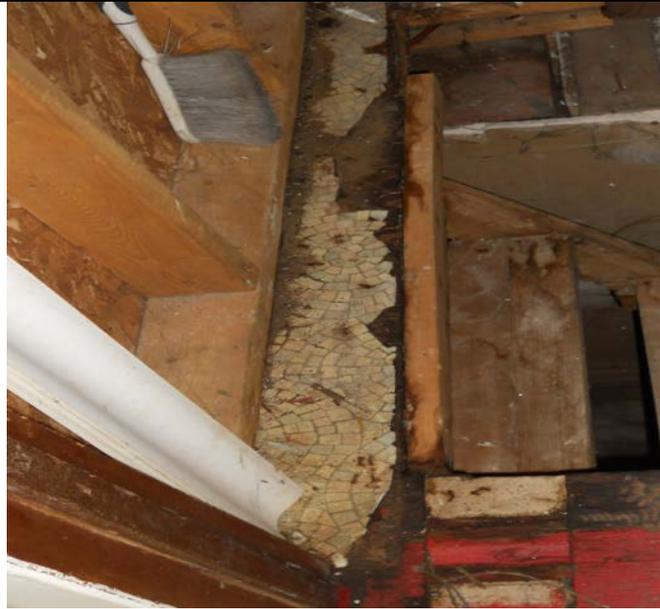
Photo #1 –Vinyl Floor Tile (Sample ID **VF4**) in the storage room of 348 Prince Arthur Street.

All asbestos containing materials encountered during demolition activities must be dealt with according to O. Reg 278/05. Disposal of asbestos containing material should be completed in accordance with O. Reg 347/11.

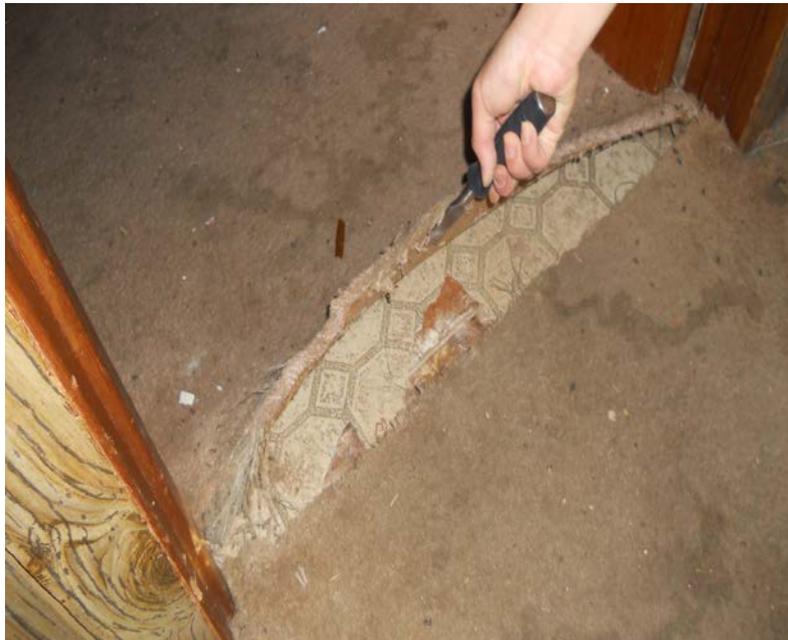
Photo #2 – Vinyl Floor Tile (Sample ID **VF7**) underneath the carpet in the bedroom of 348 Prince Arthur Street.

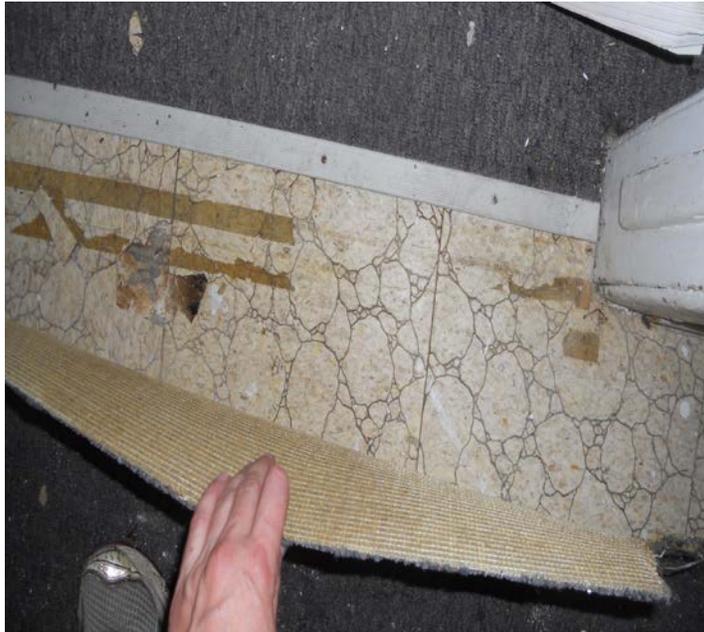
Photo #3 –Vinyl Floor Tile (Sample ID **VF10**) underneath the carpets of the bedrooms and hallway of 811 First Street East.

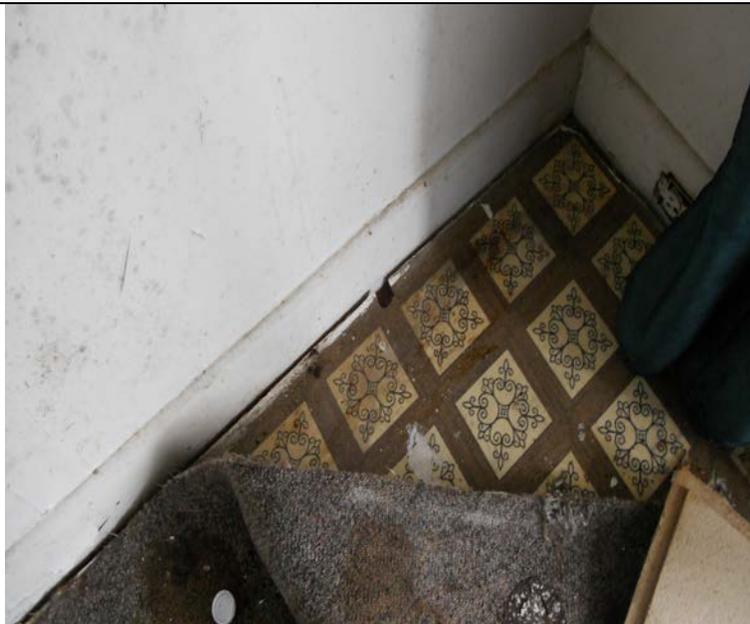
Photo #4 – Linoleum (Sample ID **lino1**) underneath the carpets in the living room, bedroom and kitchen of 813 First Street East.

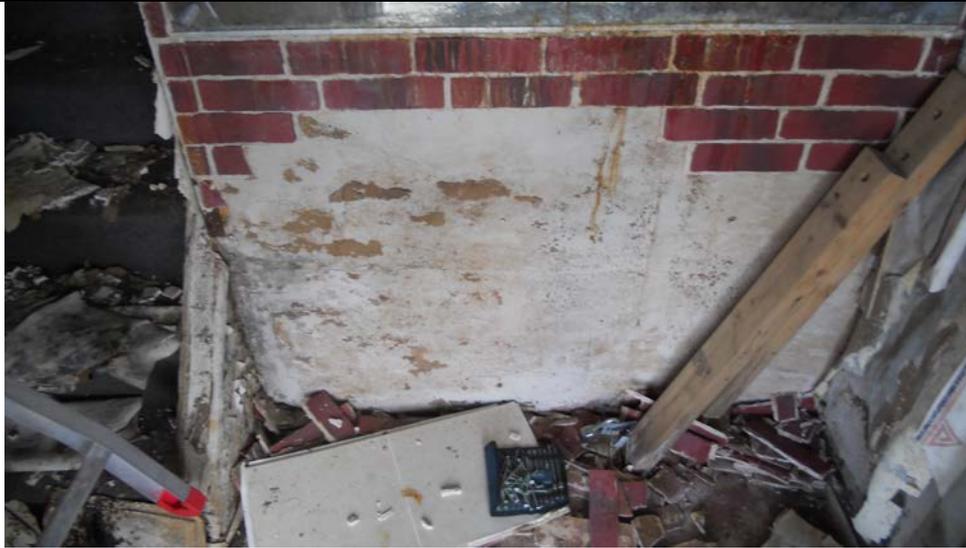
Photo #5 – Brick decorative façade (Sample ID **Int. Brick 1**) in the entranceway of 811 First Street East.
