Designated Substances and Hazardous Building Materials Assessment

Washrooms
Building Asset 243939
Major's Hill Park
Ottawa, Ontario

FEBRUARY 26, 2009

PROJECT NO. 1048176

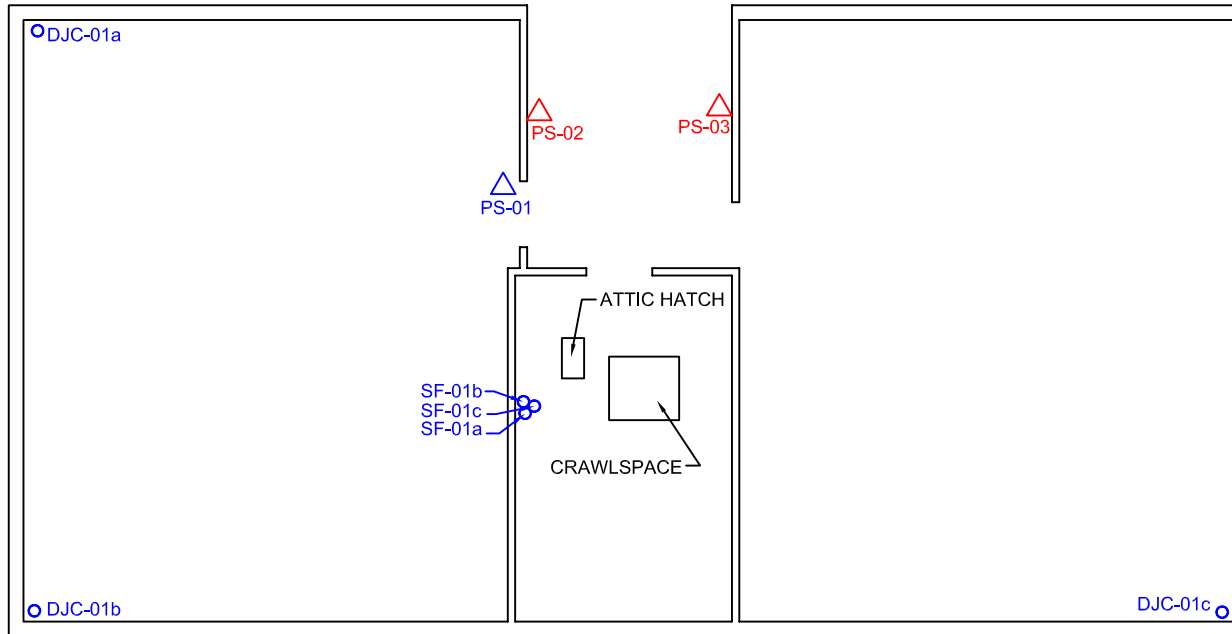
Floor Plans Showing the Location of Designated Substances Including
Sample Locations

The sampling locations are indicated on the floor plan located in **Appendix C**. Summary and occurrence reports are provided in **Appendix D and Appendix E**.

- Drywall joint compound (Samples DJC-01a, DHC-01b and DJC-01c, asbestos not detected); and,
- Sheet flooring (Samples SF-01a, SF-01b and SF-01c; asbestos not detected).
