HAZARDOUS BUILDING MATERIALS ASSESSMENT

WABUSH AIRPORT
WABUSH, NL

Prepared by:
Conestoga-Rovers
& Associates

MARCH 2012
REF. NO. 076653 (3)

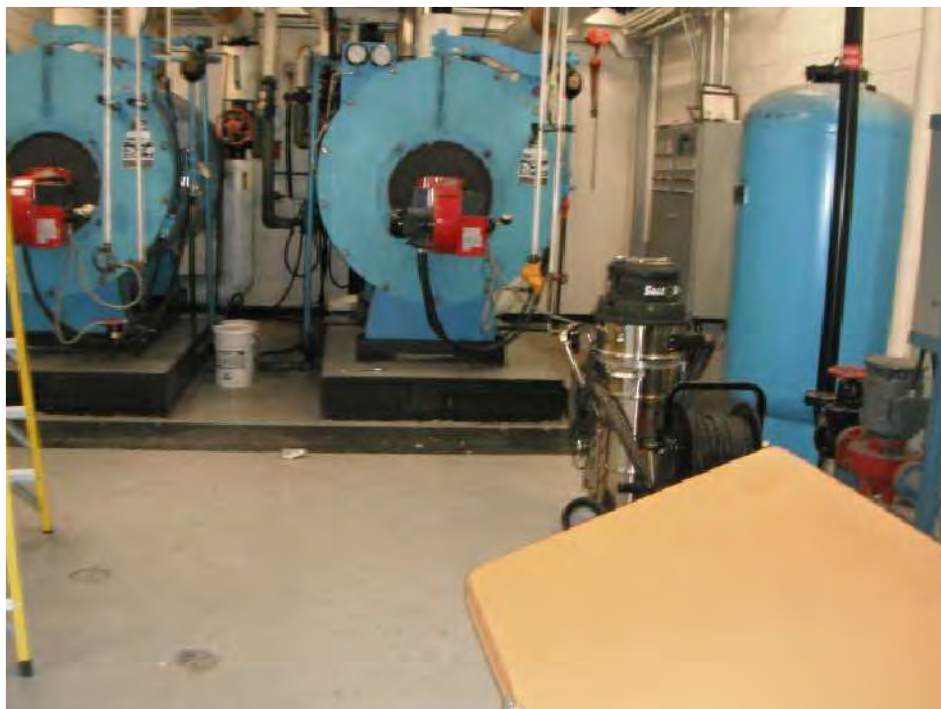
PHOTO 5: BOILER/MECHANICAL ROOM IN ATB.

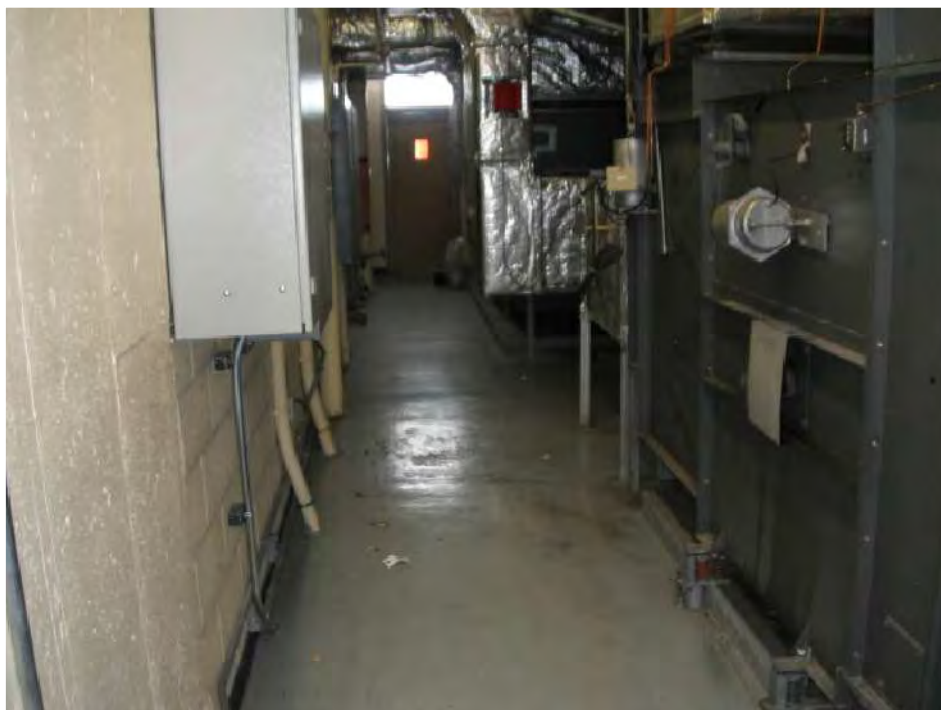
PHOTO 6: HVAC ROOM ON 2ND FLOOR OF ATB.

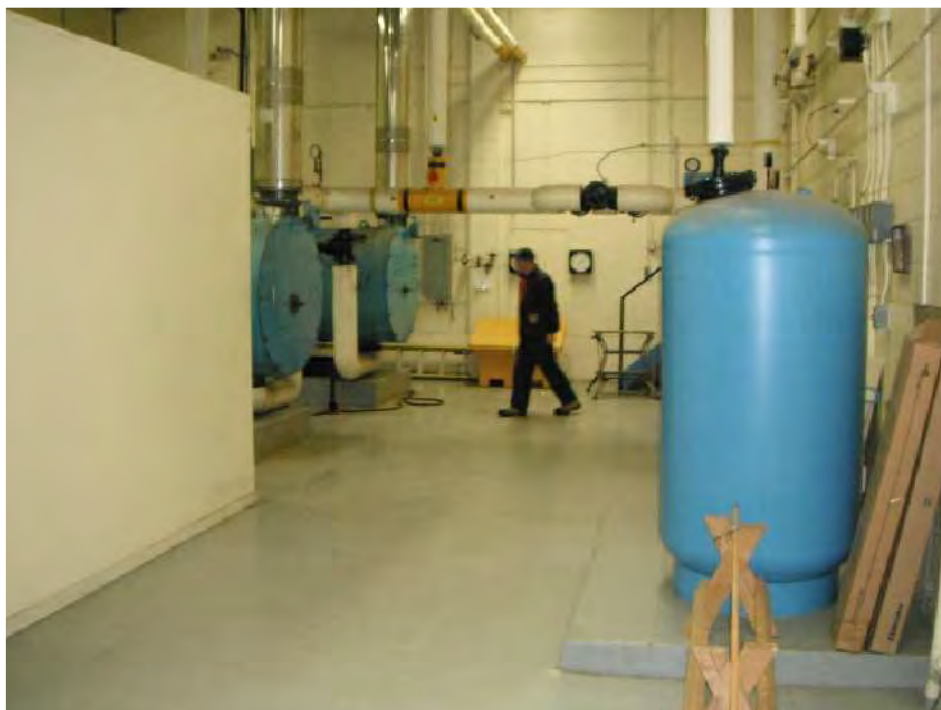
PHOTO 10: BOILER/MECHANICAL ROOM IN CSB.

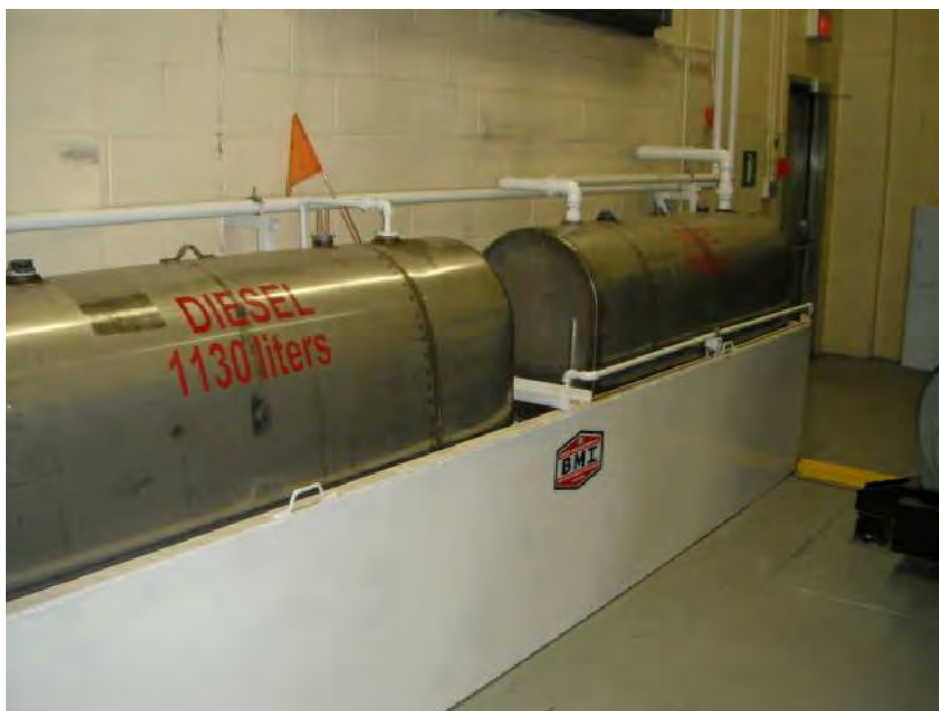
PHOTO 11: DIESEL STORAGE ROOM OFF BOILER/MECHANICAL ROOM IN CSB.

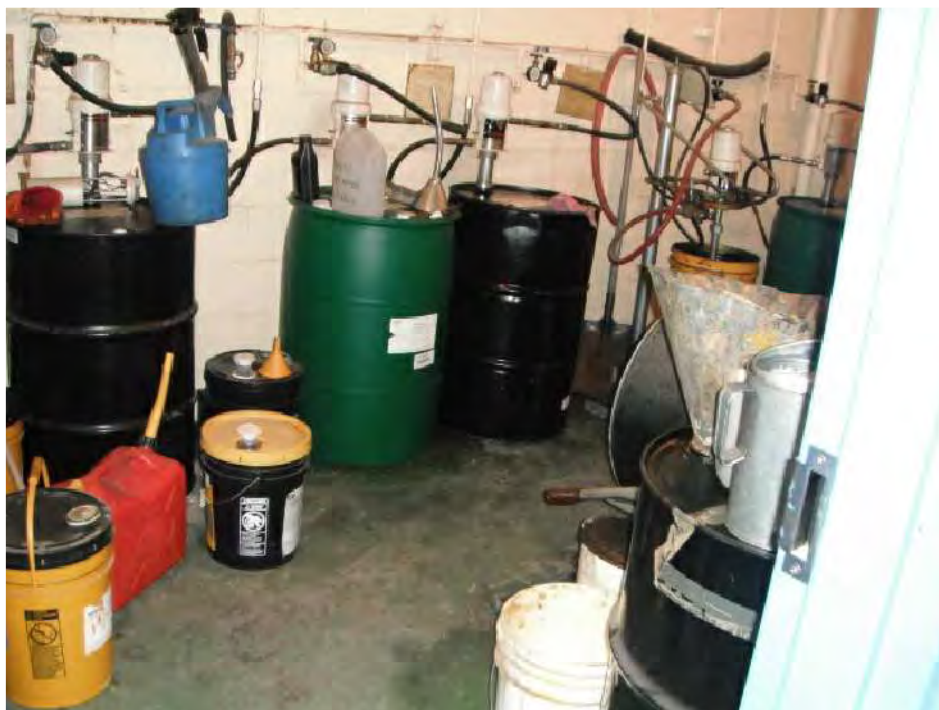
PHOTO 12: TYPICAL FLUID STORAGE IN CSB.
