17. MHK - CELL UNIT

17.1 Building Description

17.2 Survey Findings

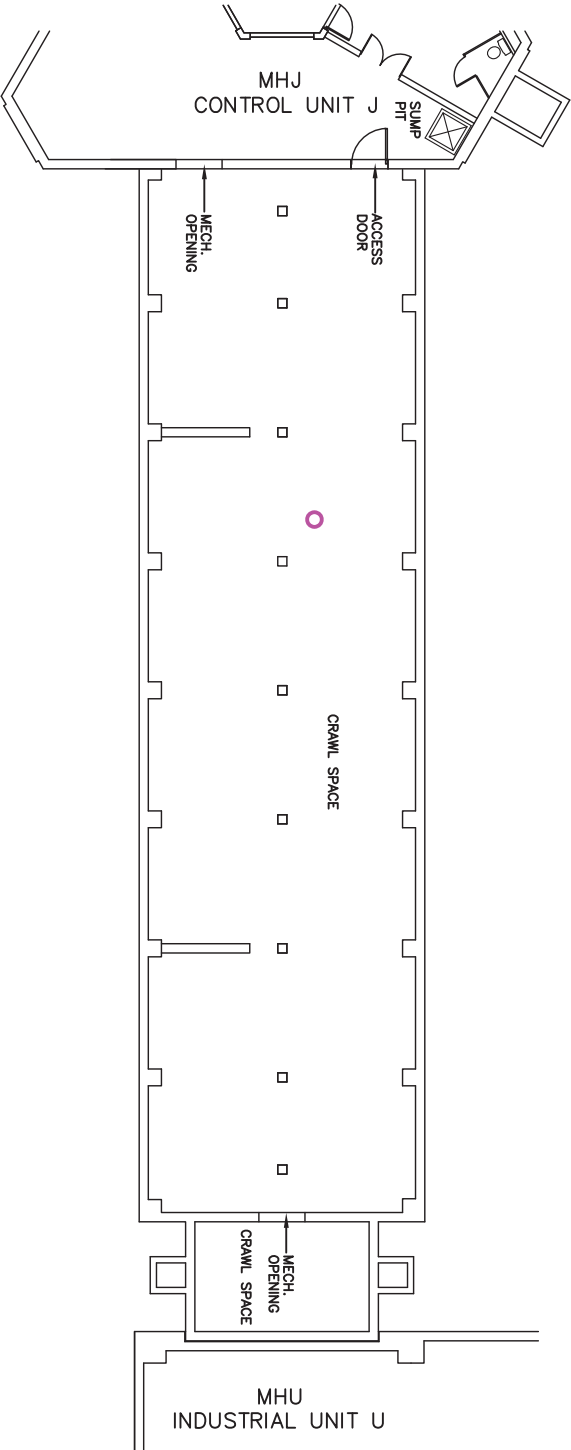
BASEMENT PLAN

- Parging material used on concrete equipment bases was previously sampled by THEM (1997) and found to contain 20 to 30% chrysotile asbestos. This parging material was observed by Aqua Terre on an equipment base in room 301. The parging material is approximately 5 cm wide around the edge of 1 concrete equipment base.
- Three incandescent light fixtures with ACM heat shields were observed in MHK (Rooms 131 and 231). Similar heat shields were previously sampled by THEM (1997) and found to contain 60% chrysotile asbestos.
- Insulation around pipe hangers was observed in the crawlspace (confined space 5). Similar insulation was sampled in MHL (MHL-As-1) and found to contain 70% chrysotile asbestos.

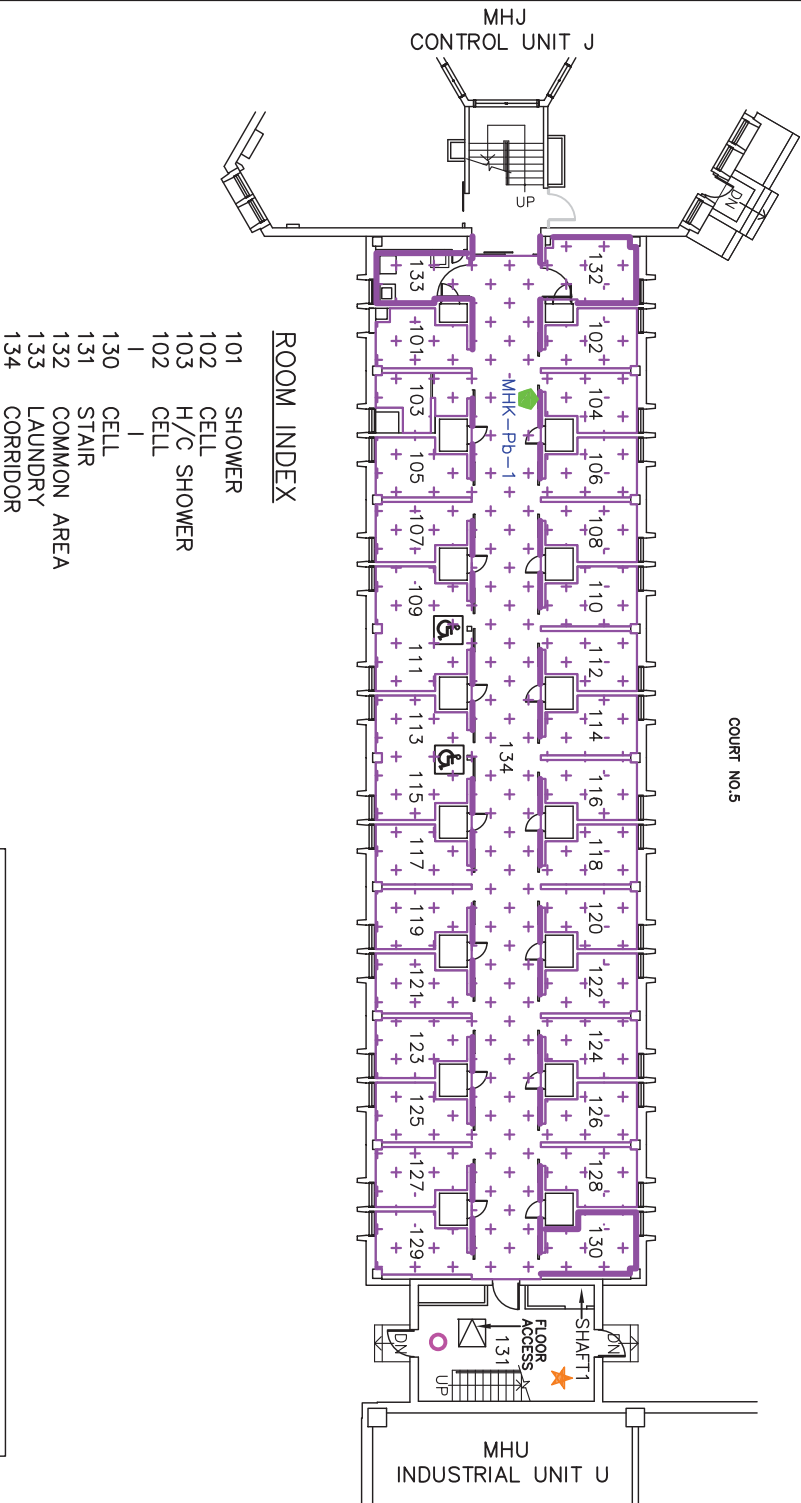
FIRST FLOOR PLAN

- Insulated pipe elbows were observed in room 131 and 301. The insulation around these elbows was previously sampled by THEM (1997) and found to contain up to 60% chrysotile asbestos. A total of 25 ACM insulated elbows were observed.

Analytical results indicate that one of the paint samples contained a concentration of lead above 600 ppm. The dark grey paint on the access doors in room 232 (range K2) contains 6020 ppm of lead and was observed to be in good condition.
