Client: RCMP	City: REGINA	Project: RCMP TRAINING CENTRE	Date: NOV 22/2011
Inspection no.: DM1	Address: SHAW ST/LOWRY PL [GYMNASE] E SIDE	Sewer: DM1	Video Tape no.: 0
Contract no.:	Reason of insp.:	Start Manhole: MH1A	Total length: 31.20 m
Operator: Frank McBride	Direction: Downstream	End Manhole: MH2A	Page: 1
Profile: Circle 200 / 200 mm	Sewer type: DOMESTIC	Material: VCT Vitrified Clay T	Condition:

sewer inspection

Project: RCMP TRAINING CENTER
Date: 15/12/2011
Description: CAMERA AND CLEAN SANITARY AND STORM
Remark: 5907 DEWDNEY AVE

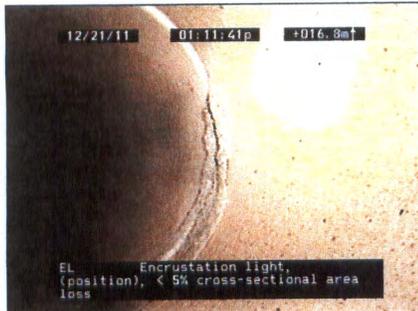
Photo : 143 Distance: 16.80 m
Code : EL

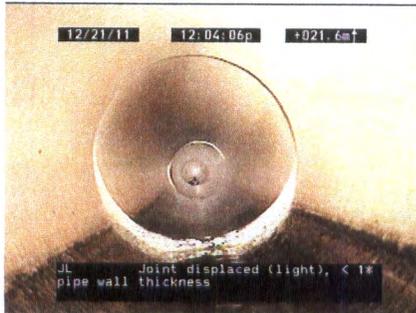
Photo : 124 Distance: 21.60 m
Code : JL

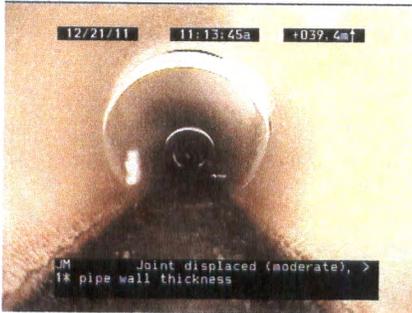
Photo : 109 Distance: 39.40 m
Code : JM

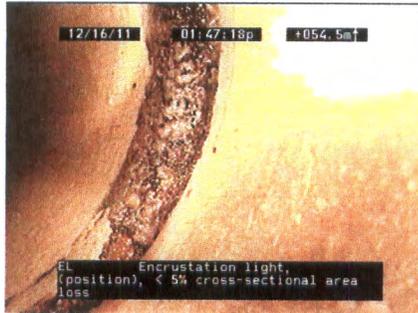
Photo : 74 Distance: 54.50 m
Code : EL

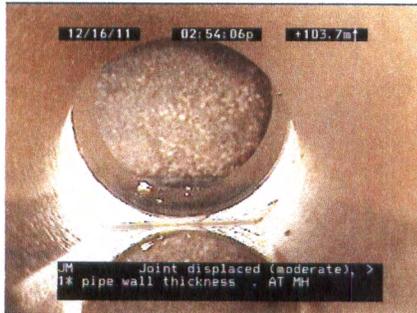
Photo : 88
Code : JM

Distance: 103.70 m

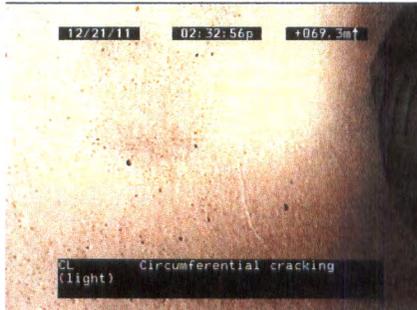
Photo : 162 Distance: 69.30 m
Code : CL

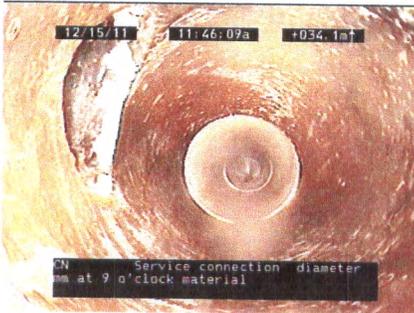
Photo : 12 Distance: 34.10 m
Code : CN

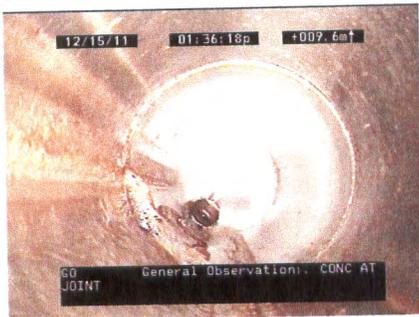
Photo : 22 Distance: 9.60 m
Code : GO

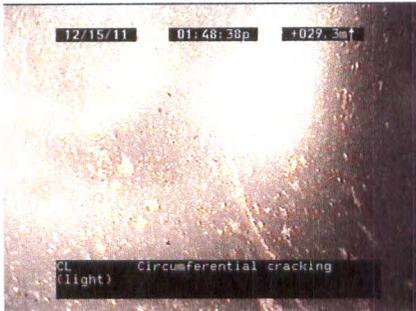
Photo : 29 Distance: 29.30 m
Code : CL

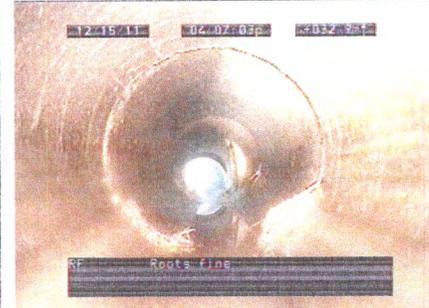
Photo : 43 Distance: 32.90 m
Code : RF

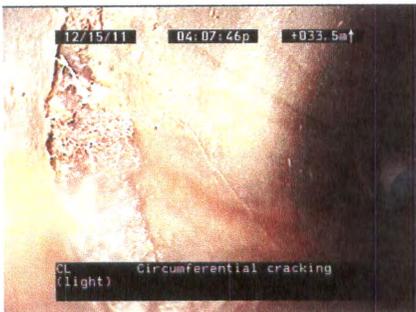
Photo : 44 Distance: 33.50 m
Code : CL

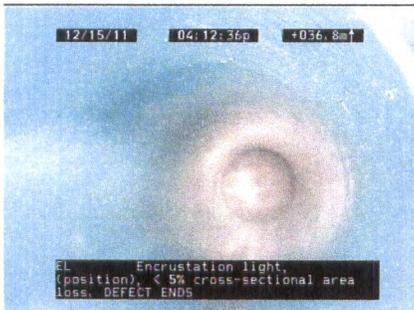
Photo : 52
Code : EL
