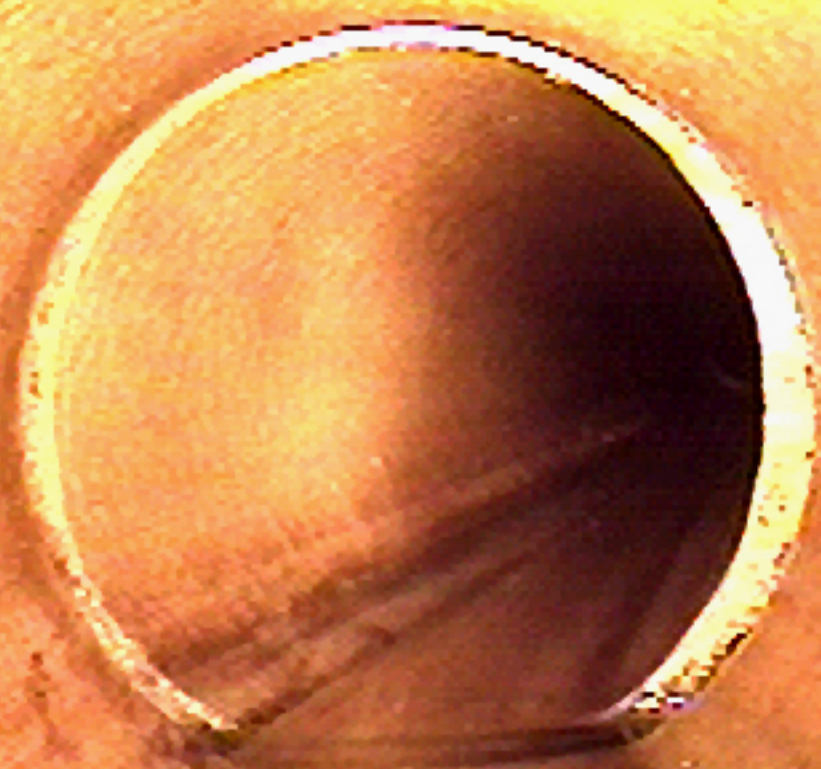
LR Line of sewer deviates right  
% height/diameter

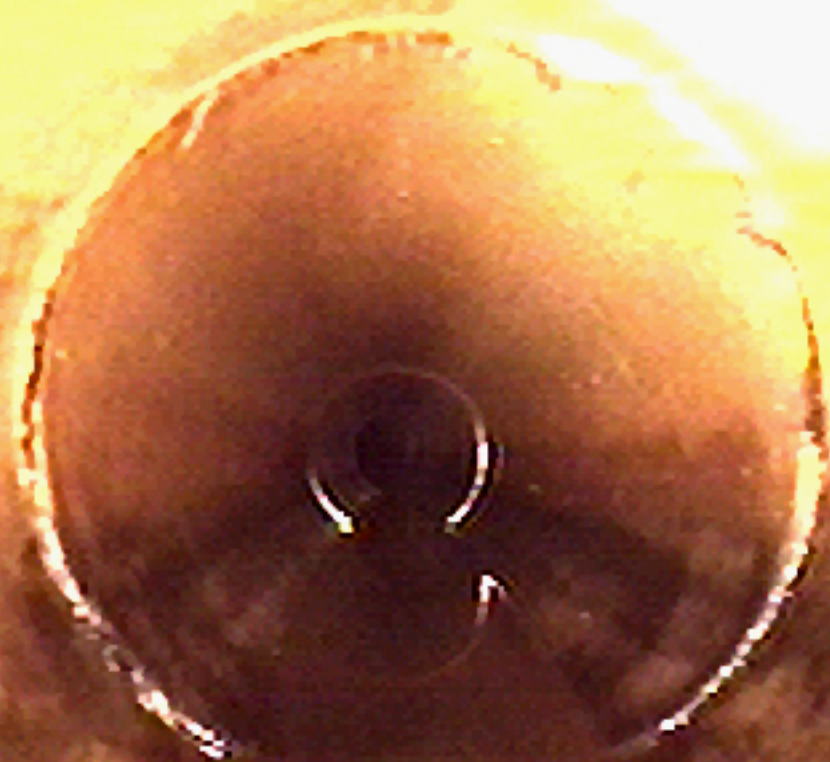
Roots fine

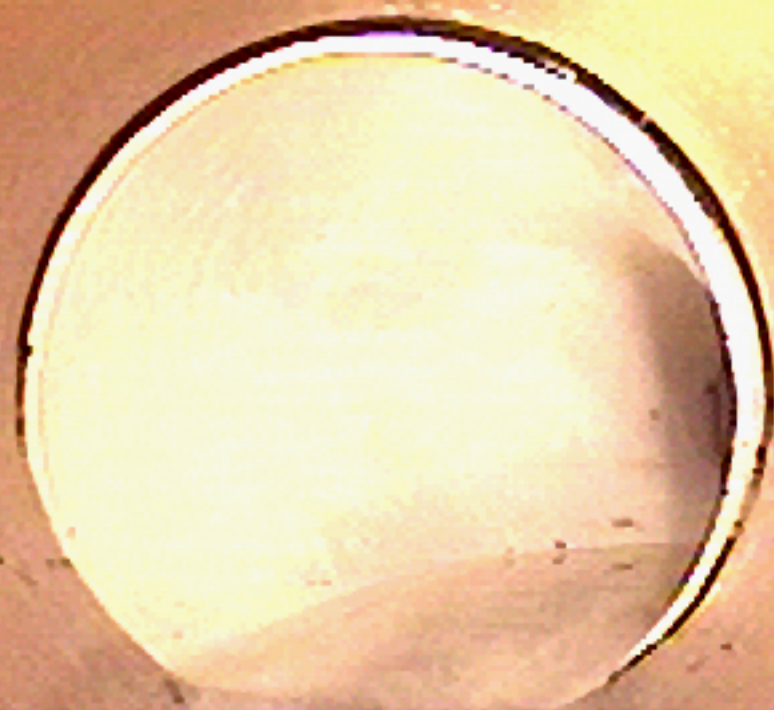
EL Encrustation light,  
(position), < 5% cross-sectional area  
loss. END OF DEFECT

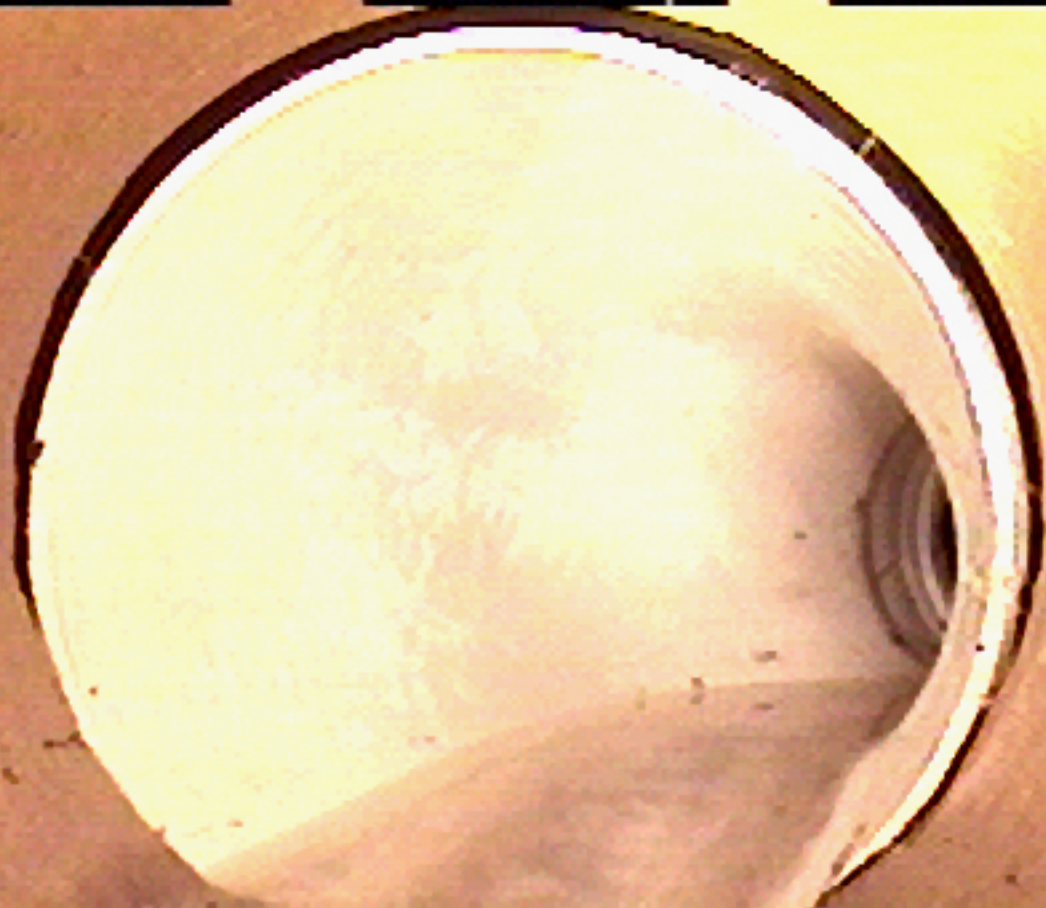
MC Pipe material changes to PVC  
Polyvinylchloride Pipe

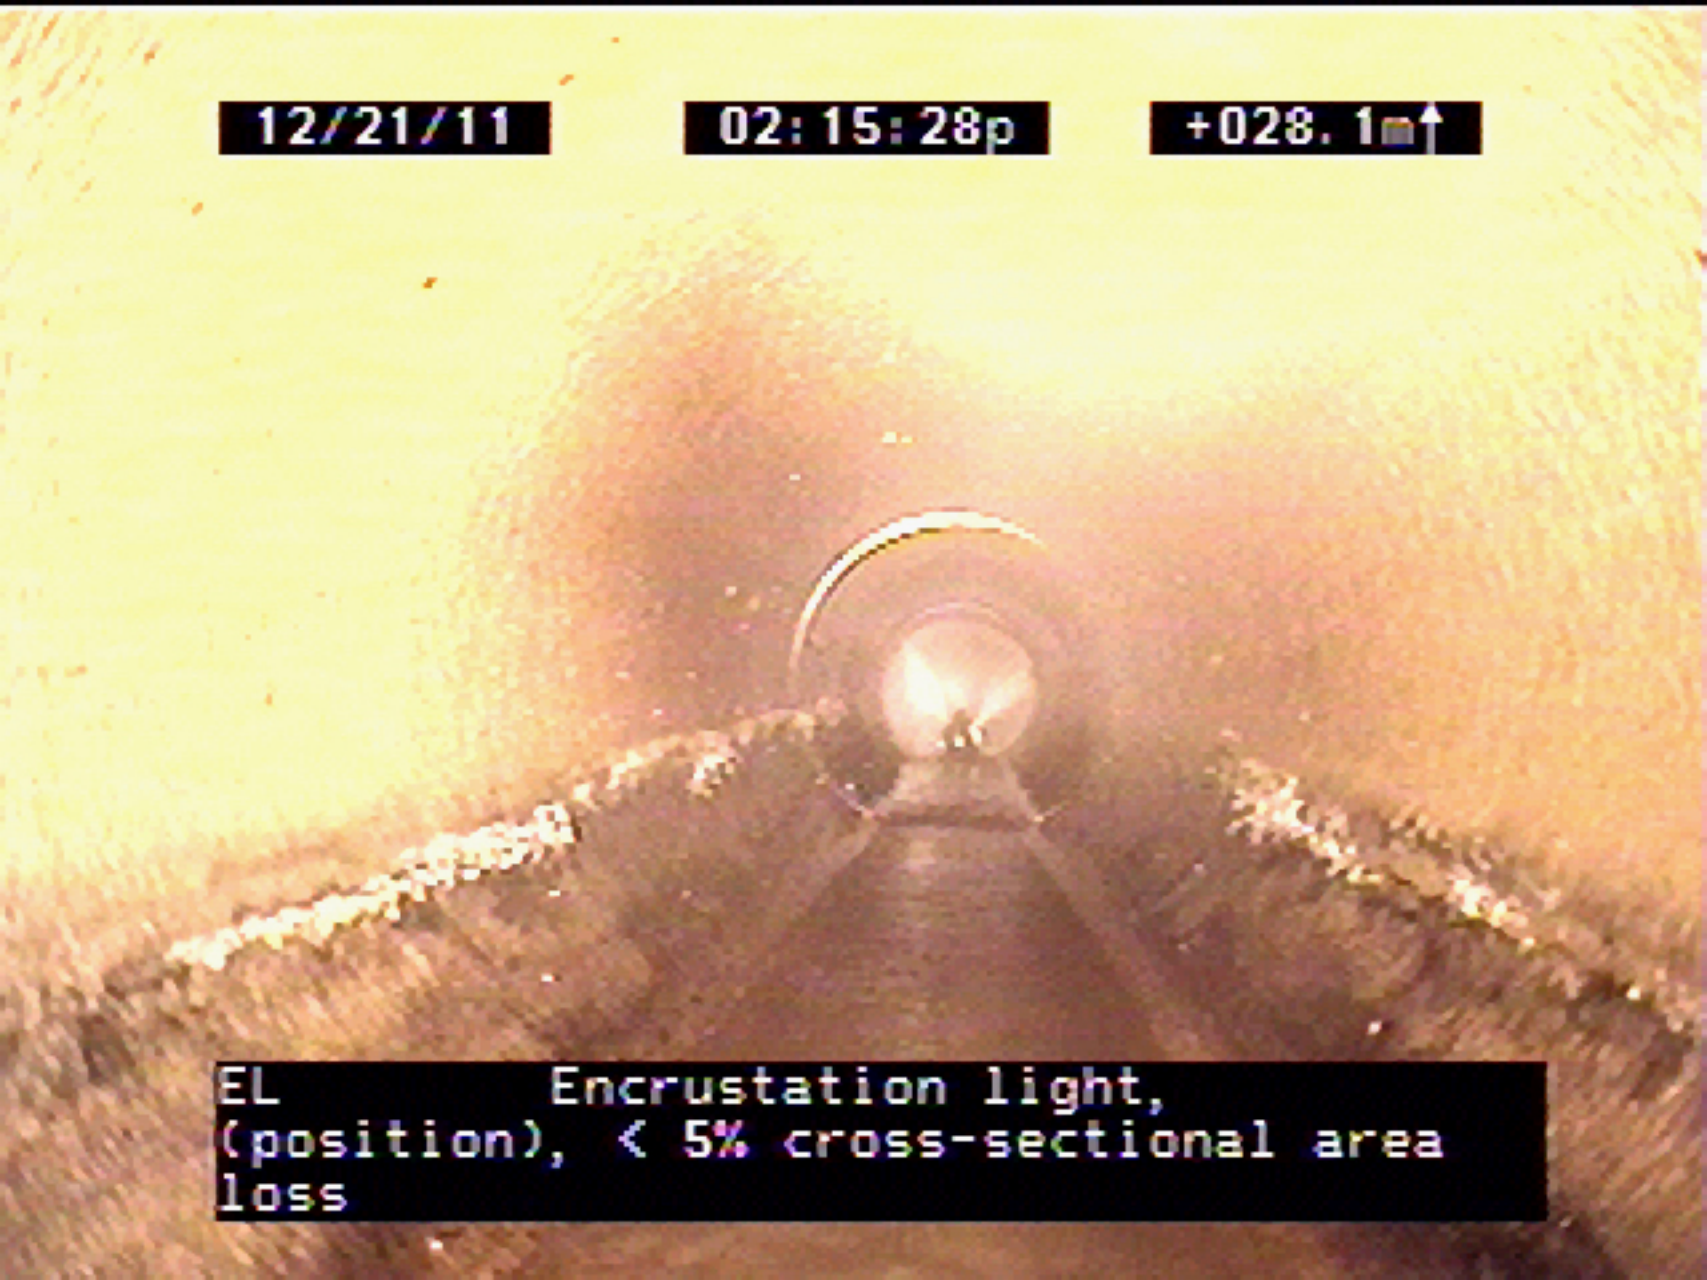
EL Encrustation light,  
(position), < 5% cross-sectional area  
loss
