XCG File #3-336-128-02

March 30, 2005

**DESIGNATED SUBSTANCES AND HAZARDOUS MATERIALS SURVEY
WARKWORTH INSTITUTION
CAMPBELLFORD, ONTARIO**

**PUBLIC WORKS AND GOVERNMENT SERVICES CANADA
REAL PROPERTY SERVICES, ENVIRONMENTAL SERVICES, ONTARIO REGION
4900 Yonge Street, 11th Floor
Toronto, Ontario
M2N 6A6**

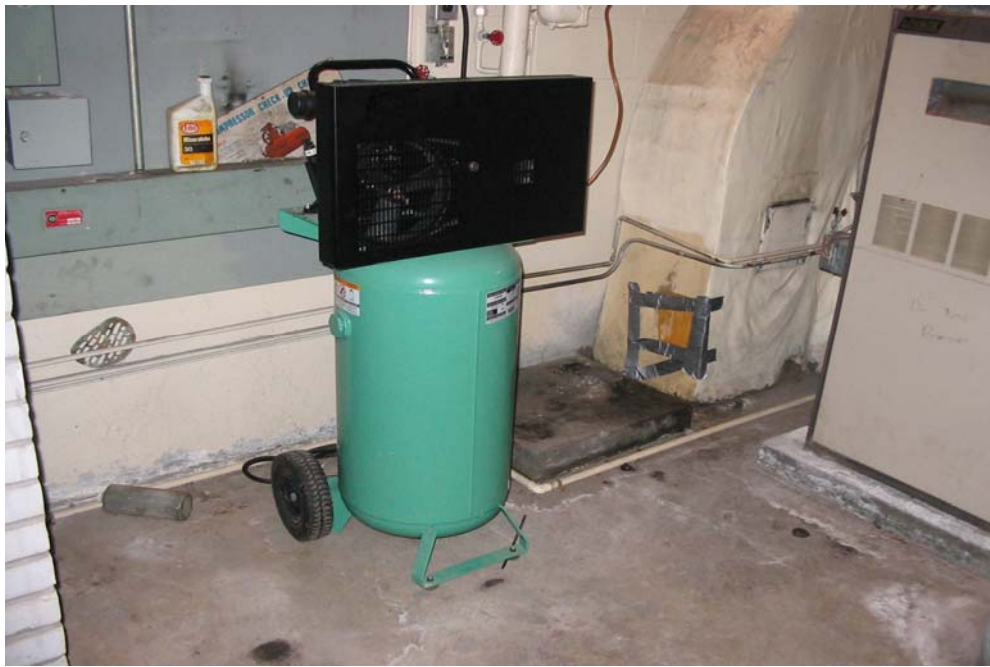
PHOTO 1: WA01 – Room 104 – View of the interior of the room. Note 1-litre container of oil that may no longer be in use and should be disposed of.

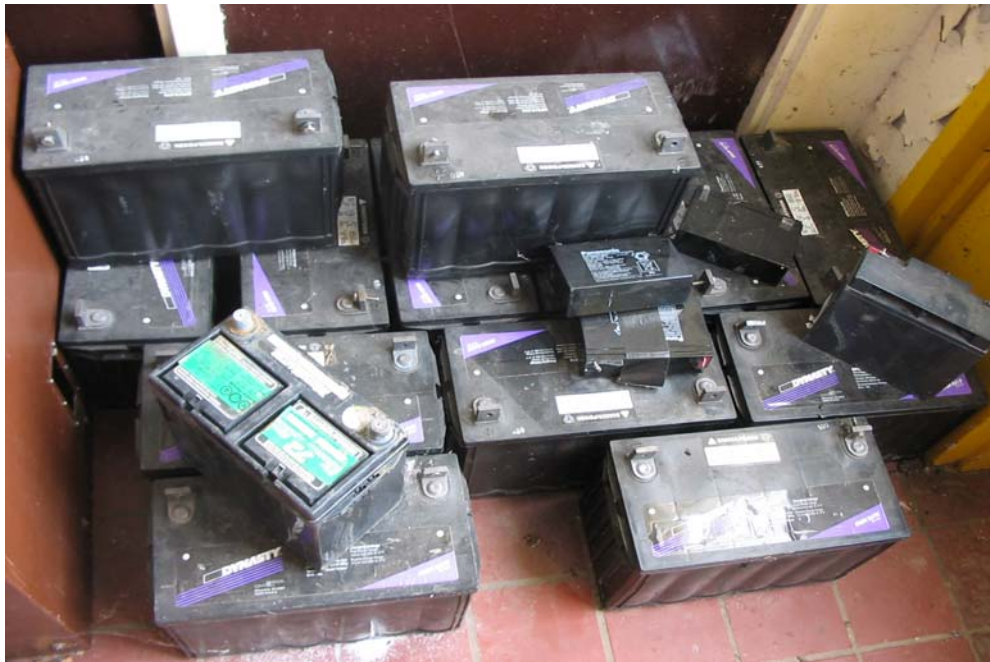
PHOTO 1: WA05 – Room 101 – Potential lead-containing automobile batteries observed, awaiting disposal.

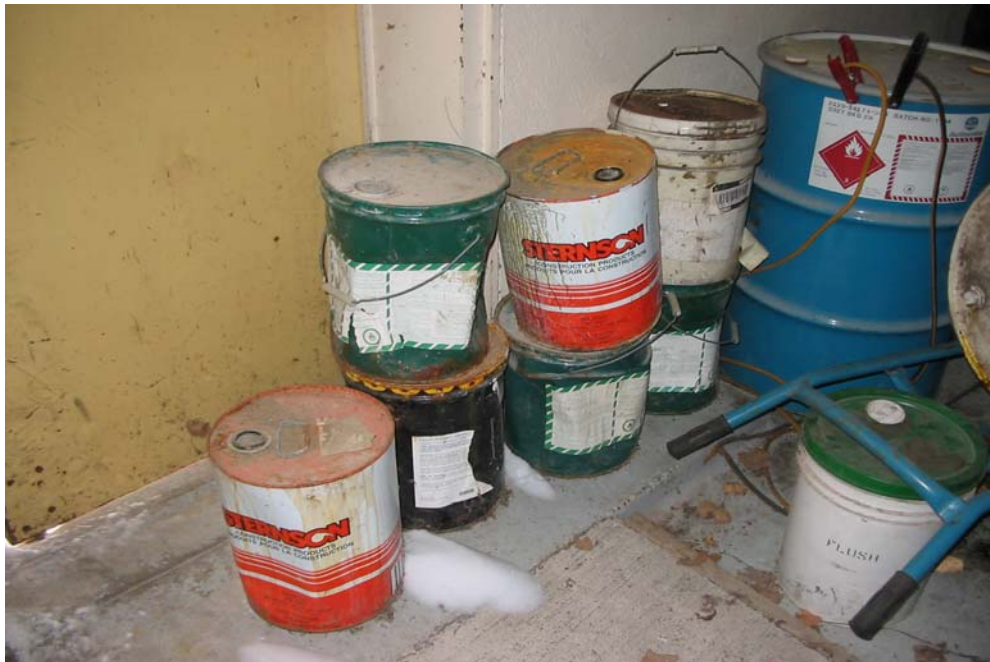
PHOTO 1: WA07 – Room 101 – View of some of the chemicals stored in this building. Note also the yellow door to the room, which was found to contain a lead concentration of 6,258 ppm.

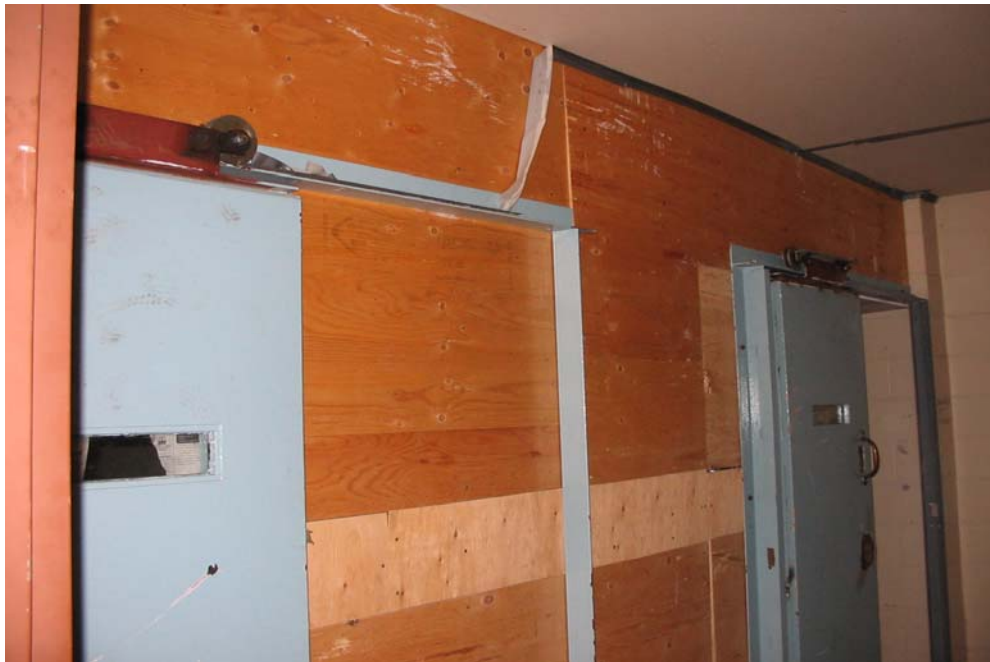
PHOTO 1: WA08 – Room 101 – The blue door paint on the mock cells were found to contain a lead concentration of 10,926 ppm.

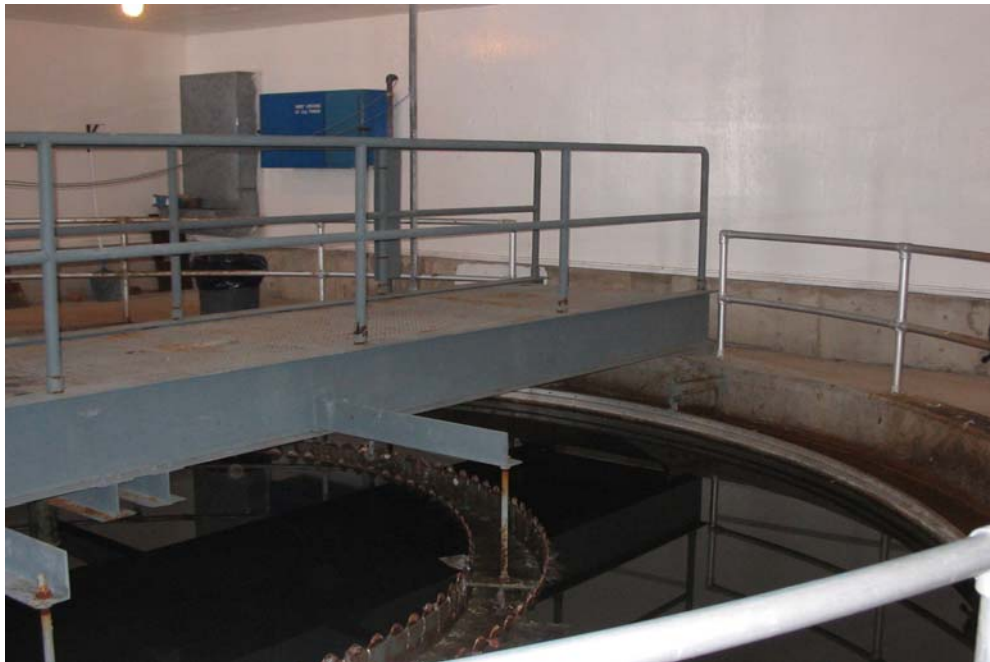
PHOTO 1: WA16 – Room 101 – View of the interior of the building.
This building had previous mould issues that have been resolved for the time being. Windows and louvers are due to be installed in the summer of 2005.

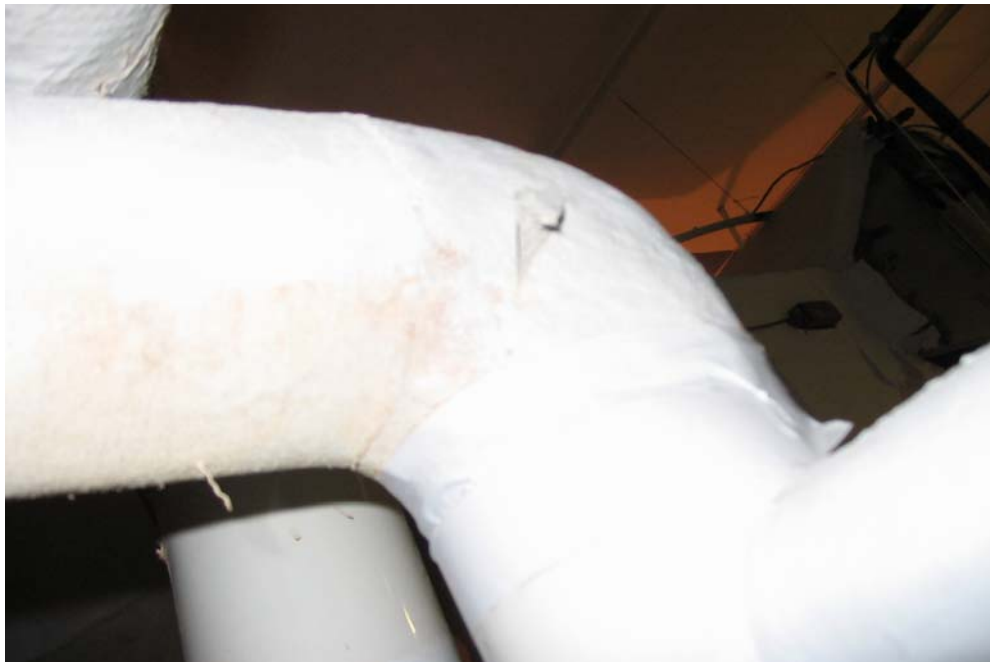
PHOTO 1: WW03 – Room 130 – This pipe elbow was sampled and found to contain between 50 and 75% chrysotile asbestos.

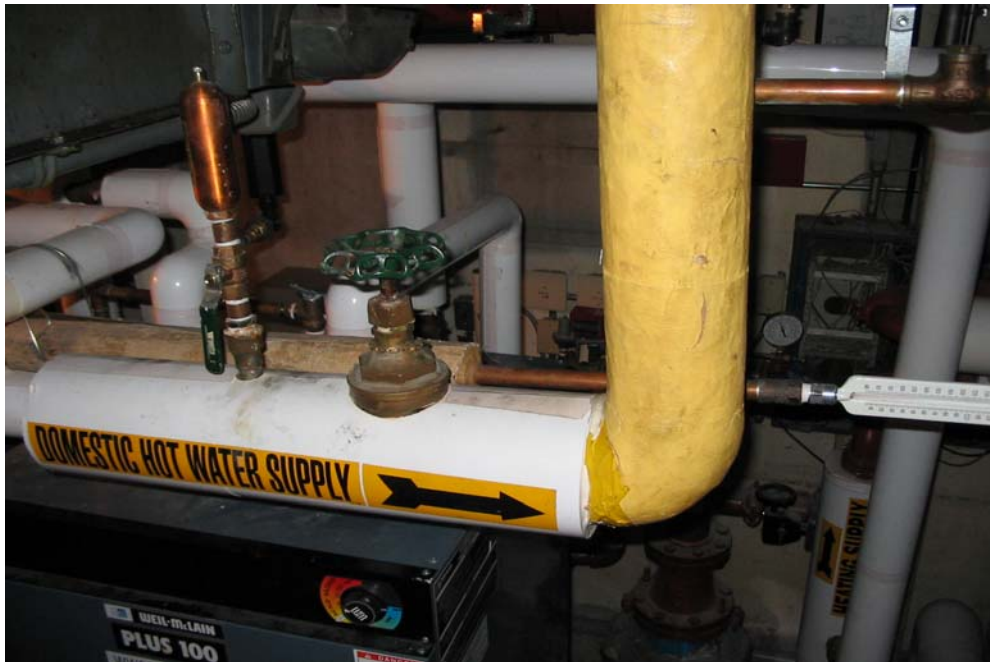
PHOTO 1: WW05 – Room 109 – An example of a pipe elbow that, along with other elbows and T-joints, contained between 50 and 75% chrysotile asbestos.

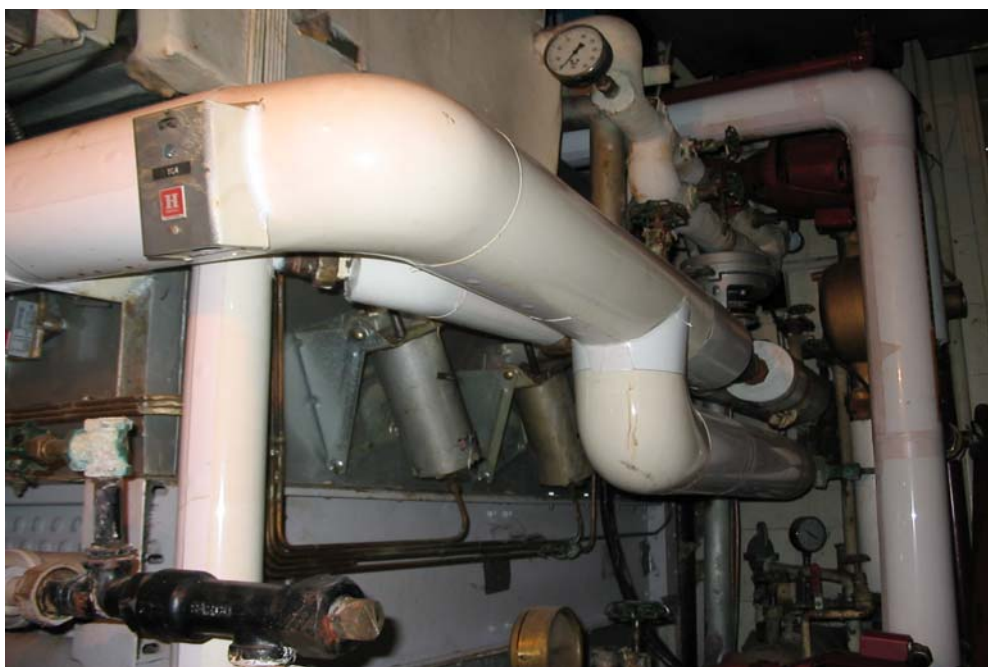
PHOTO 1: WW06 – Room 114 – A view of the pipe elbows and T-joints that contained between 25 and 50% chrysotile asbestos.

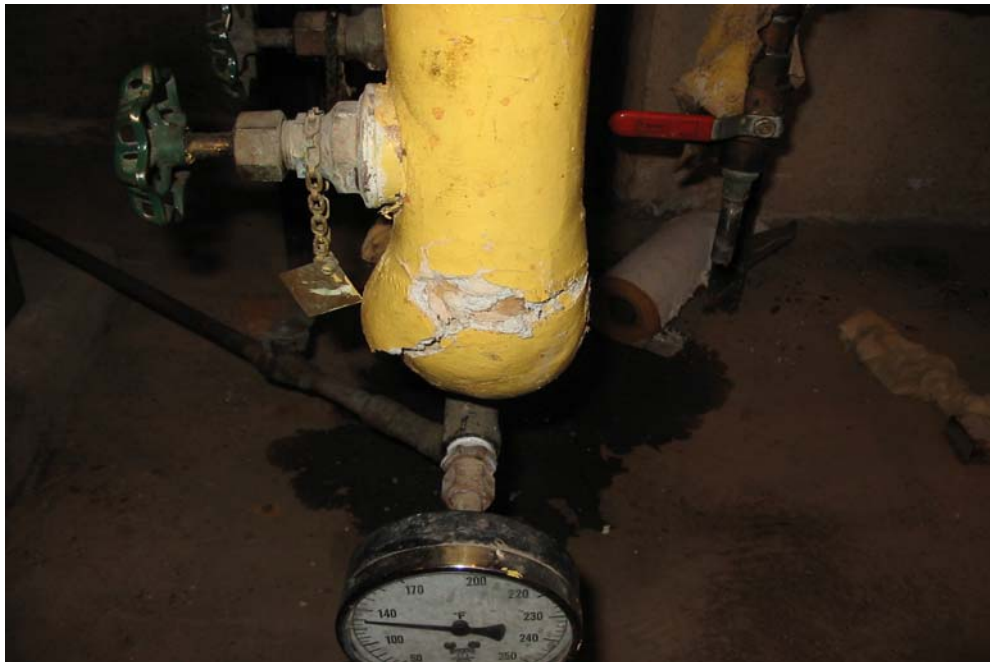
PHOTO 1: WW07 – Room 139 – An example of the many pipe elbows that were found in the room. This one was found to contain between 50 and 75% chrysotile asbestos and is in poor condition.

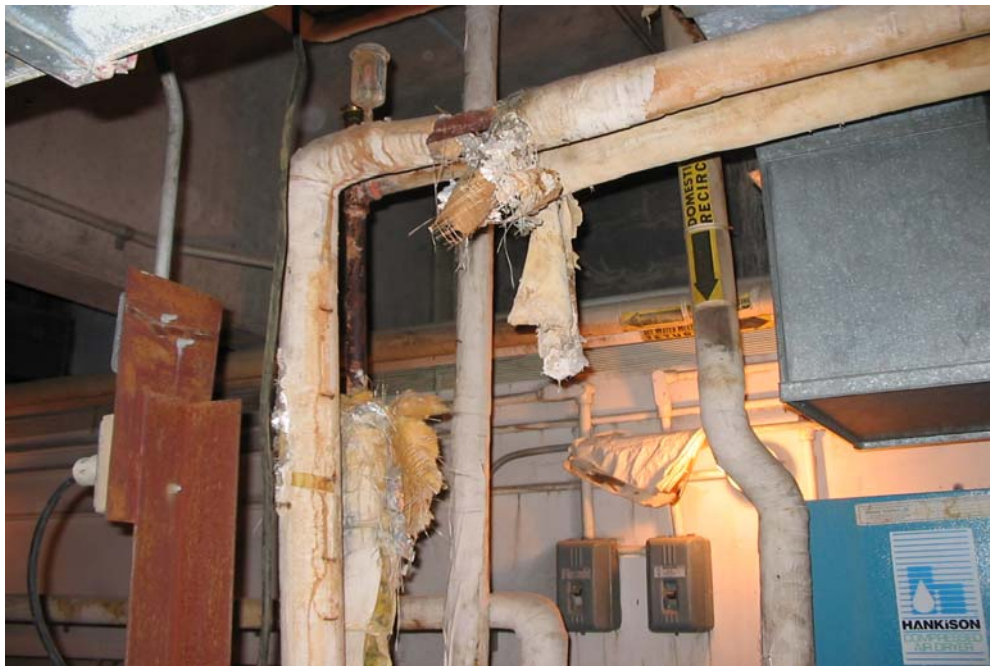
PHOTO 1: WW12 – Room 209 – An example of the pipe elbows and joints in poor condition. They were found to contain between 50 and 75 % chrysotile.

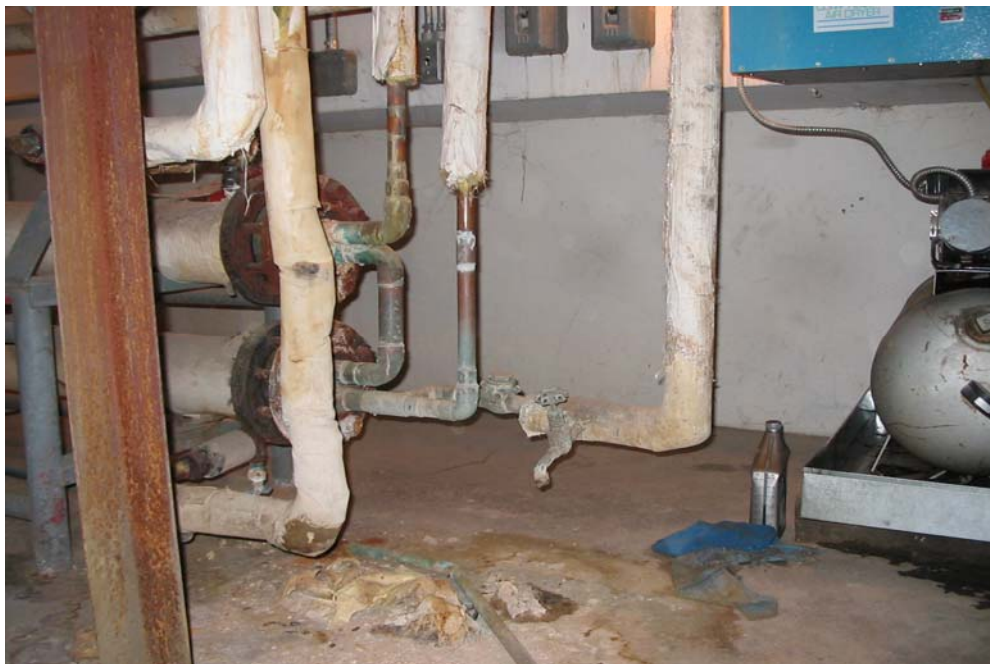
PHOTO 2: WW12 – Room 209 – Another example of the pipe elbows and joints in poor condition. They were found to contain between 50 and 75 % chrysotile.

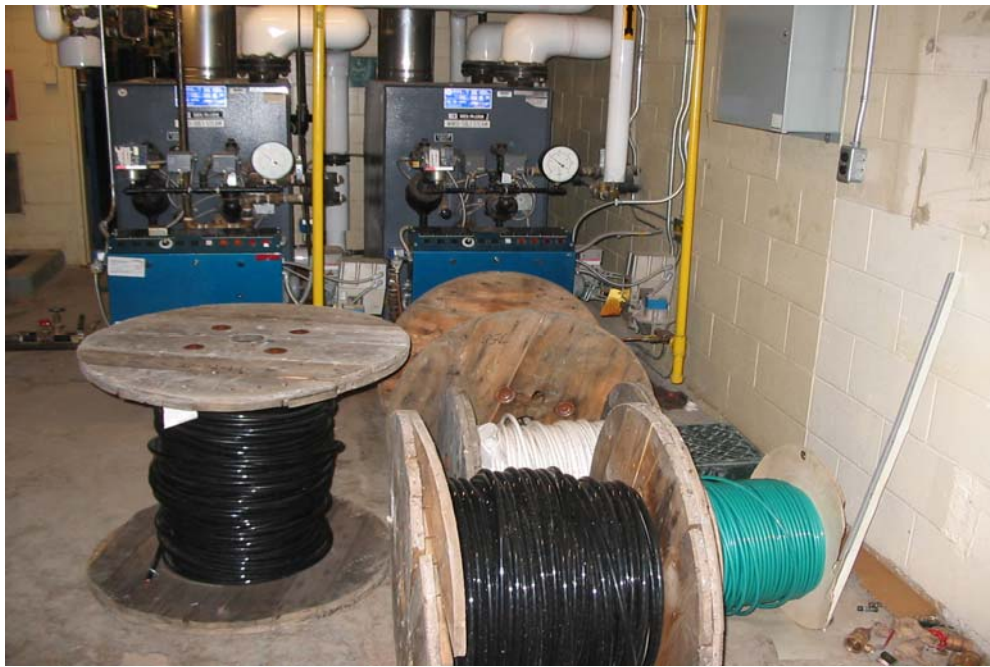
PHOTO 1: WW13 – Room 141 – An interior view of the room showing items stored there. The floor paint in this room was noted to be poor and contained a lead concentration of 68,583 ppm.

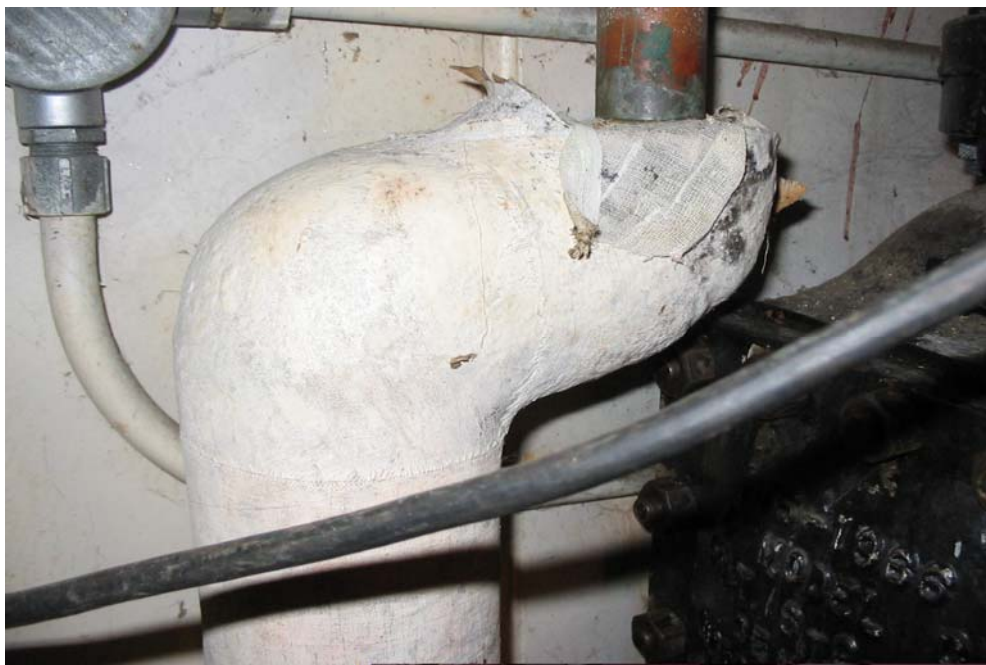
PHOTO 1: WW15 – Room 102 – A pipe elbow which, along with others, contained between 50 and 75% chrysotile asbestos. The elbow was noted to be in fair condition.

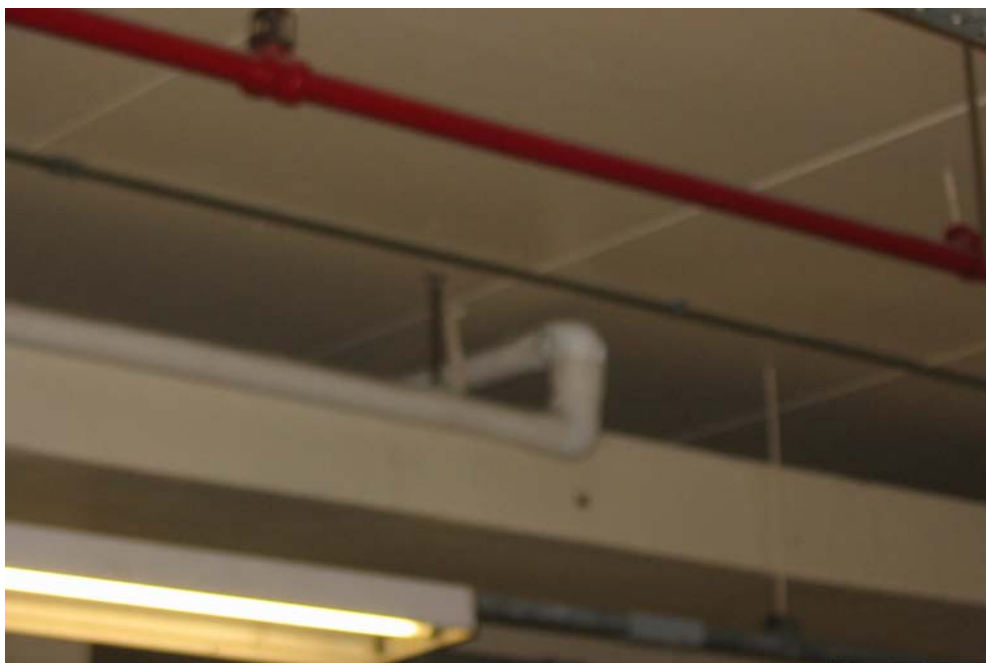
PHOTO 1: WW15 – Room 114 – Part of the pipe run that was found to contain more than 75% chrysotile asbestos. The pipe run was found to be in good condition.

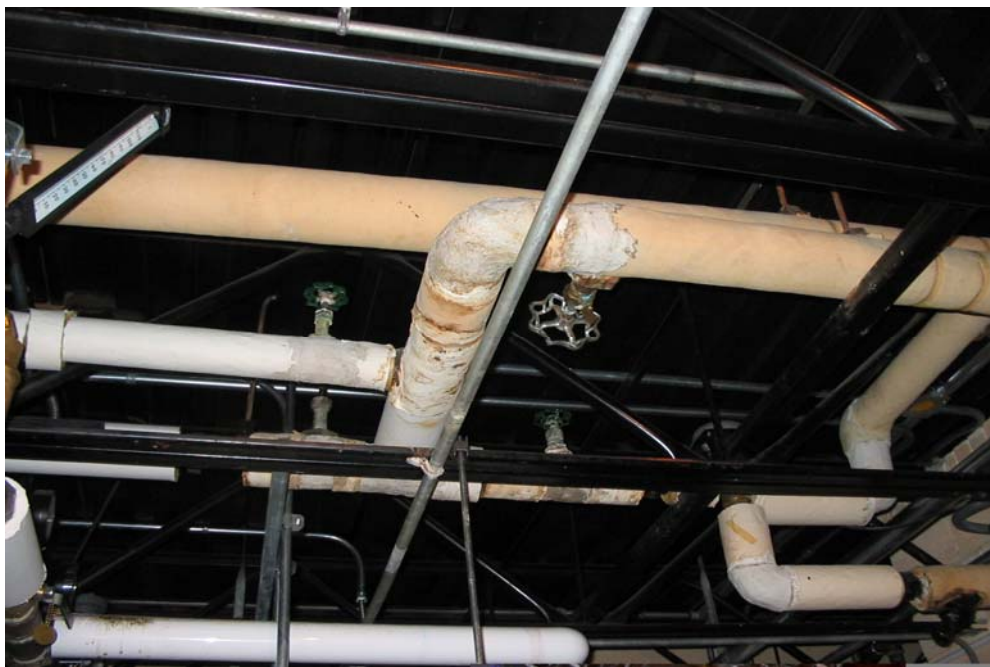
PHOTO 1: WW16 – Room 201 – Pipe elbows in the room noted to be in good condition. The elbows contained more than 75% chrysotile asbestos

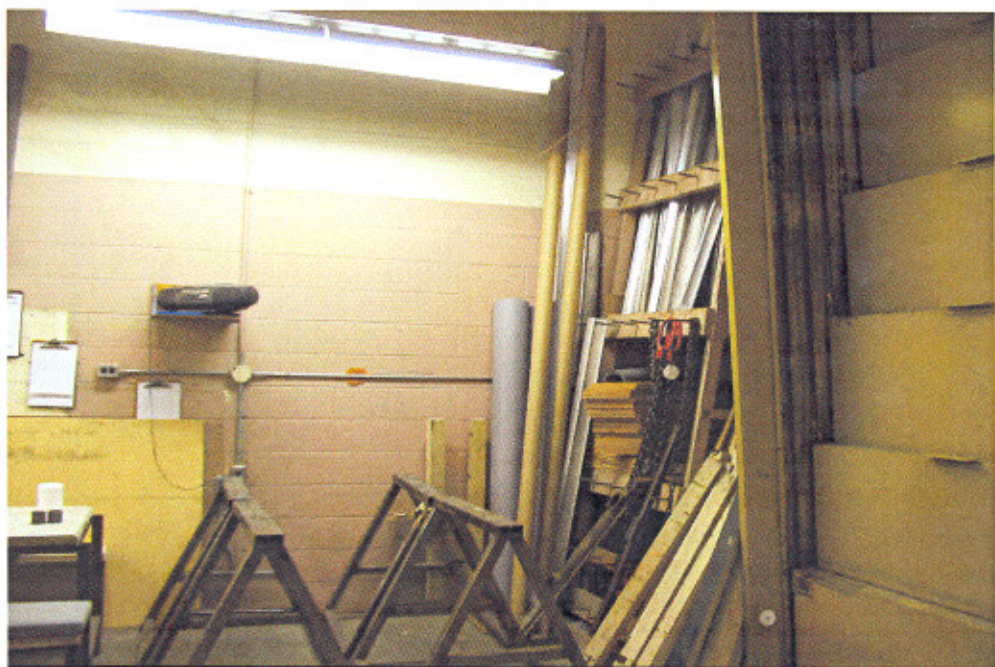
PHOTO 1: WW18 – Room 142 – Light brown paint on lower half of the wall was found to contain a lead concentration of 11,399 ppm. The paint was in fair condition.

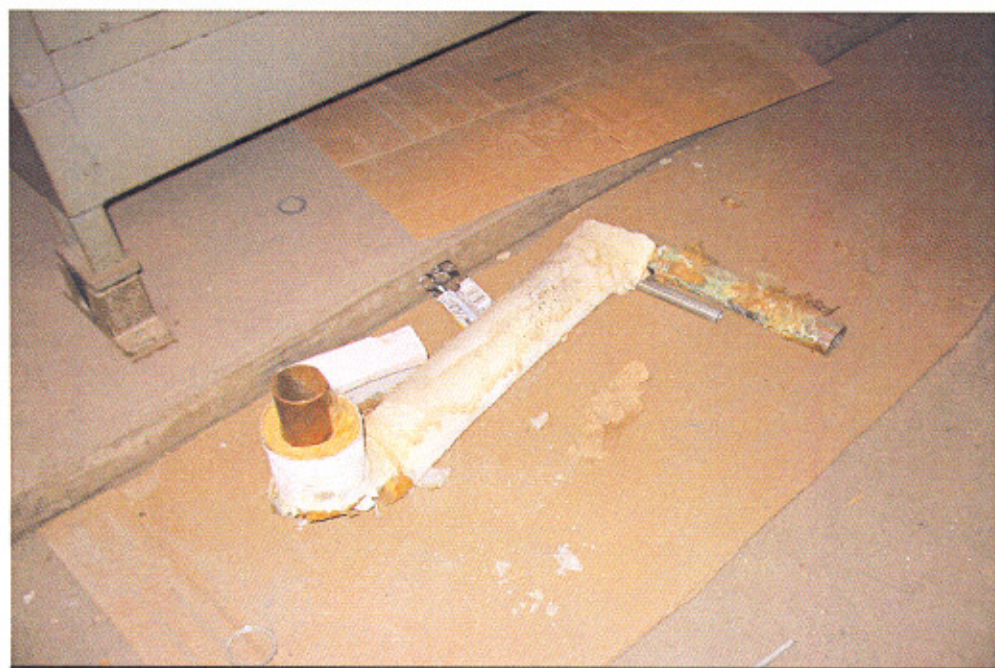
PHOTO 2: WW18 – Room 201 – A disassembled pipe elbow that contained greater than 75% chrysotile asbestos. There were other elbows and joints that were noted to be in fair or poor condition.

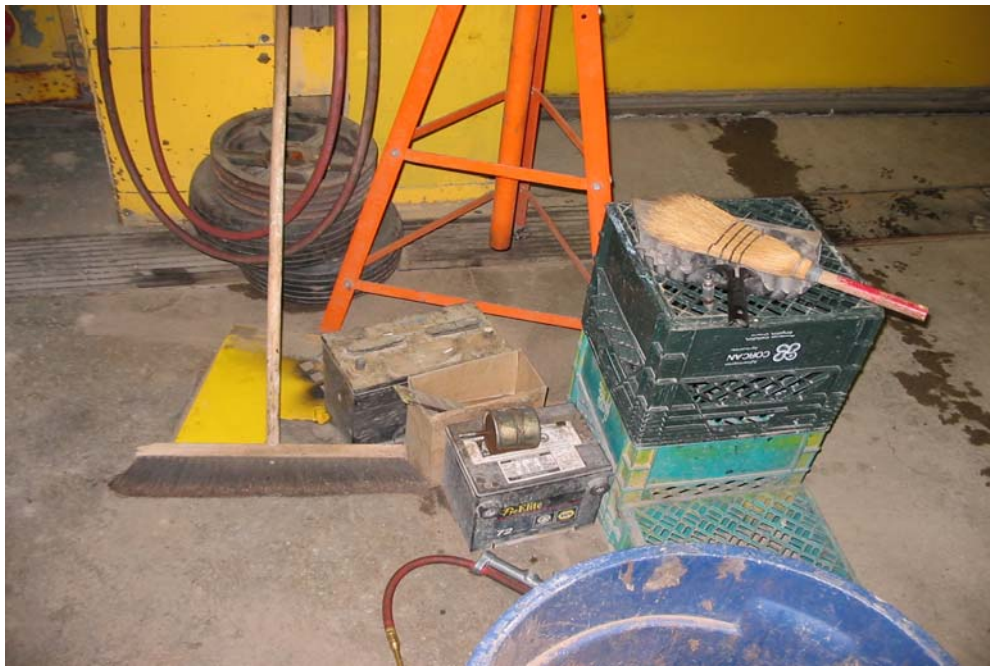
PHOTO 1: WW19 – Room 126 – Potential lead-containing automobile batteries observed, awaiting disposal.

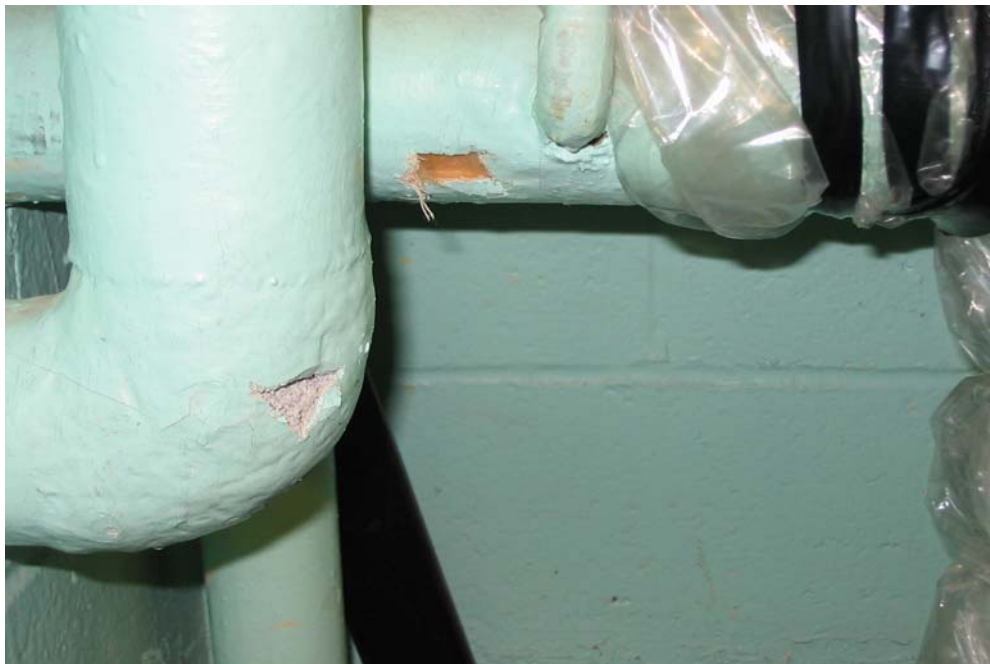
PHOTO 2: WW19 – Room 133 – A pipe elbow noted to be in good condition. The elbow contained between 50 and 75% chrysotile asbestos.

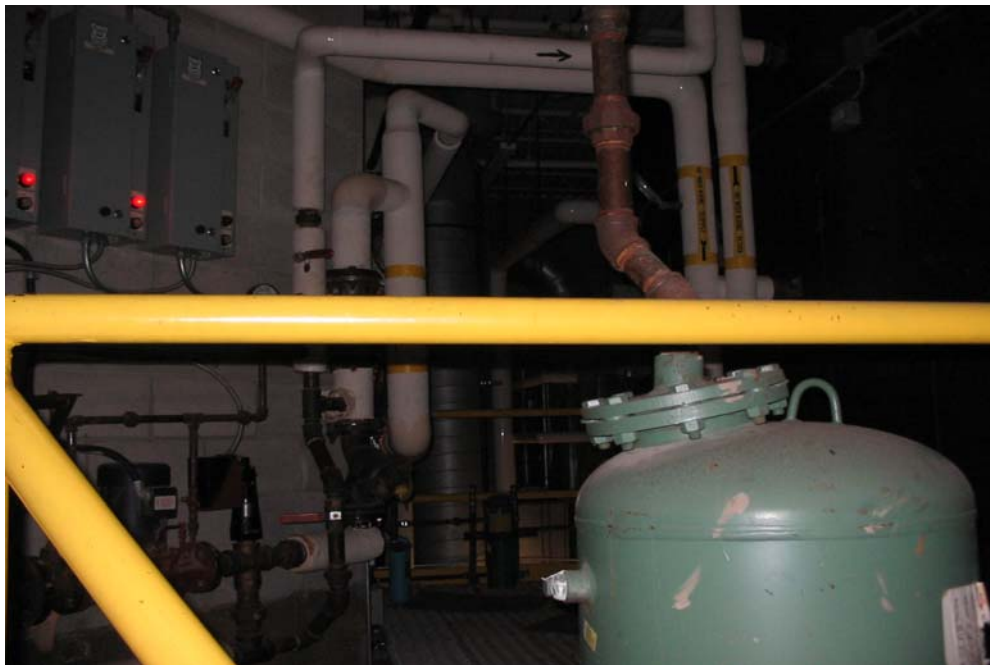
PHOTO 1: WW31 – Room M02 – Yellow railing paint that was found to contain a lead concentration of 10,052 ppm. The paint was noted to be in poor condition.

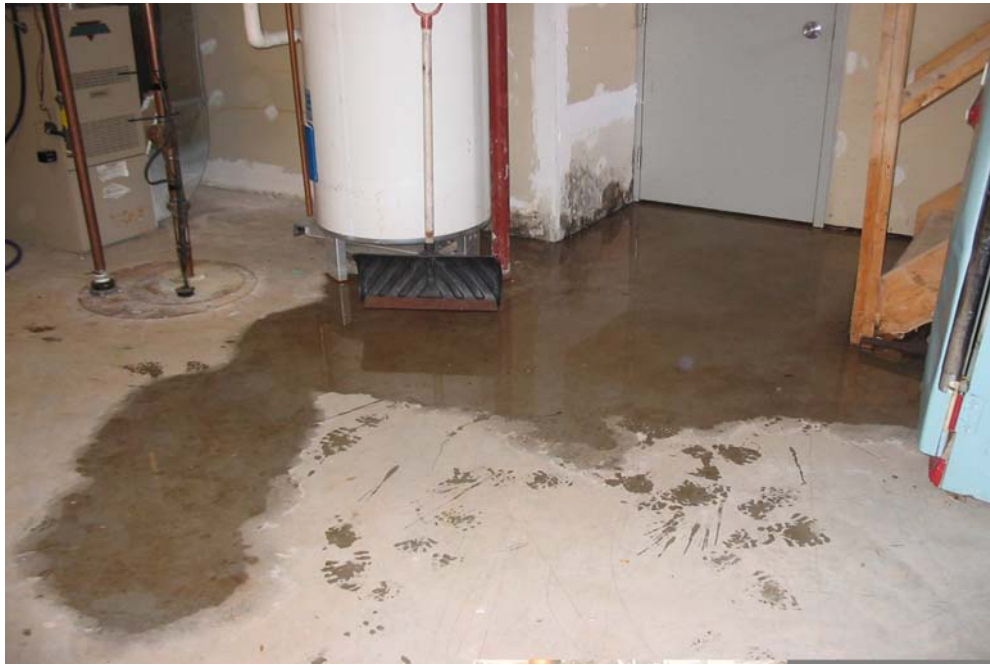
PHOTO 1: WW34 – Room B01 – Water leak and damage observed in the basement of the building. Also note mould growth on the wall to the right of the water boiler.

Water damage was observed in three of the four Private Family Duplex Units, with evidence of potential mould growth noted in two of the buildings. This water damage should be corrected and future leaks mitigated. A sampling study to determine if any and where mould growth may be occurring should be conducted. The mould investigation would cost approximately \$8,000.

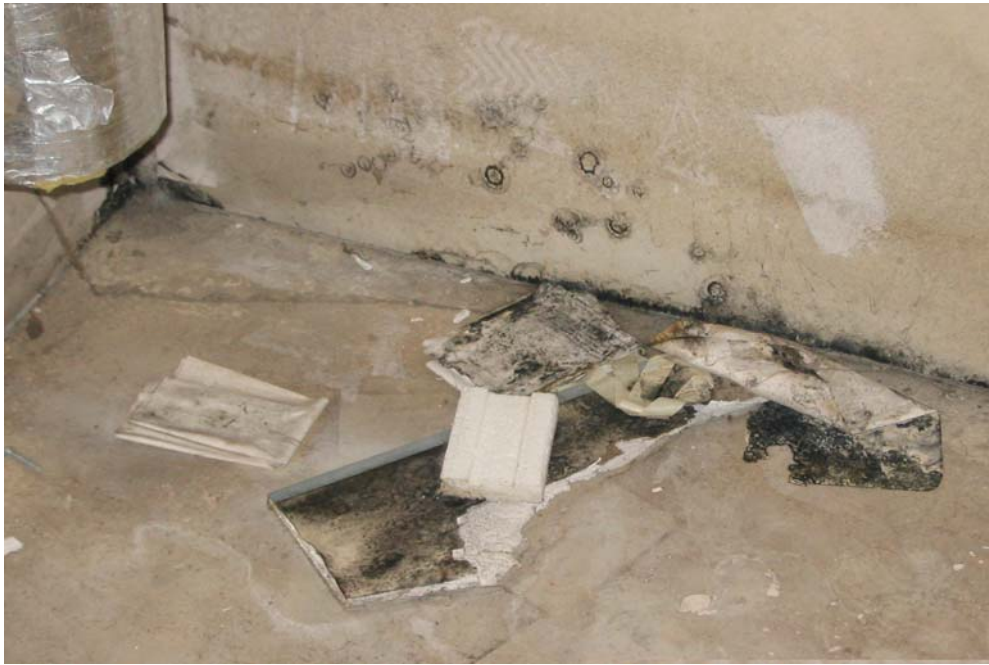
PHOTO 1: WW35– Room B01 – Water damage and mould growth observed in the basement of the building.
