**REPORT
TO
PUBLIC WORKS AND GOVERNMENT SERVICES CANADA
DESIGNATED SUBSTANCES AND
HAZARDOUS MATERIALS SURVEY
ADMINISTRATION BUILDING (WW03)
WARKWORTH INSTITUTION
WARKWORTH, ONTARIO
CORRECTIONAL SERVICE OF CANADA
PWGSC PROJECT R.033225.001**

April 2011

Re: **Designated Substances and Hazardous Materials Survey
Administration Building (WW03), Warkworth Institution
Warkworth, Ontario**

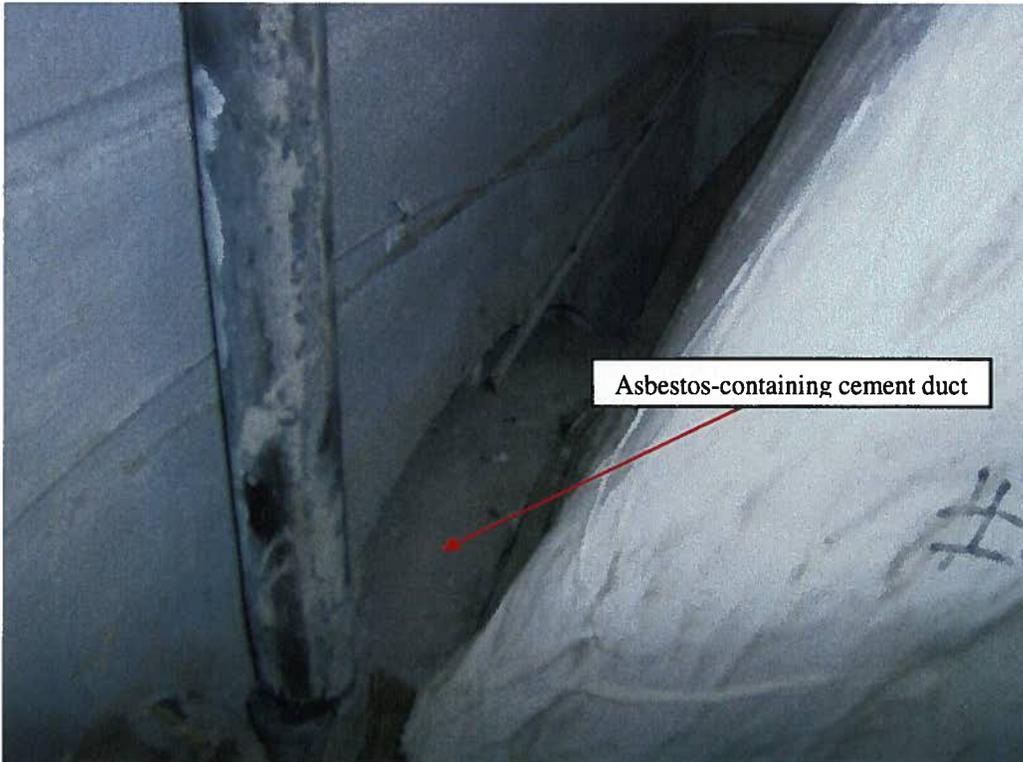
The asbestos-containing cement circular air duct observed jutting out of the north wall in the east corner of Room 130 appears to be buried below the building north of the north wall (see Photograph N^{os} 1 and 2 in Appendix E).

Photograph No. 1: Room 130 – Asbestos-containing cement duct penetrating north wall.

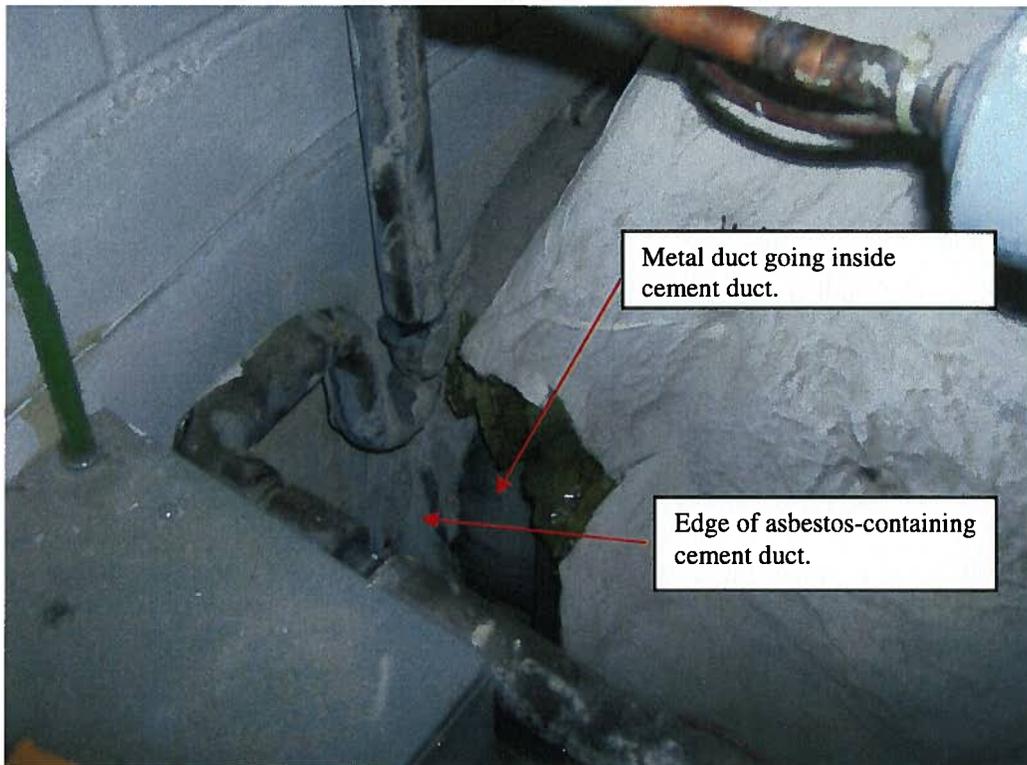
Photograph No. 2: Room 130 – Metal duct penetrating asbestos-containing cement duct in north wall.

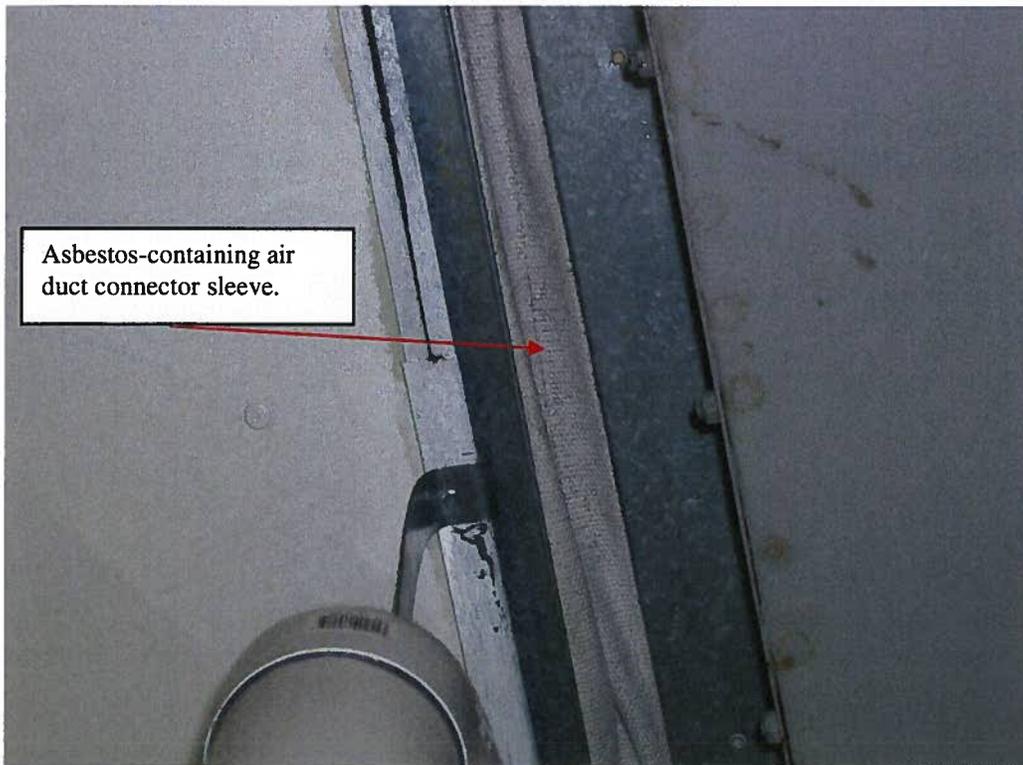
The asbestos-containing air duct connector sleeves observed in Room 130 are comprised of woven asbestos fibre (white in colour - see Photograph N^o 3 in Appendix E).

Photograph No. 3: Room 130 – Asbestos-containing air duct connector sleeve.

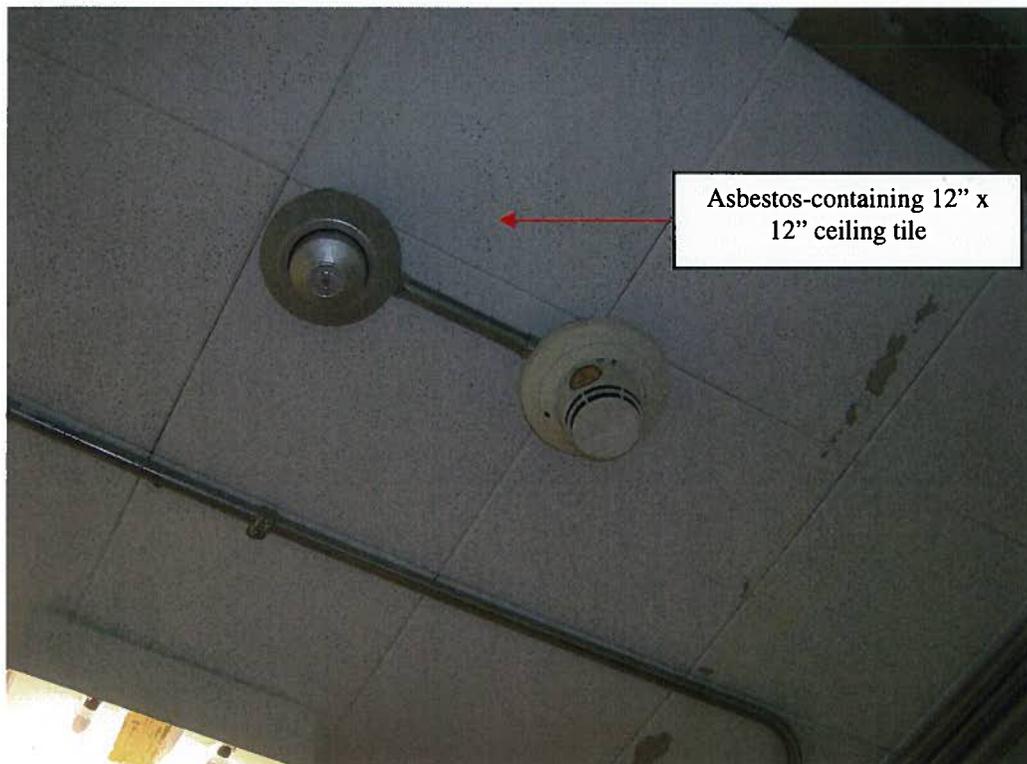
The asbestos-containing 12" x 12" ceiling tiles glued to gypsum board substrate, both exposed and above suspended ceiling tile systems, observed throughout the facility, have a pin-hole pattern on the face of the tile (see Photograph N^o 4 in Appendix E). Remnant asbestos-containing 12" x 12" ceiling tile material attached to the ceiling tile mastic on the gypsum board substrate was observed in several rooms above the suspended ceiling tile systems (see Photograph N^o 5 in Appendix E).

Photograph No. 4: Room 105 – Exposed 12" x 12" asbestos-containing ceiling tiles.

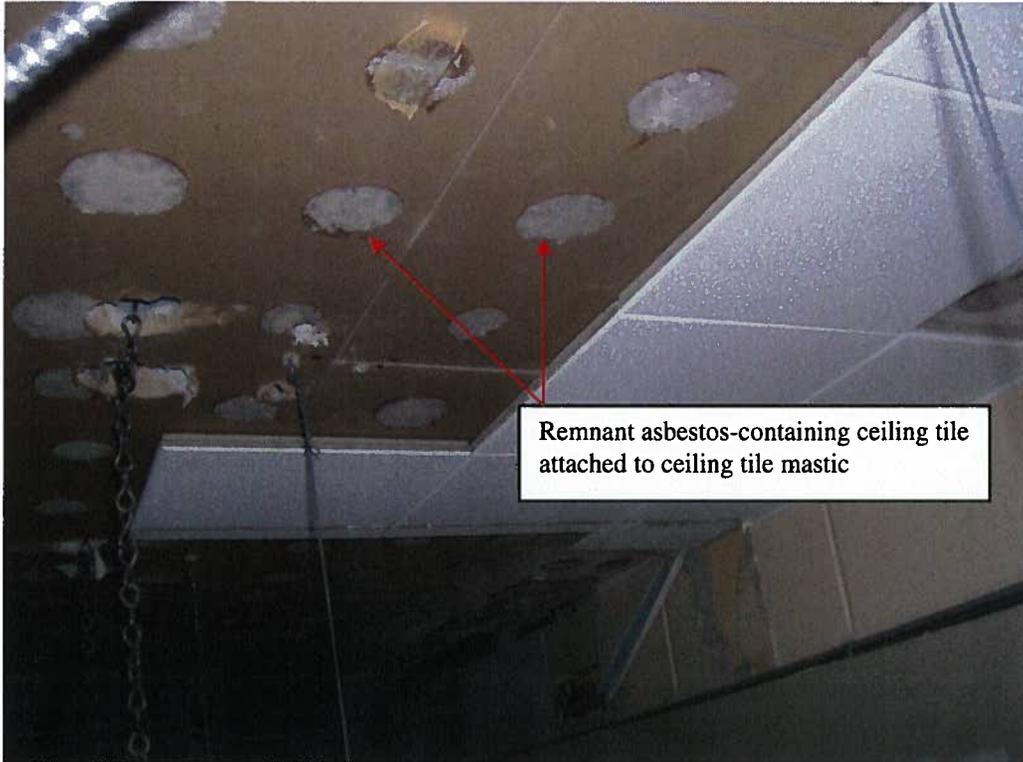
Photograph No. 5: Room 123 – Remnant asbestos-containing ceiling tile attached to ceiling tile mastic and 12” x 12” asbestos-containing ceiling tiles located above the suspended T-bar ceiling.
