**DEMOLITION WASTE SURVEY  
ENVIRONMENT CANADA FACILITY  
1082 AIRPORT ROAD, IQALUIT, NUNAVUT**

**Public Works and Government Services Canada**

**SENES Consultants**

November 2013

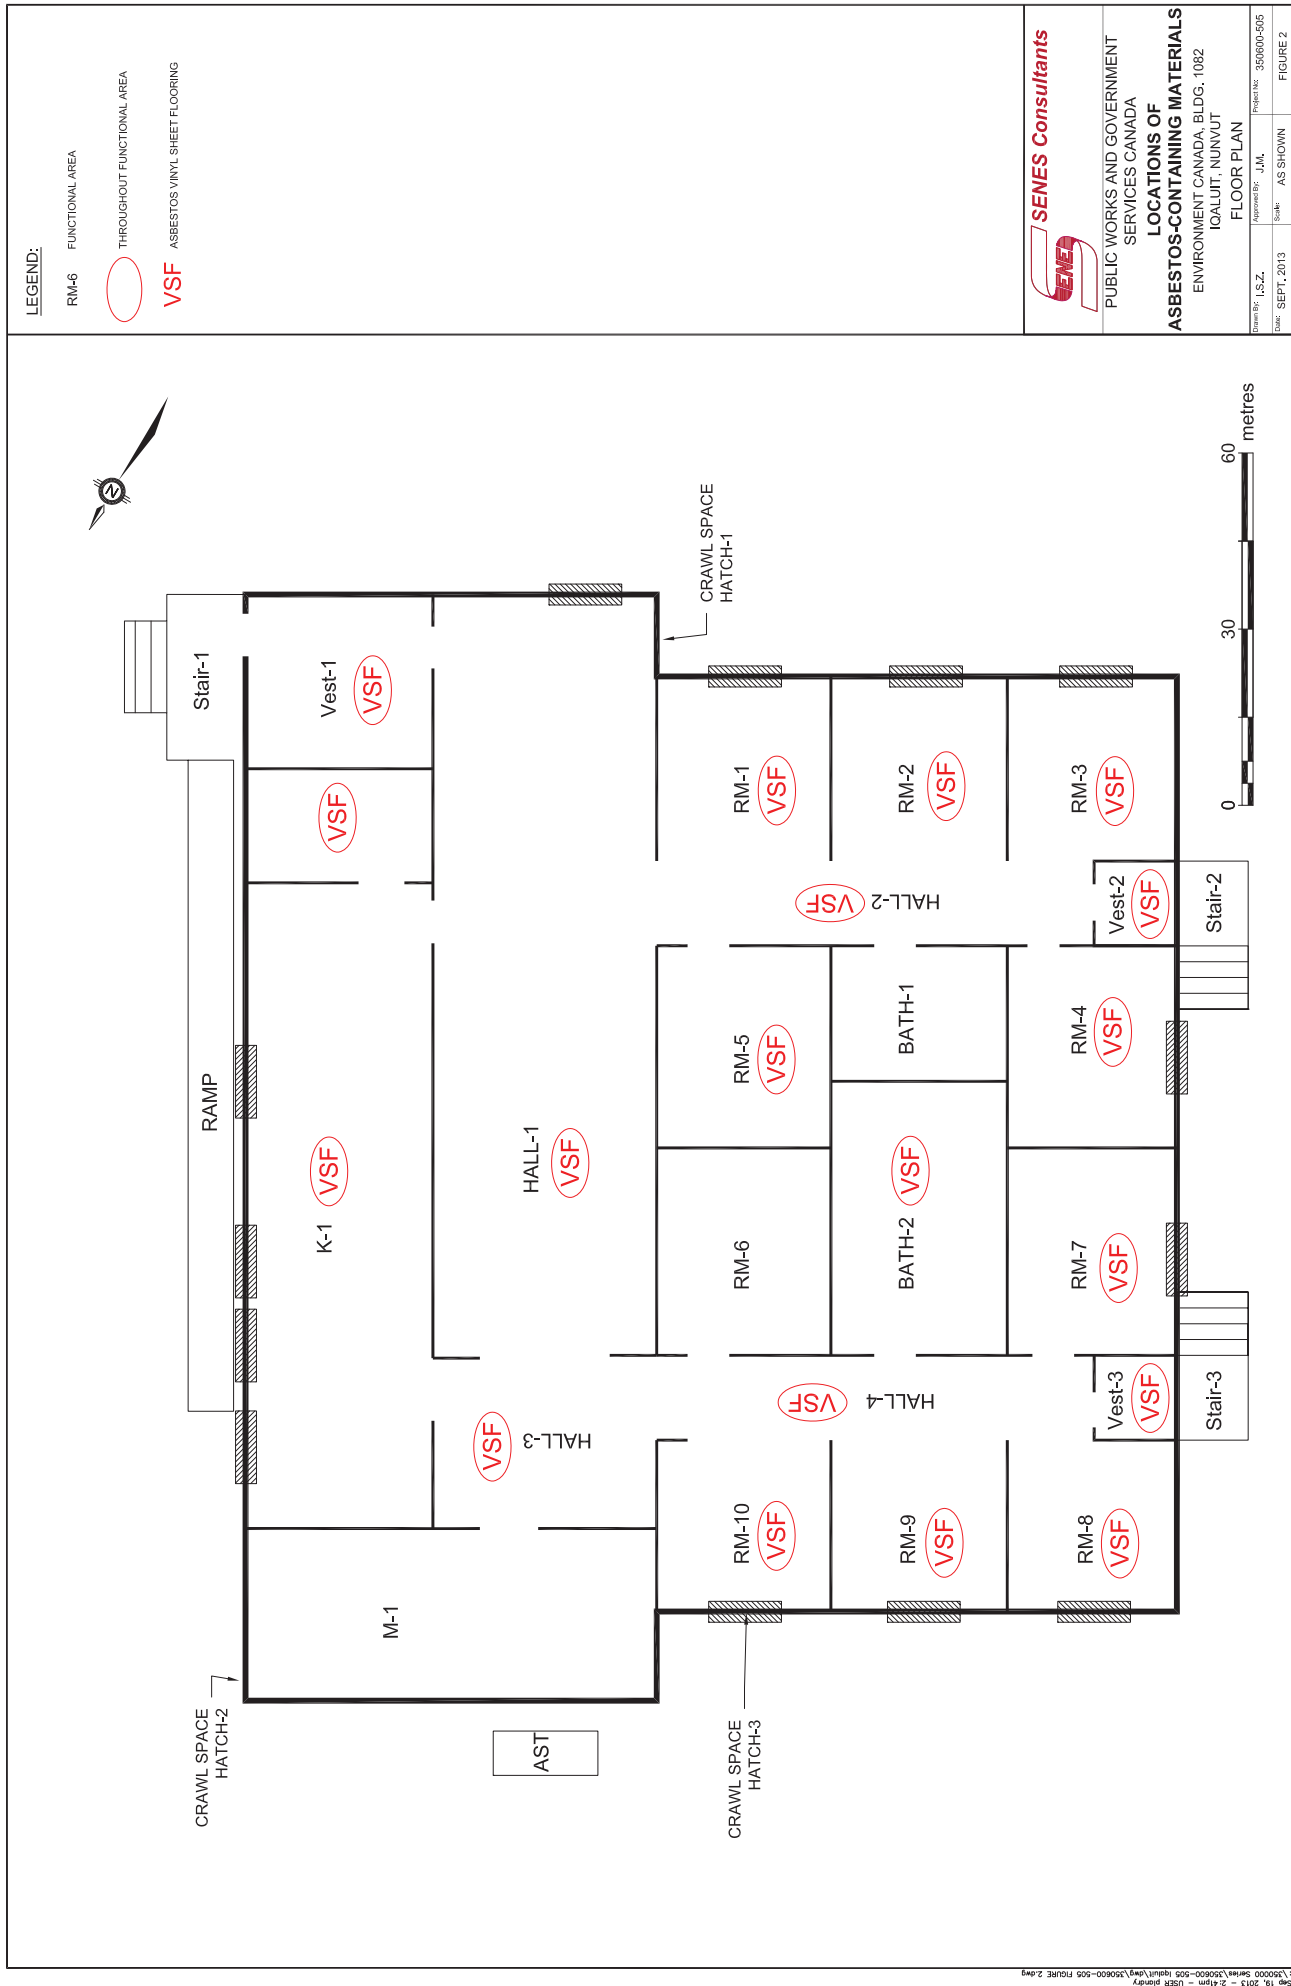
Based on visual observations and results of laboratory analyses of samples collected by SENES, the following asbestos-containing materials (i.e. - >1% asbestos) were found to be present in the subject building:

THROUGHOUT FUNCTIONAL AREA

VSF ASBESTOS VINYL SHEET FLOORING

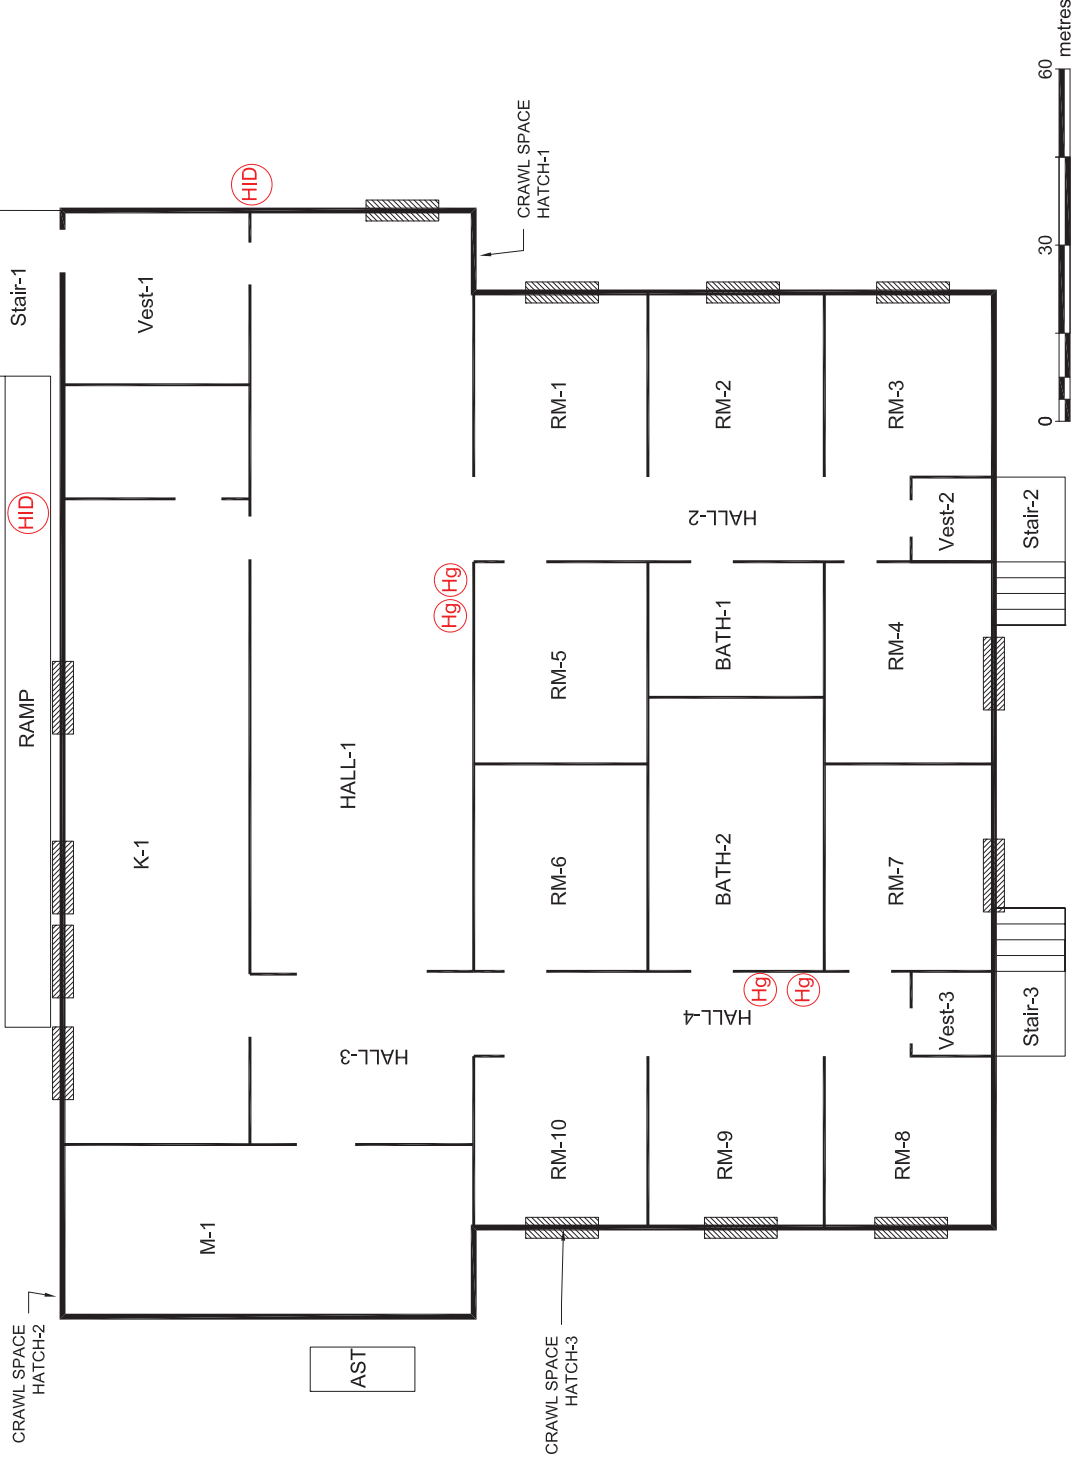
During the course of our site inspections, sixty-four interior fluorescent light tubes and two exterior H.I.D. lights were observed. Mercury should be assumed to be present as a gas in all fluorescent light tubes. Four mercury thermostats were observed in the building. The locations of the fixtures that contain mercury are shown in place on Figure 3.

(HID) EXTERIOR HID LIGHT

(Hg) MERCURY CONTAINING THERMOSTAT

Fourteen smoke detectors were observed in the building. The locations of the fixtures that are shown in place on Figure 3. Smoke detectors typically contain 1 microcurie of Americium-241. Standard smoke detectors do not require a radioactive licence and are accepted as segregated items at the Iqaluit landfill.

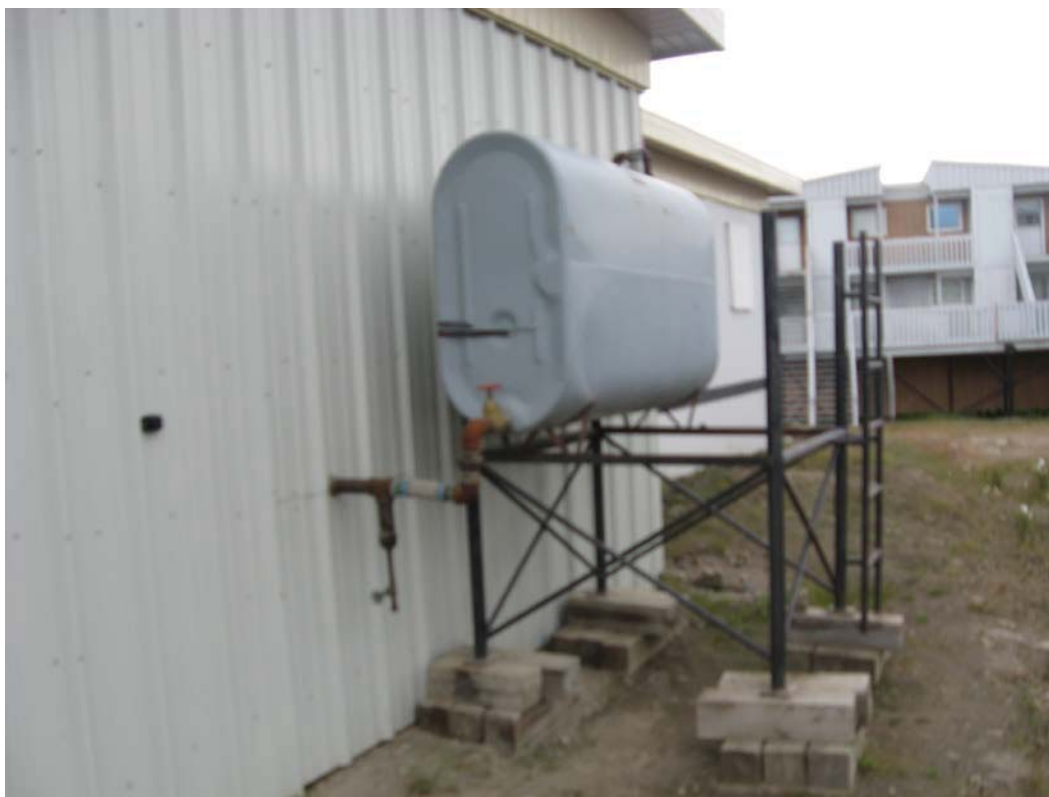
The subject property is located on the east side of Airport Road in the City of Iqaluit. The property is approximately 0.6 hectares (1.5 acres) with a single storey wood frame trailer structure, with metal cladding. The building is on City services for water, sewer and electrical power. The electric power comes to the building from a pole to the north east of the subject site. One transformer was observed on the pole. The sewer and water connection are believed to enter the building from the north side however this will have to be confirmed in the field at the time of demolition. The building is heated by one oil-fired forced air furnace in the mechanical room. There is one 1,135 L oil tank located on the exterior of the building against the north wall. The tank is like new condition and there is no evidence of leakage.

**Photo 3: Furnace Oil AST.**

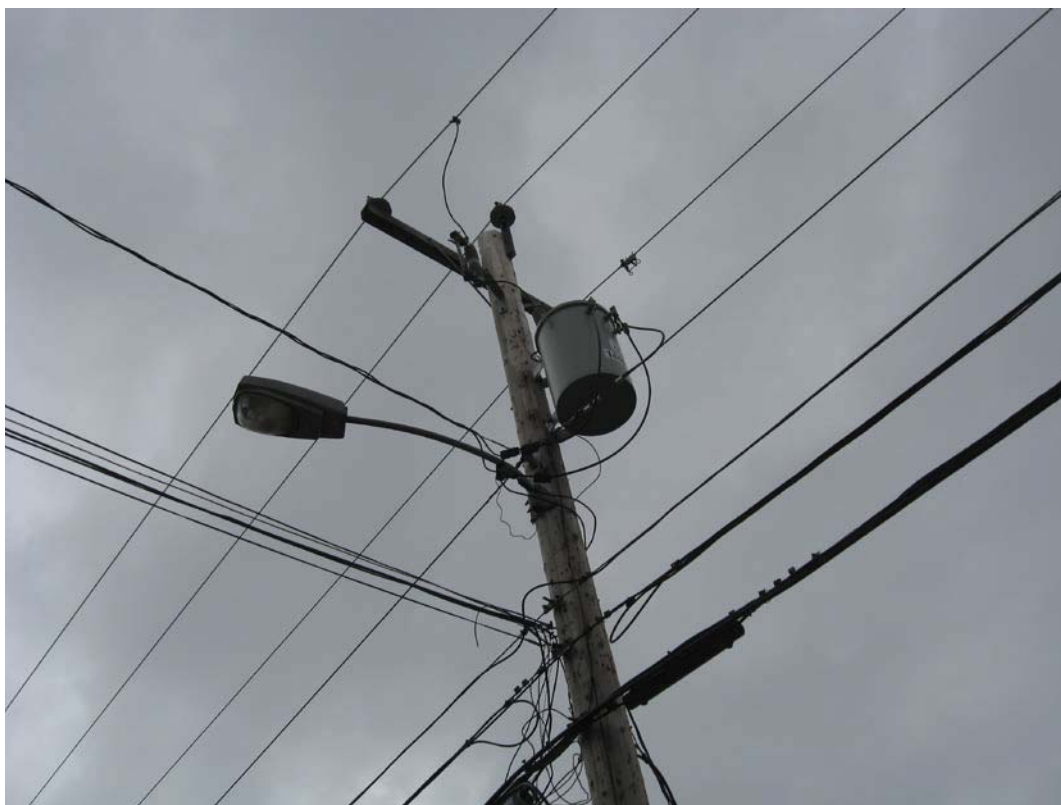
The electric power comes to the building from a pole to the north east of the subject site. One transformer was observed on the pole which is not part of the subject property. Switchgears were observed in the mechanical room. No other PCB-containing equipment or materials were identified during the waste survey.

**Photo 4: Pole-Mounted Transformer.**

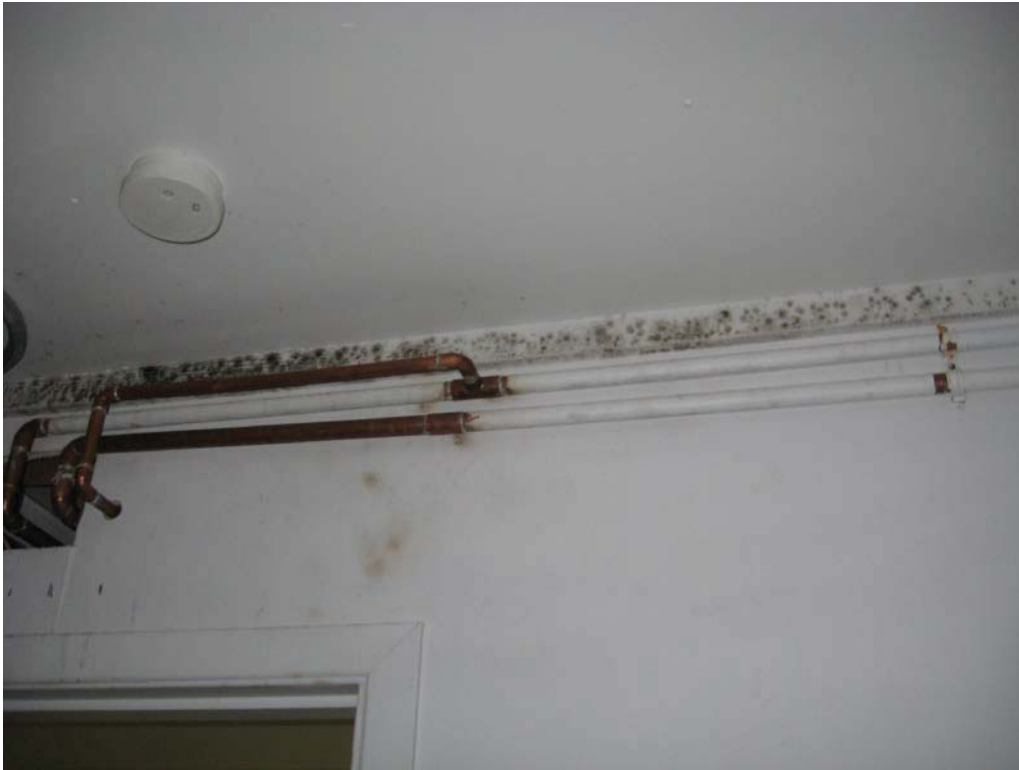
Mould was observed in several locations throughout the building including on interior surfaces and in wall cavities. Furniture in the structure as well as the stove and fridge had heavy mould impact. As such, the kitchen equipment and furniture items were included within material quantities for disposal.

**Photo 6: Suspect Mould of Wood.**

Mould should be assumed to be present on surfaces inside wall cavities (e.g. on gypsum board, etc.), and possibly in other “hidden” areas. During demolition, any mould-impacted materials should be misted or wetted with water to reduce airborne dust. The materials should then be placed into a disposal bin and sealed. Workers involved in the demolition of mould-impacted materials should wear appropriate protective clothing and equipment and follow decontamination practices as outlined in the Canadian Construction Association Standard Construction Document CCA-82 2004 – Mould guidelines for the Canadian Construction Industry.

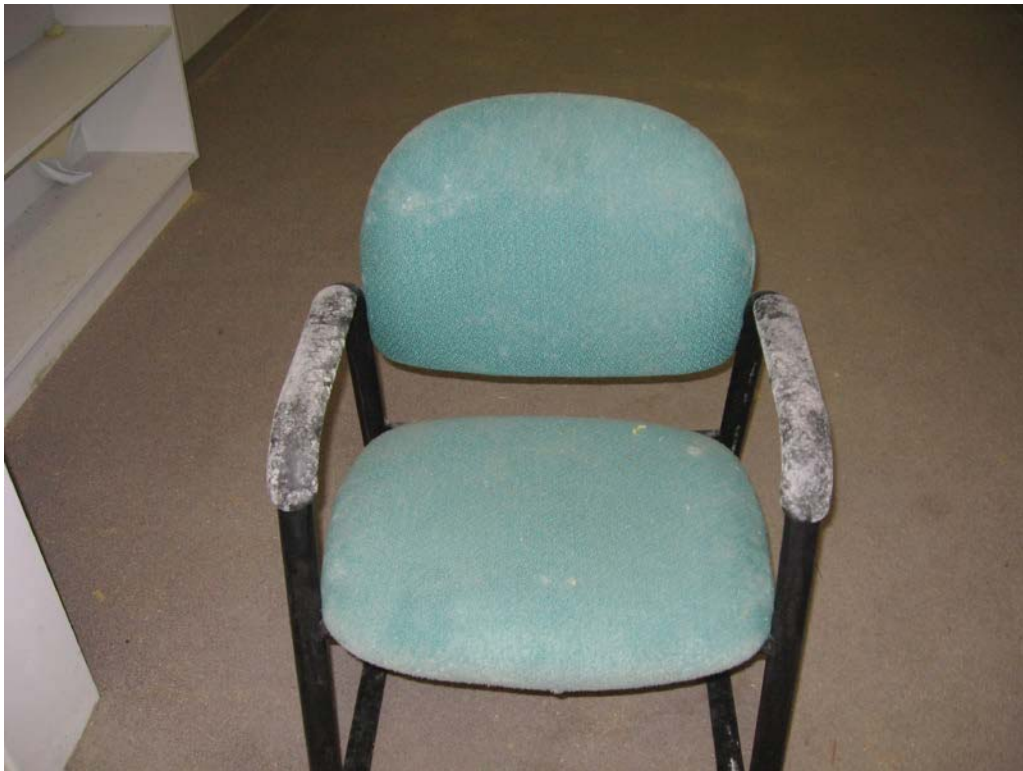
**Photo 7: Suspect Mould on Furniture.**

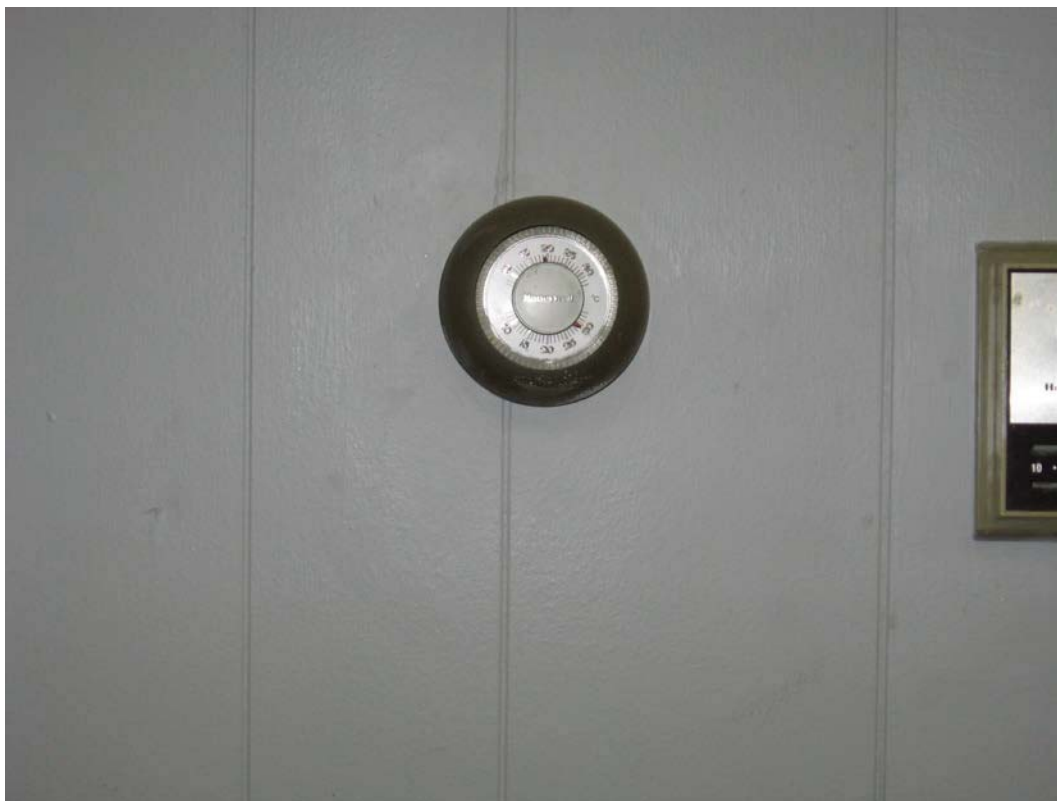
**Photo 8: Mercury-Containing Thermostats.**

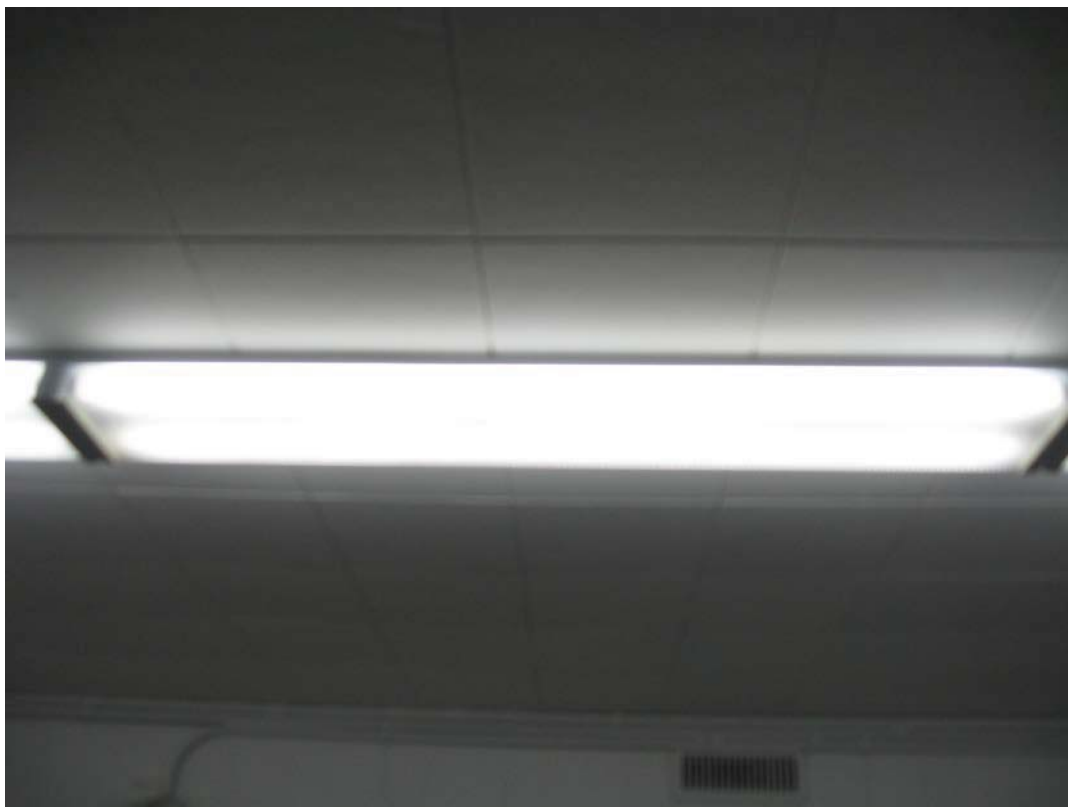
Fluorescent lights were observed throughout the facility during the course of our site inspections. Light ballasts, such as those associated with the type of fluorescent lights identified on site, may contain PCBs.

Thirty-two fluorescent light ballasts were observed in the subject building. The ballasts will have to be examined by a licensed electrician prior to disposal to confirm the presence of PCBs.

**Photo 9: Fluorescent lights (typical throughout).**

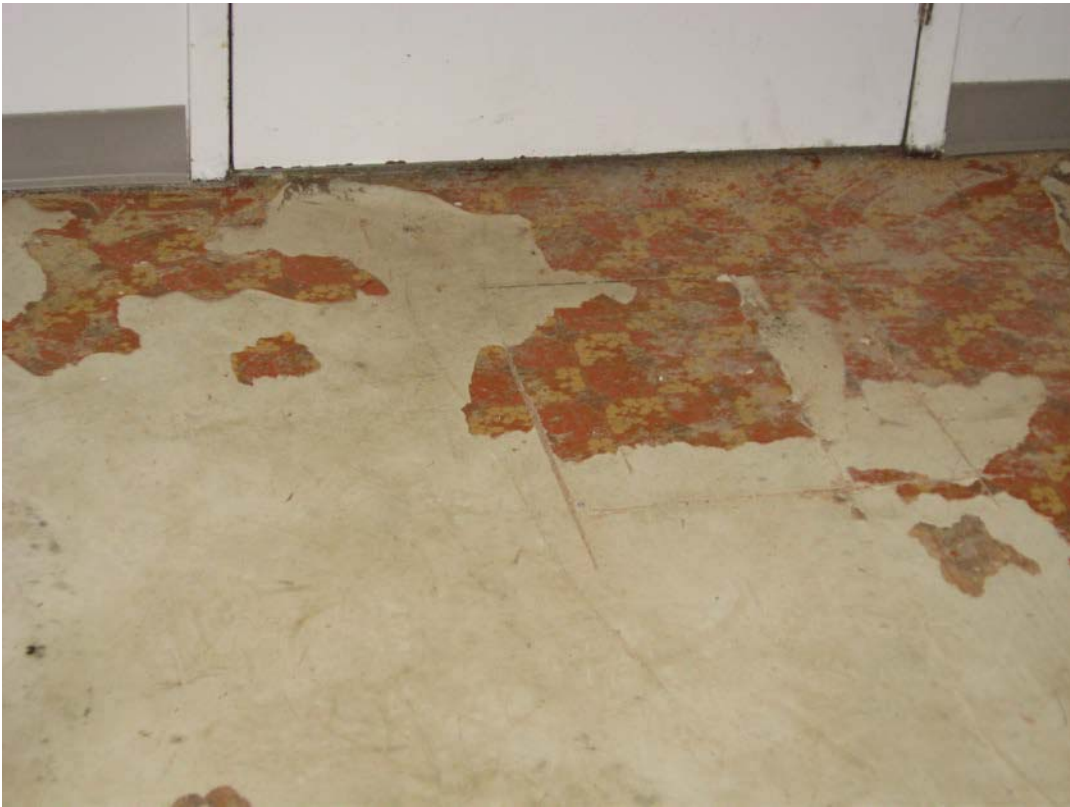
The interior is generally covered with carpeting with the exceptions being the kitchen, bathrooms and foyers which have vinyl sheet flooring. Vinyl sheet flooring was observed throughout below the carpet. In the kitchen and bathrooms there were two layers of vinyl sheet flooring observed.

**Photo 10: Vinyl sheet flooring (typical throughout).**

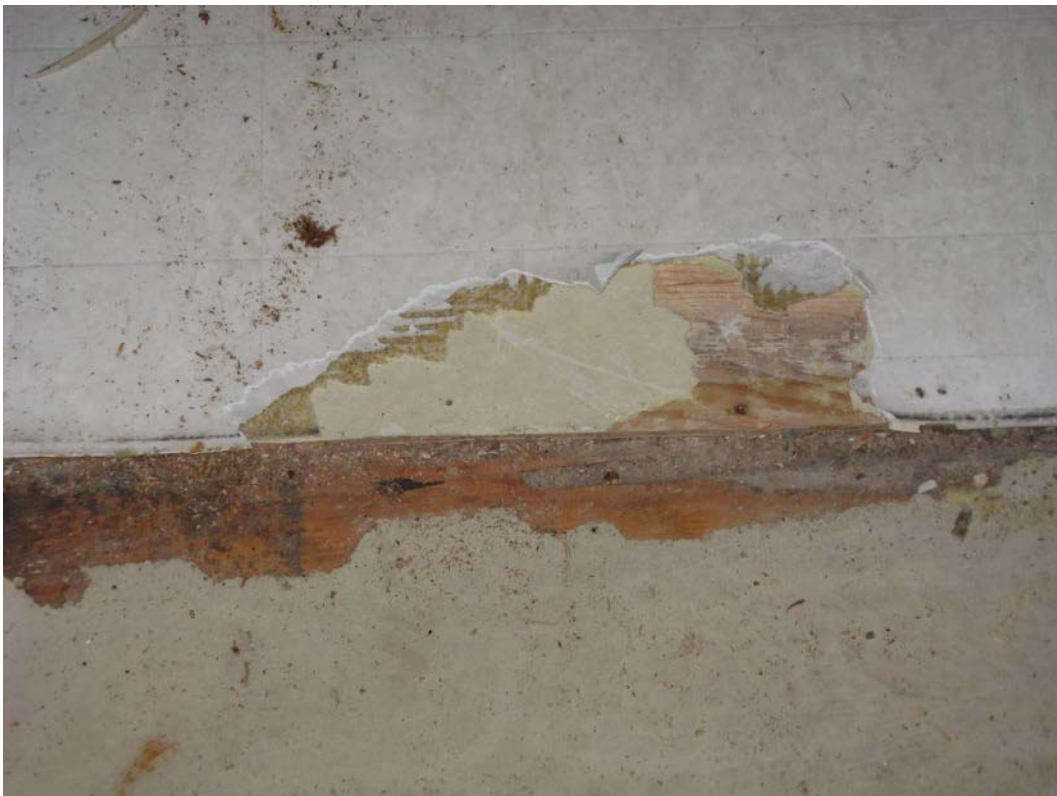
**Photo 11: Vinyl sheet flooring (typical throughout).**

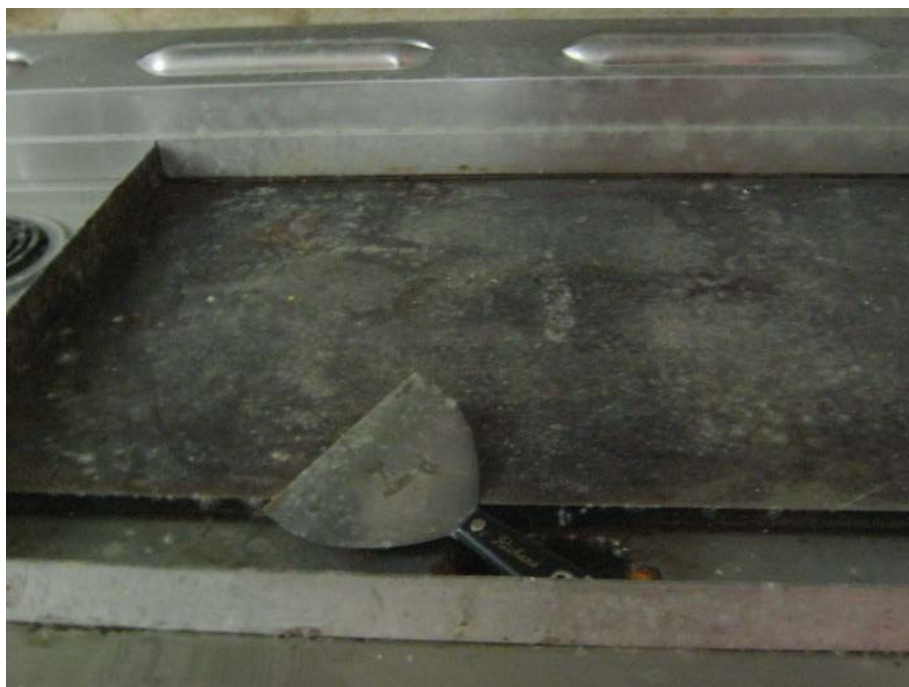
**Photo 15: Visible mould growth on kitchen stove surface.**

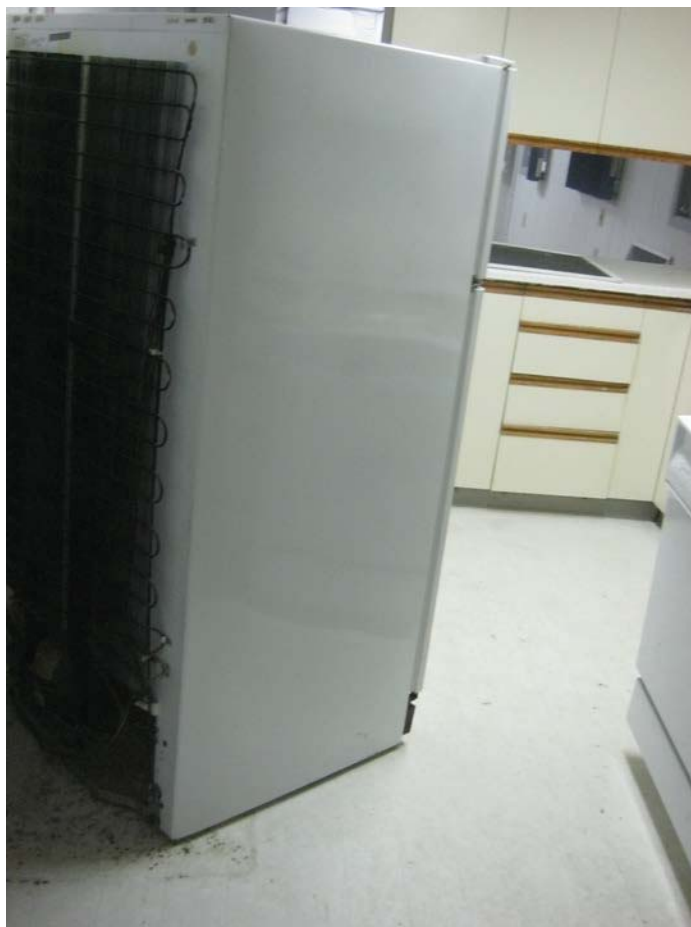
One refrigerator/ freezer unit was observed during the inspection. As this equipment appears to be in good condition and portable it is likely to be moved to a new location. However if any ODS-containing equipment is to be removed and designated for disposal as scrap it must be drained of its contents by a licensed technician and equipped with a label indicating that the equipment no longer contains any refrigerant (see Section 2.6 of this report).

**Photo 16: Kitchen fridge/freezer unit.**

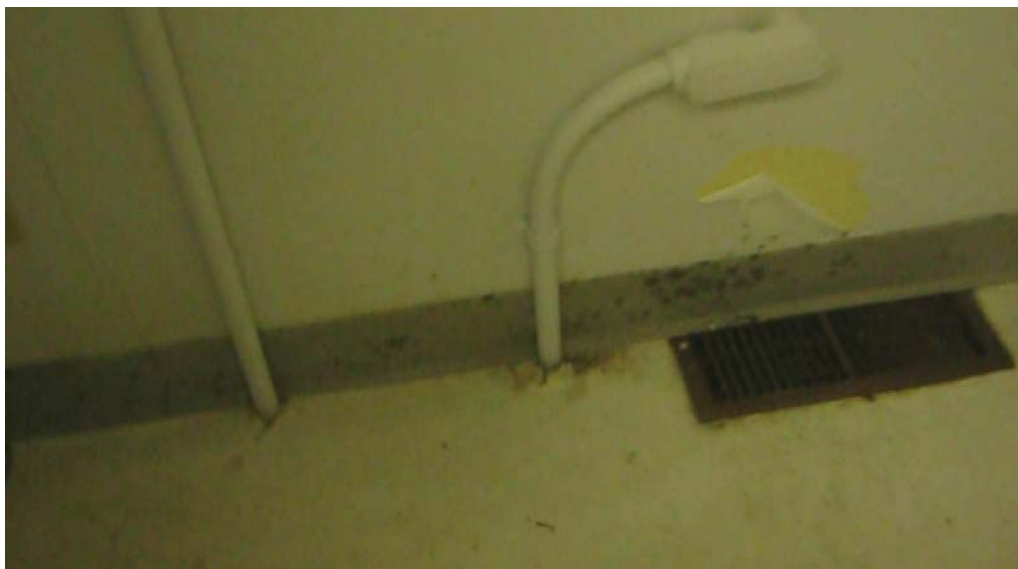
**Photo 17: Suspect mould on kitchen baseboard.**

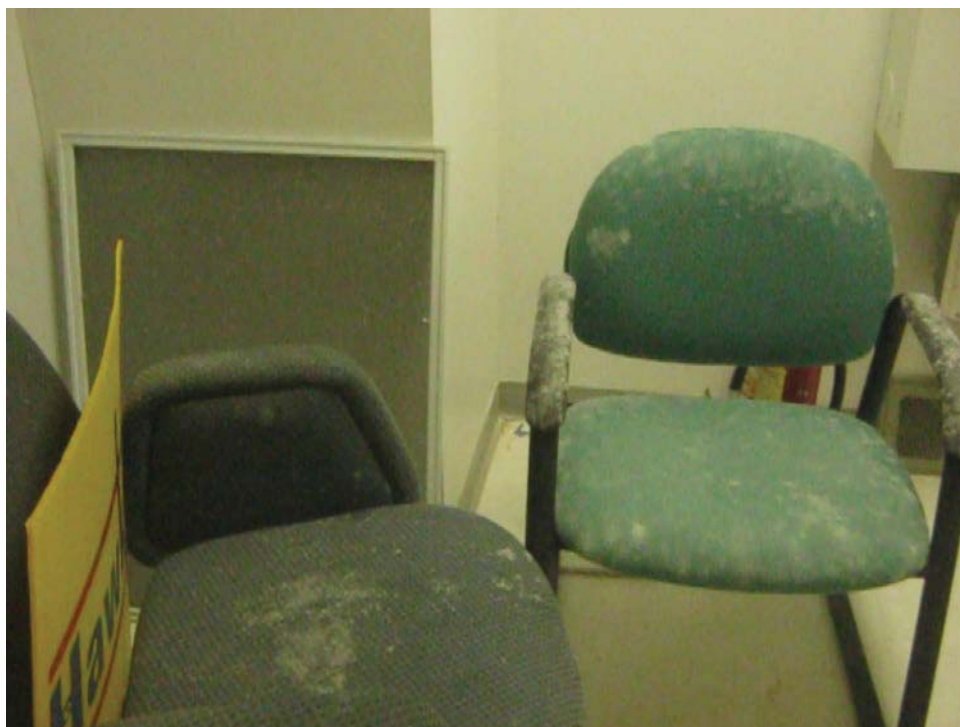
**Photo 18: Suspect mould on chairs.**

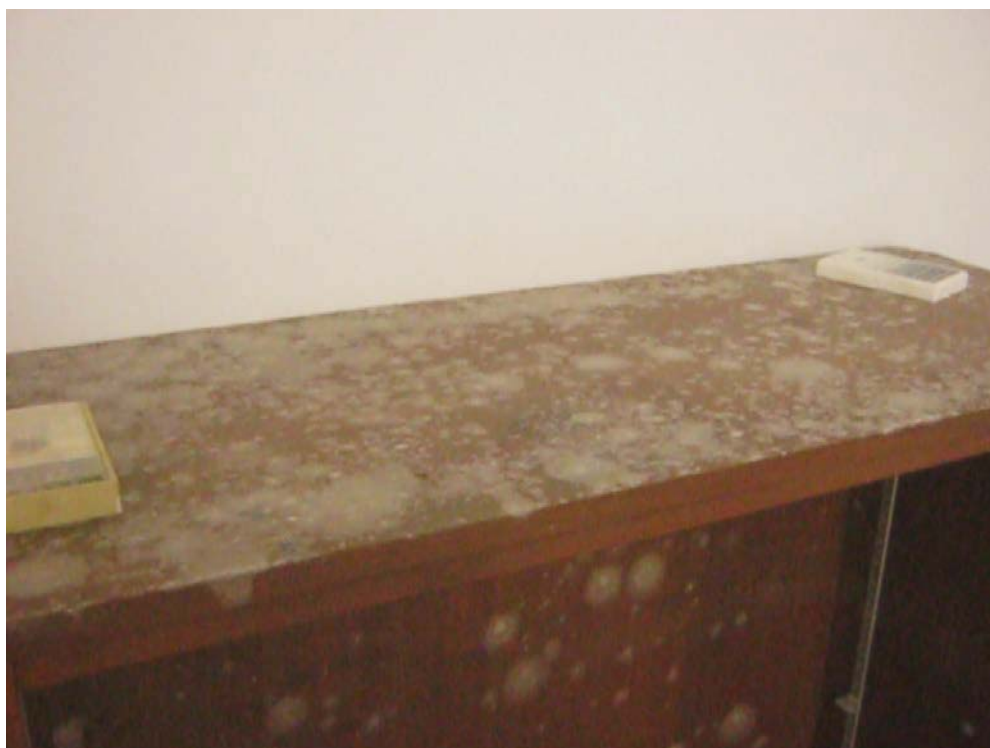
**Photo 19: Suspect mould on furniture.**

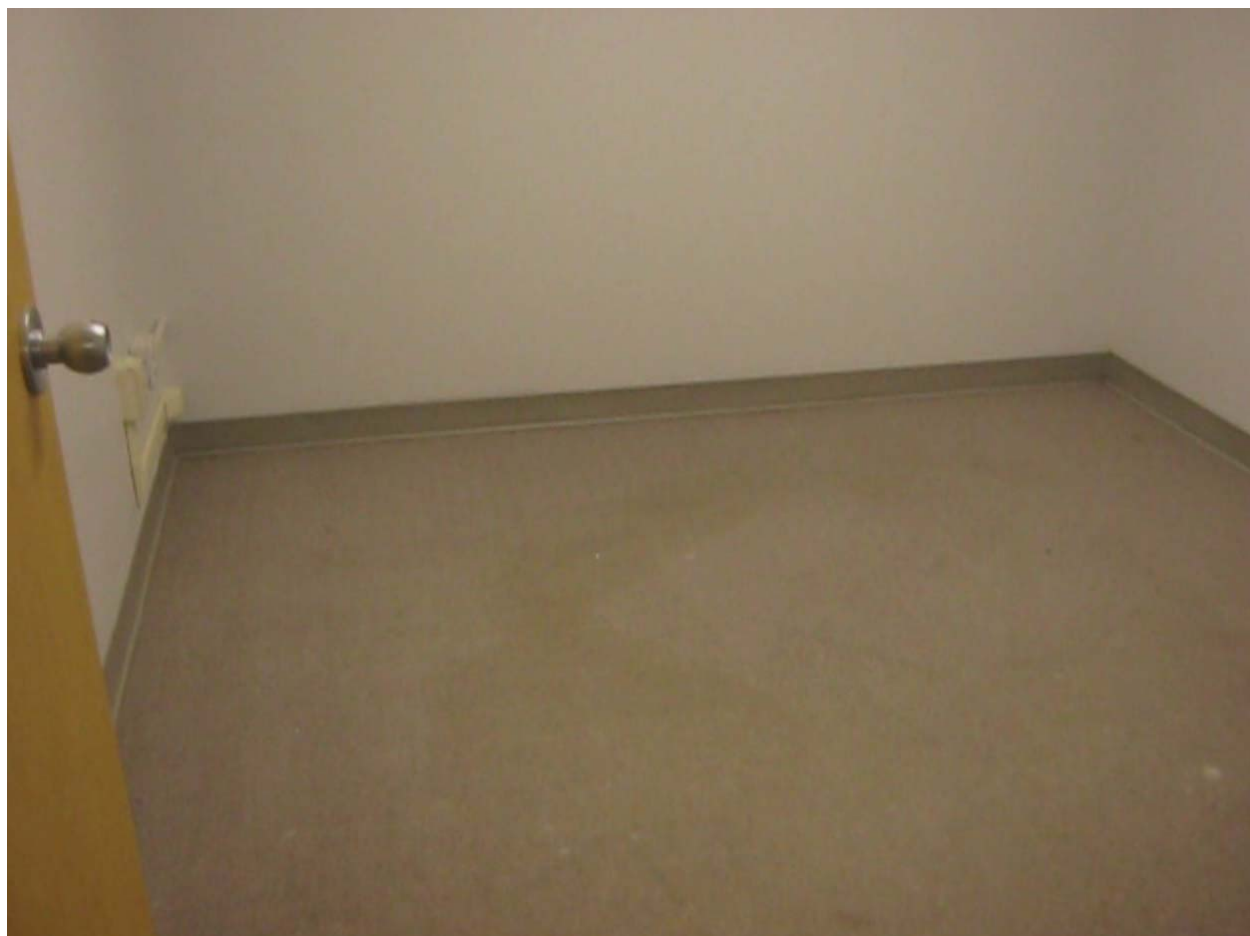
**Photo 20: Suspect mould on carpet.**
