Public Works and Government Services Canada

Pacific Agri-Food Research Centre

Hazardous Building Materials Abatement

Project no. R.057604.001
October 2013

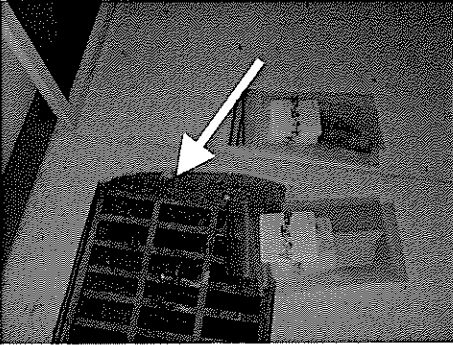
Identified ACM Description and Condition Information	Photo
<p>Sheet flooring, beige and cream pebble pattern – present within the upper main floor dining room and presumed to be present throughout upper main floor as a sub-layer of flooring.</p> <p>Friability Friable Condition Good Access Throughout upper main floor - A</p>

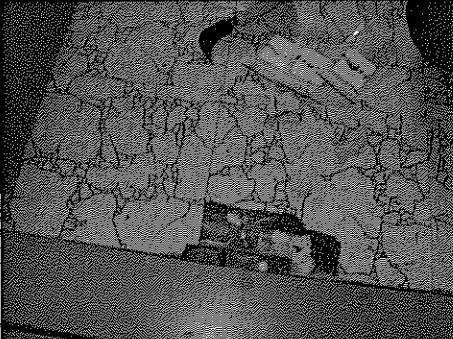
<p>Floor tile (12"x12" size) – present within second floor bedroom 4</p> <p>Friability Non-friable Condition Good Access Room 4 – A</p>

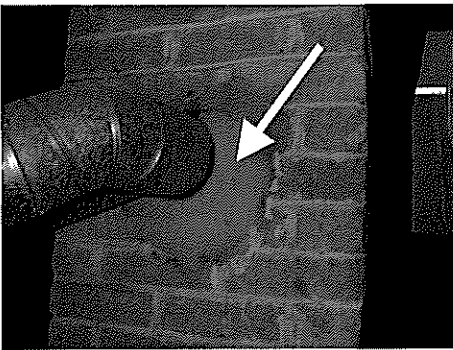
<p>Fire stop – present within the basement where the furnace exhaust leads into the chimney</p> <p>Friability Non-friable Condition Good Access Basement – A</p>

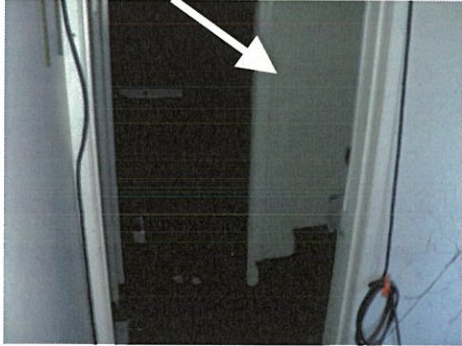
Identified LCP Description	Photo
White colour paint on interior walls. This paint was observed to be in good condition (not bubbling, flaking or peeling).

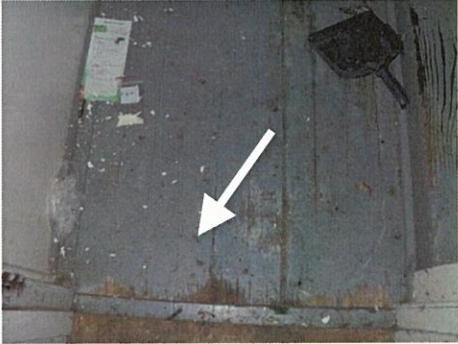
Identified LCP Description	Photo
<p>Grey colour paint on lower floor stairwell floor.</p> <p>With the exception of being worn down from foot traffic, this paint was observed to be in good condition (not bubbling, flaking or peeling).</p>

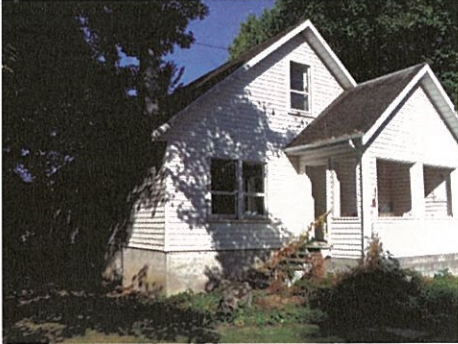
<p>White colour paint on the exterior of the residence.</p> <p>This paint was observed to be in good condition (not bubbling, flaking or peeling).</p>

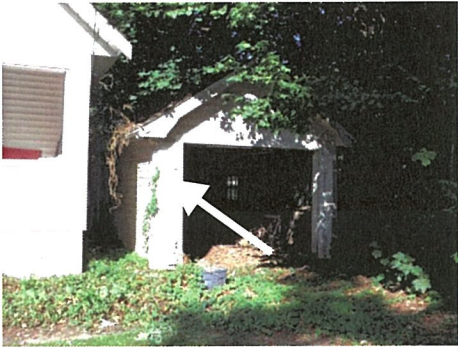
Identified LCP Description	Photo
<p>White paint on the exterior. This paint was observed to be in good condition (minimal flaking or peeling).</p>

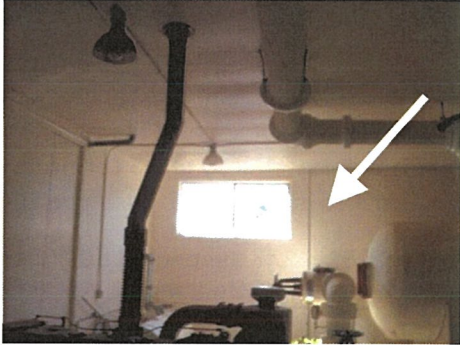
Identified ACM Description and Condition Information	Photo
<p>Drywall joint compound – present in the water tank room</p> <p>Friability Non-Friable</p> <p>Condition Good (minimal damage)</p> <p>Access A</p>

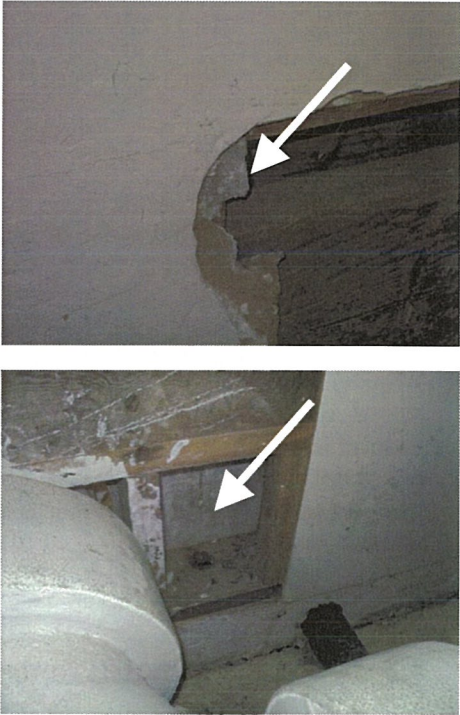
<p>Cement panel – present within walls in the water tank room (and presumed present within ceiling)</p> <p>Friability Non-friable</p> <p>Condition Good (minimal damage)</p> <p>Access A</p>

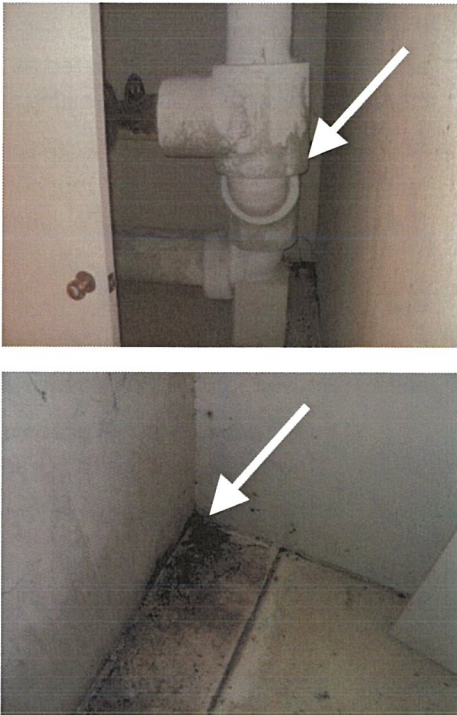
Identified ACM Description and Condition Information	Photo
<p>Suspect mould was observed on mechanical pipe lagging and various surfaces throughout.</p>

Stantec recommends that when demolition within the building proceeds, it is expected that mould and/or moisture-impacted building materials will be removed and disposed of during that process. Due to the suspected presence of mold on building materials, and if those impacted materials are to be removed by hand, demolition workers should be notified of the presence of mold-impacted building materials and be provided with respiratory protection and/or other personal protective equipment (PPE) as deemed necessary for the work that they will be conducting.

Where mould is present on drywall materials, precautions, procedures and personal protective equipment associated with asbestos will be sufficient in protecting workers from exposure to mould.

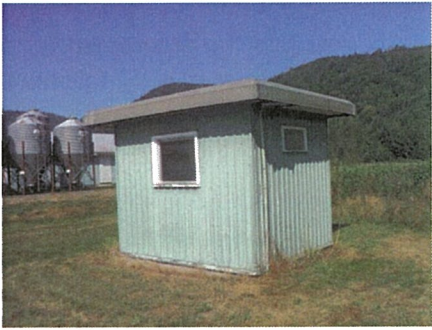
Identified LCP Description	Photo
<p>Green paint on the building's exterior. This paint was observed to be in good condition (minimal bubbling, flaking or peeling).</p>

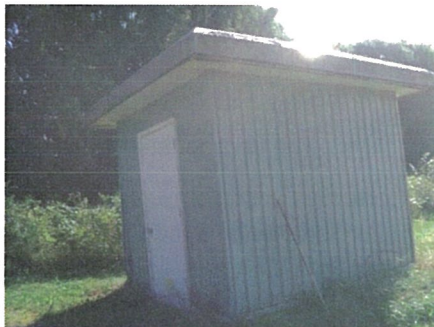
Identified LCP Description	Photo
<p>Green paint on the building's exterior (presumed lead-containing based on Building 53A Well 1 paint sample results – same construction time and materials used).</p> <p>This paint was observed to be in good condition (minimal bubbling, flaking or peeling).</p>

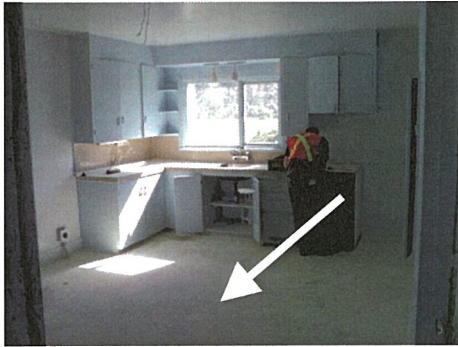
Identified ACM Description and Condition Information	Photo
<p>Beige pebble pattern sheet flooring – present in the kitchen as a sub-layer.</p> <p>Friability Friable</p> <p>Condition Good</p> <p>Access C (concealed beneath top layer of sheet flooring)</p>

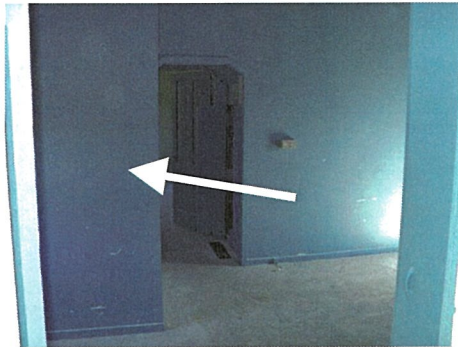
<p>Drywall joint compound throughout.</p> <p>Friability Non-Friable (Although, drywall joint-fill compound is considered to be non-friable in its undisturbed state, this material can become friable when damaged or during removal)</p> <p>Condition Good</p> <p>Access A</p>

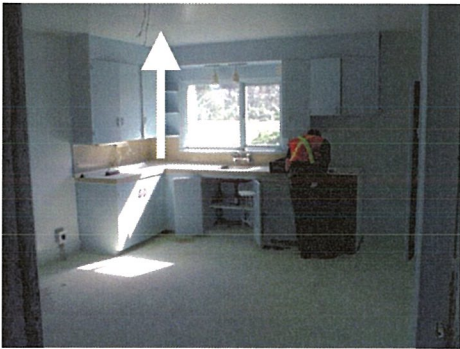
Identified LCP Description	Photo
<p>White paint on walls and ceilings in various locations throughout.</p> <p>This paint was observed to be in good condition (minimal bubbling, flaking or peeling).</p>

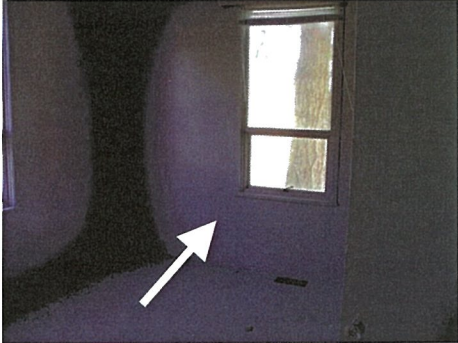
Identified LCP Description	Photo
<p>Pink paint on walls of room 4 (main floor southeast). This paint was observed to be in good condition (minimal bubbling, flaking or peeling).</p>

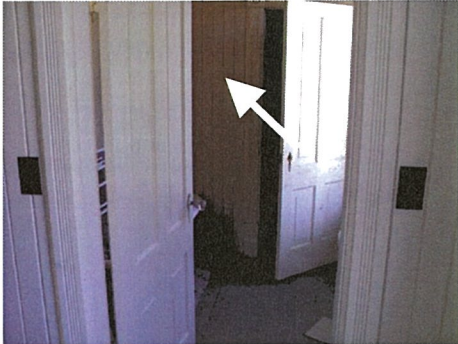
<p>Yellow paint on 2nd floor washroom walls. This paint was observed to be in good condition (minimal bubbling, flaking or peeling).</p>

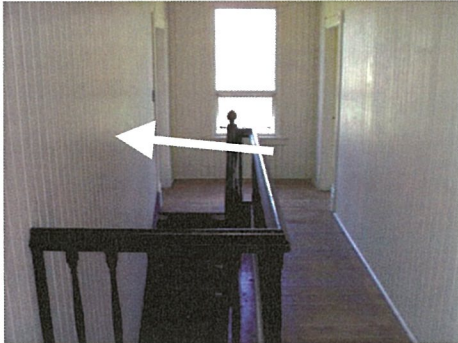
<p>White paint on 2nd floor hallway walls. This paint was observed to be in good condition (minimal bubbling, flaking or peeling).</p>

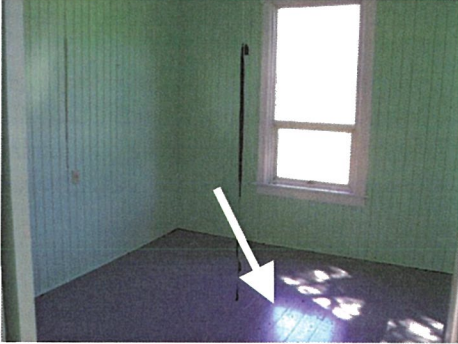
Identified LCP Description	Photo
<p>Grey paint on floors of room 7 (second floor southwest). This paint was observed to be in good condition (minimal bubbling, flaking or peeling).</p>

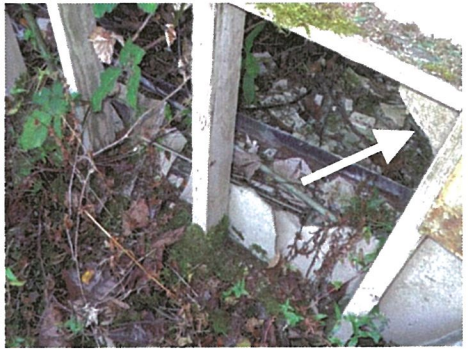
Identified ACM Description and Condition Information		Photo
Cement paneling

Friability	Non-friable	
Condition	Poor	
Access	B (Abandoned)

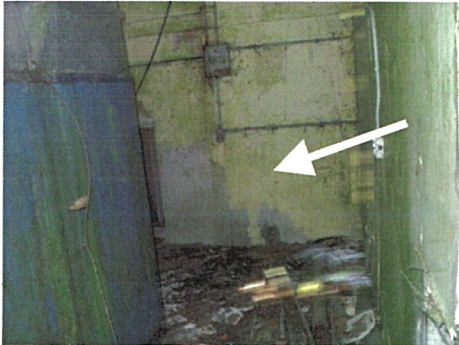
Identified LCP Description	Photo
White (green and orange layers) paint on remnant wall area. This paint was observed to be in poor condition (flaking or peeling).

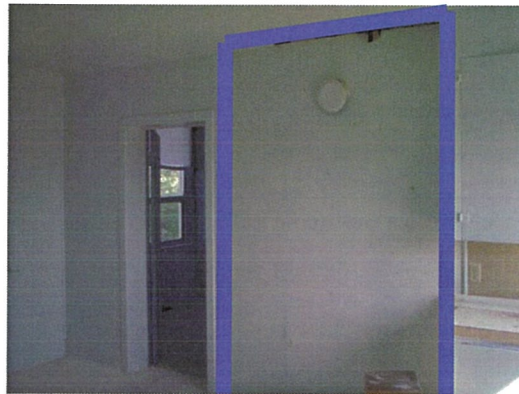
The asbestos-containing cement board material was present on the east wall in the kitchen, and comprised a total of 50 square feet of material (photo below - highlighted area showing ACM cement board on east wall).
