**Geotechnical Investigation
Proposed Multipurpose Building
Project No. R.043939.001**

Dorchester, New Brunswick
April 22, 2013

Prepared for: Public Works and Government Services
Project No. 6489.19 – R01

**Re: Geotechnical Investigation, Proposed Multipurpose Building
Westmorland Institute, Dorchester, New Brunswick**

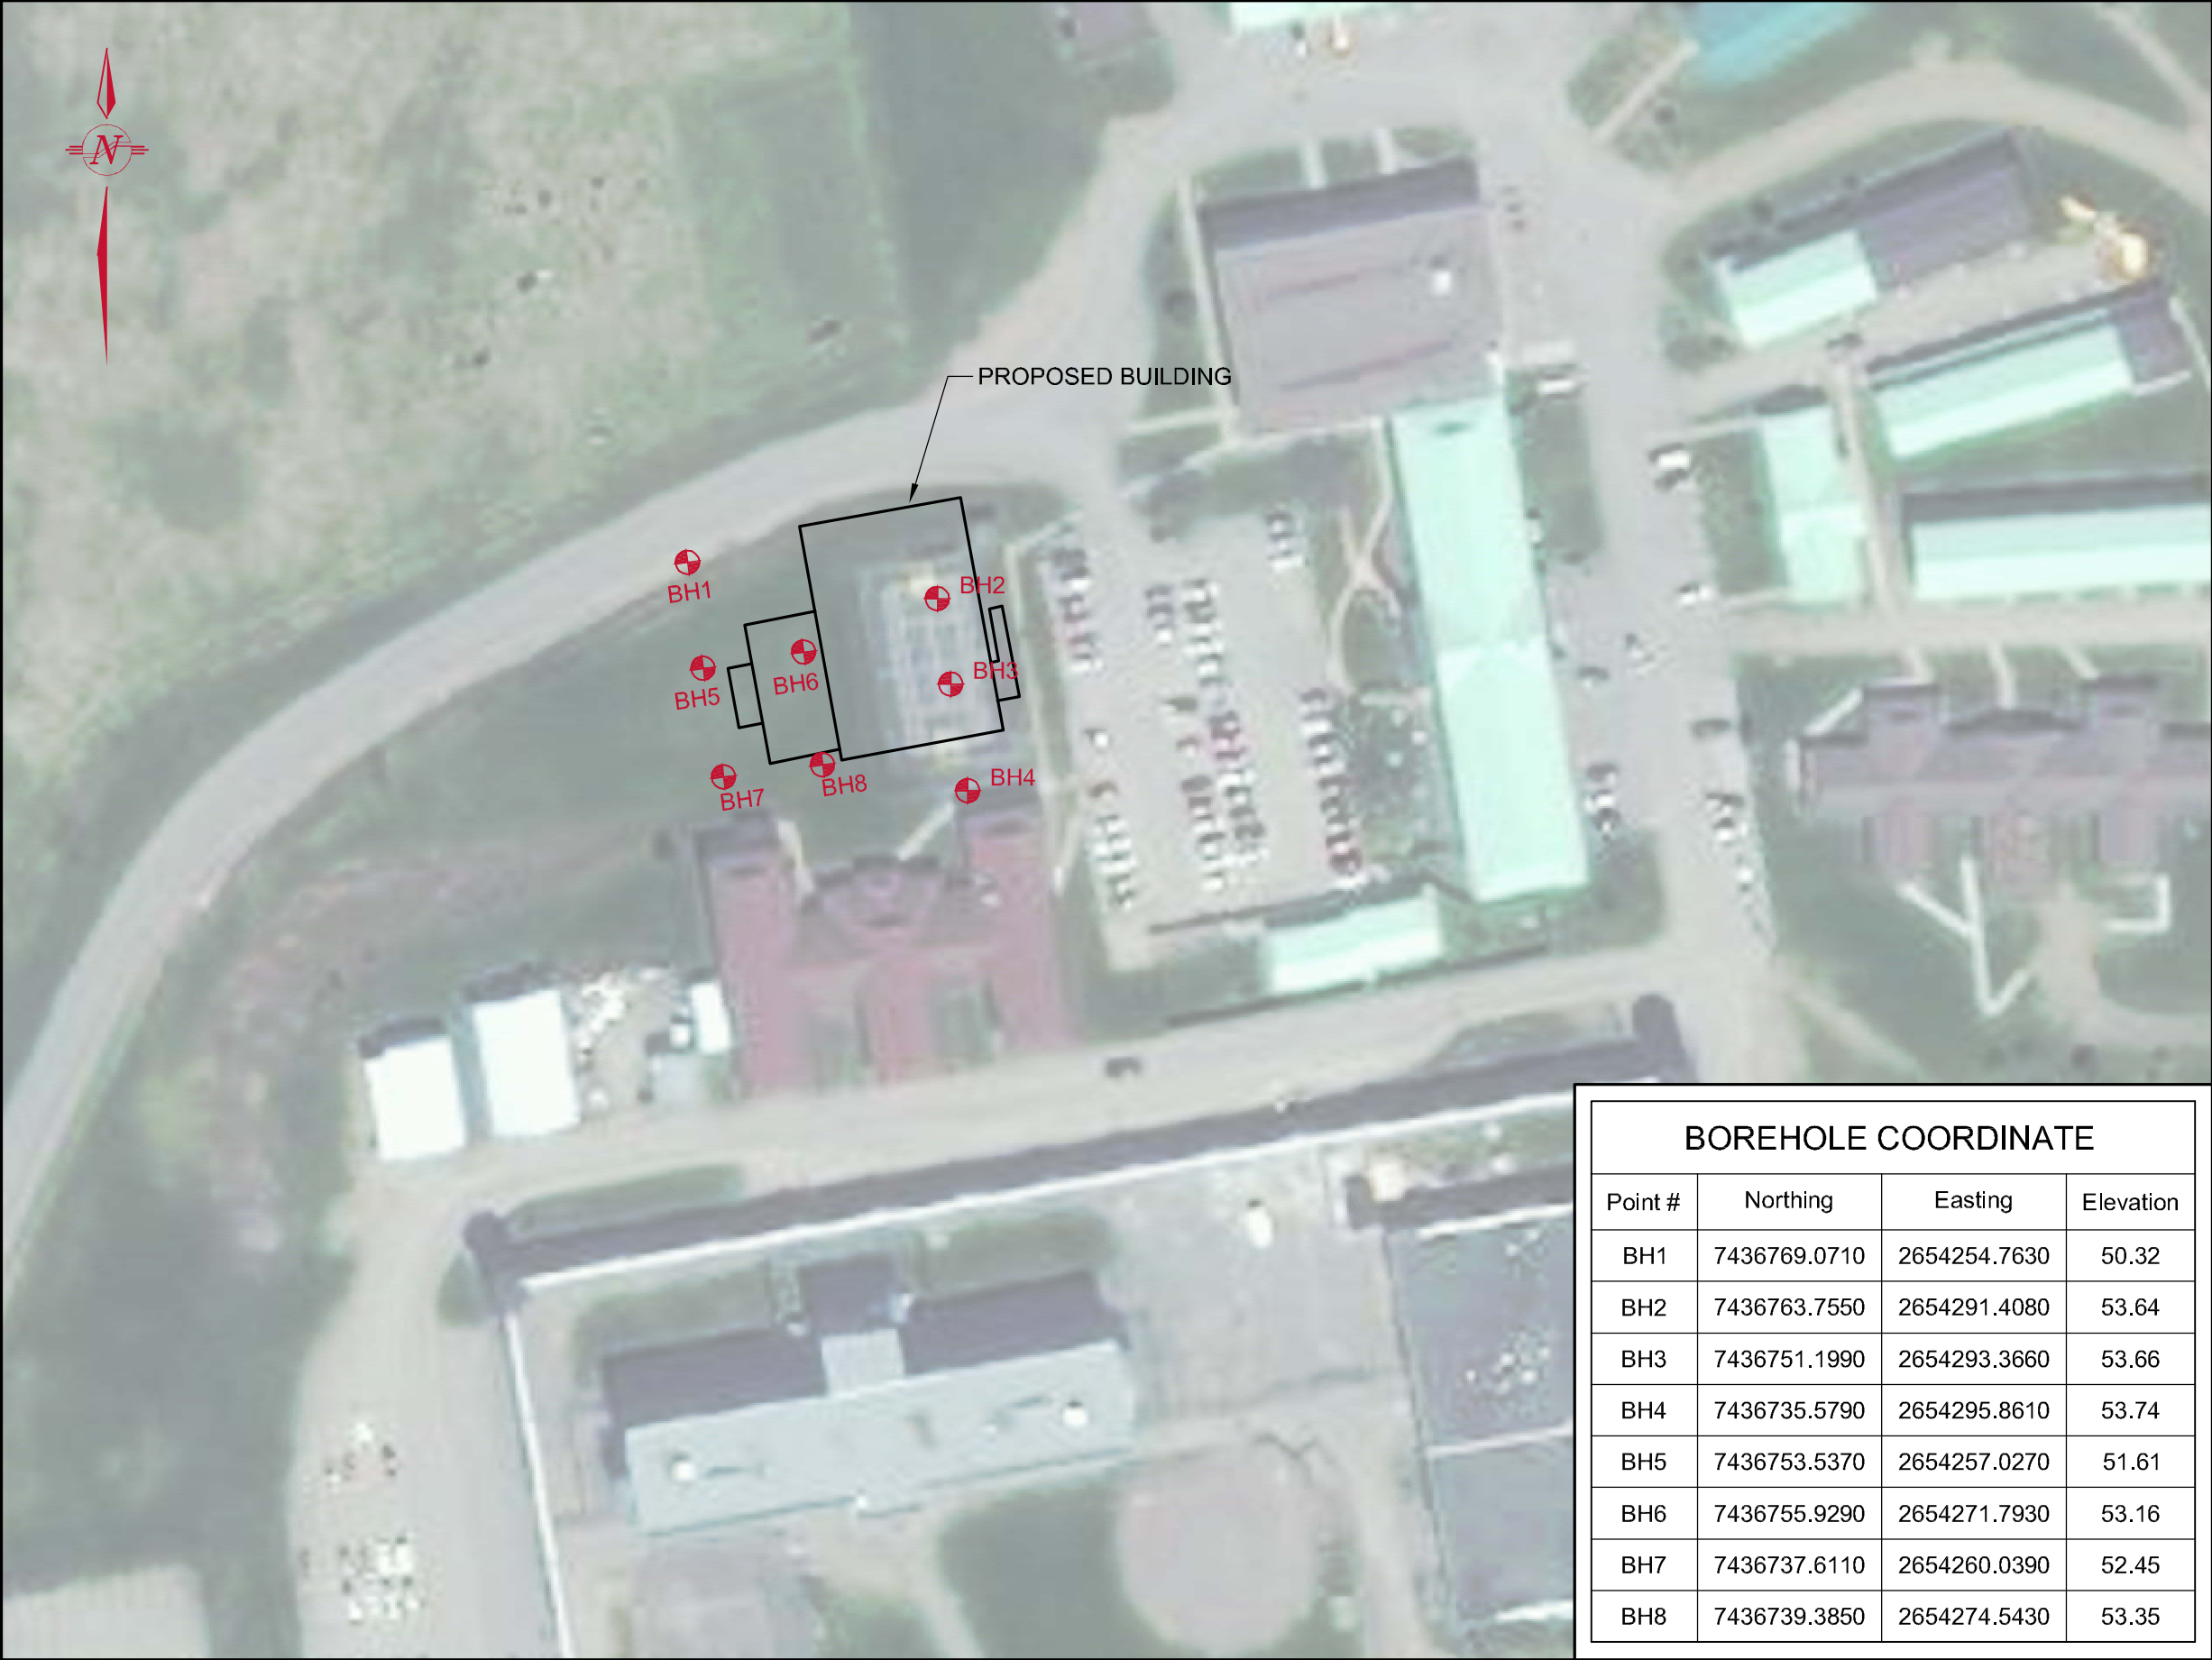
FIGURE 1

GEMTEC Limited located the borehole locations in the field referencing a borehole plan provided by PWGSC. Borehole elevations were surveyed by GEMTEC referencing NBMON 3705, with a published elevation of 29.142 metres. A site plan with borehole locations is presented in Figure 1.
