XCG File No.: 1-336-163-01

March 31, 2010

**DESIGNATED SUBSTANCES AND HAZARDOUS MATERIALS SURVEY
BUILDINGS WW05, WW06, WW08, WW09, WW10, WW11
WARKWORTH INSTITUTION
CAMPBELLFORD, ONTARIO
PWGSC PROJECT #: R.033222.001**

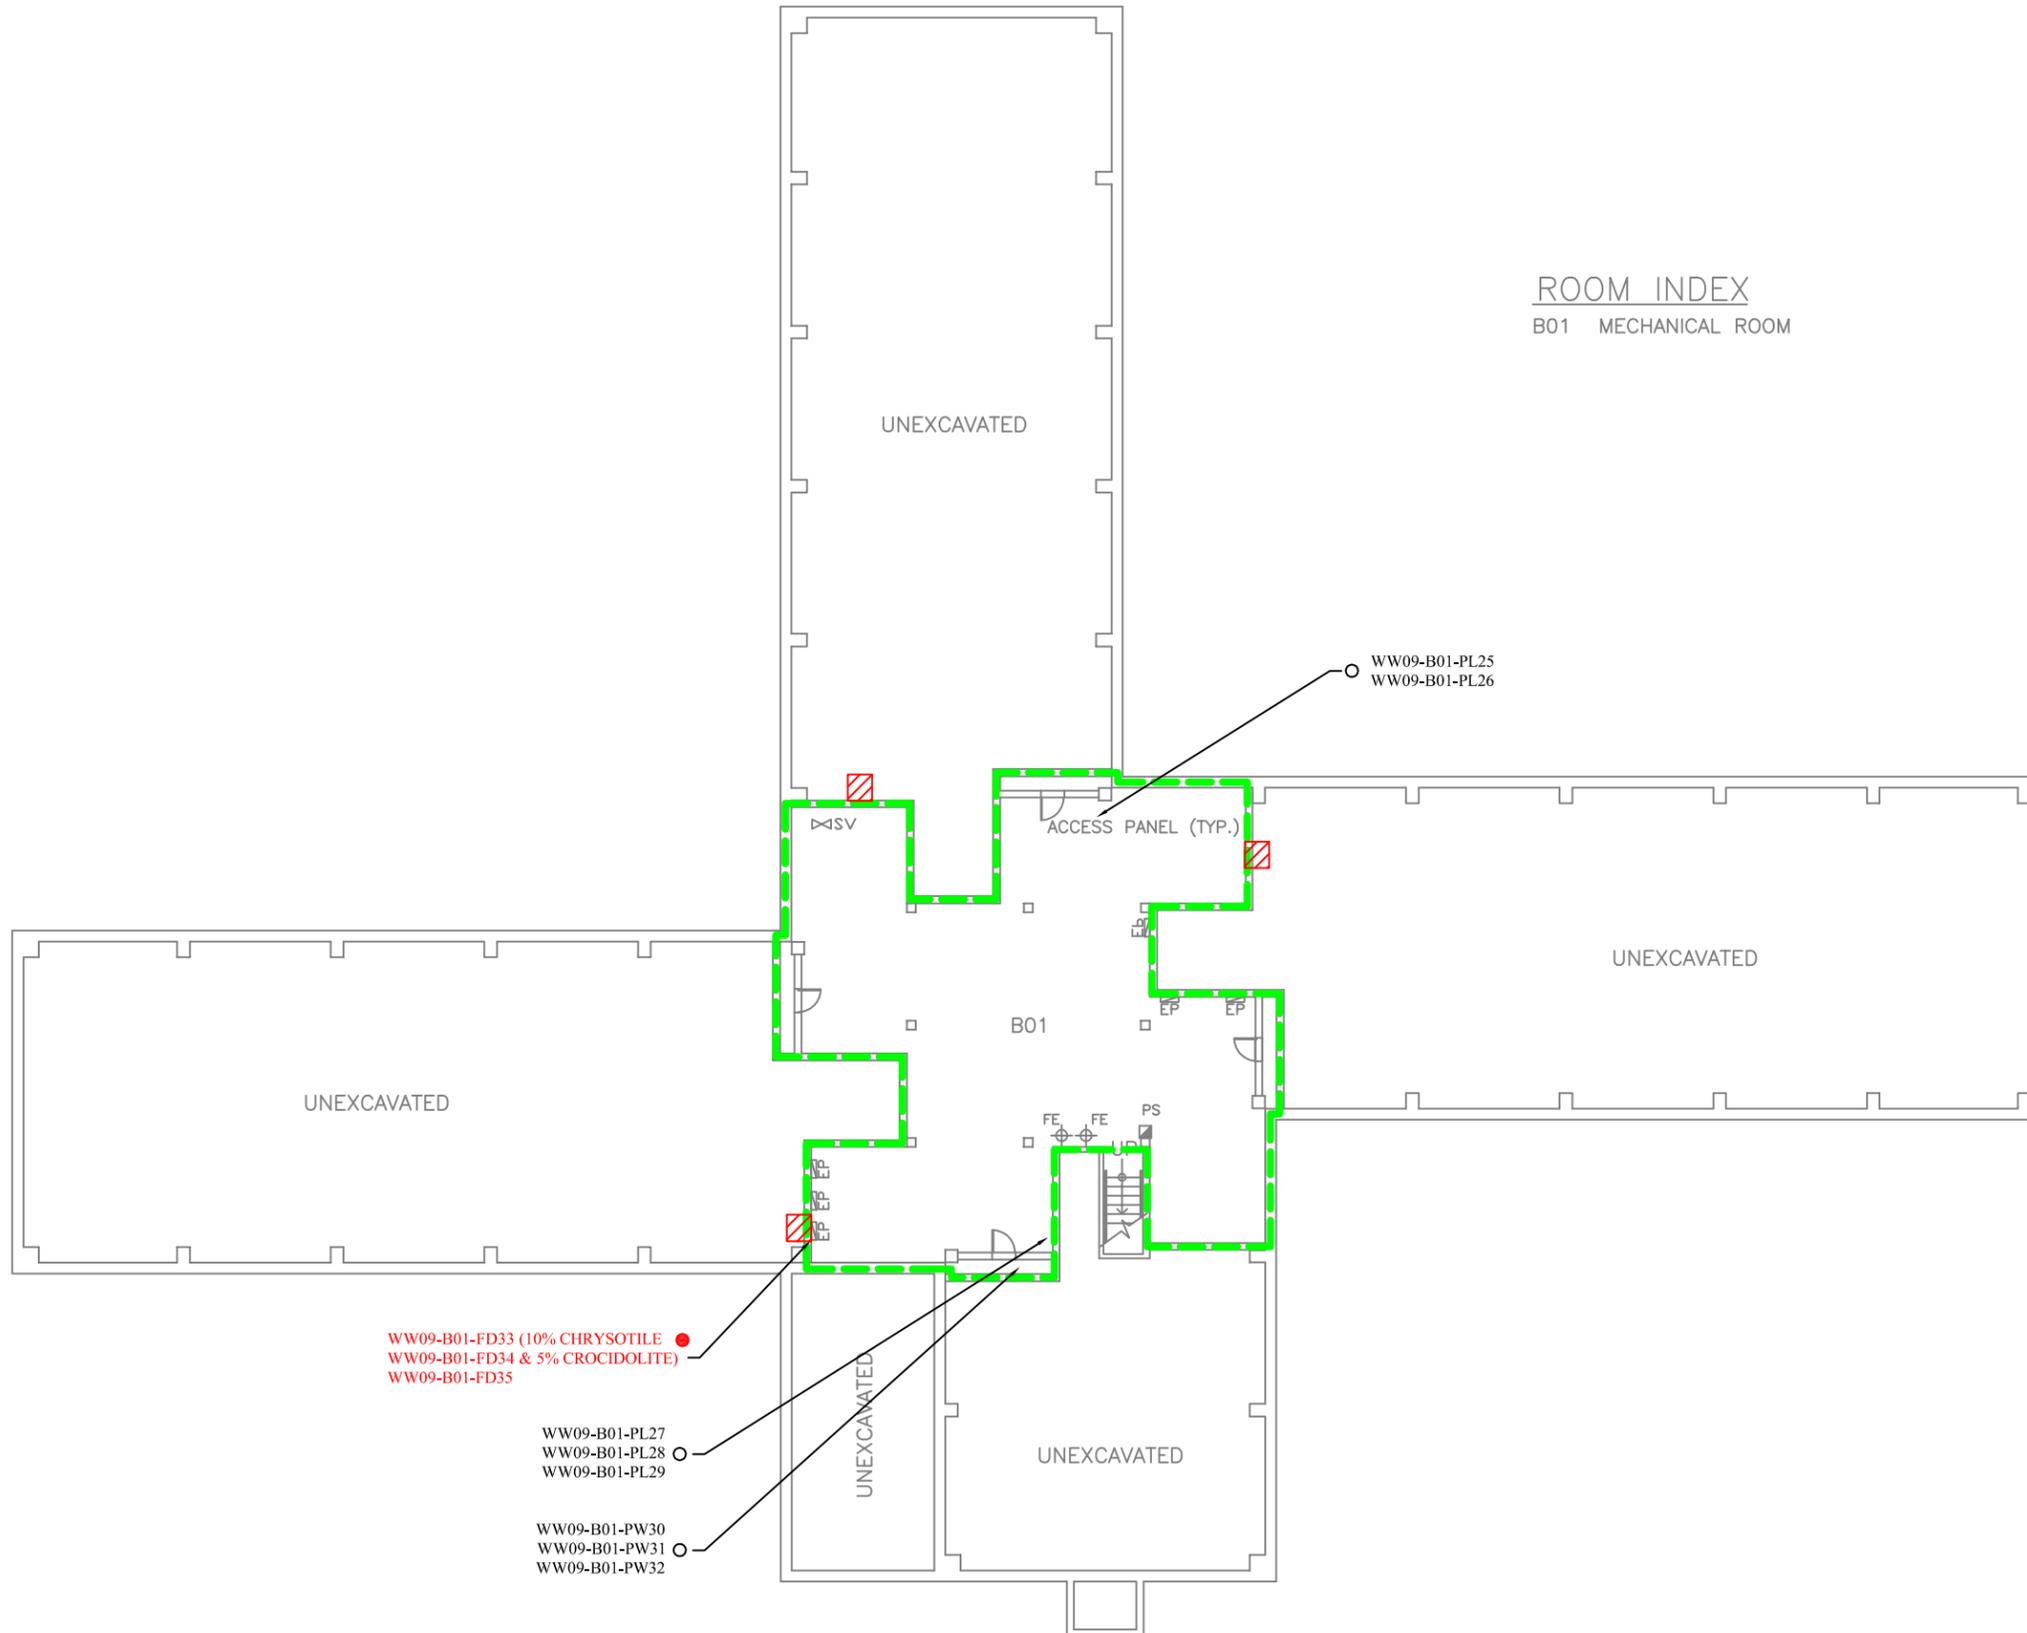
DATE: 31 MAR 10	DRAWN: GGM	FIGURE: 7
PROJECT No: 1-336-163-01

WW09-B01-FD33 (10% CHRYSOTILE)
WW09-B01-FD34 & 5% CROCIDOLITE)
WW09-B01-FD35

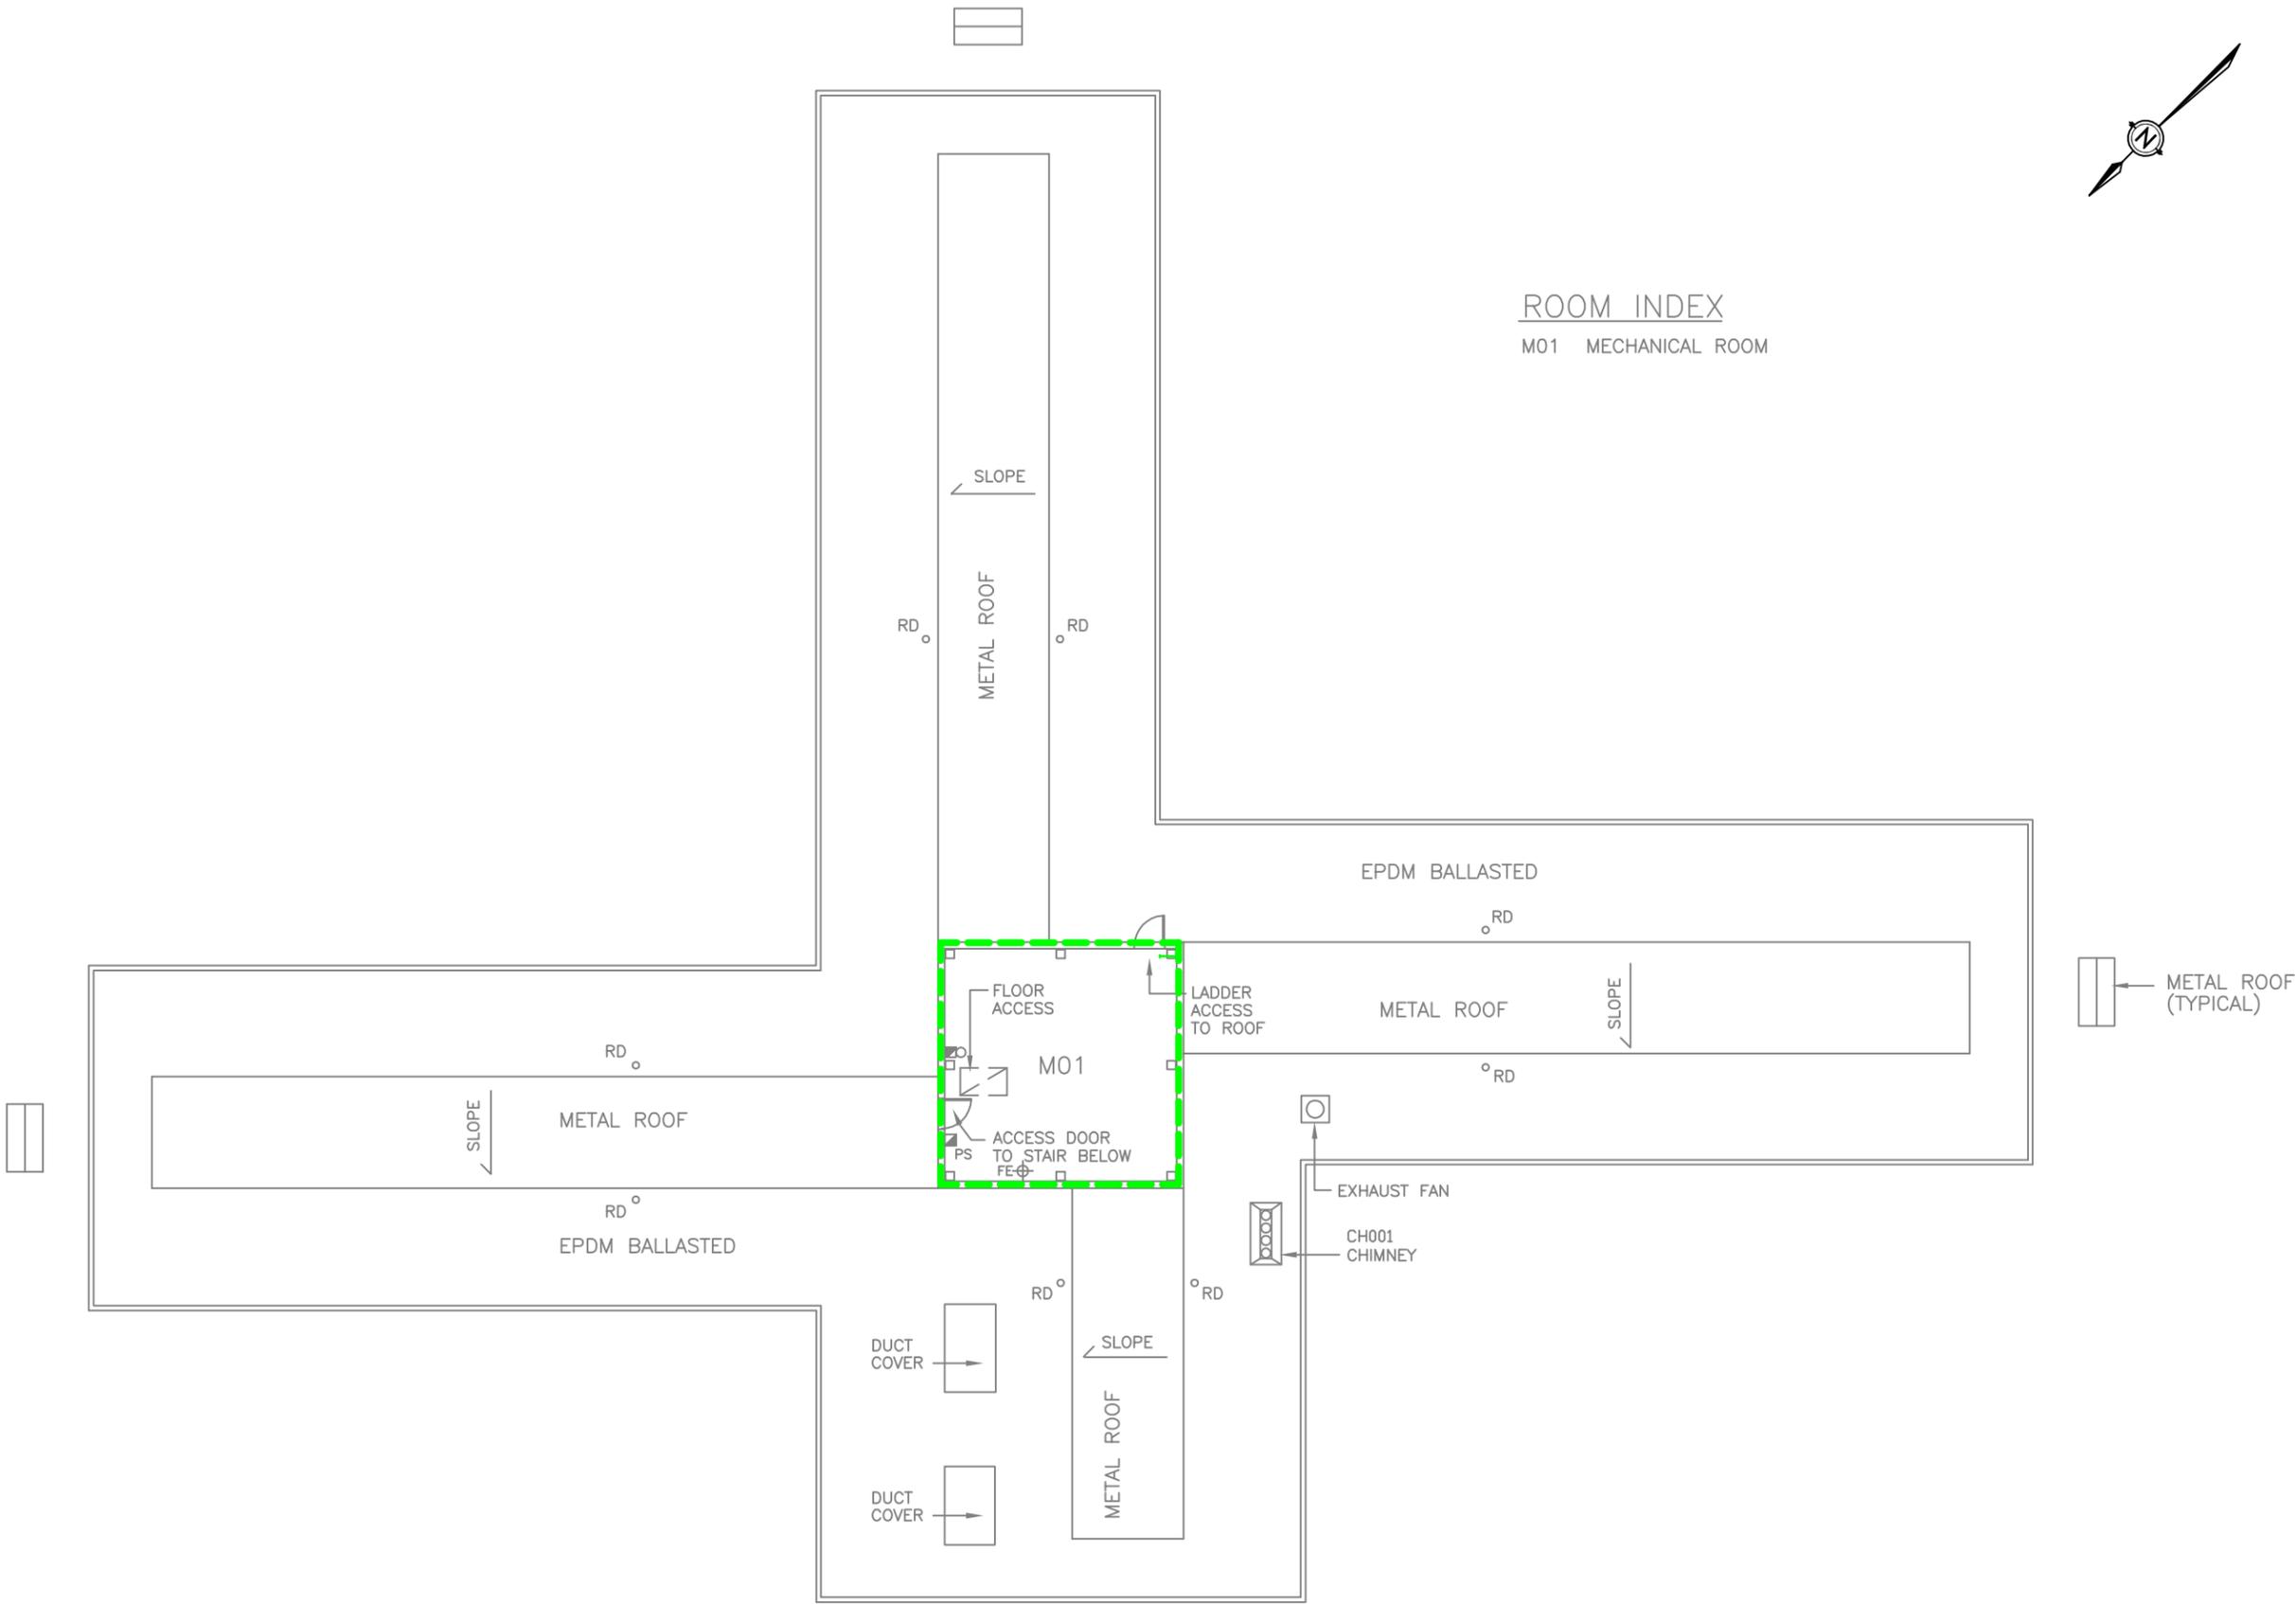
ROOF PLAN & MECHANICAL ROOM PLAN - WW10

● WW10-102-PE1 (50-75% CHRYSOTILE)
(LOCATED ON FIRST FLOOR IN THIS LOCATION)

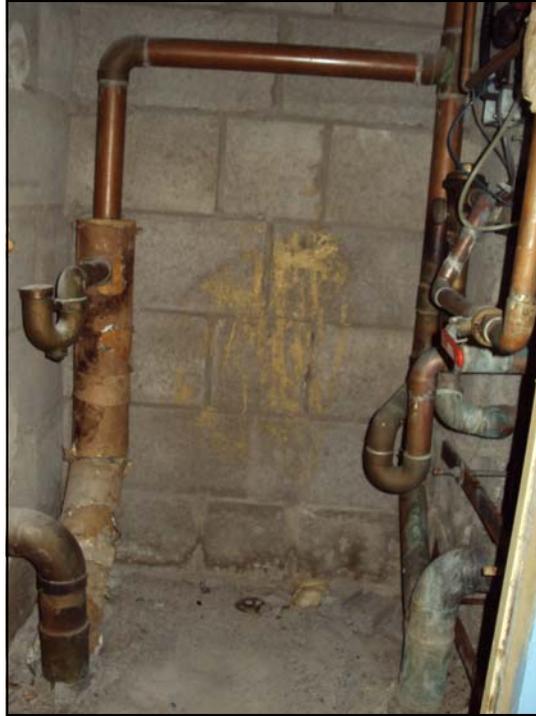
Photo 1: Typical vertical pipe chase with fiberglass pipe insulation.

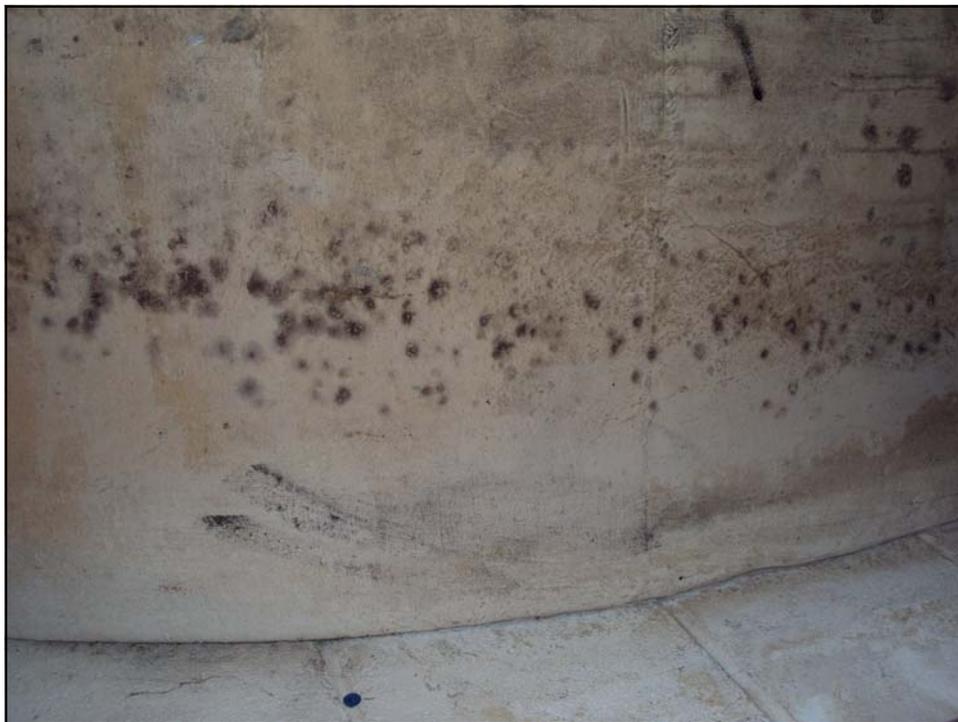
Photo 2: Building WW06 Room 114 mould on HVAC jacketing.

Renovation activities should be consistent with the requirements of the Occupational Health and Safety Act of Ontario and the guidelines issued by the Ontario Ministry of Labour for workers who may be exposed to mould issued in a “*Hazard Alert*” fact sheet in December 2000 entitled, “*Mould in Workplace Buildings*.” Standard Construction Document CCA 82 2004, “*Mould Guidelines for the Canadian Construction Industry*” as well as Environmental Abatement Council of Ontario (EACO) 2004 publication “*Mould Abatement Guidelines*”, should also be reviewed and the best management practices followed with respect to mould abatement.

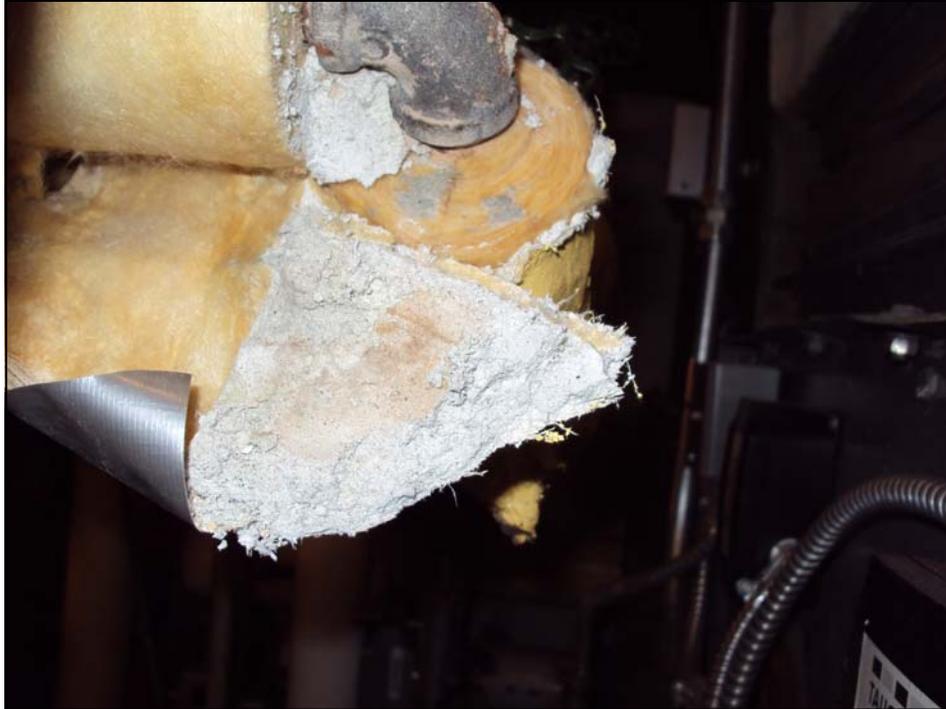
It should be noted that no immediate safety hazards were identified with respect to the materials identified, with the exception of one (1) plaster elbow in room 114 of building WW06 that was observed to be damaged. All asbestos abatement should be conducted by contractors licensed and insured for this type of abatement work. Disposal of the ACM waste should be conducted by a licensed contractor at a facility that accepts such waste.

Photo 3: Building WW06 Room 114 Damaged asbestos-containing insulation.

Based on the confirmation of asbestos in the plaster pipe elbows and fire damper gaskets in the buried spiral ductwork, XCG recommends that all hard plaster elbows present in the surveyed buildings be considered asbestos-containing. If these materials are to be disturbed as part of the renovation activities, they should be removed under Type 2 or Type 3 conditions as outlined in O. Reg. 278/05 (amended to 493/09) depending on the quantity of elbows and/or fire damper gaskets.

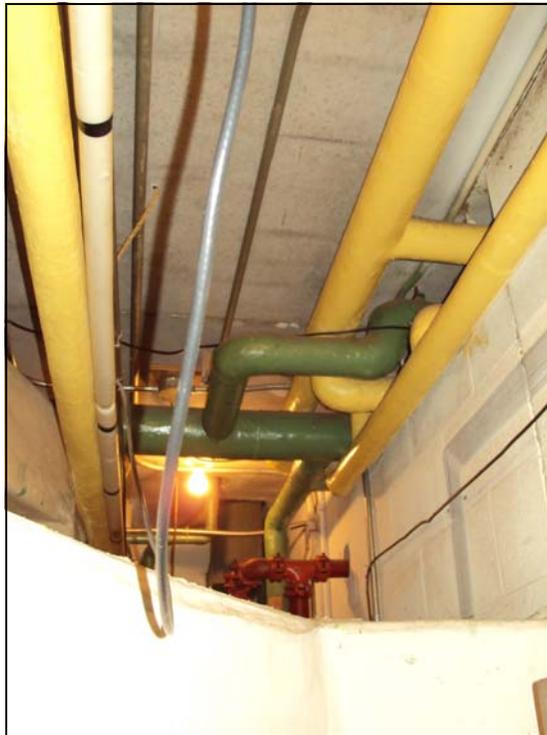
Photo 4: Example of fiberglass piping insulation and asbestos containing pipe elbow insulation in 'good condition' typical of the area above the ranges and in the mechanical rooms.

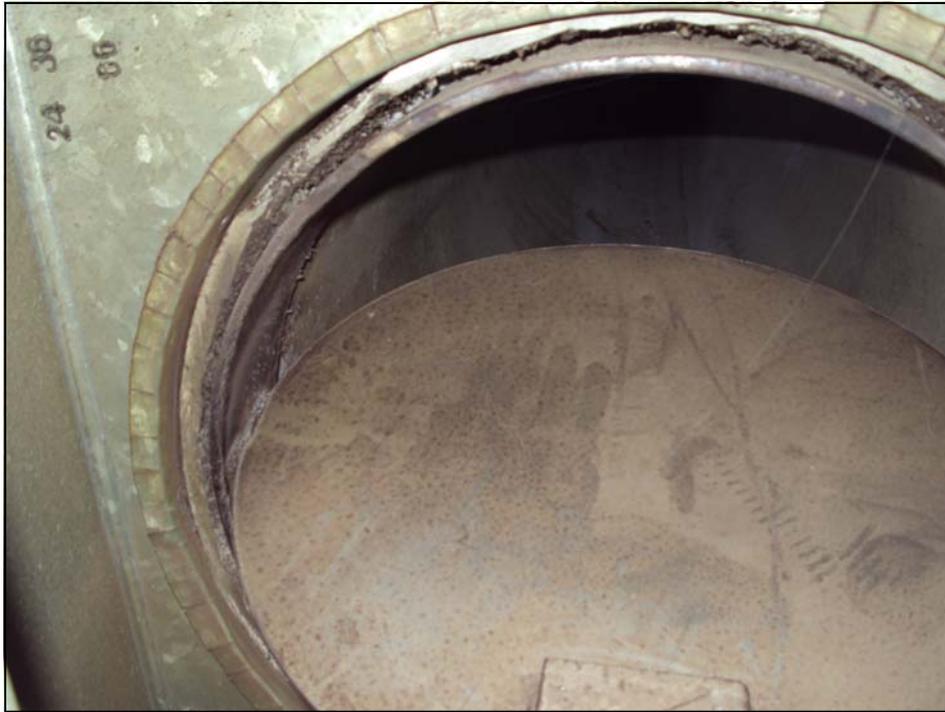
The following confirmed and suspected asbestos-containing materials were identified during the DSHM survey: pipe elbow insulation, 9" x 9" grey floor tiles, and fire damper gasket inside buried spiral ductwork. All of the asbestos-containing materials that were identified as part of the DSHM Survey should be managed in accordance with Ontario Regulations 837 (amended to O. Reg. 490/09) and O. Reg. 493/09. Based on the analytical and visual observations made during the survey, all plaster pipe elbows, and fire damper gaskets in the buried spiral ductwork should be assumed to be asbestos containing.

Photo 5: Asbestos-containing fire damper gasket (buildings WW08, WW09, WW10, WW11)

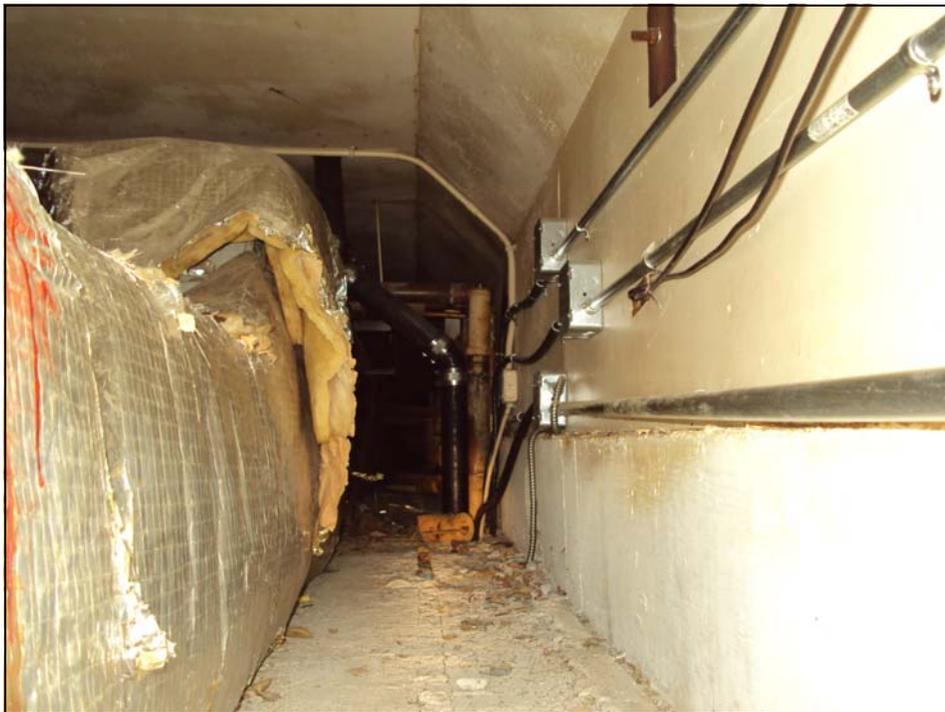
Photo 6: Typical attic space above ranges (buildings WW08, WW09, WW10, WW11)
