Re: Lead-Containing Coatings at Burlington Lift Bridge, Burlington, Ontario

XCG Consultants Ltd. (XCG) is pleased to submit this letter report describing the results of sampling potentially lead-containing coatings at the Burlington Lift Bridge, Burlington, Ontario.

***ATTACHMENT A
SITE PHOTOGRAPHS***

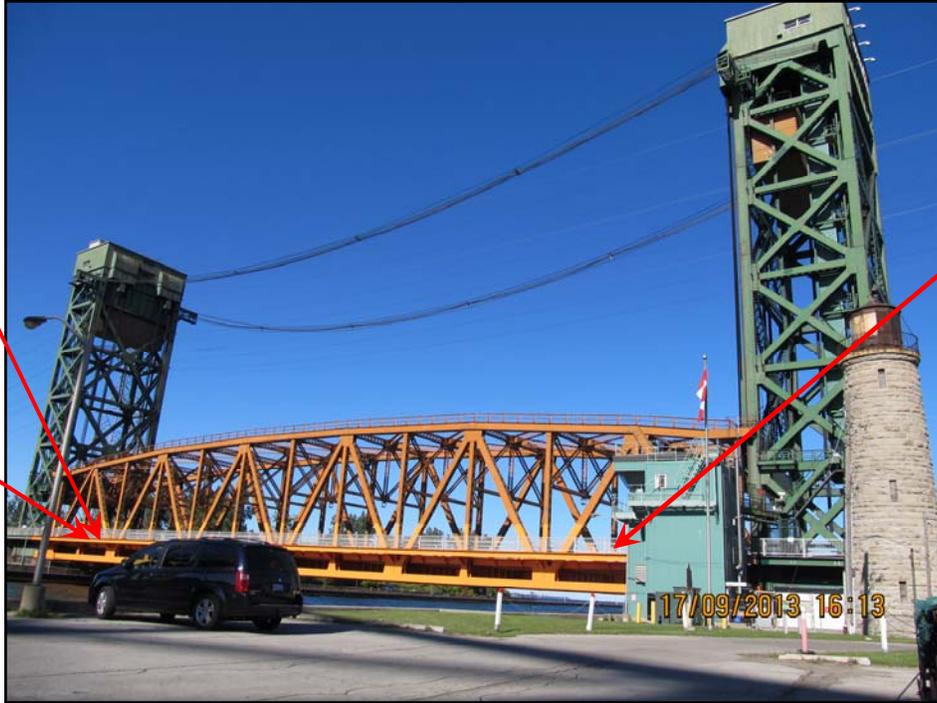
The analytical results for the samples collected from the proposed work area are summarized in Table 1. Approximate sampling locations are shown on Photo 1 in Appendix A. Laboratory certificates of analysis for the samples collected have been included in Appendix B.

Samples:
Bridge North
and
Bridge North

Sample:
Bridge South

Proposed work
area.

Photo 1: View of the Burlington Lift Bridge, looking east.

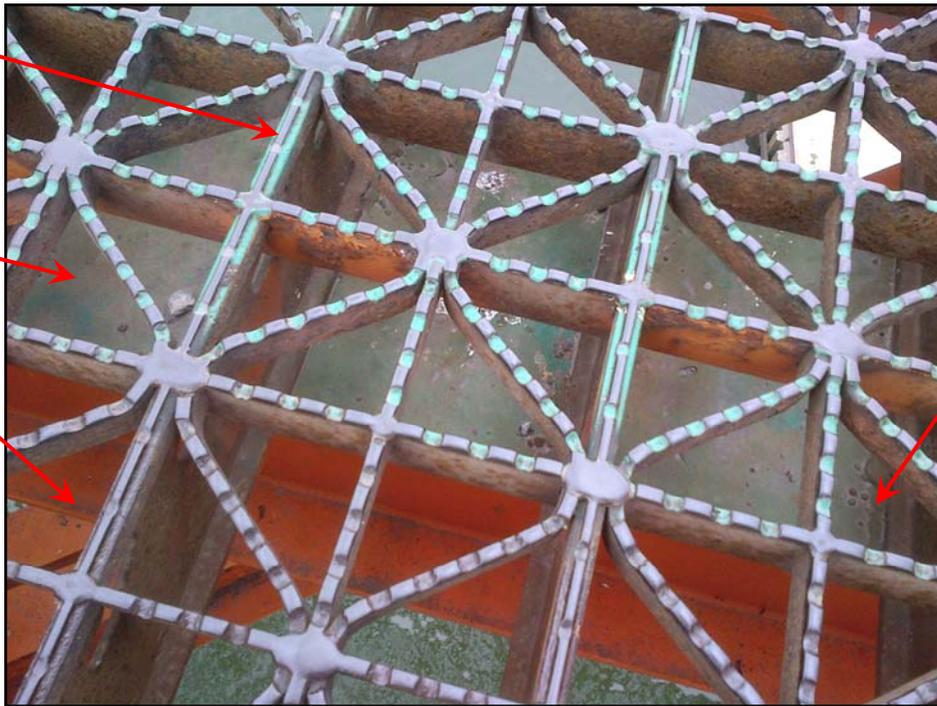
It was determined that the deck grating is welded onto the sub-deck beams. The grating, last replaced in 2000, is not painted with the exception of the white and yellow lane markings. No reports relating to the deck replacement in 2000 were available for review. The underside of the beams was recoated in 2010-2011 as part of the bridge repainting project that took two winters to complete. The underside of the bridge was pressure washed to remove existing lead-containing paint and was repainted orange. Through recent inspections the tops of the beams were identified to be painted green. Certain areas were noted to be rusting and painted rust flakes were observed in several locations on the tops of the sub-deck beams. The grating replacement project is expected to involve removal of some of the top of beam coating to prepare the beam surfaces for welding.

Grating (not
painted)

Top of Beam
(painted &
sampled)

Underside of
Beam
(repainted in
2010/2011)

Welds

Photo 2: Close up view of the grating and supporting beam.

XCG recommends that all painted surfaces be treated as lead-containing and that any demolition/renovation activities that would involve the disturbance of this paint be conducted in accordance with Ontario Regulation (O. Reg.) 490/09 and the Ontario Ministry of Labour Guideline “Lead on Construction Projects,” dated April 2011. Workers are not at risk of being exposed to lead unless they are undertaking an activity that disturbs surfaces covered with lead-based paint.

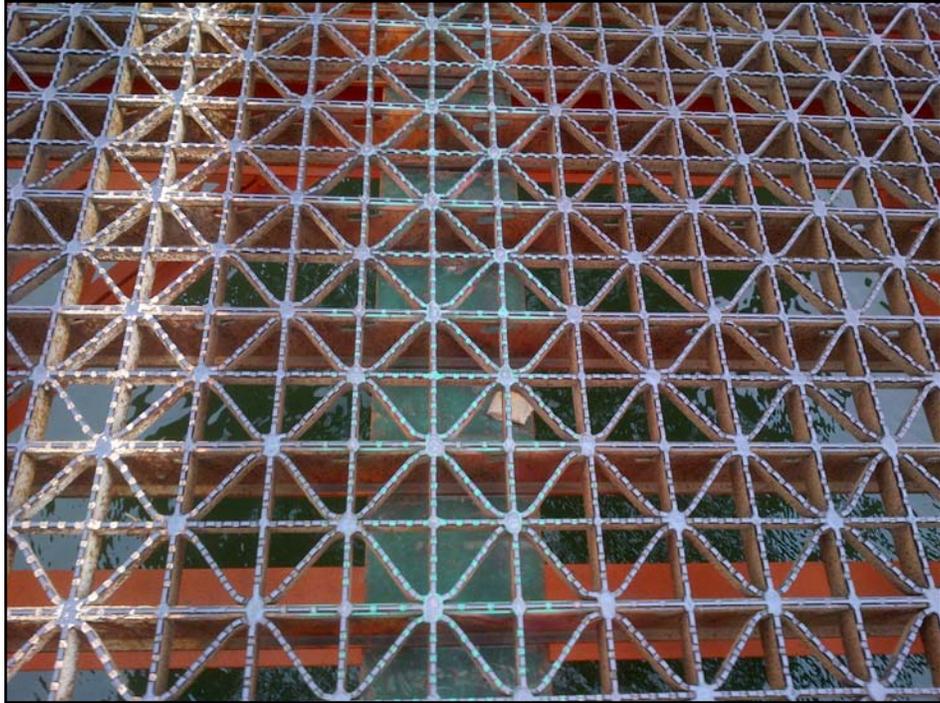
Photo 3: Close up view of the grating and supporting beams.

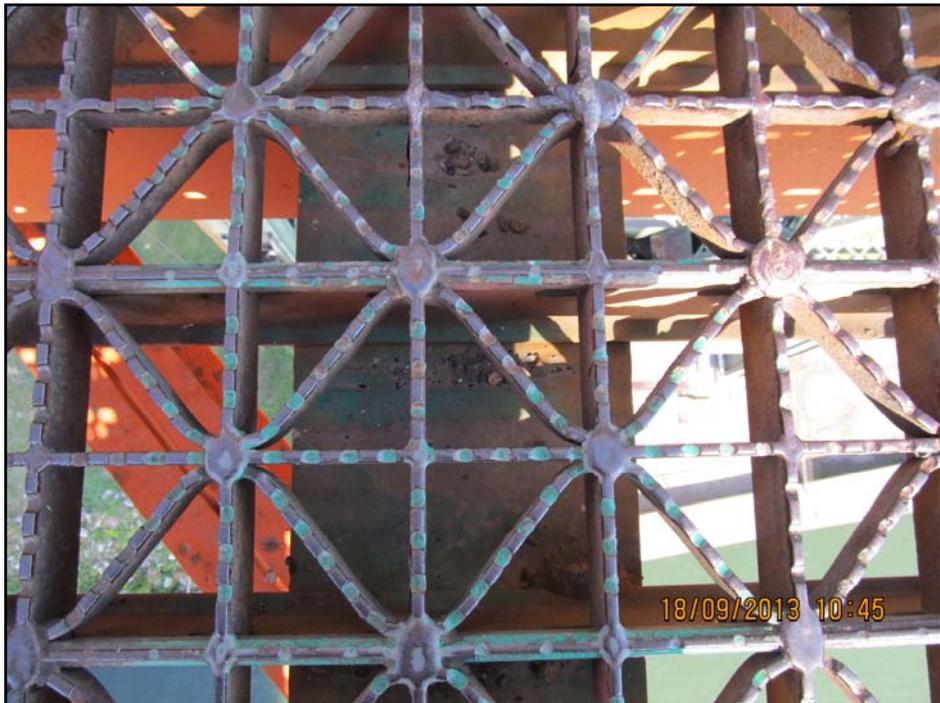
Photo 4: Close up view of the grating and supporting beam. Paint on the top of the beam is partially covered by dirt.
