SECURITY CLASSIFICATION - DE SÉCURITÉ
OUR FILE - N° RÉFÉRENCE
YOUR FILE - V° RÉFÉRENCE
DATE May 1, 1974

INNISFAIL, ALTA - PROPOSED RCMP DOG KENNELS

RECORD OF SUBSURFACE EXPLORATION AND LABORATORY TESTING PROGRAM.

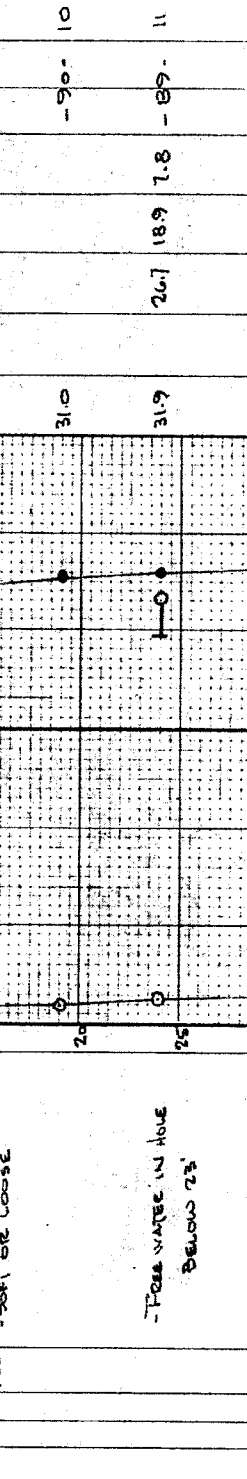
SAMPLE NO	SYMBOLS	SOIL DESCRIPTION	DEPTH FT		N	QU	MOISTURE CONTENT - w %	NATURAL MOISTURE CONTENT	BULK DENSITY	CONSISTENCY LIMITS				MECHANICAL ANALYSIS			RECEIVED STRENGTH	REMOLDED STRENGTH	SENSITIVITY
			START	END						LIQUID LIMIT	PLASTIC LIMIT	PLASTICITY INDEX	CLAY	SILT	SAND	GRAVEL			
		FILL MATERIAL - SILTS, CLAYS, SANDS, ORGANICS - SOFT OR LOOSE	5	10	0	0	27.6												
	ML CL	SILT - SANDY CLAYAY - LOW PLASTIC - SOFT OR LOOSE	10	15	0	0	28.2												
			15	20	0	0	31.0												
			20	25	0	0	31.9			26.7	18.9	7.8							
			25	30	0	0	33.3												
			30	35	0	0													
			35	40	0	0	35.2			25.0	16.0	19.0							
			40	45	0	0

Bottom of hole - 40'
NOTE: - WATER TABLE @ 22' IMMEDIATELY AFTER DRILLING

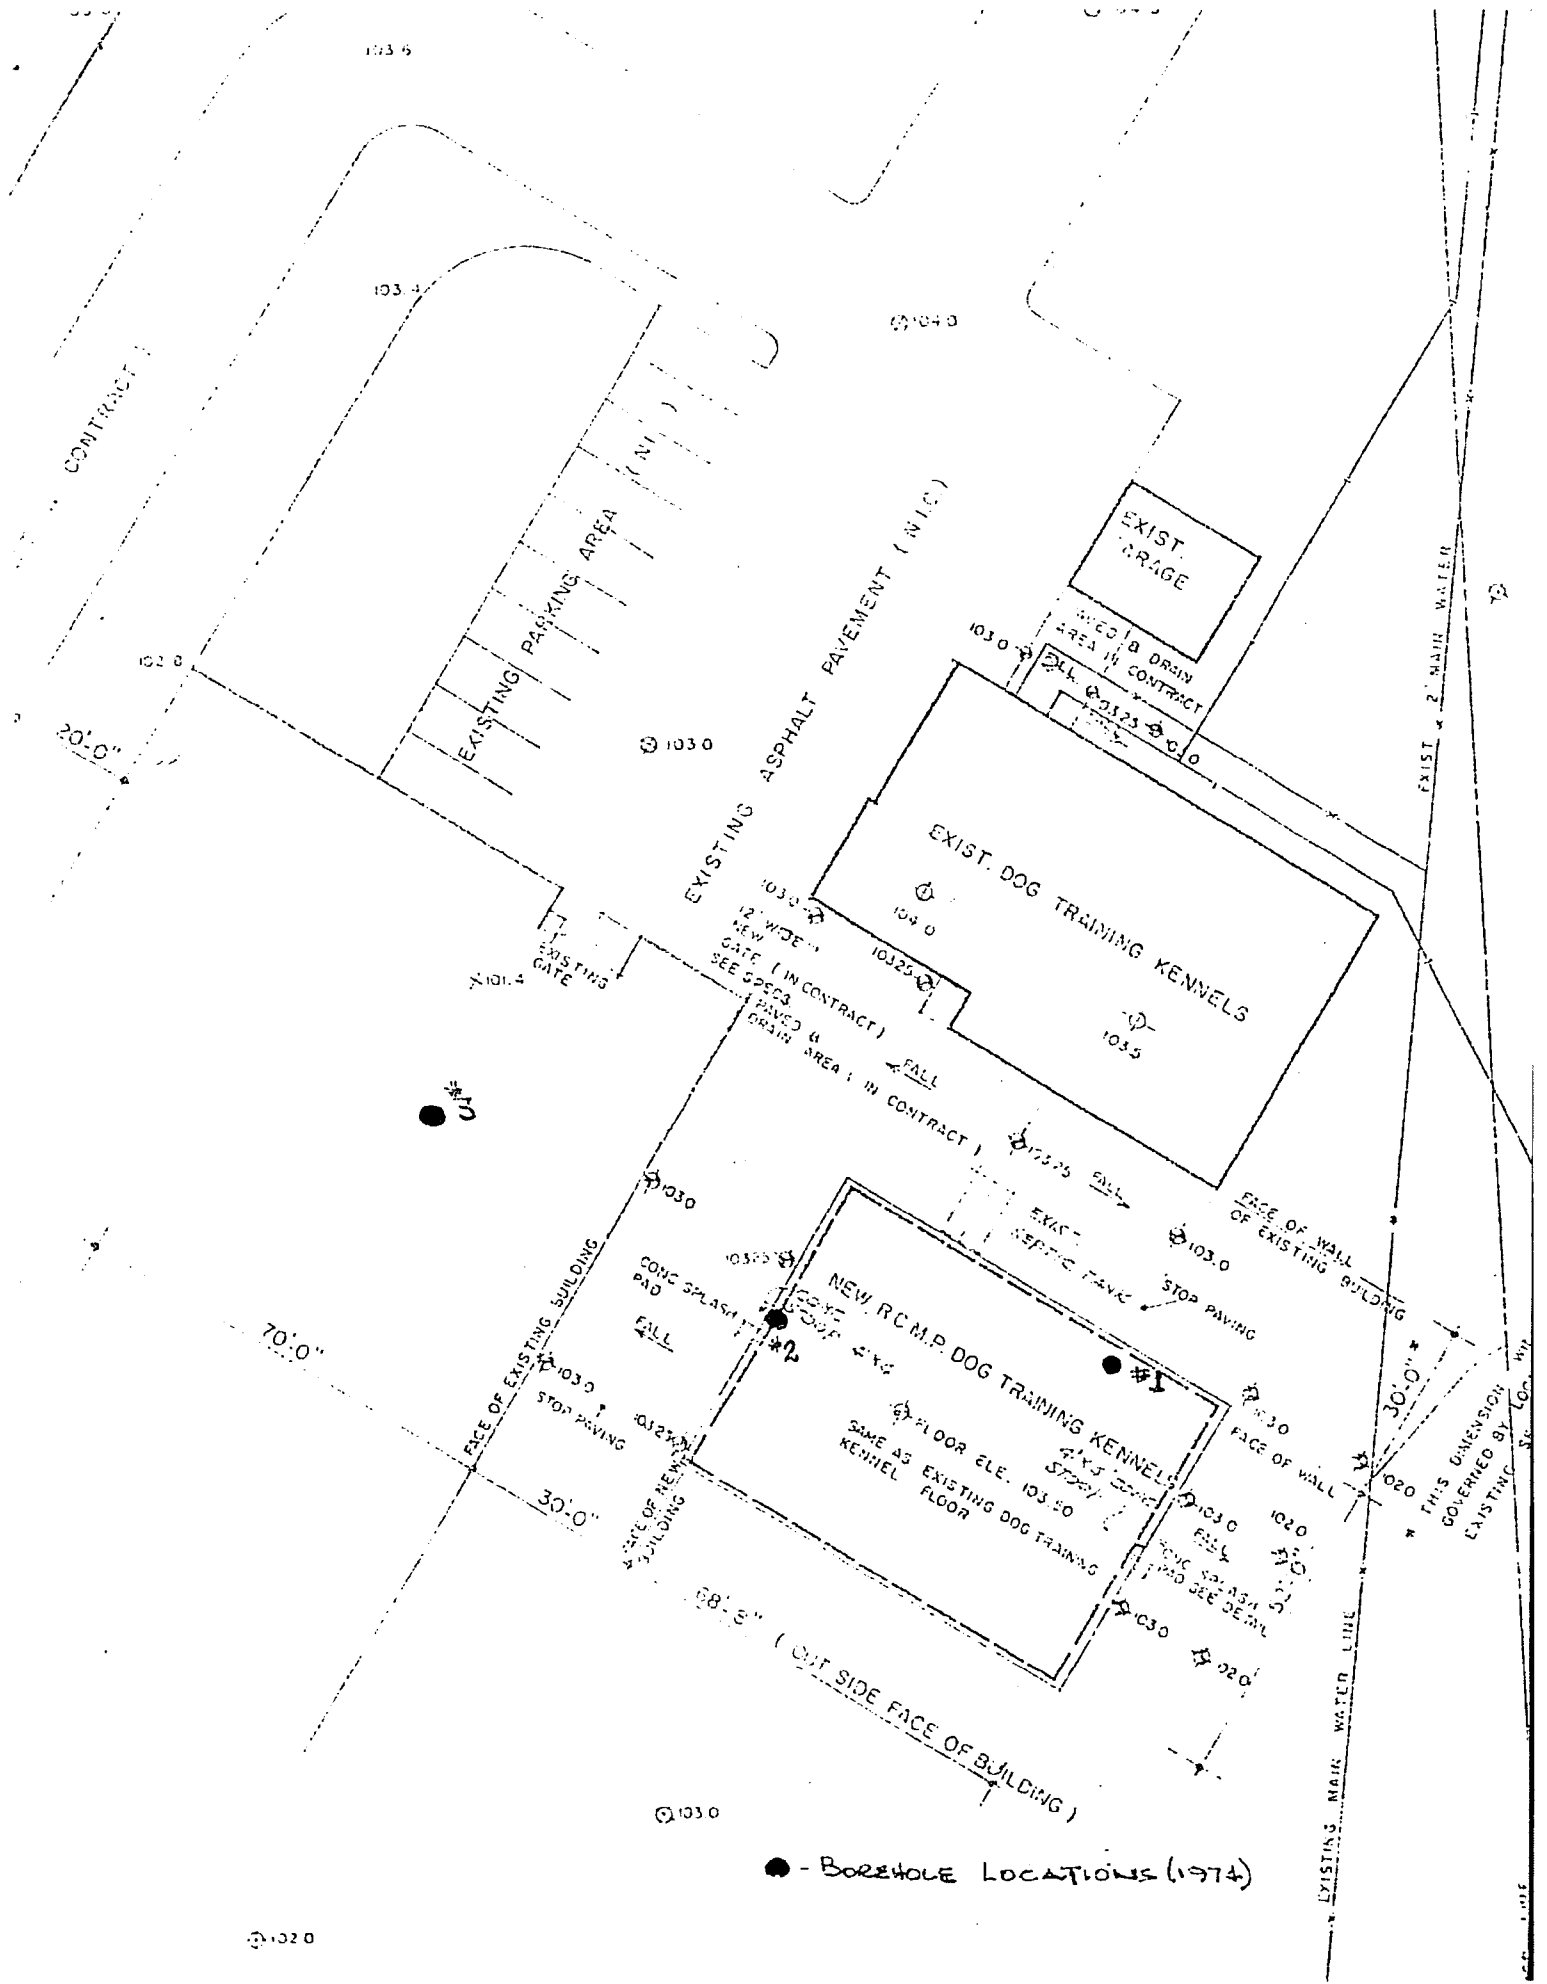
SITE PLAN

The fill material is composed of intermixed sands, clays, silts and organic material and is relatively unconsolidated or poorly compacted. It will not provide a good bearing for the proposed structure and will undoubtedly settle or consolidate under even light loads. This fill was apparently placed in conjunction with installation of a septic tank and tile field which lies in the proposed building area as indicated on the site plan.

Unfortunately this site is not a good construction site from the foundation aspect. The 8 - 10' of poorly compacted fill material at the surface, plus the presence of the septic tank and field below the building area precludes the use of a 'normal' spread footing foundation.

Therefore it is suggested the site be subexcavated to a depth of 4' below final grade and backfilled with compacted pit run gravel over an area extending roughly 10' beyond the edges of the proposed building. The structure could then be founded upon this granular pad with the footings placed at a depth of 1' below the surface and designed on the basis of 2000 psf. Ground floor slabs could bear directly upon the pad and would undergo little or no vertical movements. I believe this would provide the most economical foundation and an adequate foundation for the structure. The material excavated could be utilized for landscaping on-site. It would be necessary to remove all or part of the septic tank, and replace with compacted material accordingly.
