CCGS Ann Harvey Port Side Fresh Water Tank Repairs Specification

Issued
April 2014

Project Number 2518

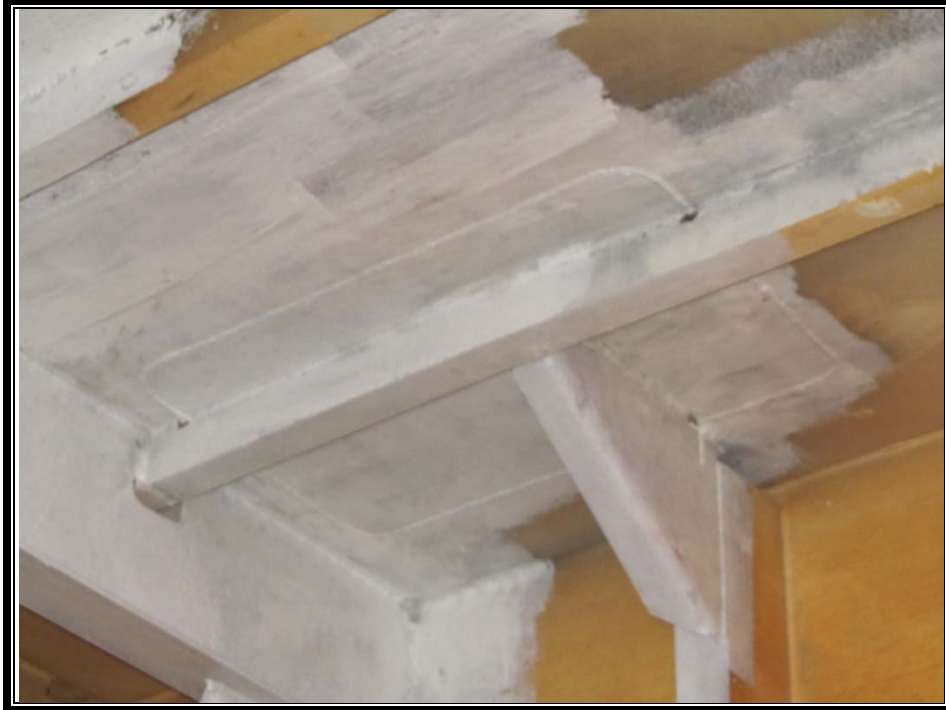
The above noted repairs will be in addition to the repairs that were completed for the tank in October 2013 which included the renewal of a section of the tank top/deck plate where a small hole was evident and also the renewal of a section of the tank top/main deck transverse deep beam in which the previous beam incurred buckling damage.

Tank Top - Section of Plating & Transverse Deep Beam Renewed(See attached Dwg.)

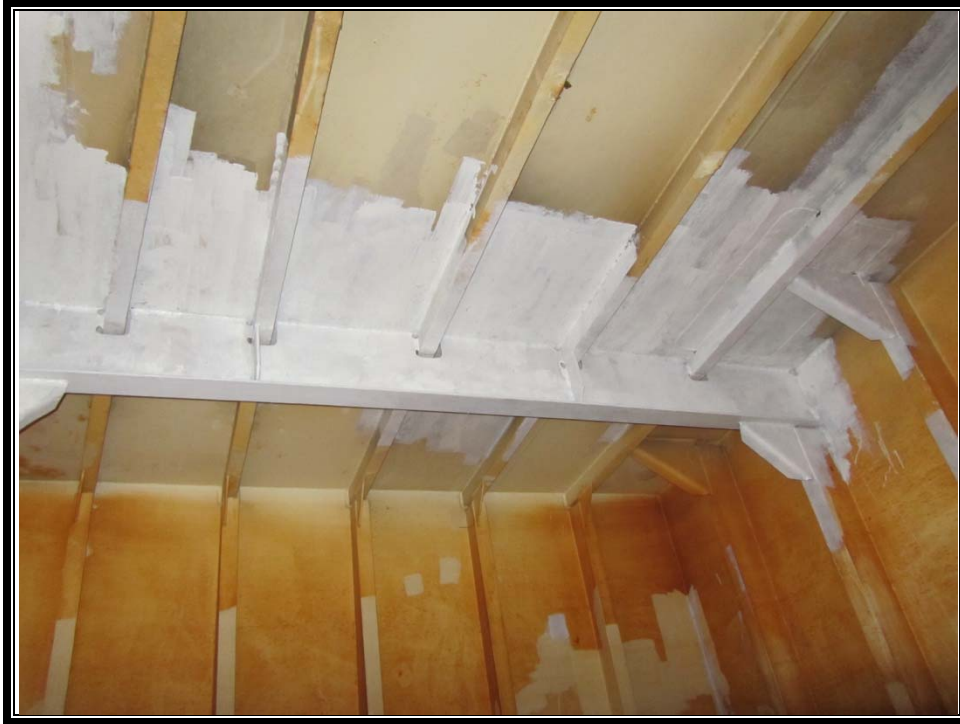
Tank Top, Inboard Bulkhead & Forward Bulkhead

Although the inboard longitudinal bulkhead shows no apparent signs of damage to either the stiffeners or plating, there may still be cracks in the welds specifically in the after section of the bulkhead. Therefore all panels, insulation, fittings aft of the ship shore transformer will have to be removed in order to inspect steel. The outboard longitudinal tank bulkhead also shows no apparent signs of damage although weld seams will have to be tested. Inspection of all plate weld seams and stiffener to plate welds on all tank bulkheads will require inspection after completion of steel renewals

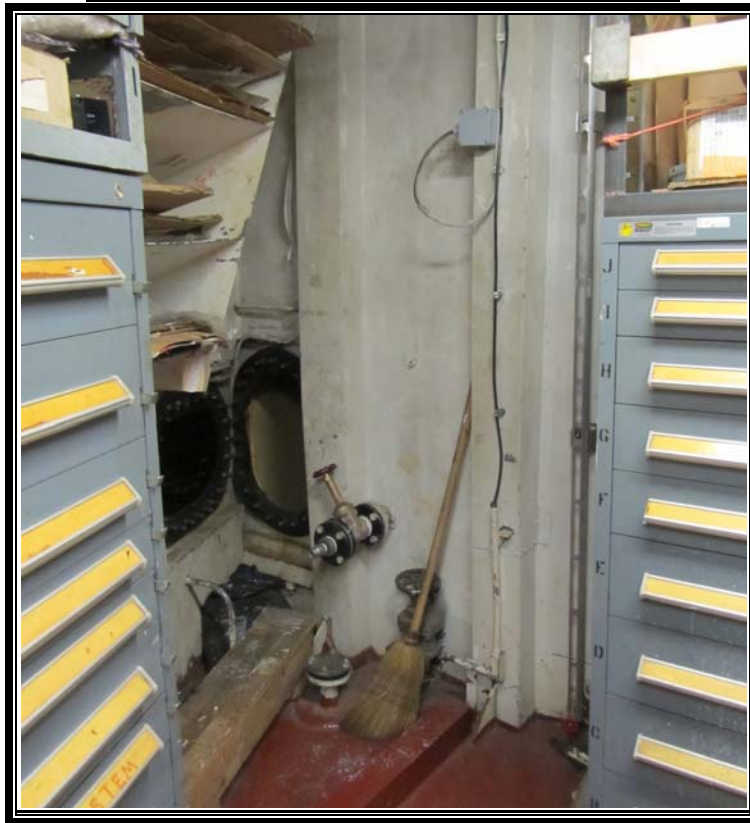
The fresh water tank is located on the port side above the main engine compartment from frames 30 – 41. Access to the tank can be obtained through a manhole located outboard on the after tank bulkhead.

Access to tank from Manhole on Aft Bulkhead

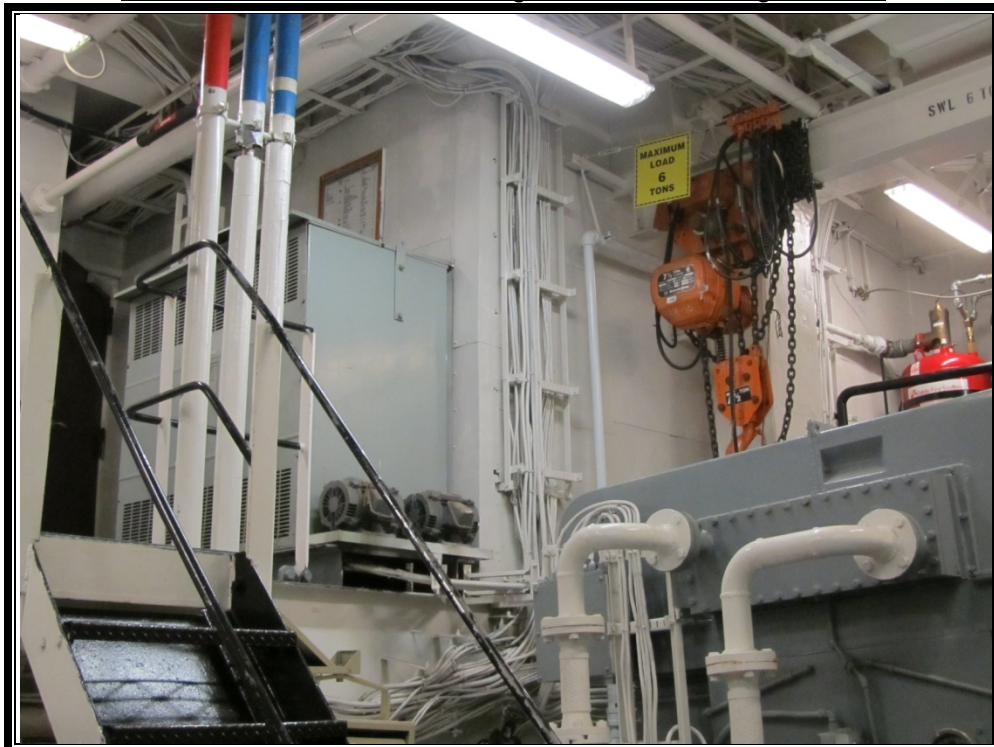
View of Tank Exterior from Engine Room. Looking Aft/Port.

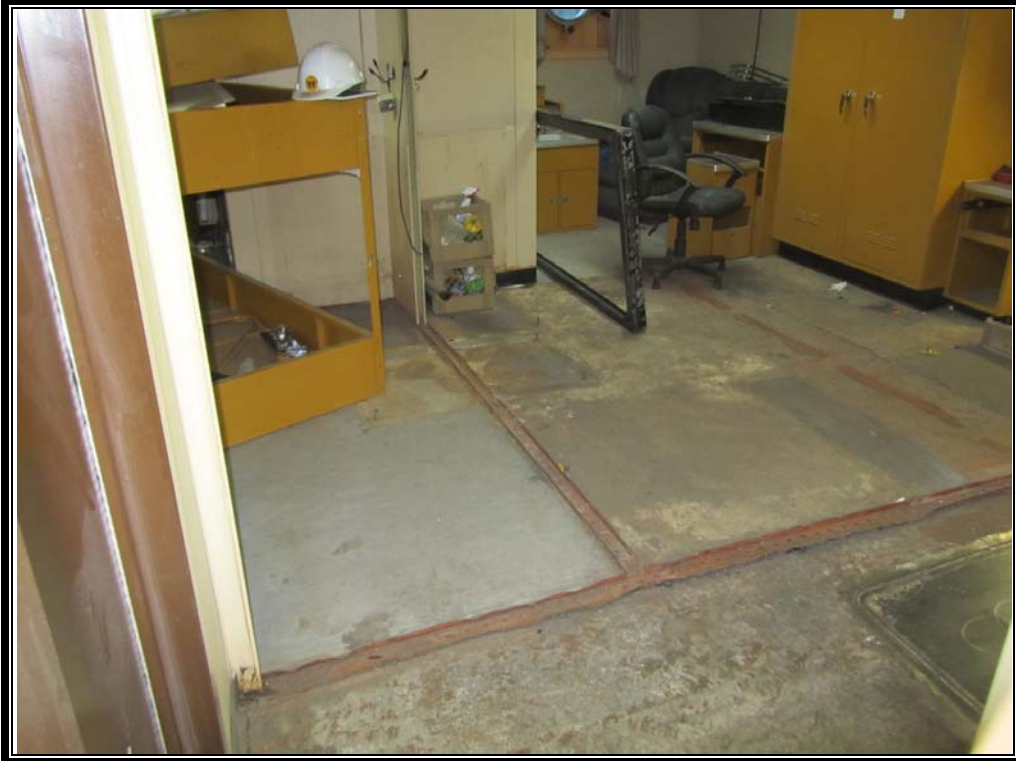
Main Deck Cabins above Fresh Water Tank - Bulkheads/Flooring Removed for Inspection

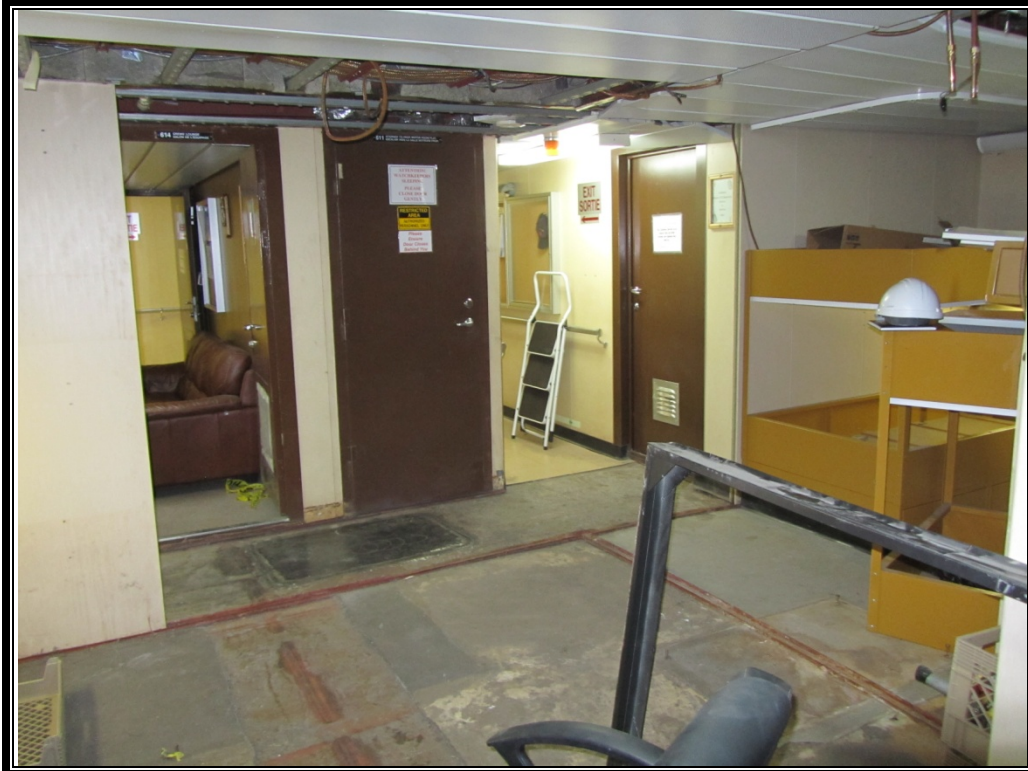
Main Deck Cabins above Fresh Water Tank - Bulkheads/Flooring Removed for Inspection
