Gwaii Haanas Mooring Buoys

Dive Inspection Report Oct, 2013

Dive Inspection Report Gwaii Haanas Mooring Buoy's

Contract # GHNPSL13040

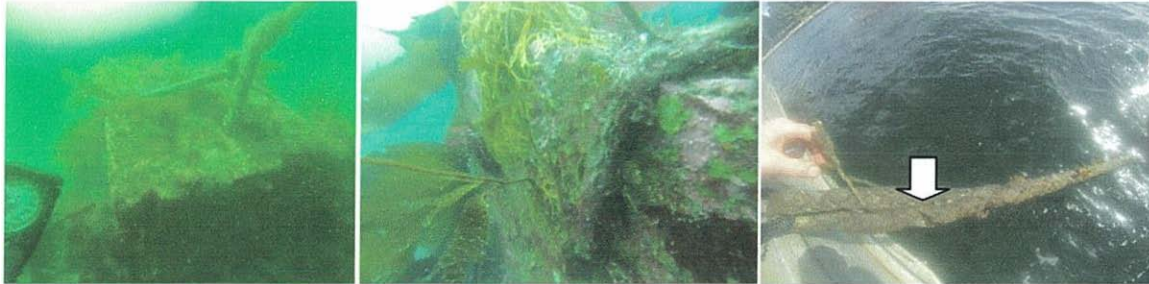
Skedans: N 52 57.755 W 131 36.408 Two Buoys. North buoy (closest to beach) consisted of a dragger ball buoy to amsteel rope to a 5ton anchor with a hole through it in approx. 7.6m(25ft) water. No observed defects in rope from the buoy to the block, the rope goes through the hole in the block and is tied back to itself The loop through the block has minor fraying where it rubs on the comers of the block (see middle picture below). Last picture below shows divot in tie up tail, probably from a prop (see arrow).

Comments: Rope too short to retie past wear points. Buoy was replaced with new parks float. Length of mooring rope is marginal.

Recommendations: Put boom chain through hole in block and attach min. 6m(20ft) chain or replace rope through block.

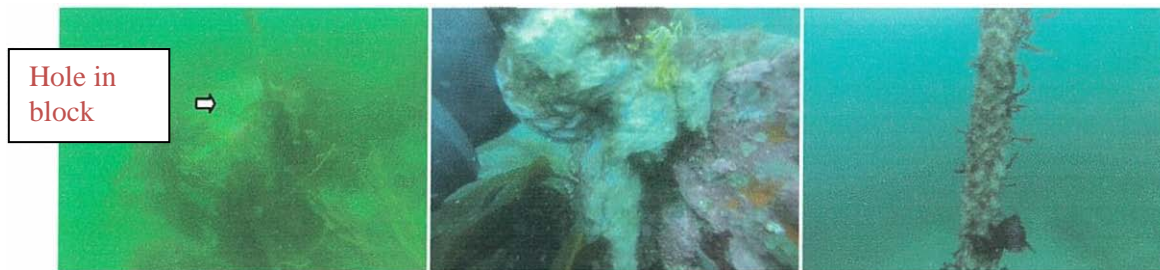
2"d buoy consists of a foam crab pot float to amsteel rope to a 5 ton anchor with a hole through it in 7.62m(25ft) of water. Tail on surface is frayed, is also badly frayed on the comers of the anchor block (see middle picture below). There was not enough slack in rope to re-tie. The anchor block is laying on it's side (see picture on left below). In order for the mooring line to be changed the block needs to be flipped over to access the hole in the block. Buoy is not serviceable until repairs made.

Comments: Mooring buoy not serviceable until repairs made.

Recommendations: Replace float and minimum 12m(40ft) rope and flip upright the anchor or add 6m(20ft) piece of chain to anchor and replace float.

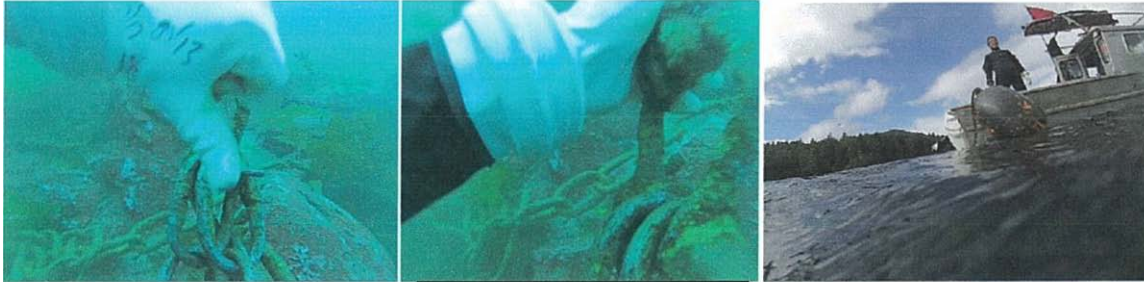
Tanu: N 52 45.682 W13136.643, One Buoy, (Co-ordinates given were N52 45.763 W131 39.396) Consists of a large oblong dragger float (see picture on right below) lashed to heavy poly rope 3cm(1.25") to 5m(15ft) of 2.54cm(1") chain to a 5 ton cement anchor in approx. 20m(65ft) of water. Eye on block is serviceable. Mooring rope is faded, brittle and slightly frayed on the surface. Rope is attached to plastic float with lashings which were frayed. We attached some heavy plastic ties to repair the frayed lashings. Chain at block is about 30% (see left picture below).

Chain and shackle at less than 50 percent. Tanu anchor

Comments: Didn't change buoy as chain is marginal and the float is a good one (see picture above). Shackles attaching chain to block are welded. Shackle attaching rope to chain is about 30%. Chain 30-40%.

Recommendation: Change chain and rope for 2014 season. Min. 20m(65ft) rope and 6m(20ft) chain. Use minimum 2.54cm(1") shackles when attaching rope.

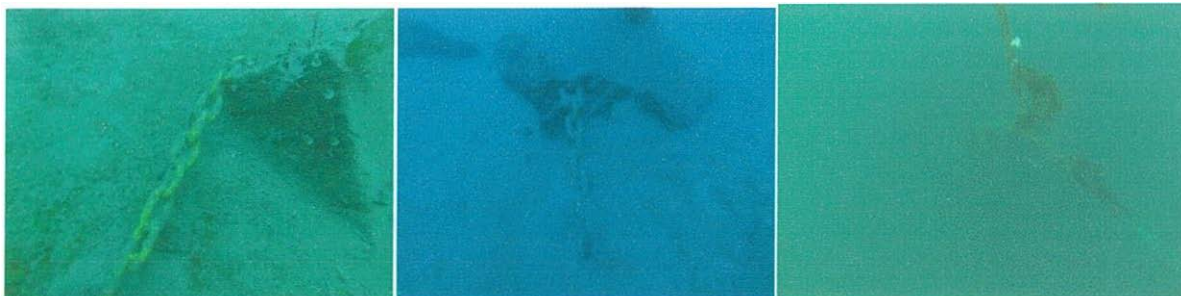
Shuttle Island, two buoys: N52 3990 W1314370 East/West buoys are old D.F.O floats, steel with foam filled tires sandwiched between steel plates. The East buoy has a single 2.54cm chain going down to 6m(20ft) then splits (see picture on right below) and goes to two cement anchors that are buried (see left and middle pictures below) at approx. 18m(60ft) water. Eye & swivel are good on buoy, single chain to 6m(20ft) where it splits is less than 5000. Remainder of chain is marginally serviceable 40-50%. West anchor is buried. The East anchor has its eye exposed & in good condition.

Buried anchor block, East buoy at shuttle Isl. West anchor block

Buried anchor with eye showing, easy buoy, east block

East buoy chain splitting to east and west anchors.

Recommendations: Mooring buoy is not safe to tie-up to until top section of chain changed. Suggest changing all the chain. Change chain from buoy to east block. 30m(100ft) of chain or rope required.

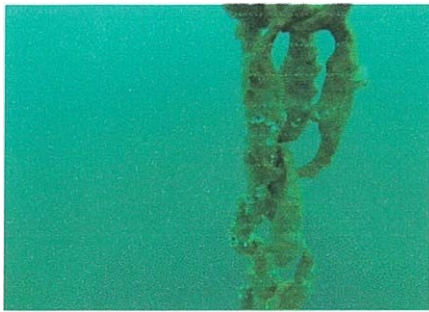
2nd buoy (shuttle Island) anchor is in approx. 15m(50ft) water and is buried. Mooring chain is less than 10 % in sections (see picture below), Mooring eye and swivel are good.

West buoy anchor chain at Shuttle Island. Shows totally unserviceable chain

Comments: The unserviceable condition of these buoys was communicated to Marvin Pearson by phone (Asset Manager) on Sept. 24. The West buoy is unlikely to survive the winter and once lost will make finding the anchor very difficult.

Recommendation: Replace chain immediately as it is unsafe to tie- up to. Min. Chain length or rope 19m(65ft).

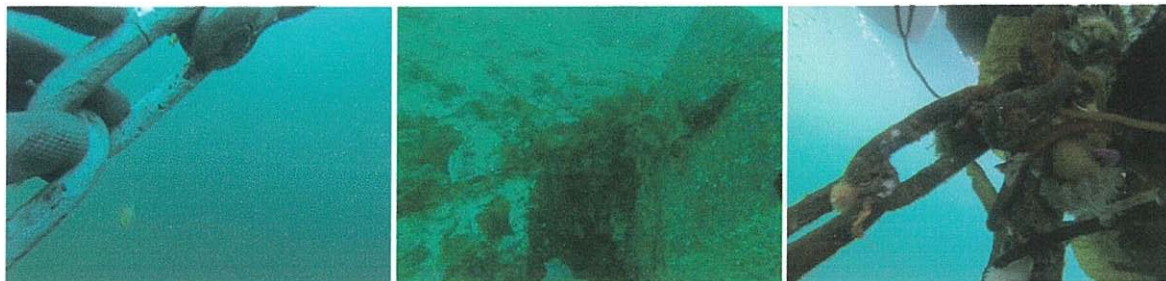
Murchison Island: N52 35.59 W13128.23 Two buoys, steel with foam filled tire floats. S.E Buoy has two chains to two 5 ton anchors. South chain is 2cm($\frac{3}{4}$ ") and is at about 60percent, some evidence of galvanic action, as some chains had welds corroded (see picture to left below). Anchor in approx. 21m(70ft) water. North chain 50% remaining to about 18m(60ft) and from 18m to 5 ton block is 40 percent (see picture middle). Cement anchor is in approx. 24m(80ft) water. Eye on Buoy and swivel are good (see picture below, right).

Recommendations: Change North chain, Min. 42m(140ft) of 2cm($\frac{3}{4}$ ") chain or rope.

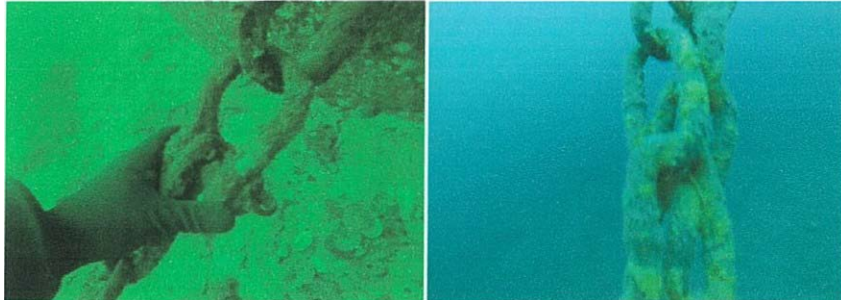
2nd Buoy (Murchison), North buoy has 2 old chains hanging off it (see right hand picture below). One is old, unserviceable chain. The other has 50% remaining to 18m(60ft). From 18m(60ft) to 5 ton cement anchor it goes to a single chain which is 30-40%. Shackle and eye at the 5 ton block have less 50% remaining. (see picture below) Shackle pin is welded. Buoy eye is good.

Comments: A 2.54cm(1") poly safety was tied from the block to the buoy as the float camp was dependent on this buoy. As the rope was attached to a much corroded, sharp eye on the block, the staff was notified that the rope would be very temporary if the chain broke. This information was phoned into the Asset Manager on Sept .24/13.

Recommendation: This Buoy is not serviceable for 2014. Min.27m(90ft) chain should be replaced.

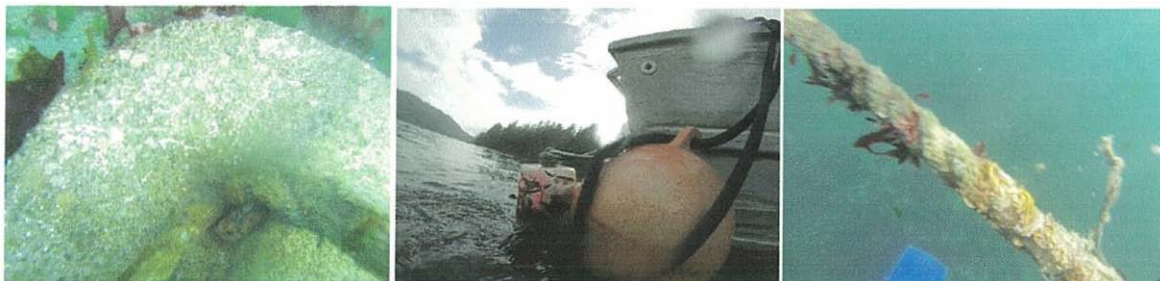
Hot Spring Island: Two Bouys: one on the North side and one on the south side. North buoy: N52 34.735 W 131 26.586. Consists of a Dragger float, with 2cm(3/4") poly rope (see right hand picture below) spliced directly to an anchor, consisting of 1/3 of a 170litre(45gal) drum filled with cement in approx. 4m(13ft) water. The rope is brittle and faded. The anchor can be moved by hand underwater and it would be difficult to change rope with such a small eye (see left hand picture below)

Comments: Didn't put new float on as anchoring not adequate.

Recommendations: Replace rope and anchor. Min.7.6m(25ft) rope and at least a one ton anchor.

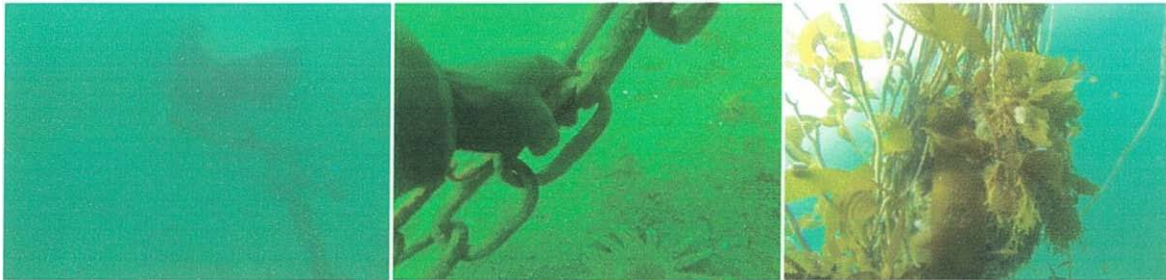
2nd **Buoy** (South side of Hot Spring Island) N52 34.468 W131 26.744. Consists of a dragger ball buoy to amsteel rope to 2cm($\frac{3}{4}$ ") chain to a 5 ton block in approx. 9m(30ft) water. Chain: less 40% (see middle picture below), worst chain was last 3m(10ft) to rope. Re-tied rope past the worst of the chain. Rope was quite twisted. Block is lying on the chain so couldn't assess the eye or tie to it (see left picture below). Picture to right shows accumulated kelp on mooring line.

Recommendations: Replace chain on block for 2014 season. Block must be flipped to do this. Min. 6m(20ft) chain. Use min. 2.54cm(1") shackles where rope ties to chain. Swivel on buoy will help with twisting rope, swivel at chain rope connection would be better.

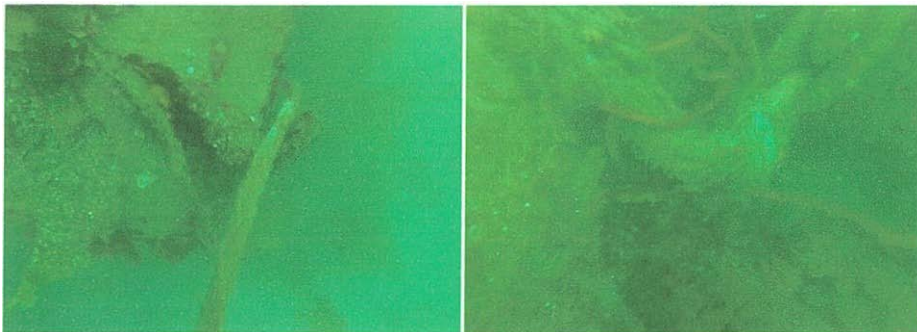
Ramsey Island: 3 buoys at N52 34.40 W131 24.00 Buoy closest to shore consists of a Dragger ball buoy lashed to amsteel rope to a few links of chain to a 5 ton block. Block is lying on its side (see picture below) in about 7.6m(25ft) water. Rope is good. Chain remaining is 70%. Eye of block is good.

Recommendations: Replace chain with min. 6m(20ft) of 2cm($\frac{3}{4}$ ") or larger **or** flip block up to prevent rope from abrading on corner of block.

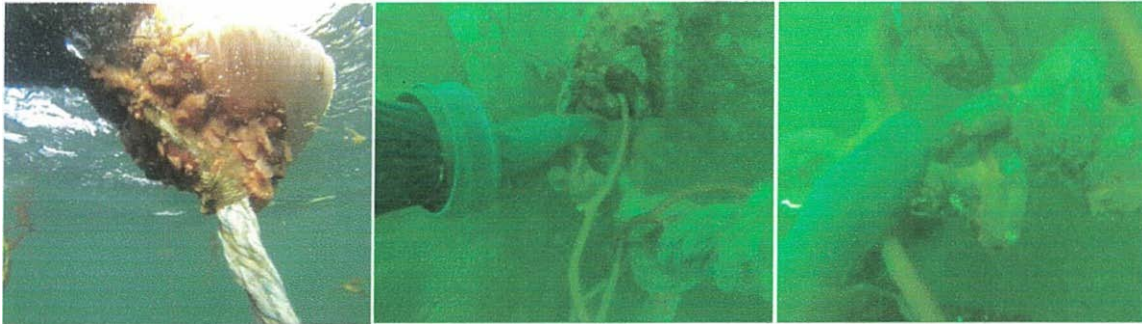
2nd buoy (Ramsey Island) Consists of dragger ball lashed to amsteel rope (see picture of lashings) to a 5ton block. Block is on its side in about 11m(35ft) water and the rope is tied to a ring at the block. The ring has 50% remaining . (see pictures below).

Recommendations: Attach piece of chain to block **or** flip block upright to prevent rope abrading on corner of block.

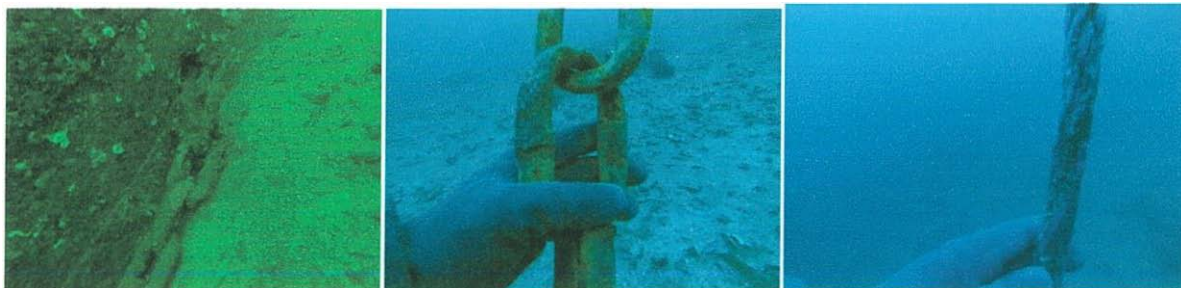
Huxley Island Ops: Two Buoys, N52 25.987 W13122.232, East Buoy consisted of a low floatation foam float to amsteel rope to 2cm($\frac{3}{4}$ ”) chain to a 5 ton block with a hole through it in approximately 26m(85ft) water, with a boom chain through the hole. The chain is less than 50% remaining about 5m(16ft) from block(see middle picture). The amsteel rope is very stretched but has no obvious defects (see right hand picture below)

Comments: Buoy was replaced with a new parks float as the float in use was in danger of being sunk with accumulated growth and Kelp.

Recommendations: Replace a min. 6m(20ft) chain from block to rope for 2014 season.

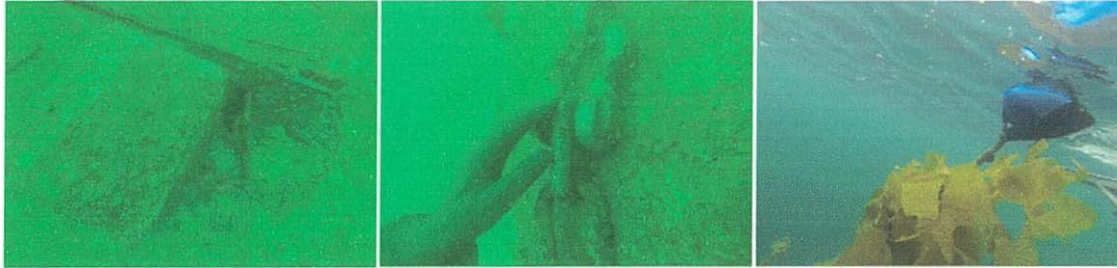
2nd Buoy (Huxley Island). The West buoy consists of a blue rubber float attached to Amsteel rope to a shackle with welded pin (see middle picture) to 2.5cm(1") chain to two small anchors (see left picture below) connected with chain in approx.24m(80ft) water. The amsteel rope is very compressed but with no defects, the chain is 60%, eyes on blocks are good.

Recommendations: Inspect in two years.

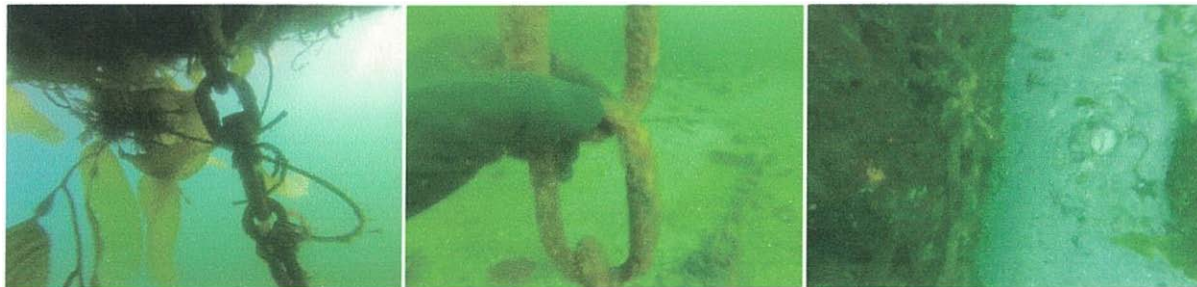
Burnaby Island (N.Dolomite Narrows): One buoy at N52 34.40 W B121.11, Anchor lies in approx. 6.7m(22ft) of water. Consists of steel buoy with tire filled foam floats, anchor is a 5 ton with a hole through it with a piece of 2cm(¾") boom chain through the hole. A 6m(20ft) section of chain adjacent to the block is less than 50 percent remaining (see middle picture below). Eye on buoy and swivel are good (see picture on left below)

Recommendation: Replace 6m(20ft) section with worst wear. Consider replacing all of chain from block to buoy for 2014 season. Minimum 11m(35ft) of chain to replace all.

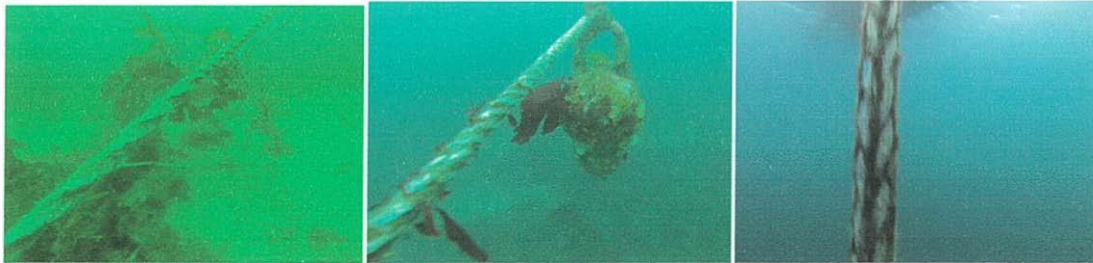
Rose Harbour: Two Buoys, N52 09 020 W131 05 196 (Position given in contract, N52 09.00 W131 21.11). South Buoy consists of a large buoy with a steel tie up eye on top attached to blue amsteel rope to chain links sticking out of a 5 ton block in approx. 14m(45ft) water. Rope has a steel weight (counter weight) attached part way down to prevent rope floating up on a low tide. At time of inspection on a high tide the rope was very tight. No obvious defects on rope, however it was severely twisted (see left hand picture below) from counterweight to anchor block (see middle picture below). Right hand picture shows rope above counterweight with no twist.

Comments: Zinc on buoy was at about 60%.

Recommendations: Mooring line needs to be lengthened. Attach 6m(20 ft) piece of chain to anchor or replace rope with min .20m(65ft) rope. Attach swivel to bottom of buoy or to chain at block to prevent excessive twisting of rope.

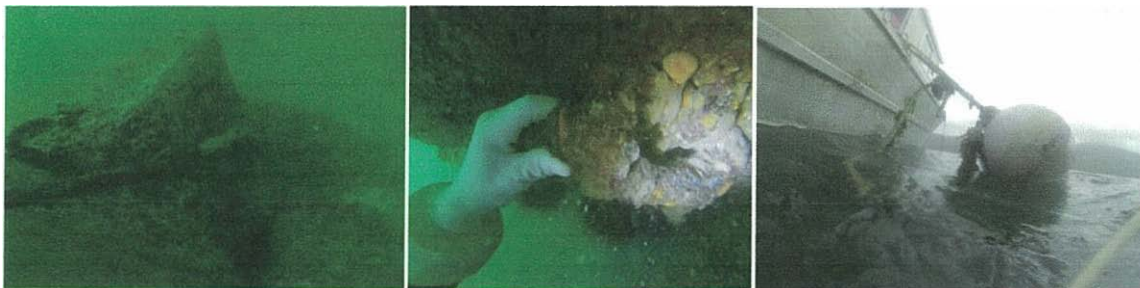
2nd Buoy, N52 09 189 W13104822 Is around point of small island to North east of South Buoy. Consists of small dragger ball for a buoy (see picture below) connected to 3 different pieces of rope, one piece being white multi-braid poly (old D.F.O rope) and two separate pieces of amsteel, attached to a 5 ton block on its side (see picture below) in approx. 14m(45ft) water. No obvious cuts or fraying on rope to block, knots appear tight, minor fraying on rope where rubs on the corner of the block. Eye on block is good (see picture below).

Recommendations: Flip anchor upright or attach piece of chain to anchor, min 6m(20 ft). Consider replacing 3 pieces of rope with one piece.

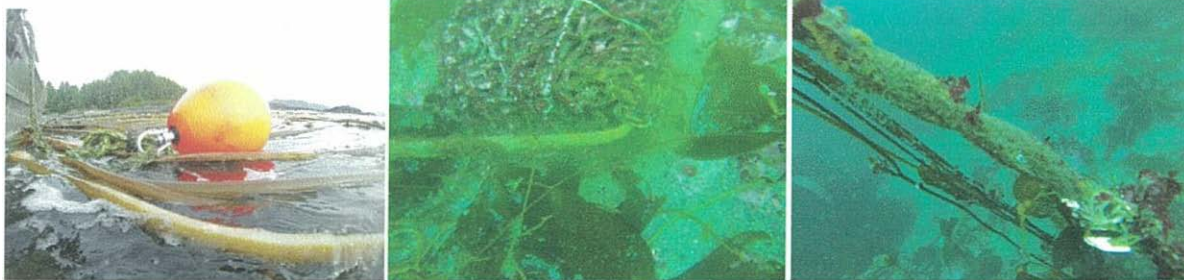
Sgaang Gwaii: Two Buoys, South East location N52 05.773 W131 12.840, consisted of dragger ball buoy connected to two pieces of amsteel rope, with one end tied into a pile of 2cm(¾") chain for a anchor (see middle picture below) in approx. 7.6m(25ft) water. Pile of chain had some links at 40% and others 60-70%. Could not really tell if rope was attached to good chain or to rotten chain. Rope appeared in good condition and anchor /chain seemed solid when pulled on. Minor fraying where rope goes into pile of chain. Rope was minimal for length. Buoy is serviceable for small boats.

Recommendations: Replace chain-anchor with a cement anchor.

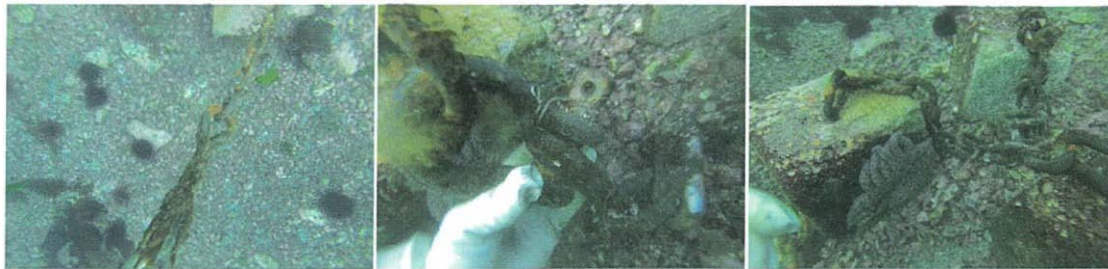
2nd buoy(Sgaang Gwaii), N52 06.138 W131 13.517 (Contract says N52 06 171 W131 13.616) consisted of a small dragger ball buoy attached to 2cm(¾") poly steel rope with a hard eye shackled to a swivel to ¾" chain to 3 small cement anchors approx. 113kg (250lbs) each in 6m(20ft) water (see pictures below). Swivel, Chain and shackles are good 80% plus, rope has no obvious signs of wear or deterioration.

Recommendations: Consider adding a little more weight to anchor.

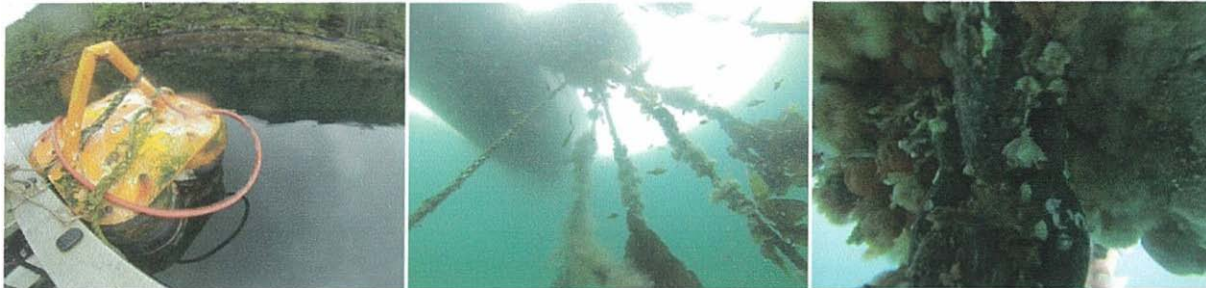
Louscoone Inlet water-line: One Buoy N52 11.64W131 15.37. Buoy was a steel (former D.FO float) attached to three, 2.54-2.84cm(1"-1 1/8") poly steel ropes, one rope with 3 floats attached along it, goes to a 5 ton block with a zinc on the eye of the block (east block) in approx. 24m(80ft) water. The 2nd rope goes to a short piece of chain attached to a 5ton anchor in approx. 23m(75ft) water, this anchor also has a piece of chain leading towards the beach attached. The 3rd rope goes to a short piece of heavy chain to a beach rock anchor. The last 7.6m(25ft) of the rope is sheathed with plastic pipe to prevent rope abraiding on beach rocks and from U.V breakdown . This plastic pipe is broken and a minor amount of fraying was observed on the rope at that point. The beach rope also has some minor fraying where it attaches to beach chain. No other signs of deterioration was observed on either of the anchor ropes. Eye on buoy was good, eye on blocks good, chain on West block 60%. Minor wear observed on rope attachment points on anchor and buoy.

Recommendations: Attach another length of chain at least 7.6m(25ft) to replace plastic sheathed rope and get the attachment point of rope past possible points of abrasion. Consider attaching lengths of chain to anchors to give more spring. Replace tied eyes of rope with spliced eyes. Remove old ropes when they are replaced, the middle picture above shows some of the clutter (there should only be three lines).
