Project Description / Description de projet		
M-6 Hot Well Piping Replacement		
Solicitation No. / No de sollicitation	Project No./N ^o de projet	W.O. No./N ^o d'ordre de travail
14-22025	M6-3562	
Project Engineer / Ingénieur de projet		Date
Allan Smith		June 2 nd , 2014
Notice: This addendum shall form part of the tender documents and all conditions shall apply and be read in conjunction with the original plans and specifications.		Nota: Cet addenda fait partie intégrale des dossiers d'appel d'offres; toutes les conditions énoncées doivent être lues et appliquées en conjonction avec les plans et les devis originaux.

**Hazardous Building Materials Assessment
National Research Council of Canada
Building M-06
1200 Montreal Road, Ottawa, Ontario**

Pinchin File: 93951

May 27, 2014

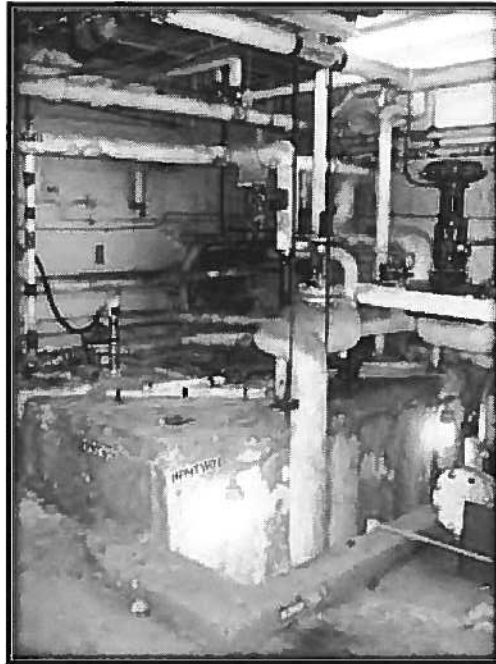
Non-asbestos fibreglass insulation is present on straight sections of pipe throughout the project area. There was no asbestos parging cement noted on pipe fittings (elbows, valves, tees, hangers etc.) or the seams of the insulation at the locations inspected.

Photo 1 – View of non-asbestos fibreglass pipe insulation atop hot well HPHTW01 on the basement level.

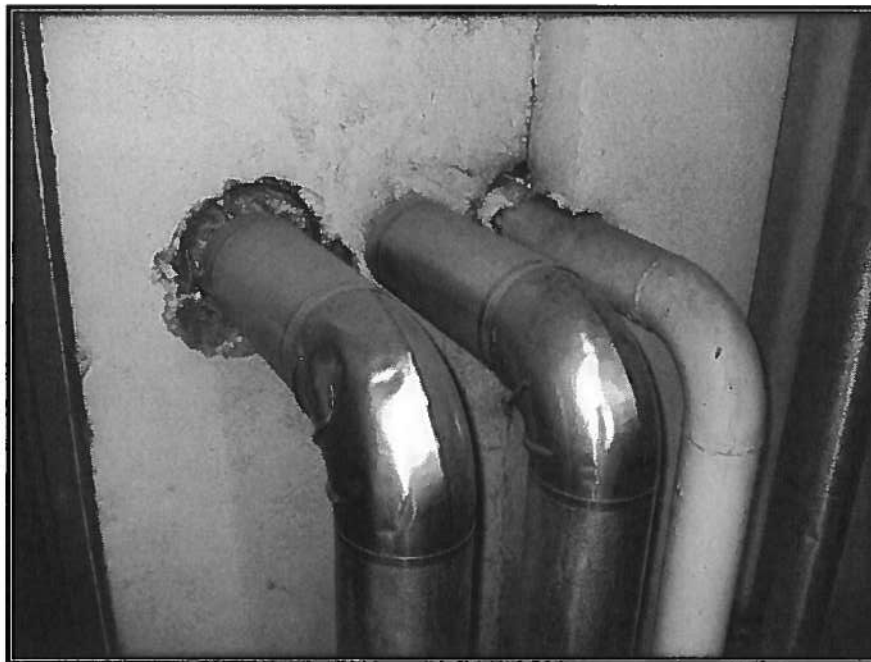
Rough plaster is present on walls in the room housing boiler unit HPBLR05 on the upper mezzanine level. Three samples of rough plaster were collected (Samples 02A-C). No asbestos was detected in the rough plaster.

Photo 2 – View of non-asbestos fibreglass pipe insulation beneath metal jacketing and non-asbestos rough plaster (Samples 02A-C) in the room housing boiler unit HPBLR05 on the upper mezzanine level.

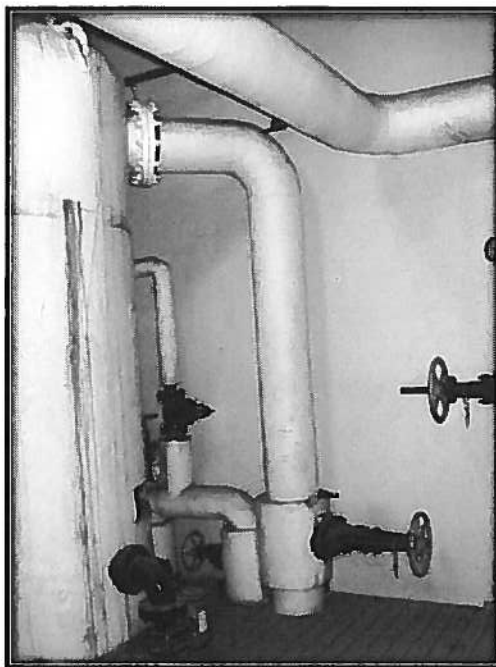
Photo 3 – View of non-asbestos fibreglass pipe insulation associated with de-aerator tank HPDEA03 on the upper mezzanine level.

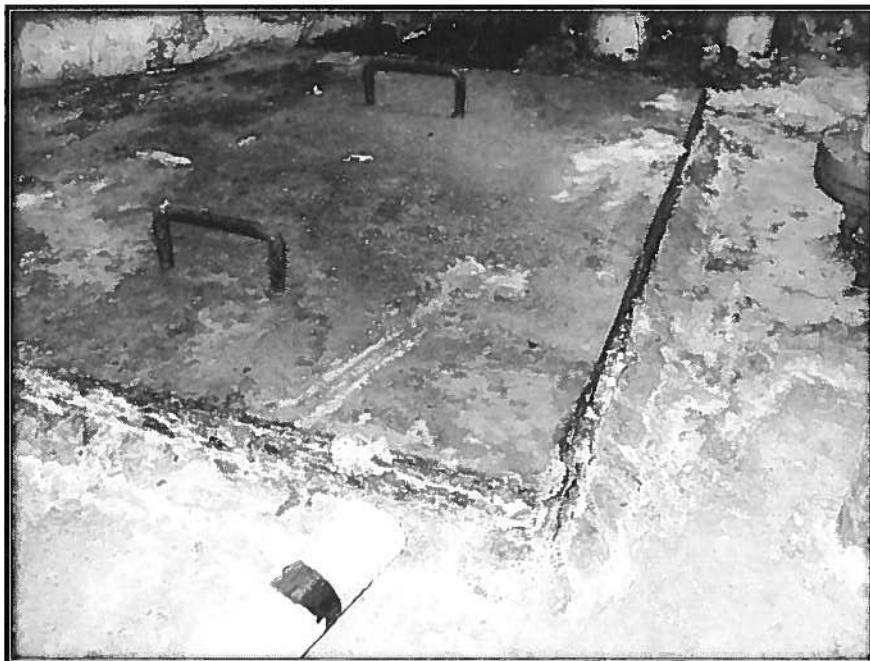
Cementitious parging is present around the hatch of hot well HPHTW01 on the basement level. Three samples of the parging were collected (Samples 01A-C). Asbestos was not detected in the parging.

Photo 4 – View of non-asbestos parging around the top hatch of hot well HPHTW01 on the basement level (Samples 01A-C).

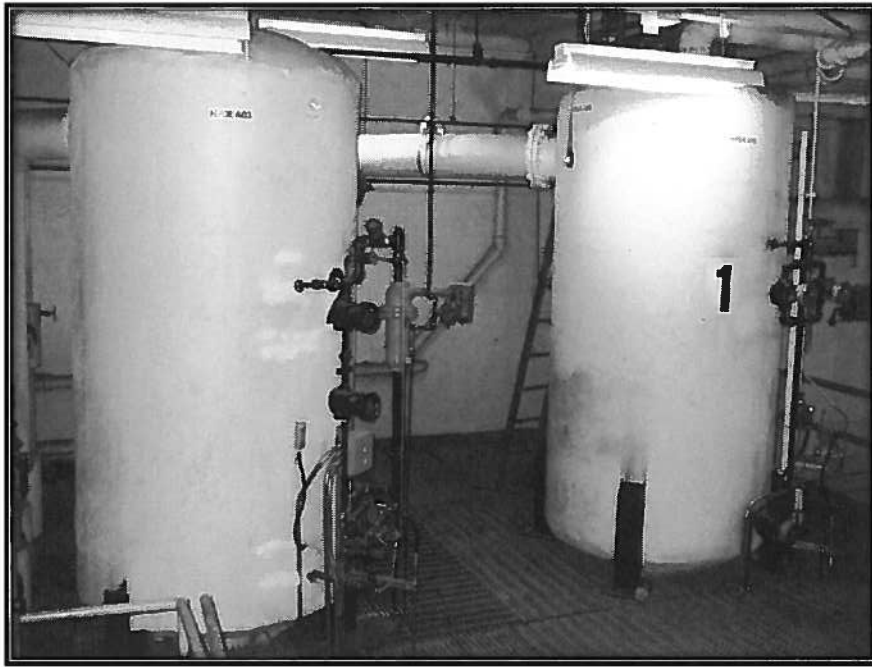
Asbestos-containing insulations were not found on remaining mechanical equipment. All mechanical equipment is insulated with non-asbestos fibreglass or not insulated.

Photo 5 – View of non-asbestos fibreglass insulation present on de-aerator tanks HPDEA02 and HPDEA03 on the upper mezzanine level.

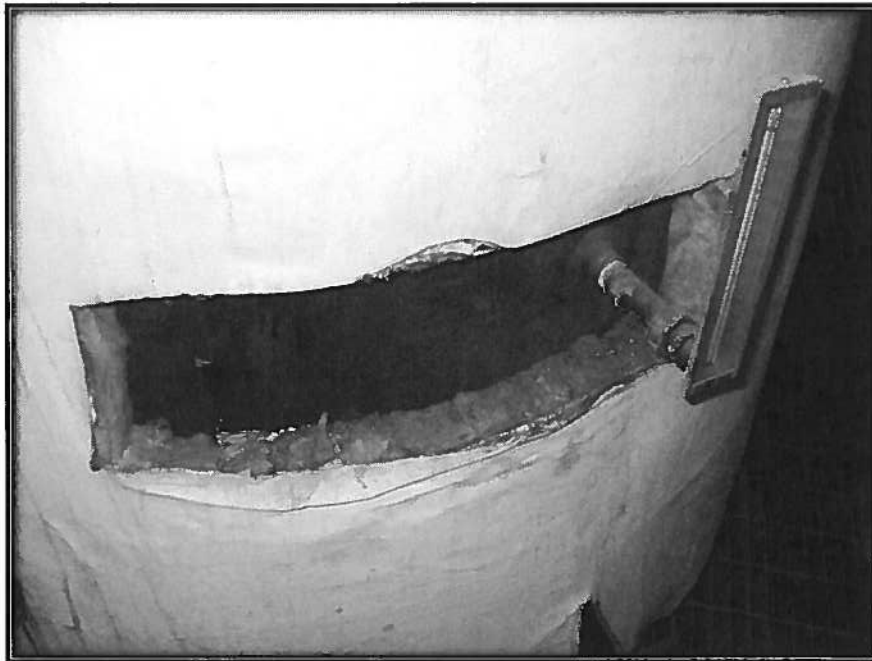
Photo 6 – View of non-asbestos fibreglass insulation present on de-aerator tank HPDEA02 on the upper mezzanine level.

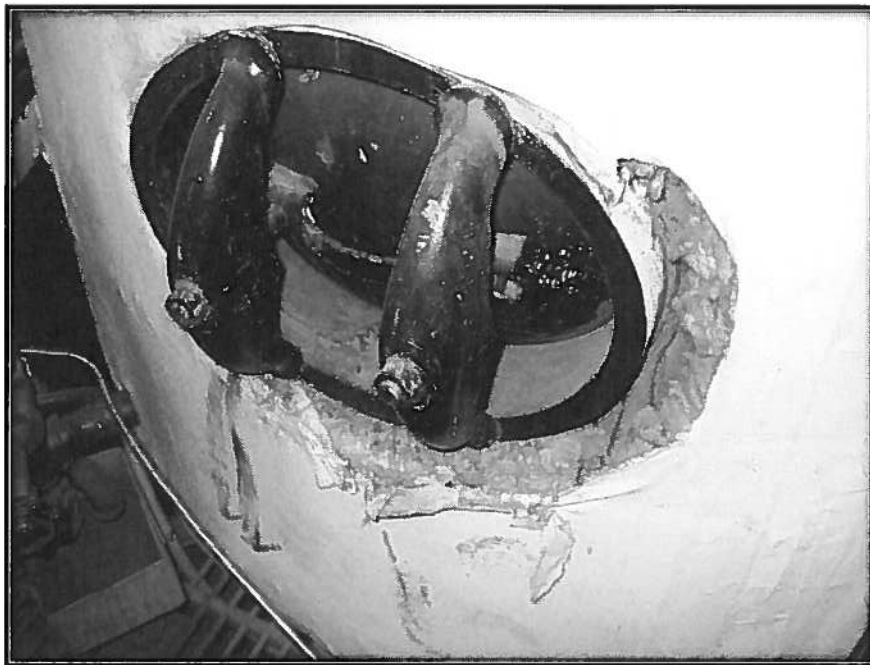
Photo 7 – View of non-asbestos fibreglass insulation present on de-aerator tank HPDEA03 on the upper mezzanine level.
