## VOID BACKFILLING WORK SUMMARY

# Giant Mine B1-18 Stope Complex

**Golder Reference Number:** 1314260010-120-R-RevC-1000  
**AECOM Reference Number:** 330-B1-18 Stope-10-RPT-0001-Rev.0\_20140331

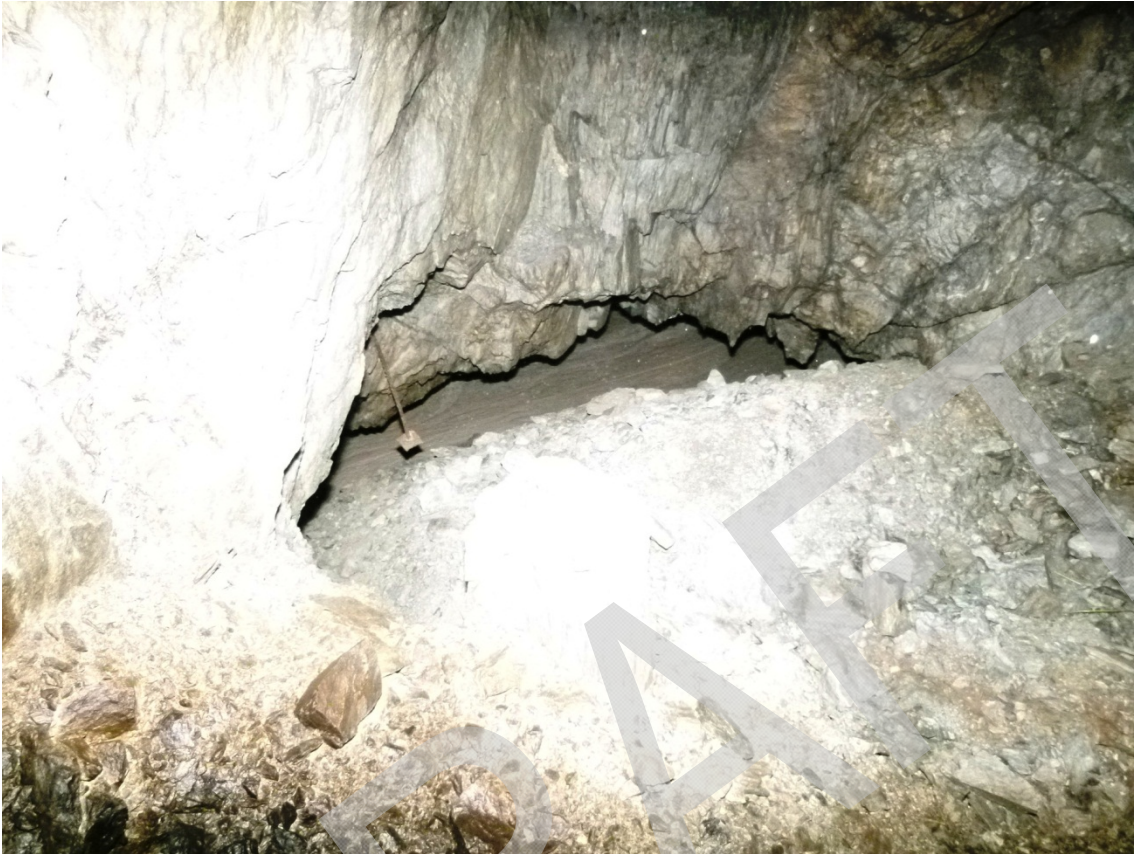
*Photograph 1: Partially backfilled connection between voids – example of leakage point that was plugged*

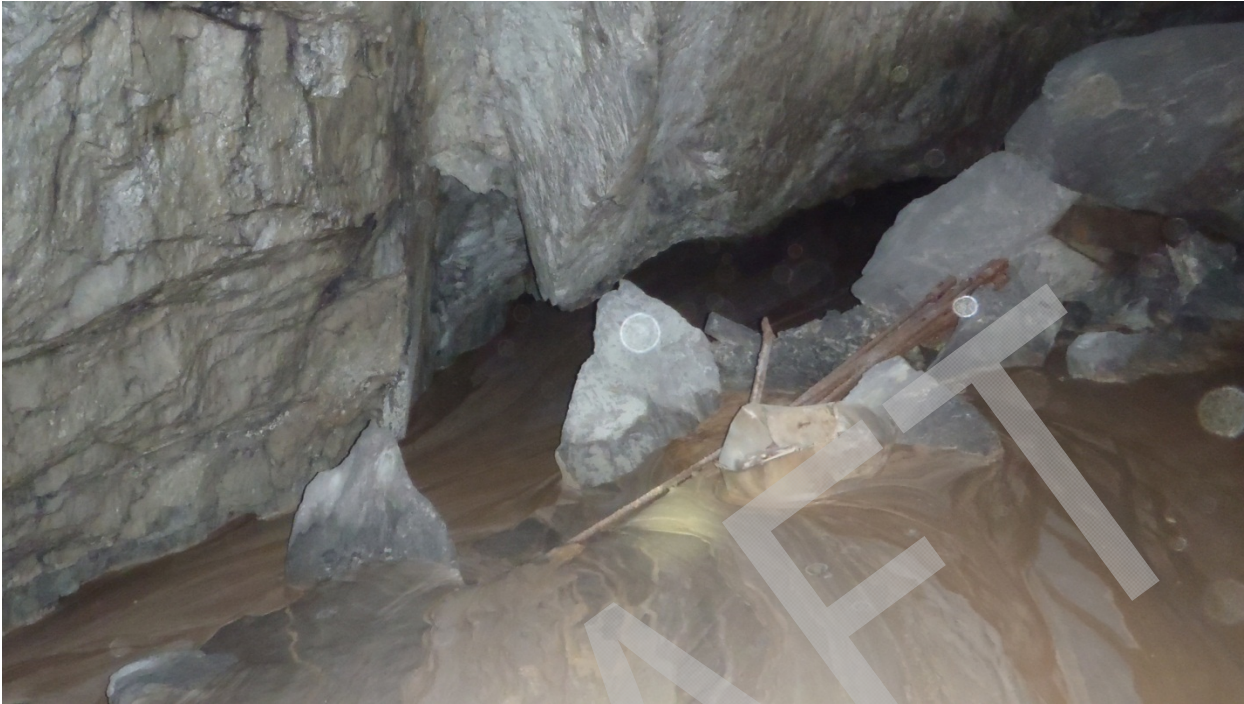
Photograph 2 shows an example leakage point at the northern end of B1-18 EA void that was not plugged by the end of the paste production period.

*Photograph 2: Partially backfilled connection between voids – example of leakage point that was not plugged.*

Plugging the leak shown in Photograph 2 would allow paste to fill an area that would not be anticipated to impact Baker Creek and was therefore not deemed critical to the project in 2013.

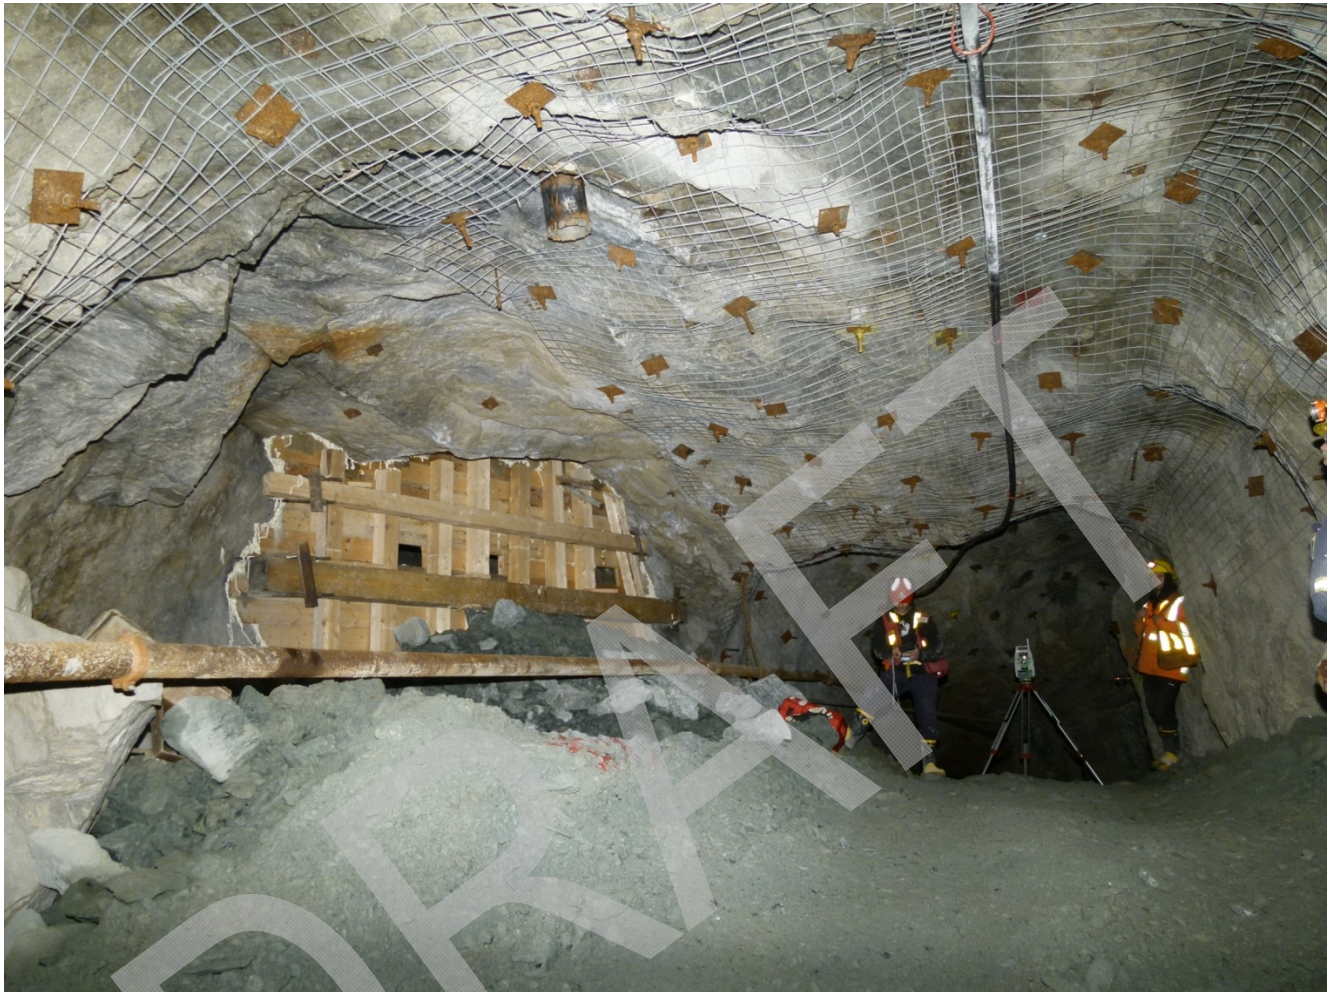
Photograph 3 shows Barricade 1 prior to paste delivery and Photograph 4 shows the area after the paste level had risen to the first spill point. This was noted in the underground cameras. Paste pumping was stopped and personnel re-entered the mine 24 hours later to inspect the barricade. Photograph 5, taken through one of the ports in Barricade 1 shows the flat profile of the paste.

*Photograph 3: Constructed fill fence (barricade 1) showing ports for paste spillage prior to backfilling*

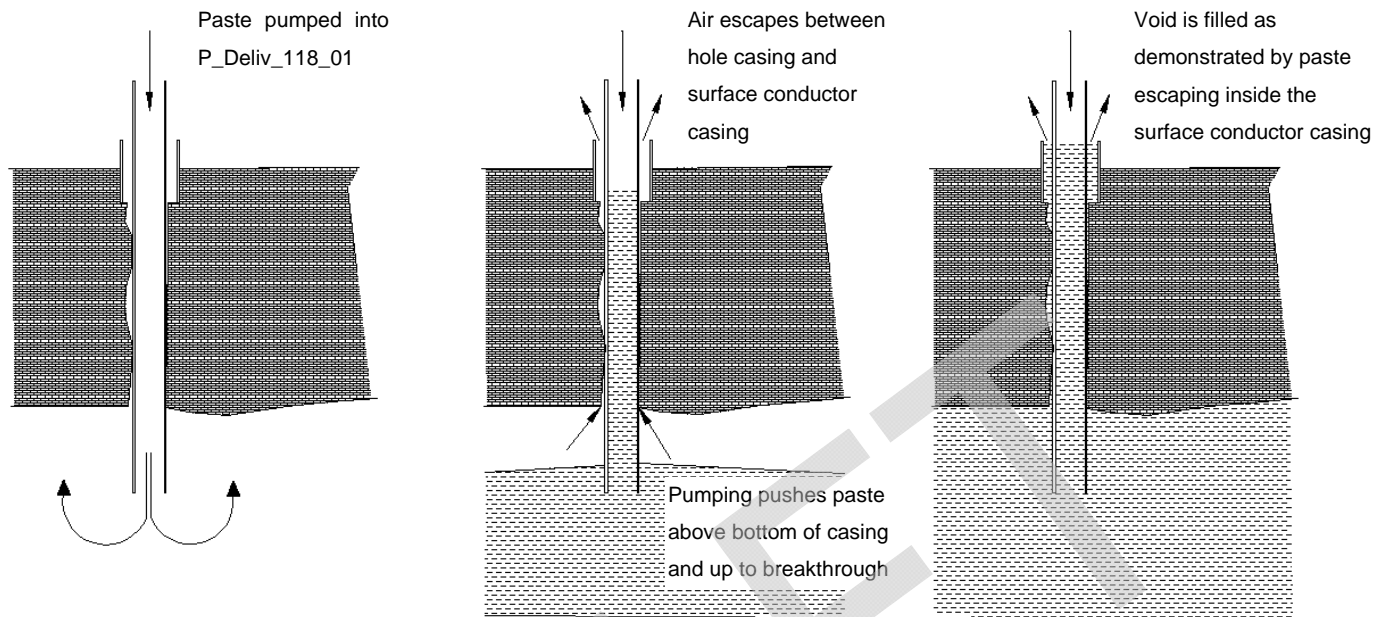
Plate 1: Schematic of final filling of P\_Deliv\_118\_01

The evidence that the B1-18 Lower stope is full comes from the fact that during the pumping of the final lift into P\_Deliv\_118\_01, paste was observed coming out of borehole BKG\_T\_12\_15. As the underground leak points from the B1-18 Lower had been sealed, the only avenue for the air/paste to escape from the B1-18 Lower was back to surface through BKG\_T\_12\_15. It was also observed that during the pumping, paste came out of the ground between the surface conductor casing and the full length hole casing on P\_Deliv\_118\_01. Due to the very low viscosity of the paste pumped and the fact that the paste inside the full length hole casing settled at the same level as the paste inside the surface conductor casing it can be concluded that all of the air around the breakthrough of the borehole has been forced out and the void is completely filled. This is illustrated below in Plate 1.

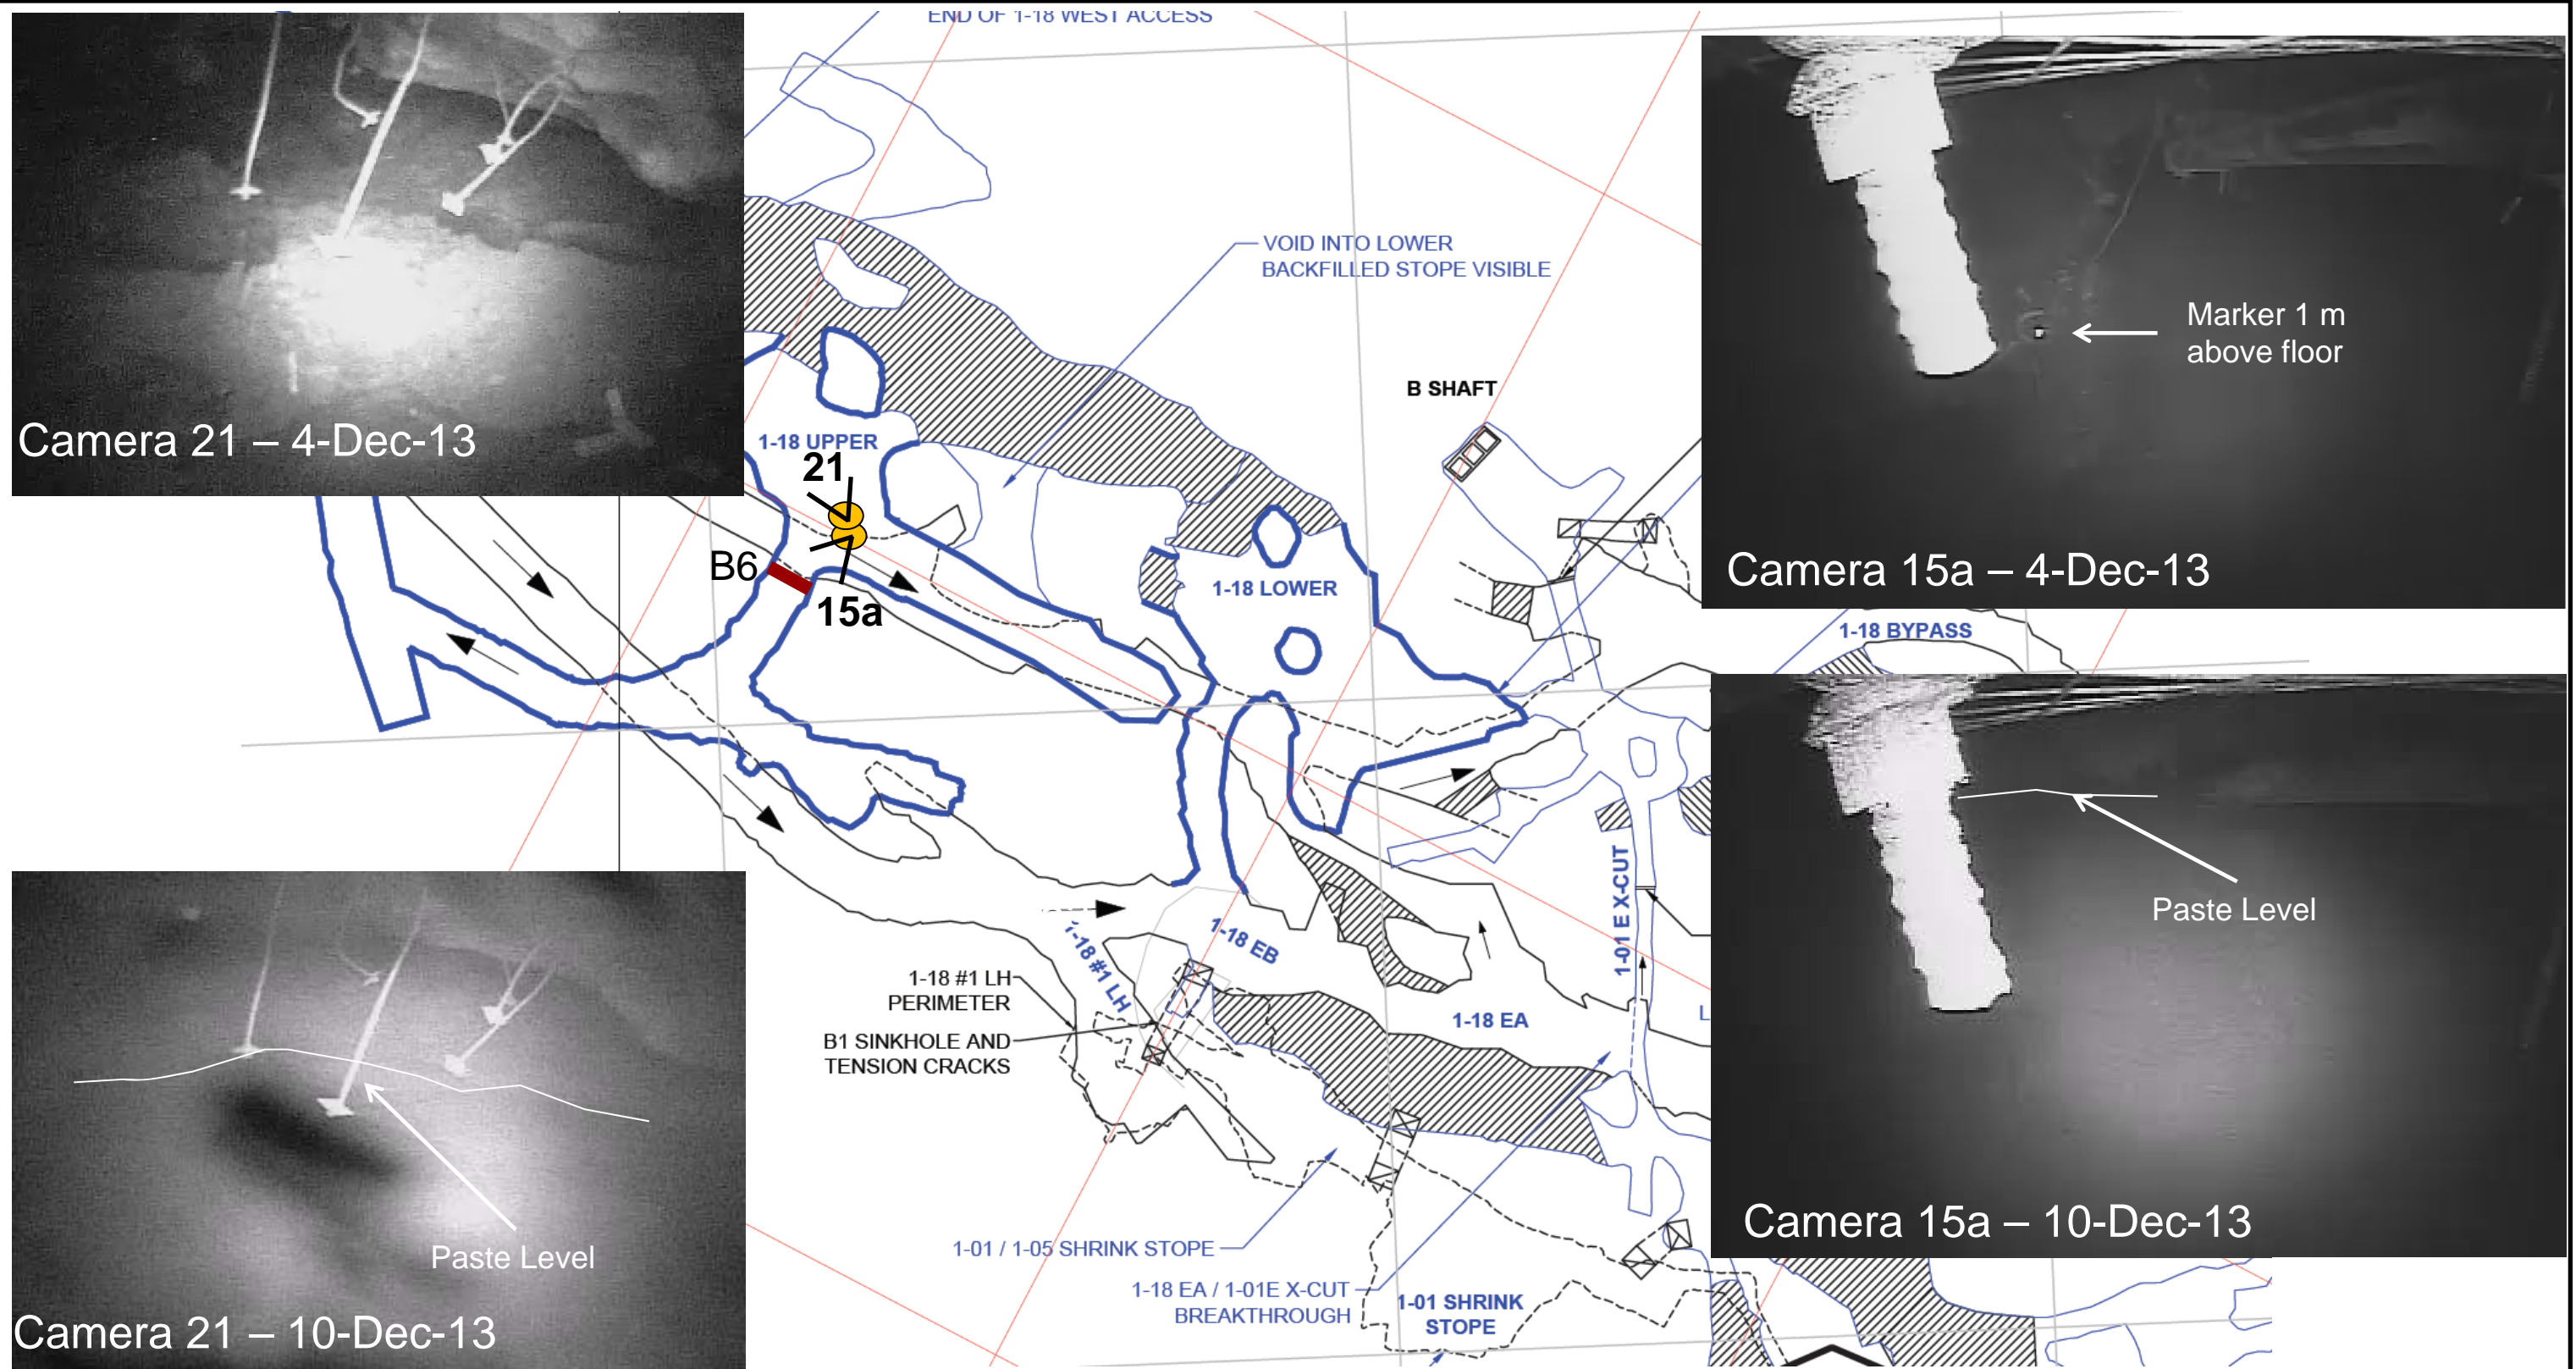
- Camera 15a looking at Barricade 6 shows paste ~ 2 m depth
- Camera 21 looking at the high spot in 1-18 Upper stope shows paste above muck berm ~2 m depth.
