DESIGNATED SUBSTANCE SURVEY

LaSalle Causeway
Kingston, Ontario

FINAL REPORT

March 26, 2009

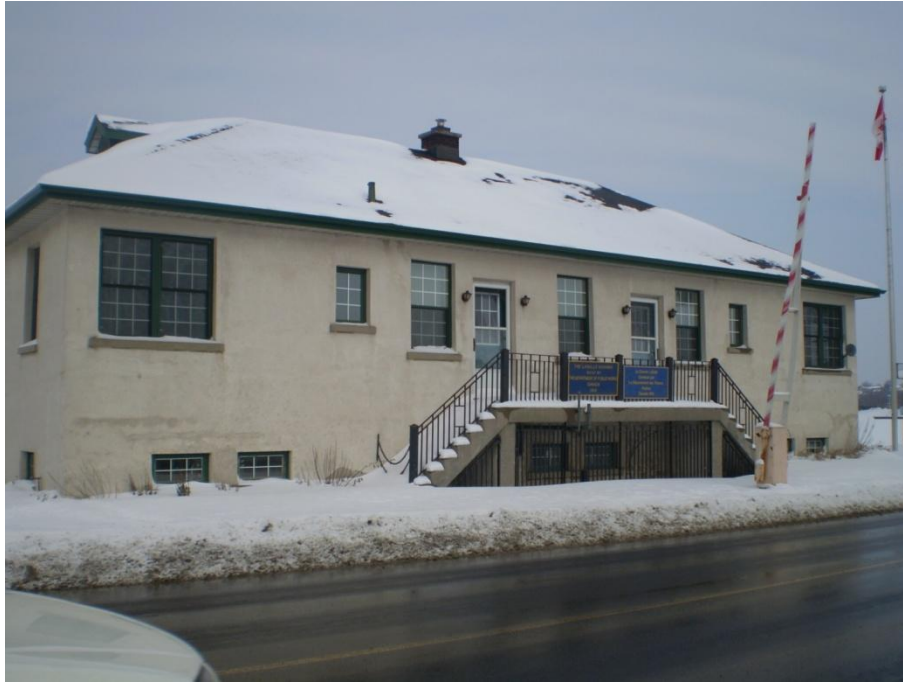
Photo 1: Main office building

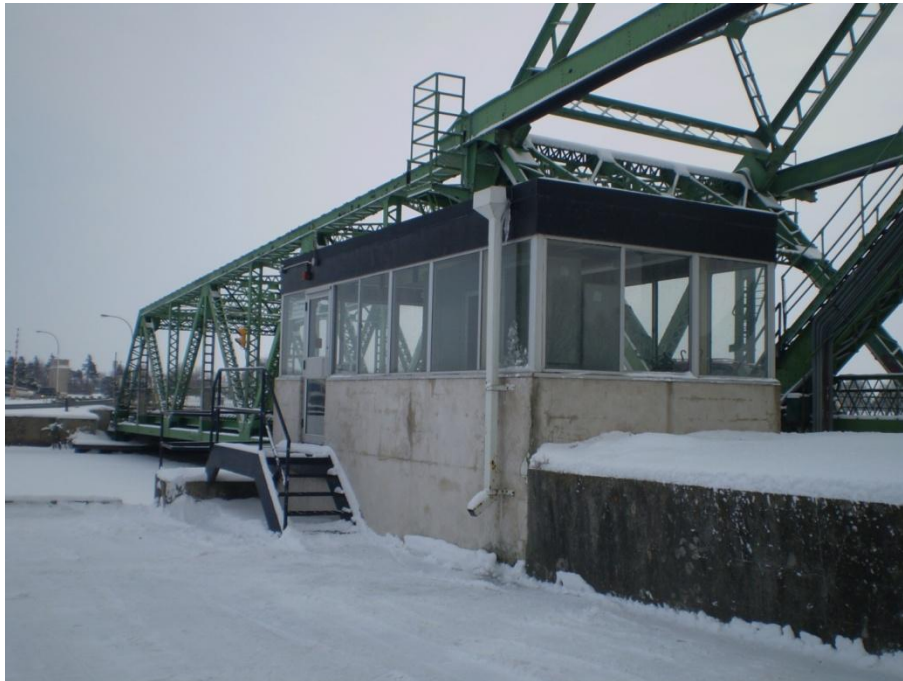
Photo 2: Control building

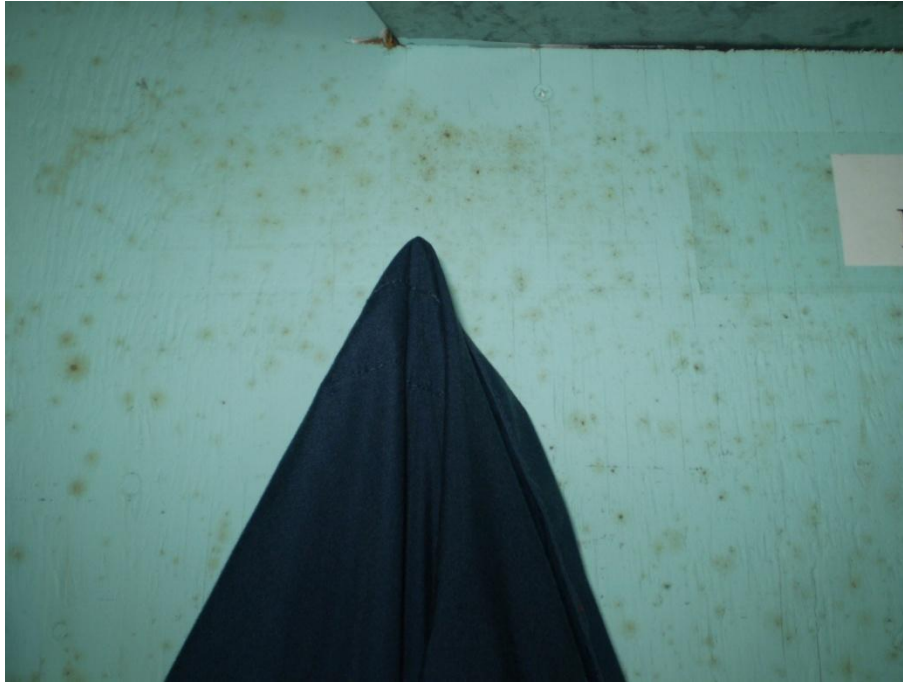
Approximately 2.5 square meters of potential mould was visually identified in the southwest room on the main floor as well as on the door of a wooden storage cabinet in the furnace room. The rooms did not exhibit signs of excessive humidity or visible moisture at the time of the site visit and no leaking or condensing piping was observed in these rooms at the time of the site visit. It was noted that the area of mould growth in the southwest corner room was directly beneath the coat hooks. Wet coats and gear are hung on these coats and may be a potential source of moisture.

Photo 3: Area of suspected mould growth on wooden storage cabinet.

Remediation is recommended in accordance with Canadian Construction Association mould remediation guidelines. (Photo 3, Appendix C)

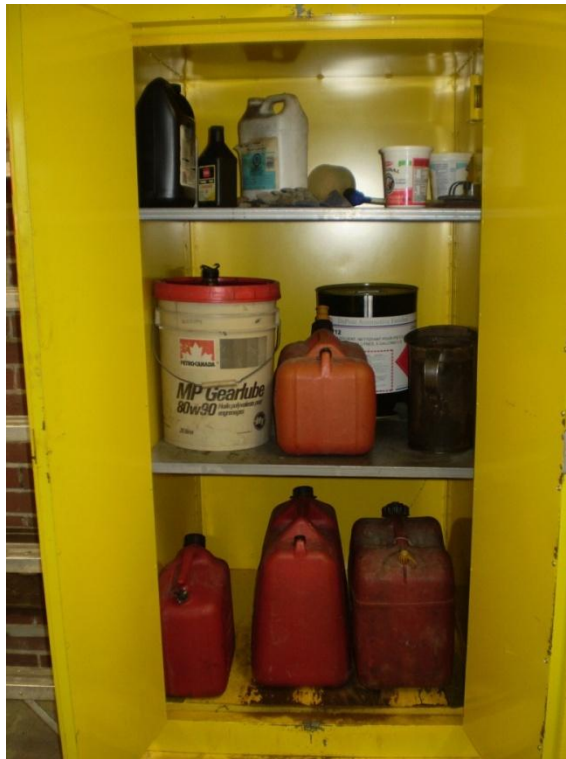
There were a number of unidentifiable chemical containers located in the fireproof cabinet in the furnace room that also houses various cans of paints and thinners. A MSDS binder was not readily available during the site visit and not all chemicals were labelled properly as per the Workplace Hazardous Materials Information System (WHMIS). (Photo 4, Appendix C)

Photo 4: Flammable storage cabinet with fuel and other chemicals

These unlabeled or improperly labelled containers should be appropriately labelled as per WHMIS regulation.
