## **PRE-DEMOLITION HAZARDOUS MATERIALS SURVEY**

### **Lower Post, B.C. - Vacant Home**

**Sterling IAQ Consultants Ltd. # 51247**

**February 18<sup>th</sup>, 2014**

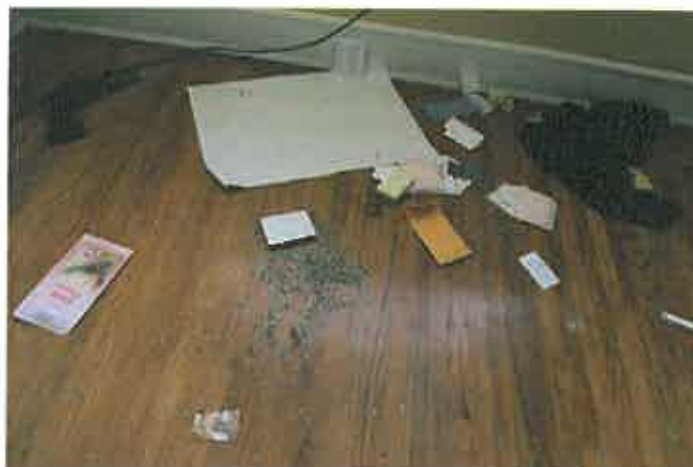
Photo 1

Mechanical insulation and taping sampled throughout the basement all tested negative for asbestos. A thorough inspection of the wall cavities, ceiling cavities, and attic identified only fibreglass insulation throughout the subject building. However, it should be noted that approximately 3 tablespoons of vermiculite insulation was observed on the floor of the upstairs rear bedroom (Photo 1). As there was not enough of the material present to collect a viable sample for analysis, this material must be assumed to contain asbestos and be treated as such.

Visual inspection of the area surrounding the vermiculite insulation found no signs that it originated from the walls or ceiling, as they were all intact. Rather, it was suspected that the material may have fallen out of a damaged appliance or other item that was previously in the home. It was reported that a sample of exterior flooring collected on the front patio some time in the past was found to be asbestos containing. However, inspection of the patio floor by Sterling IAS did not identify any suspected asbestos-containing materials.
