**ADDITIONAL GEOTECHNICAL TEST HOLE INVESTIGATION
PROPOSED STRUCTURAL STABILIZATION OF STORES BUILDING
SAULT STE. MARIE, ONTARIO**

**AMEC Environment & Infrastructure,
A Division of AMEC Americas Limited**

11 March 2014

AMEC Project No.: **TY1230281**

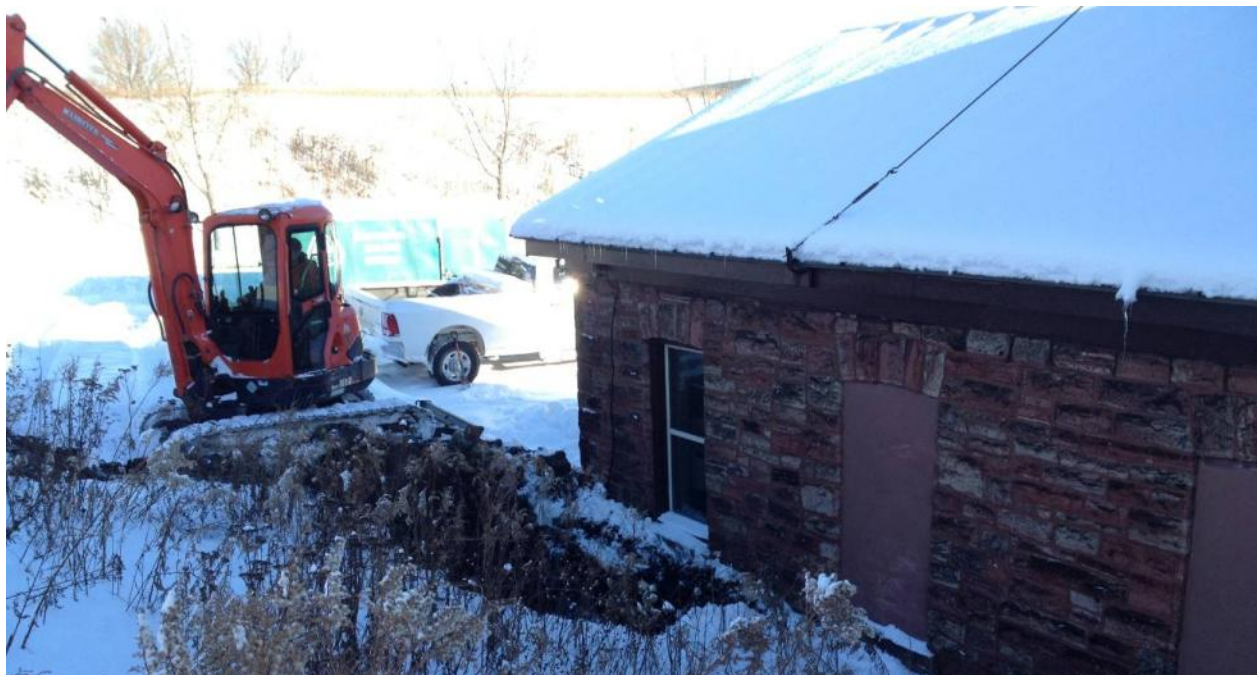
Photo 2: View of TP13-03 excavated at northwest corner of the building. The northern portion of the building does not appear to be moving, so this test pit was for comparative purposes.

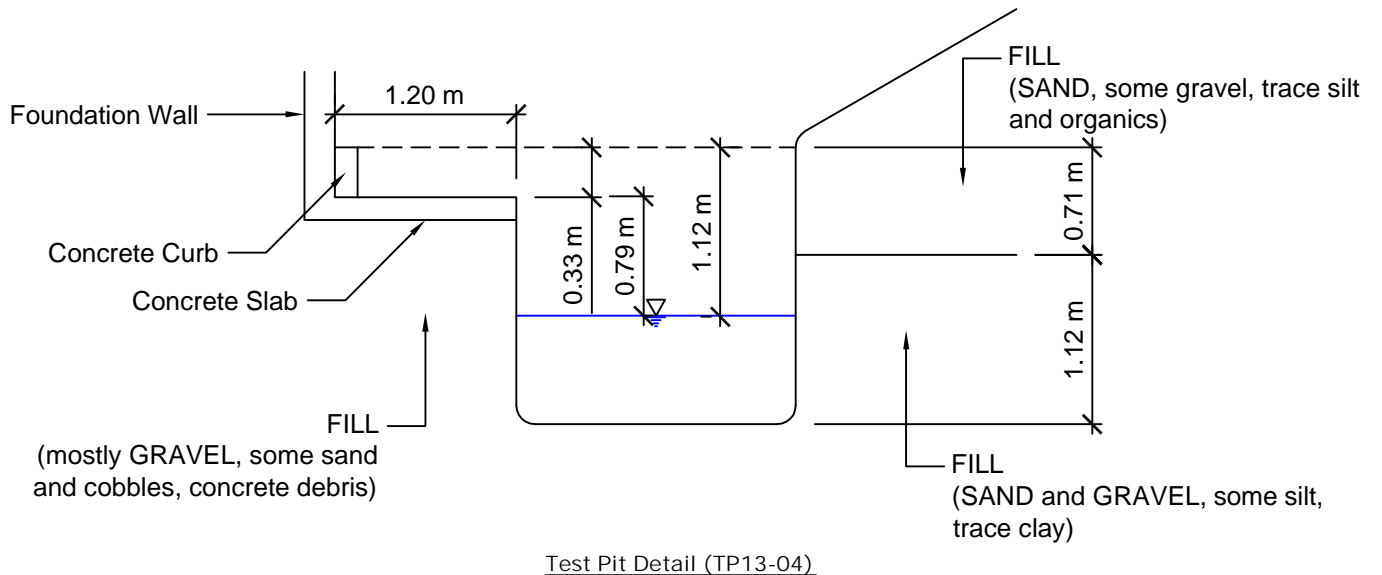
Foundation and Test Pit Details

A cross-section of the foundation wall is depicted on Figure 3.

Note: Wall section detail based on data from coreholes CH13-01 & CH13-02.

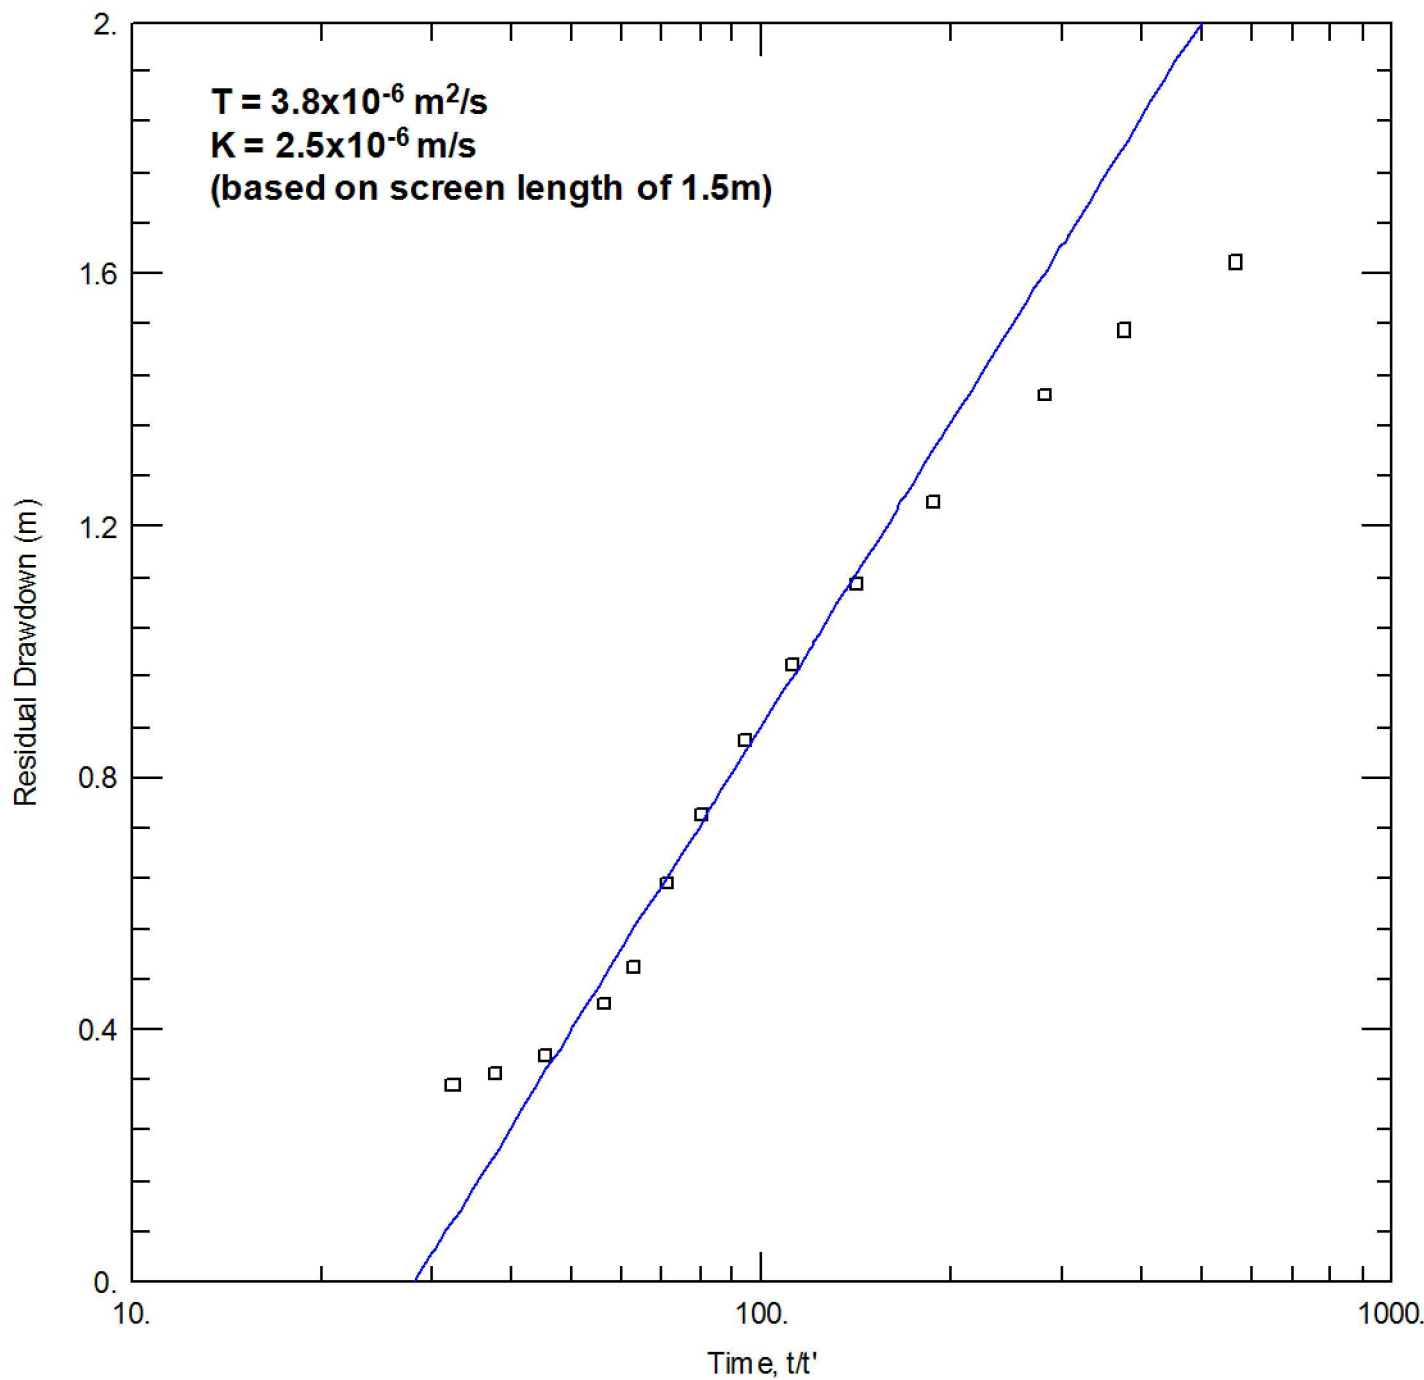
Theis (1935) analysis of recovery observed in BH13-04 after cessation of pumping is shown on Figure 9 and yielded an estimated aquifer transmissivity of $3.8 \times 10^{-6} \text{ m}^2/\text{s}$.

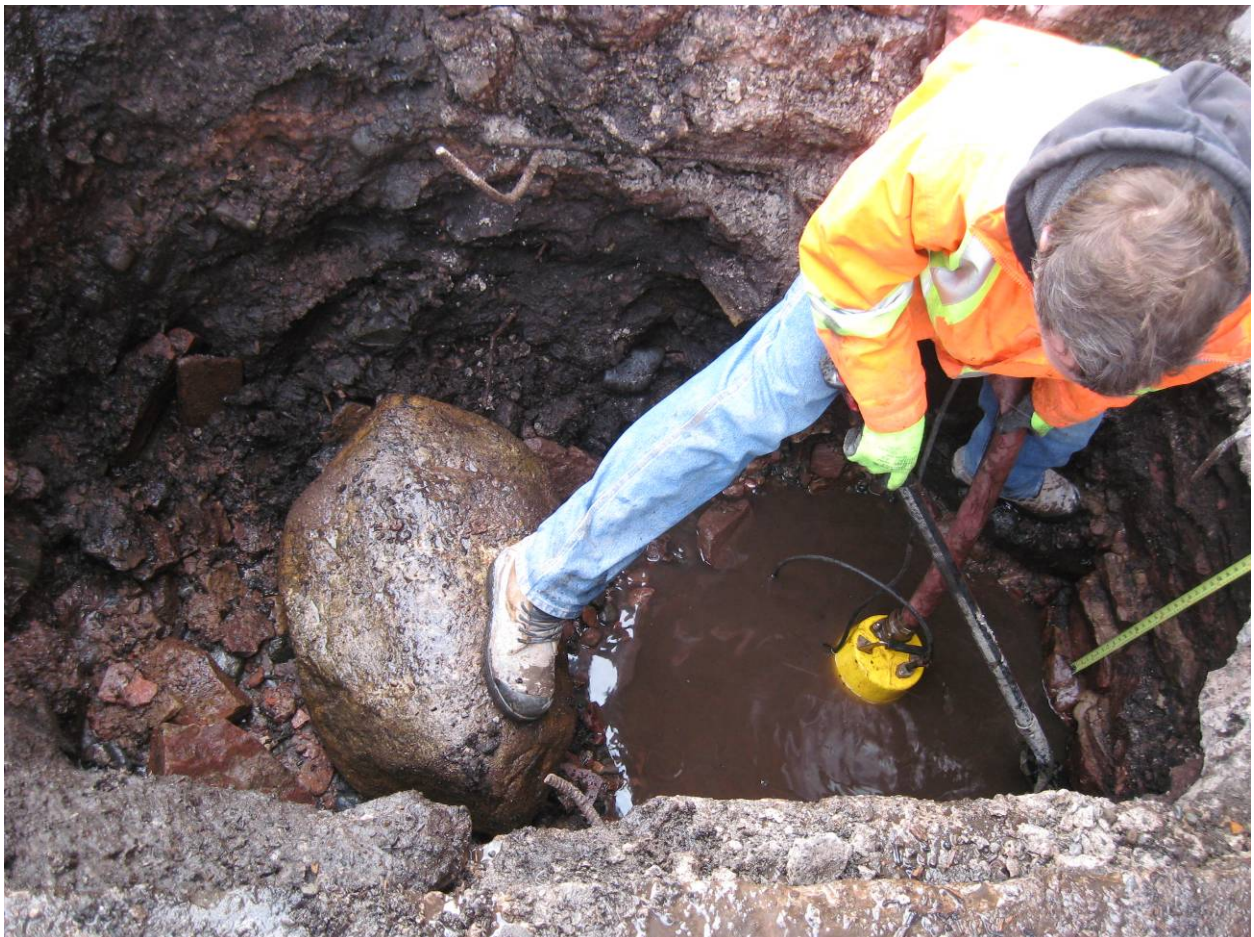
Photo 1: View of TP13-01. Poor quality fill, foundation wall to the right and infiltrating groundwater.
