Title - Sujet SWING BRIDGE REPLACEMENT	
Solicitation No. - N° de l'invitation EB144-150508/A	Amendment No. - N° modif. 002
Client Reference No. - N° de référence du client EB144-15-0508	Date 2014-09-17
GETS Reference No. - N° de référence de SEAG PW-\$PWA-115-5118	
File No. - N° de dossier PWA-4-72016 (115)	CCC No./N° CCC - FMS No./N° VME
Solicitation Closes - L'invitation prend fin at - à 02:00 PM on - le 2014-10-06	Time Zone Fuseau horaire Atlantic Daylight Saving Time ADT
F.O.B. - F.A.B. Plant-Usine: <input type="checkbox"/> Destination: <input checked="" type="checkbox"/> Other-Autre: <input type="checkbox"/>	
Address Enquiries to: - Adresser toutes questions à: Allen (PWA), Tanya	Buyer Id - Id de l'acheteur pwa115
Telephone No. - N° de téléphone (902) 496-5142 ()	FAX No. - N° de FAX (902) 496-5016
Destination - of Goods, Services, and Construction: Destination - des biens, services et construction:

ST. PETERS CANAL SWING BRIDGE
CAPE BRETON ISLAND

Mechanical and Electrical Inspection

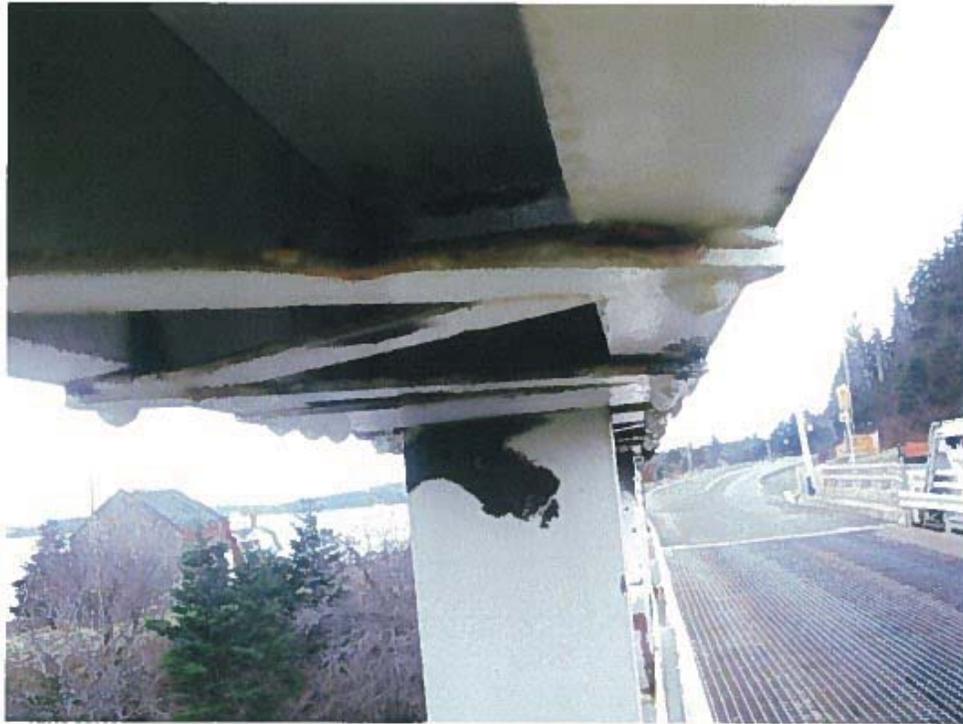
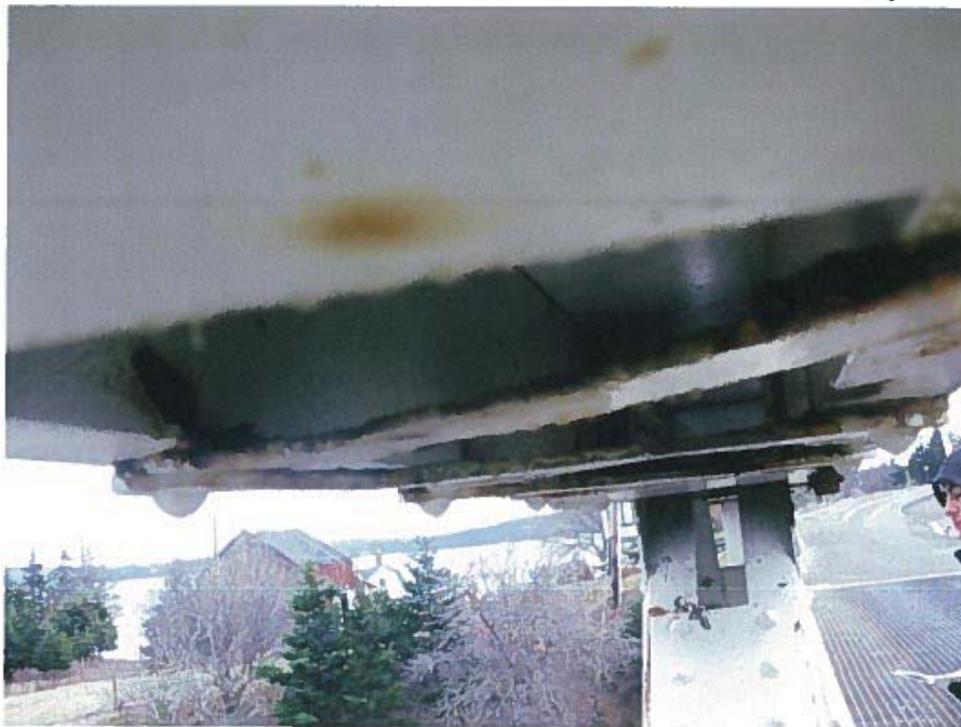
Photograph 3 – Lacing bars along top chord at north truss. Note: Section loss in lacing bars.

Photograph 4 – Lacing bars along top chord at north truss. Note: Section loss in lacing bars.

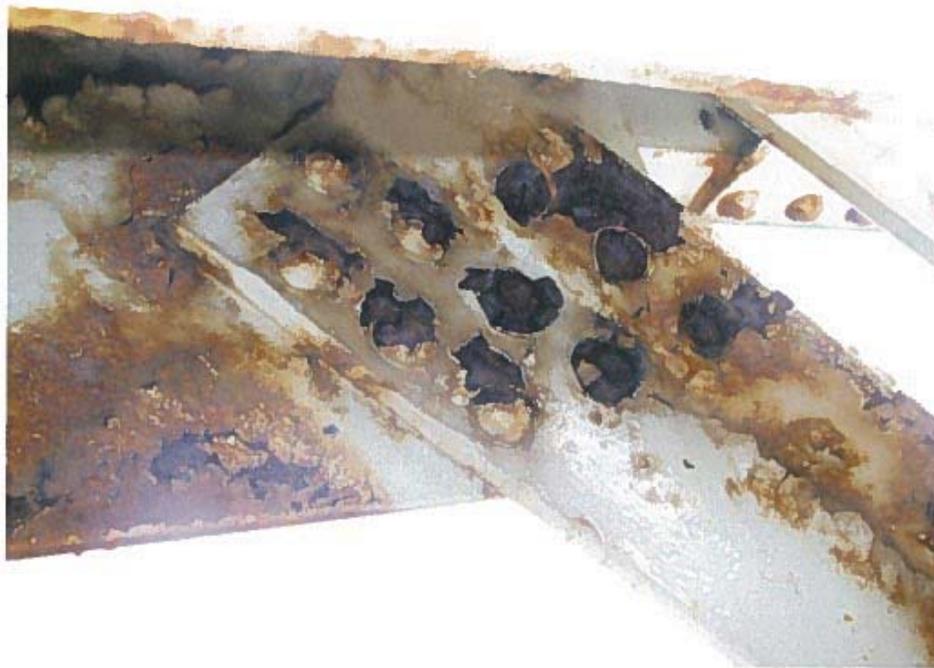
Photograph 5 – Condition of rivets at top chord (node 2W) on north truss. Note: Section loss and corrosion.

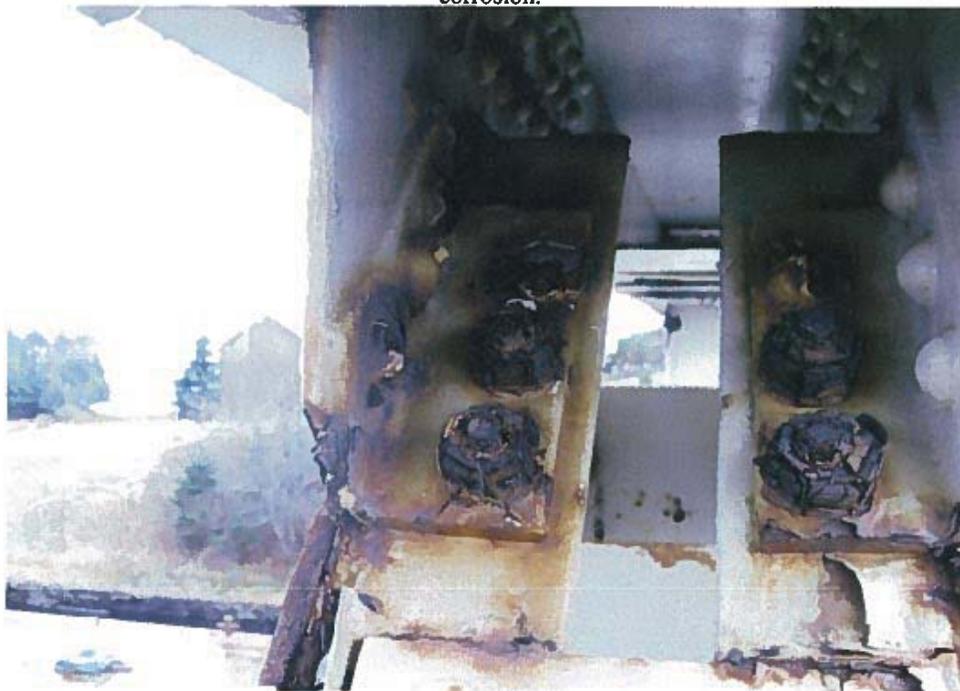
Photograph 6 – Condition of bolts at top chord (node 1W) on north truss. Note: Section loss and corrosion.

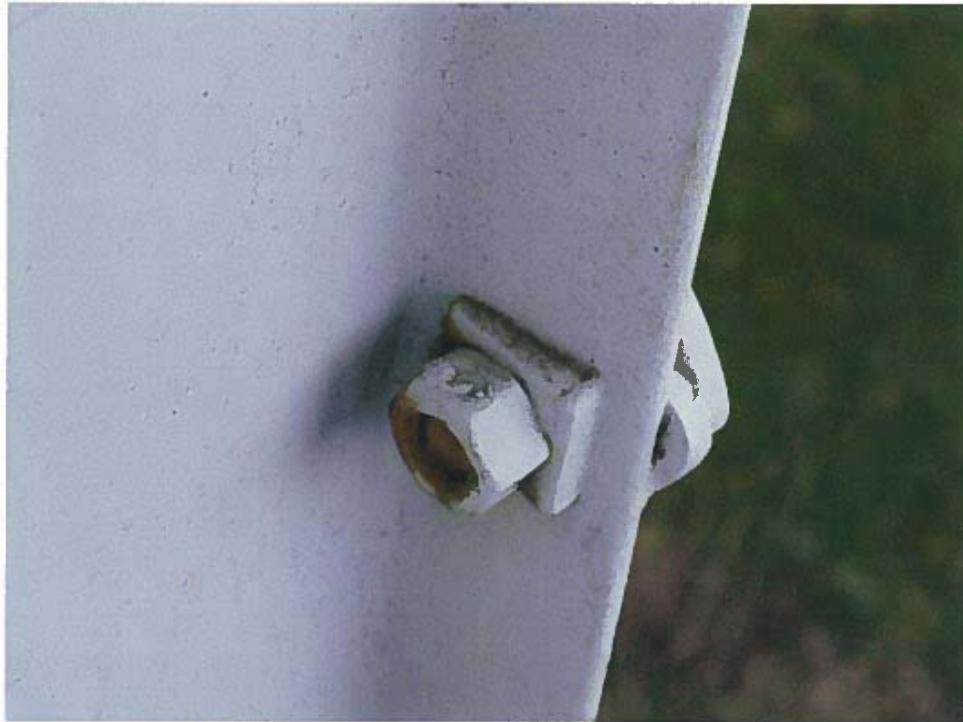
Photograph 7 – Insufficient bolt thread (typical).

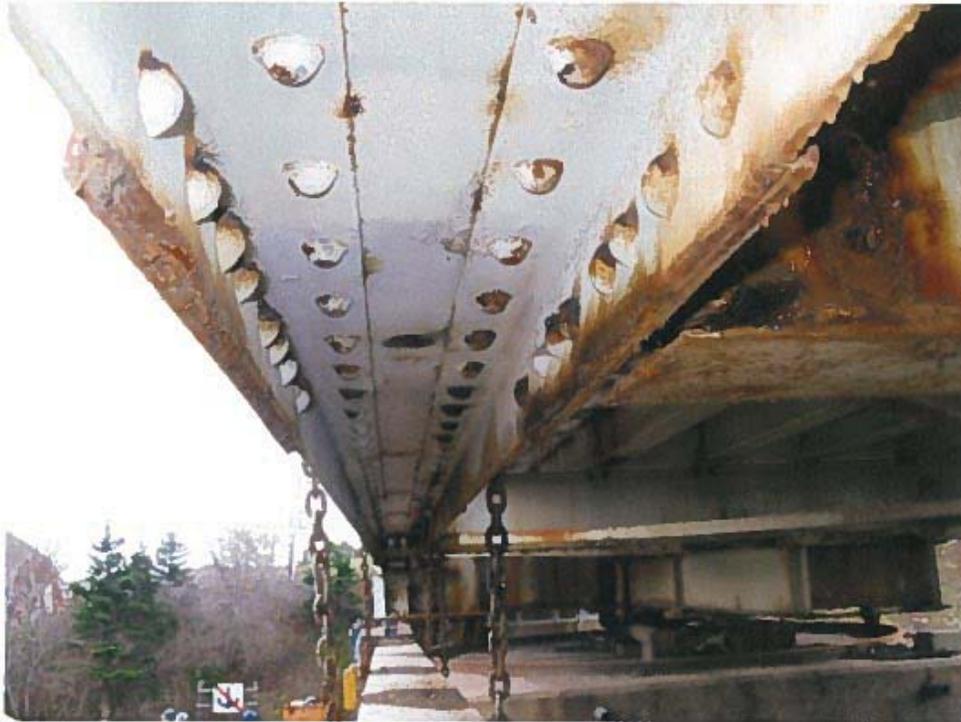
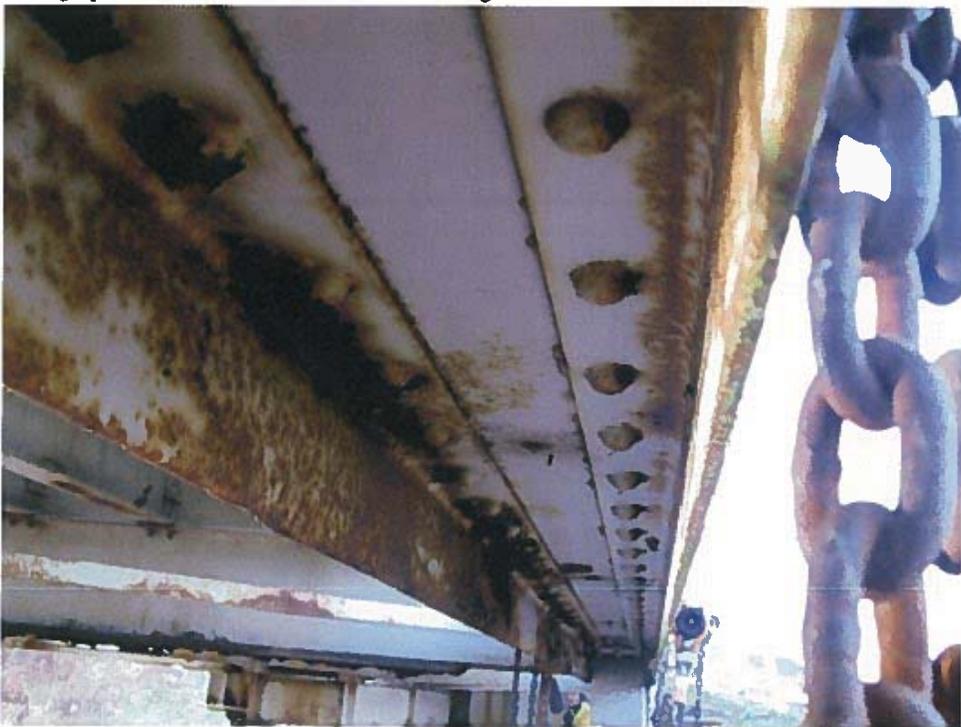
Below deck truss components, particularly the bottom chord, exhibited medium to severe corrosion as shown in Photograph 9 and 10. Numerous perforations were noted at the web and flanges of the bottom chord. Perforation at the web of the bottom chord at panel point 3W is shown in Photographs 11 and 12. Significant section loss can be noted throughout many lower chord members.

Photograph 9 – Condition of bottom chord along north truss. Note: Medium to severe corrosion.

Photograph 10 - Condition of bottom chord along north truss. Note: Medium to severe corrosion.

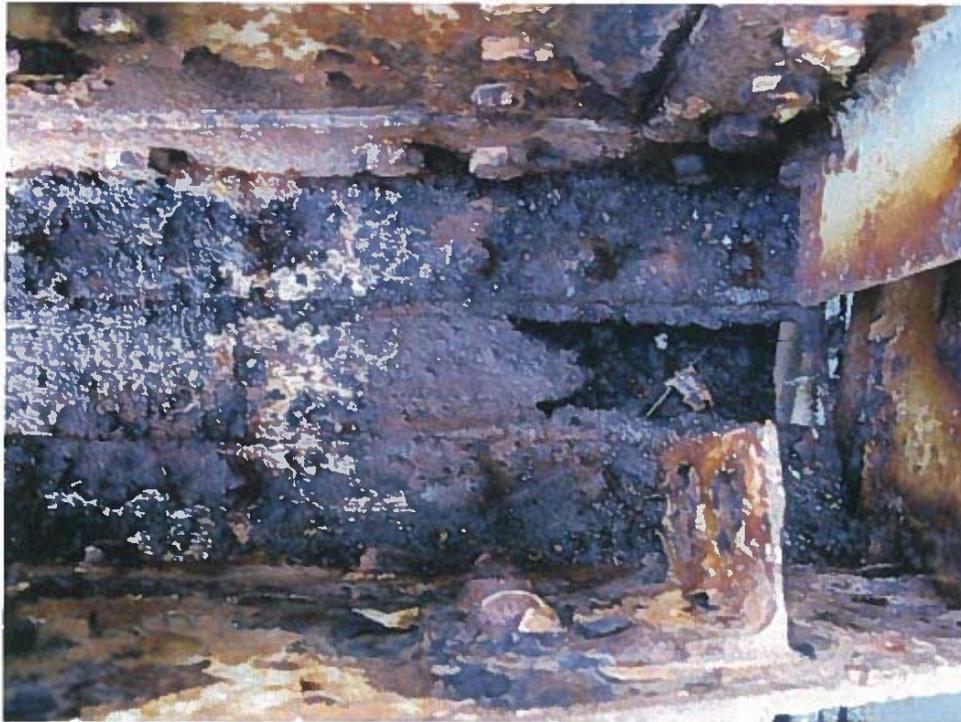
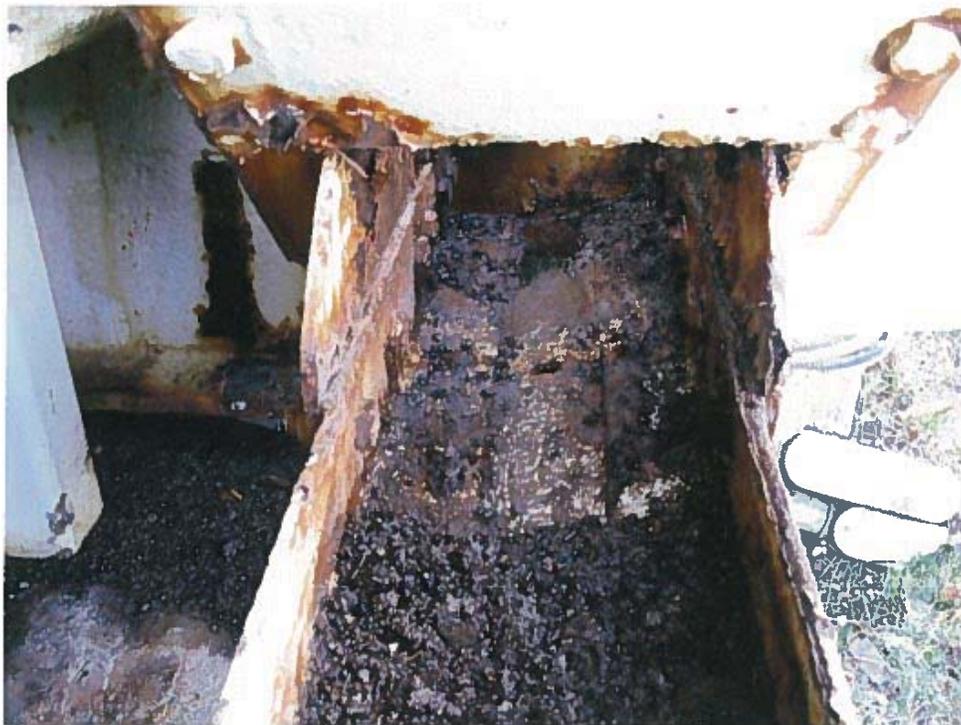
Photograph 11 – Perforation at north truss bottom chord at panel point 3W.

Photograph 12 – Perforation at north truss bottom chord at panel point 3W.

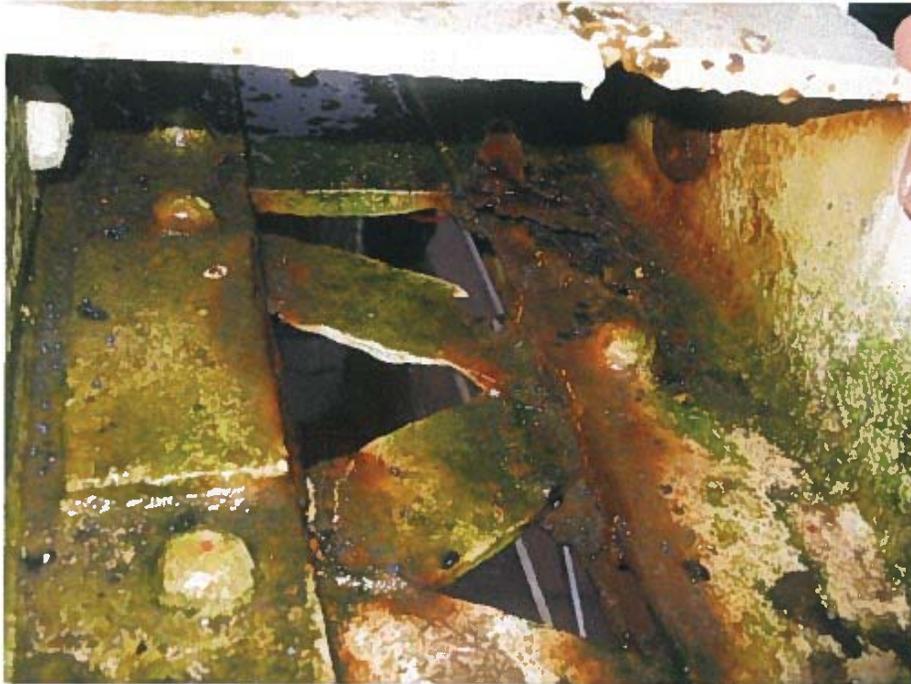
Lacing bars along the bottom of the chord between panel points 3E and 5E had section loss and perforations as shown in Photograph 13. MRC observed that the lacing bars at the connection points also had severe corrosion with pack rust.

Photograph 13 – Perforation / section loss and corrosion at lacing bars at north truss bottom chord.

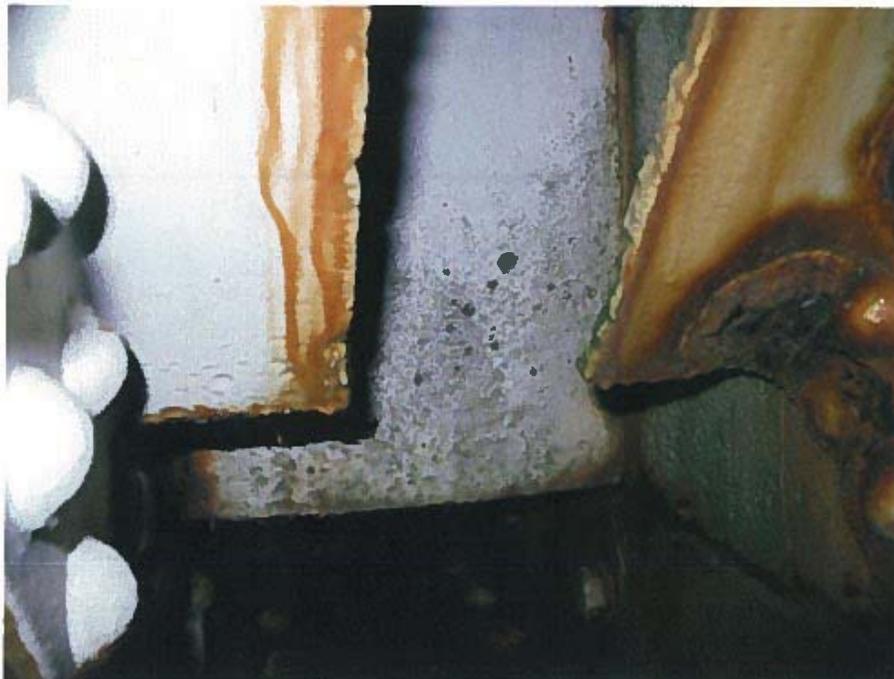
The diagonal and vertical members of the north truss were in good to fair condition with localized perforations and section loss noted at several locations. A typical perforation and section loss at a vertical member at panel point E4 is shown in the Photograph 14.

Photograph 14 – Section loss and perforation of the vertical member at panel point location along north truss bottom chord.

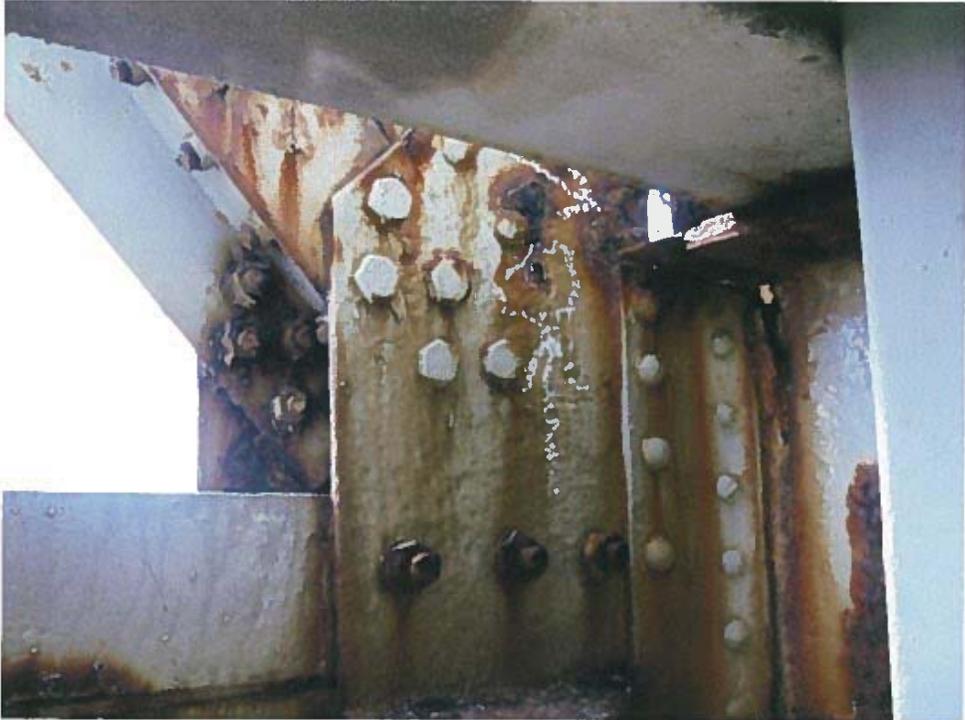
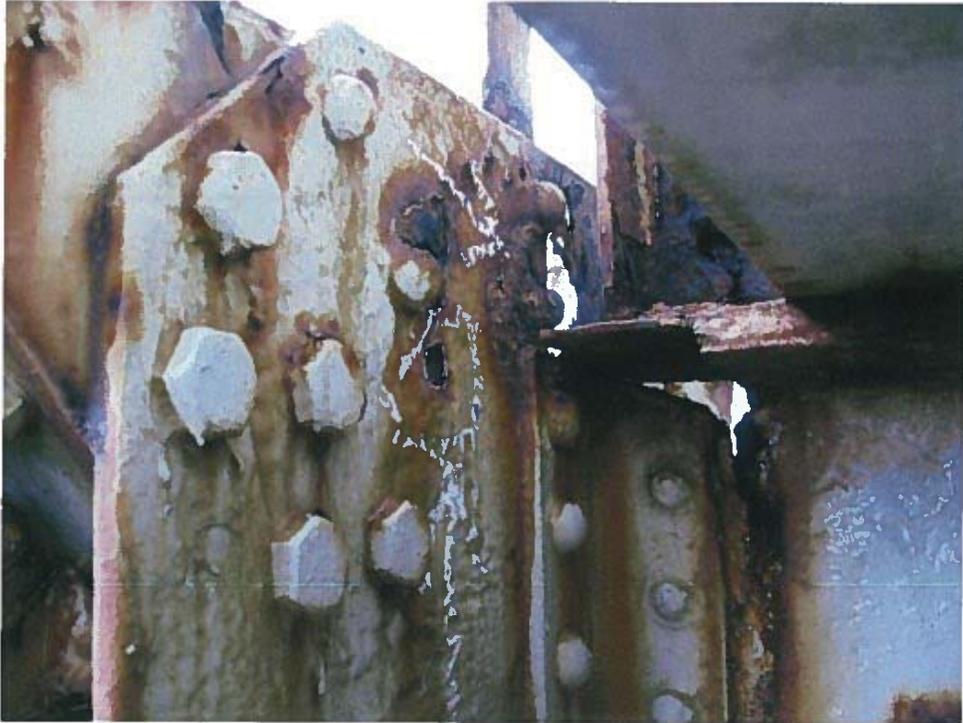
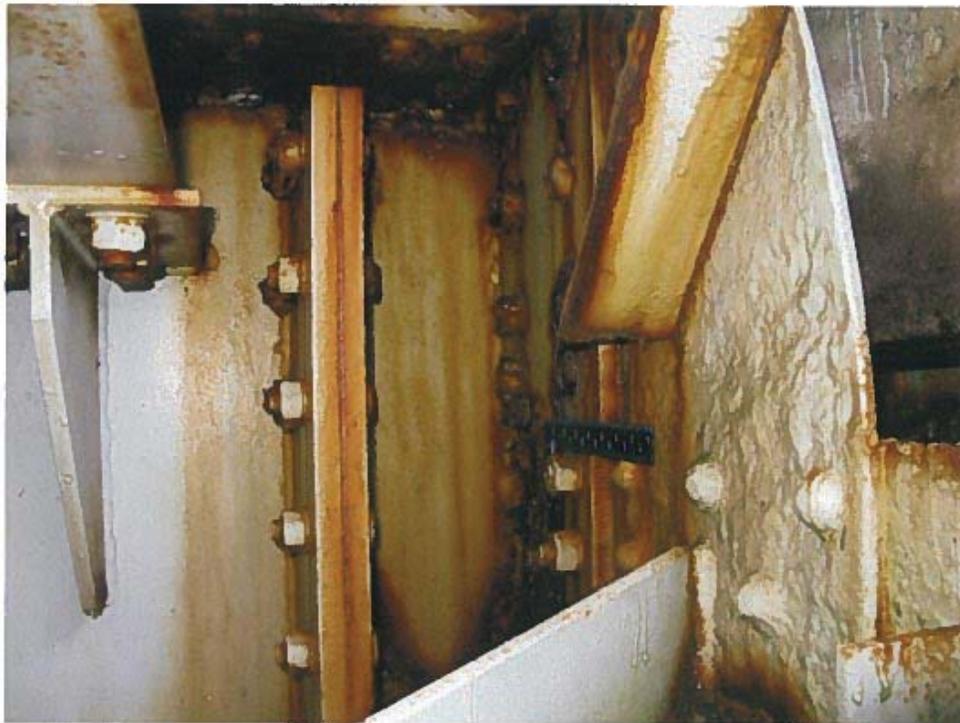
The condition of the gusset plates at the panel point locations along the bottom chord varied from good to poor. Perforations and section loss were noted. Typical conditions are shown in Photographs 15, 16 and 17. Using the Ultrasonic thickness gauge, MRC recorded the section loss at gusset plate locations where we visually observed the gusset plates had undergone section loss. We noted that the section loss at gusset plates at W2 (Interior Plate), E1 (Interior Plate) and E3 (Interior Plate) varied from 20% - 50%.

Photograph 15 – Section loss and perforation at gusset plate location at north truss panel point 2W.

Photograph 16 - Section loss and perforation at gusset plate location at north truss panel point 2W

Photograph 17 – Section loss and perforation at gusset plate (panel point 0) at north truss.

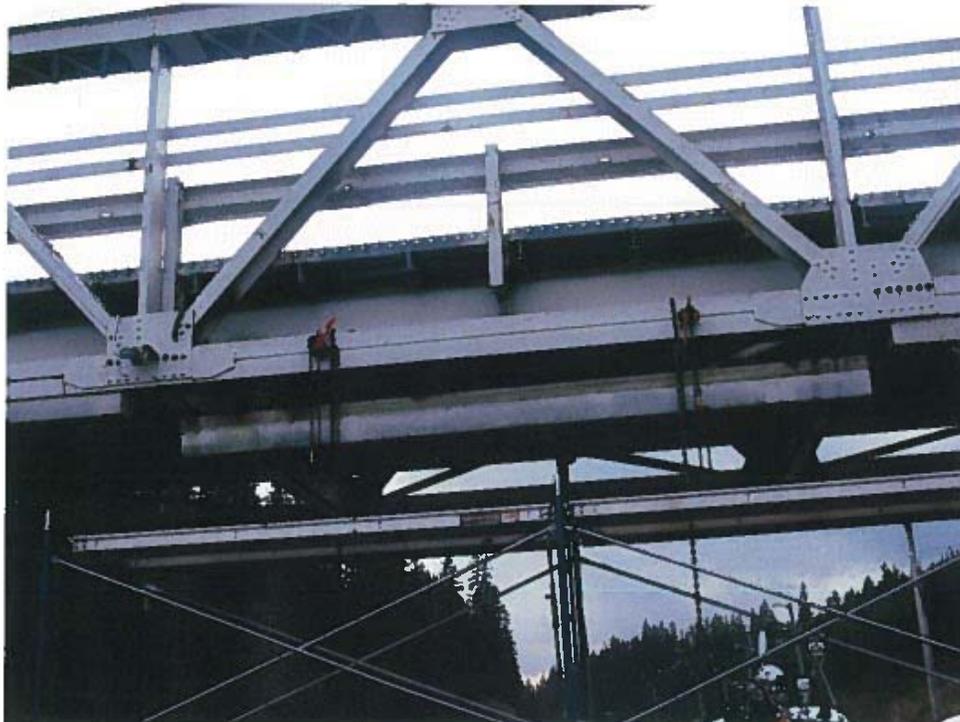
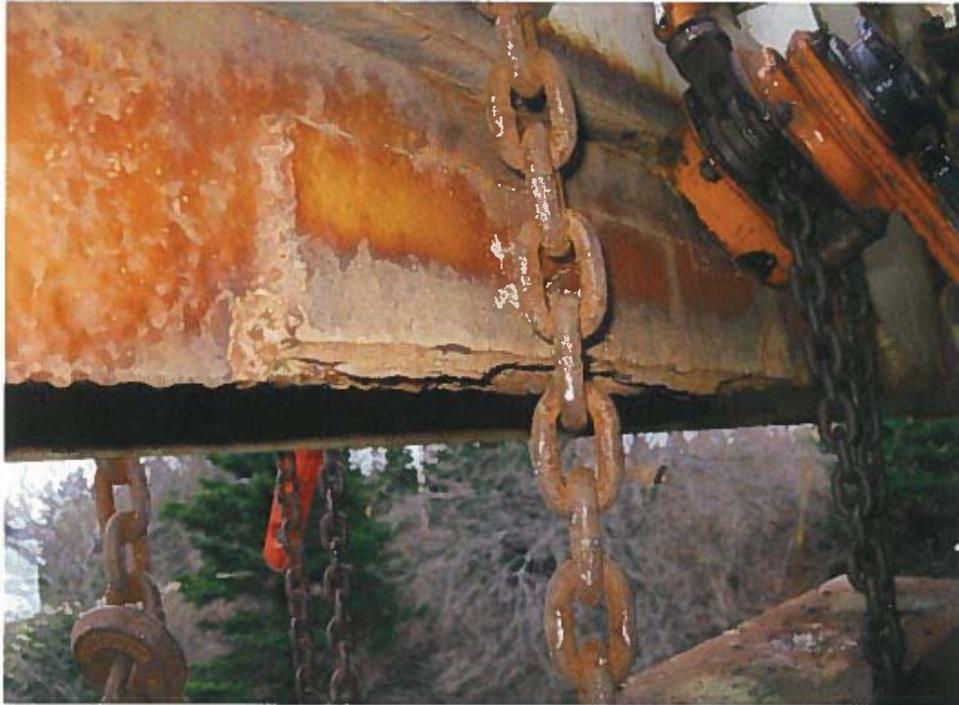
Numerous reinforcements have previously been completed to the north truss components by welding as shown in Photographs 18 and 19. Dynamically loaded structures such as bridges are subjected to variations in forces in the members. Movable bridges are even more unique with stress reversals in many members at some point during the movement of the bridge. Welded repair/reinforcement is generally not desirable in the tension zone, due to fatigue.

Truss members are typically reinforced due to inadequate tension or compression capacity for plain bolted or riveted members. The act of reinforcing the members by welding, generally creates weld fatigue details with stress range limits set by codes which are far less than the original member (without reinforcement). The reinforcement must be designed with this reduced capacity in mind.

Photograph 18 – Welded reinforcement along north truss bottom chord and at panel point locations.

Photograph 19 – Welded reinforcements along north truss bottom chord (between panel points 3E and 4E).

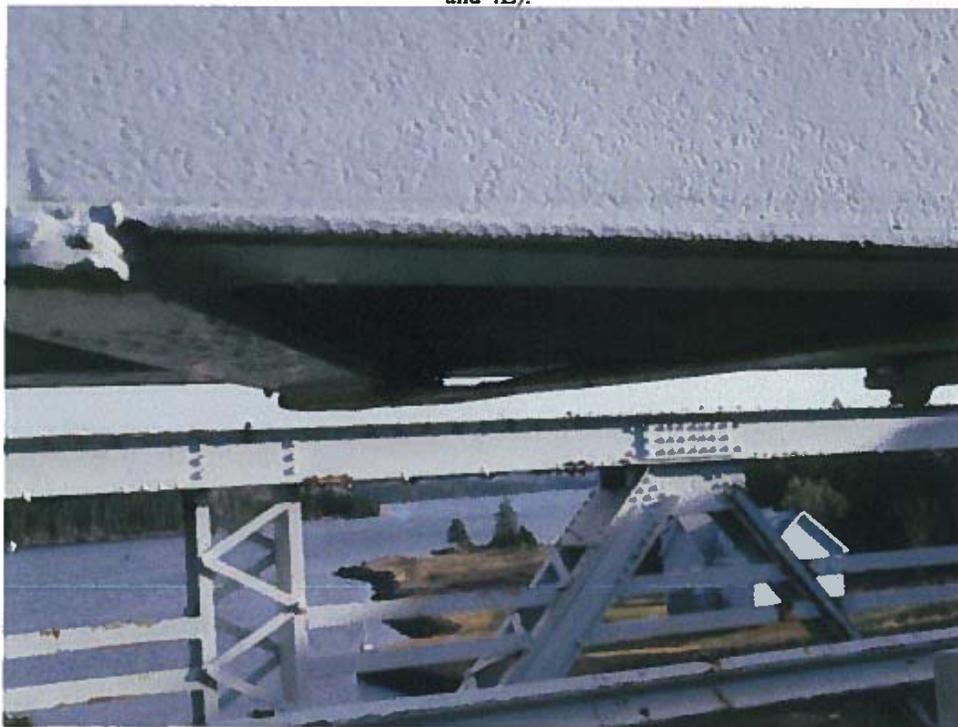
The south truss components above deck were in good to fair condition with localized areas of light, medium and severe corrosion. Lacing bars at the top chord between nodes 0 to 1W, 2W to 3W and 0 to 1E were noted to have section loss as shown in Photograph 20. Numerous rivets and bolts had section loss and had undergone severe corrosion.

Photograph 20 – Lacing bars along top chord at south truss. Note: Section loss at lacing bars.

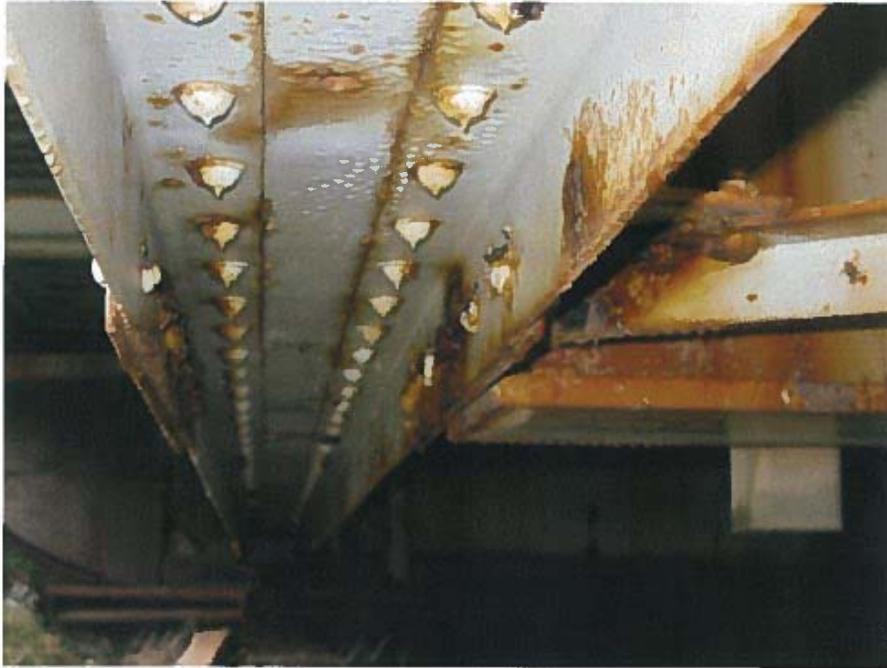
The bottom chord exhibited medium to severe corrosion as shown in Photograph 21. Numerous perforations were noted at the web and flanges of the bottom chord.

Photograph 21 – Condition of bottom chord along south truss. Note: Medium to severe corrosion.

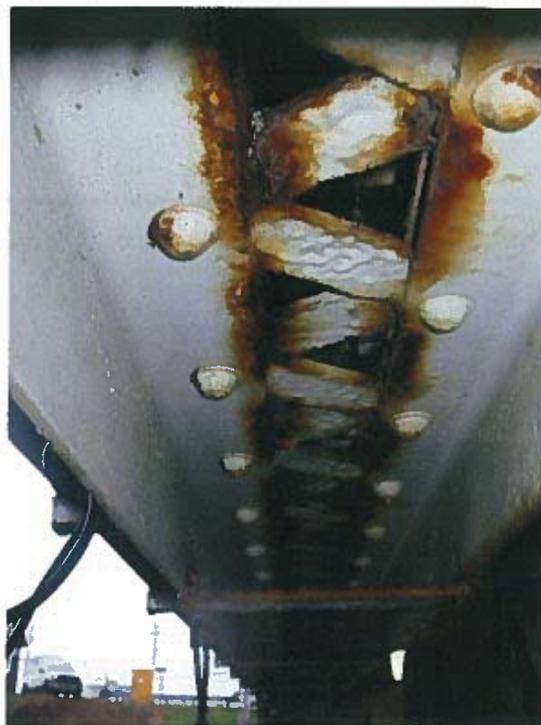
Lacing bars along the bottom chord between panel points 3E and 5E had section loss and perforations as shown in Photograph 22. We noted that the lacing bars at the connection points had severe corrosion and pack rust.

Photograph 22 – Condition of lacing bars along south truss bottom chord between panel points 3E and 5E.

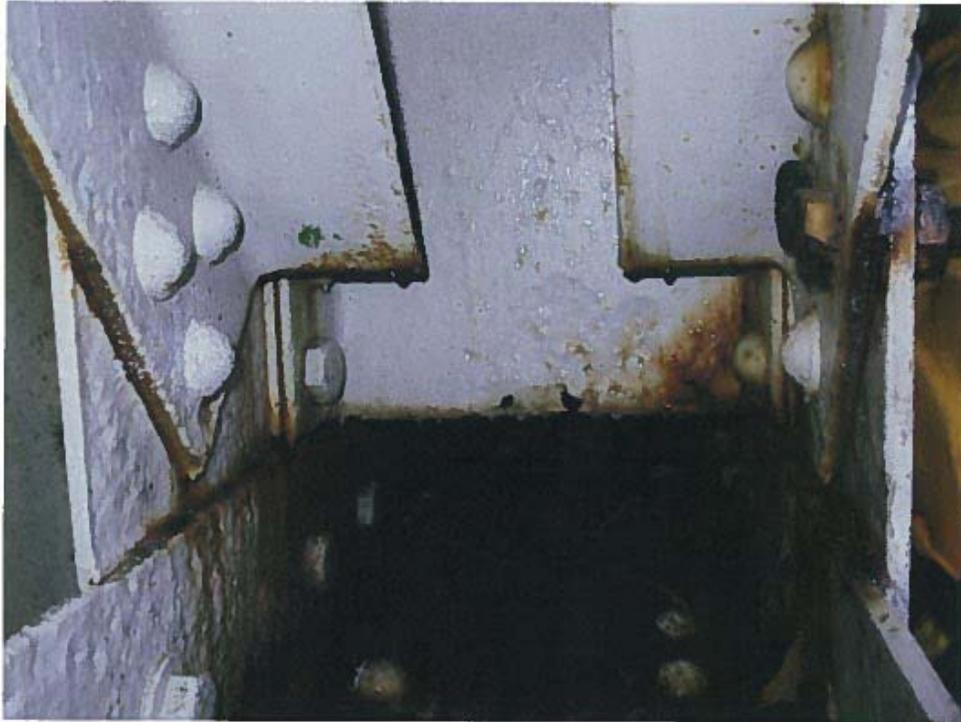
The diagonal and vertical members of the south truss were in good to fair condition with localized perforations and section loss noted at some locations. Typical perforation and section loss at the vertical member at panel point E4 is shown in the Photograph 23.

Photograph 23 – Perforation and section loss at vertical member at panel point 4E on south truss.

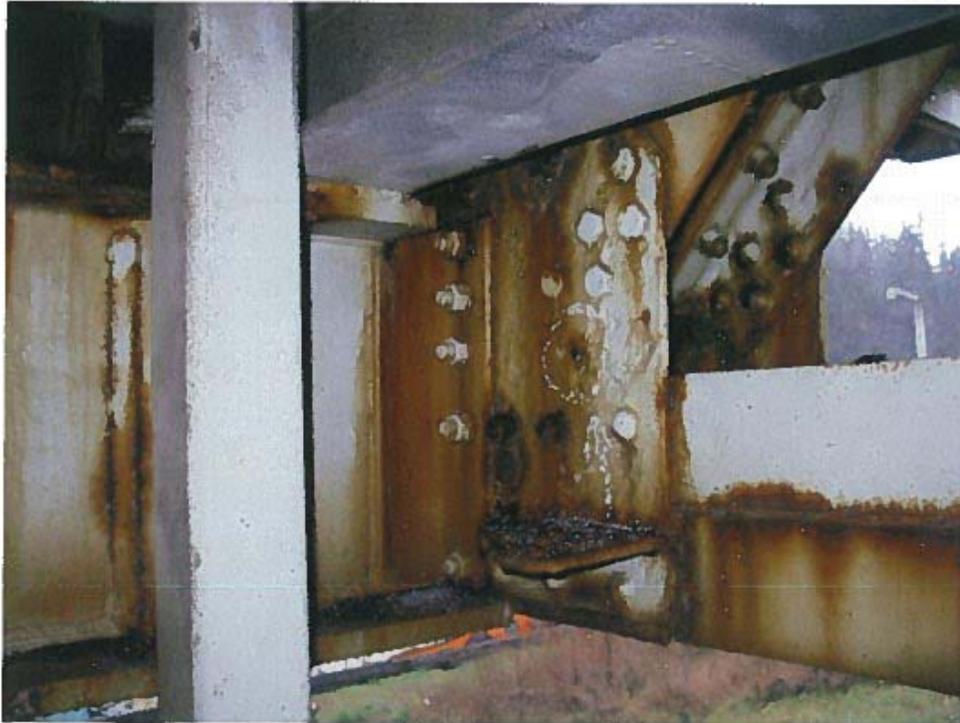
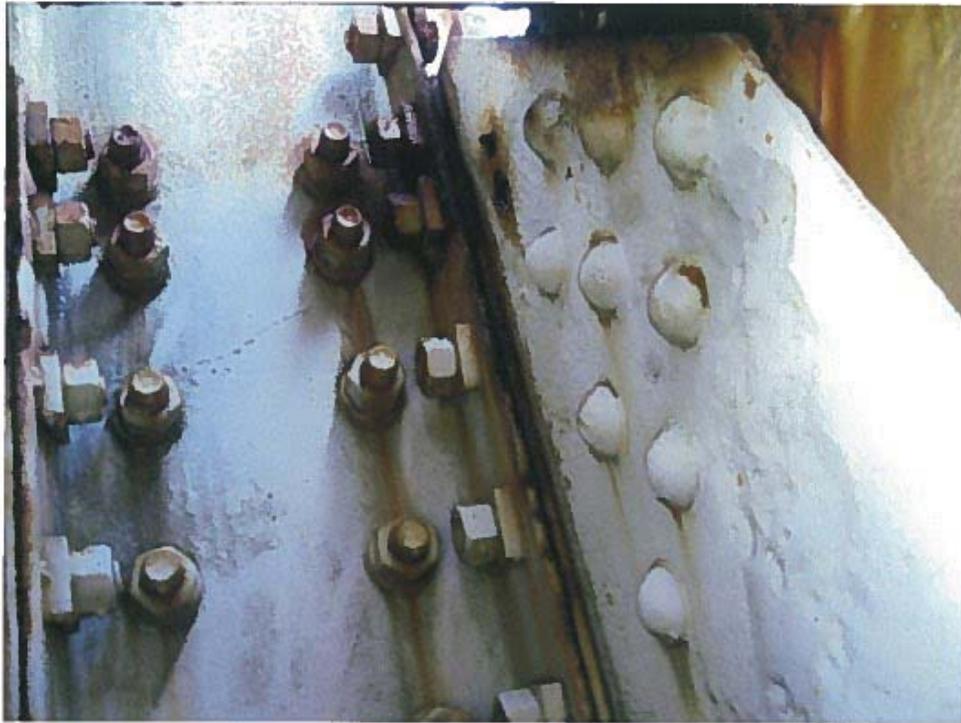
The condition of the gusset plates at the panel point locations along the bottom chord varied from good to poor. Perforations and section loss were noted. Typical conditions are shown in Photographs 24 and 25. Measurements of the section loss at gusset plates at W2 (Interior Plate), 0 (Interior Plate) and E3 (Interior and Exterior Plates) varied from 20% to 50%.

Photograph 24 – Perforation / section loss at gusset plate panel point 2W south truss bottom chord.

Photograph 25 – Perforation / section loss at gusset plate panel point 0 south truss bottom chord.

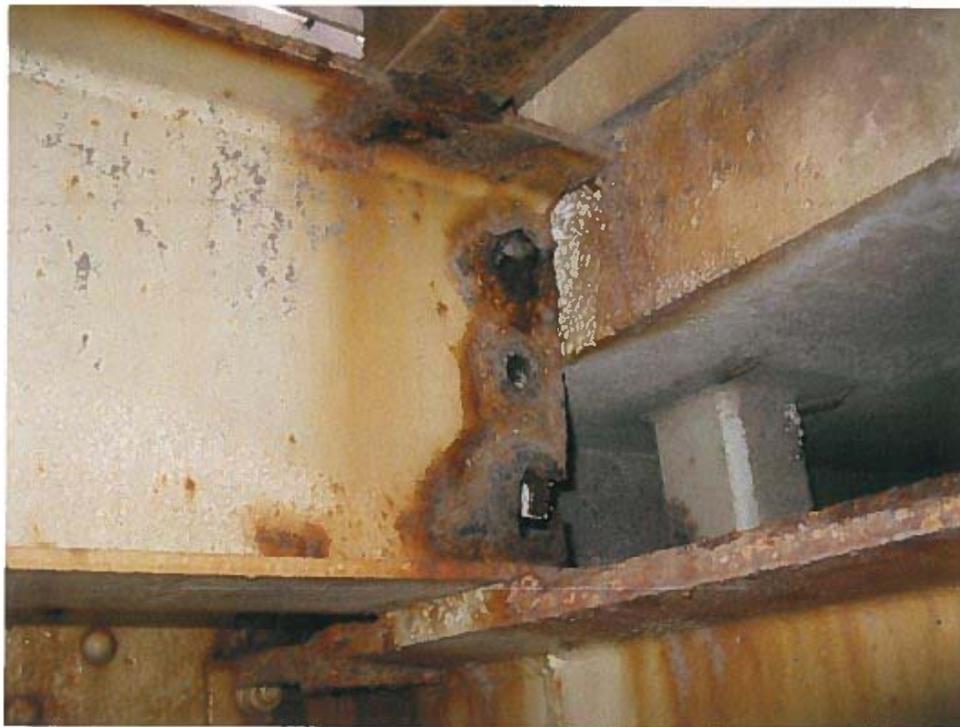
The transverse decking beams and the longitudinal stringers were in good condition with light to medium corrosion at the connections and along the bottom flange. Perforations and section loss at S8 between nodes 2W and 1W were noted as shown in Photograph 28. Typical condition of stringers and decking beams are shown in Photographs 29 and 30.

Photograph 28 – Perforation and section loss at stringer S8 between panel points 2W and 3W.

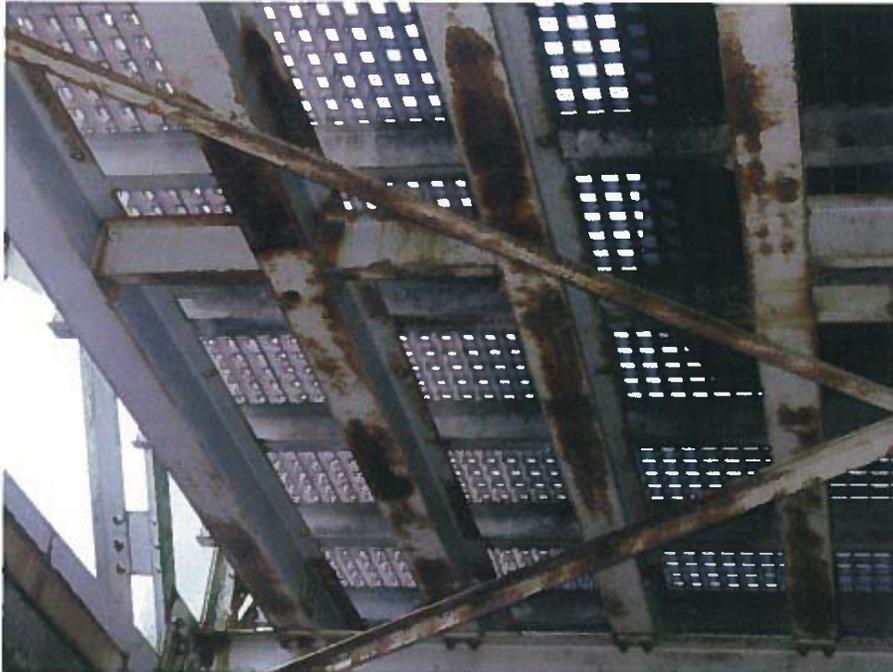
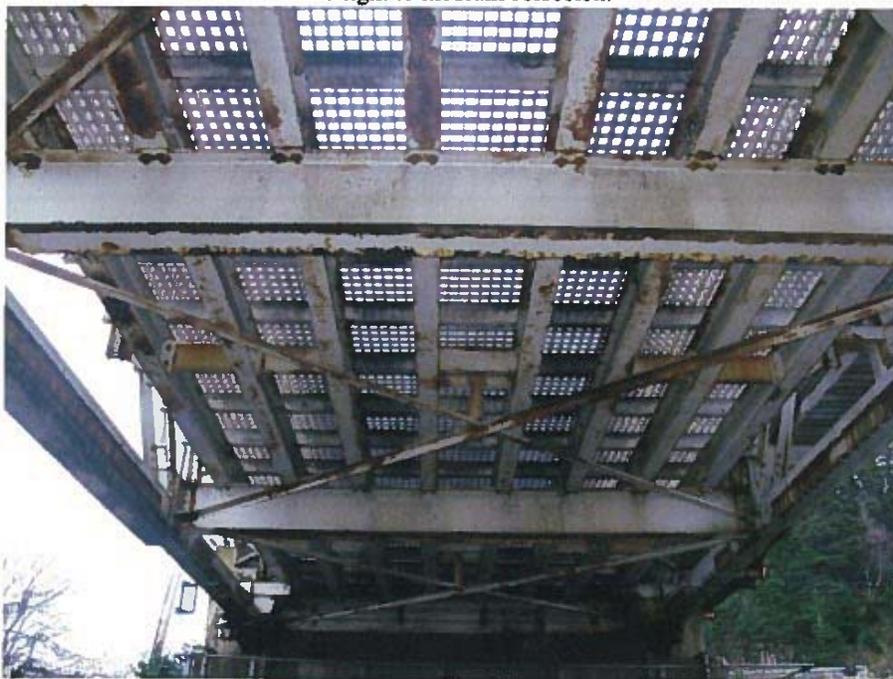
Photograph 29 – Typical condition of stringer/decking beams and grating. Note: coating break down and light to medium corrosion.

Photograph 30 – Typical condition of stringer/deck beams and grating. Note: the welded reinforcement to the bottom flange of the floor beam.

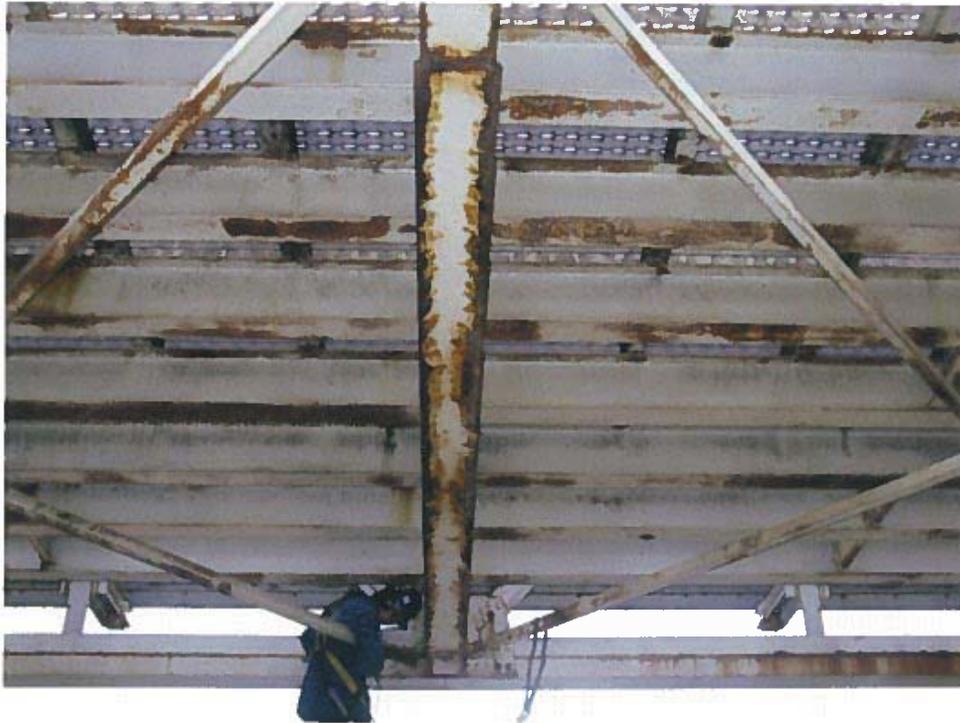
The transverse floor beams were generally noted to be in good to fair condition. It was noted that reinforcement has been welded at some floor beam locations along the bottom flanges (as shown in Photograph 31) and also on the web of the floor beams close to the connection angles (where the floor beam connects to the truss section). The end sections of the floor beams at panel point locations had medium to severe corrosion at the web and bottom flanges. The angles connecting the floor beams to the main truss were noted to be in poor condition at select locations with medium to severe corrosion along with section loss as shown in Photograph 32.

Photograph 31 – Typical condition of floor beams. Note: Welded reinforcement at the bottom flange.

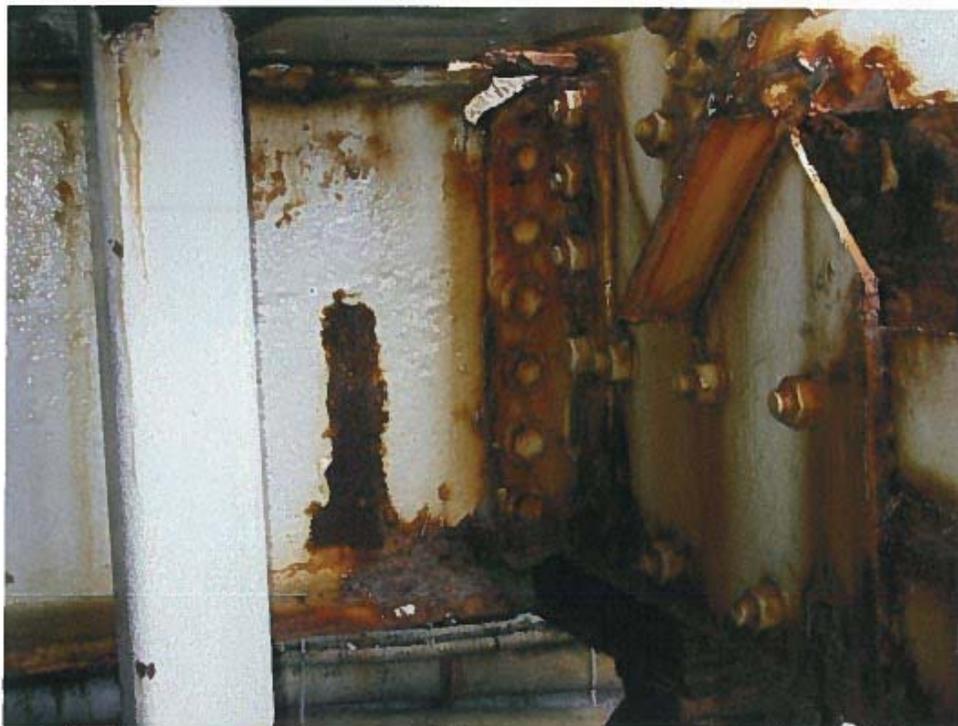
Photograph 32 – Typical condition of connection angles of the floor beam to the lower chord.

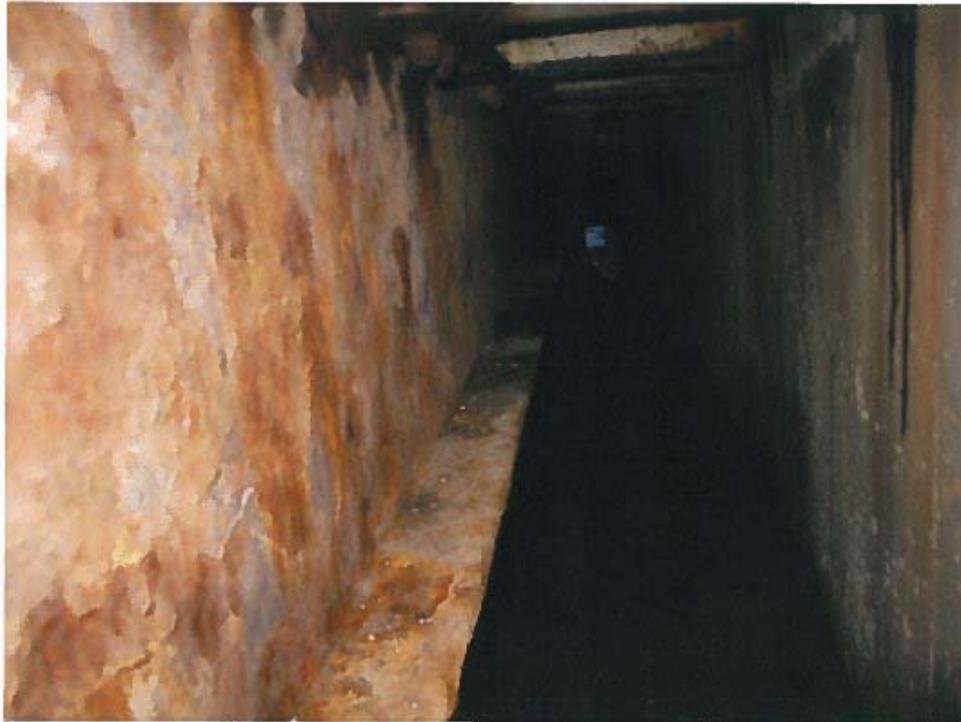
The web of the end floor beams (facing the ballast walls) had no coating protection as shown in Photograph 33. We believe the web of the end floor beam was probably not coated in 1991 (the time of the last cleaning and coating). Using the ultra sonic thickness gauge, the web thickness of the end floor beams was measured. Although unprotected, it was noted that the end floor beam had only minimal section loss.

Photograph 33 – Inside face of the end floor beam at east abutment.

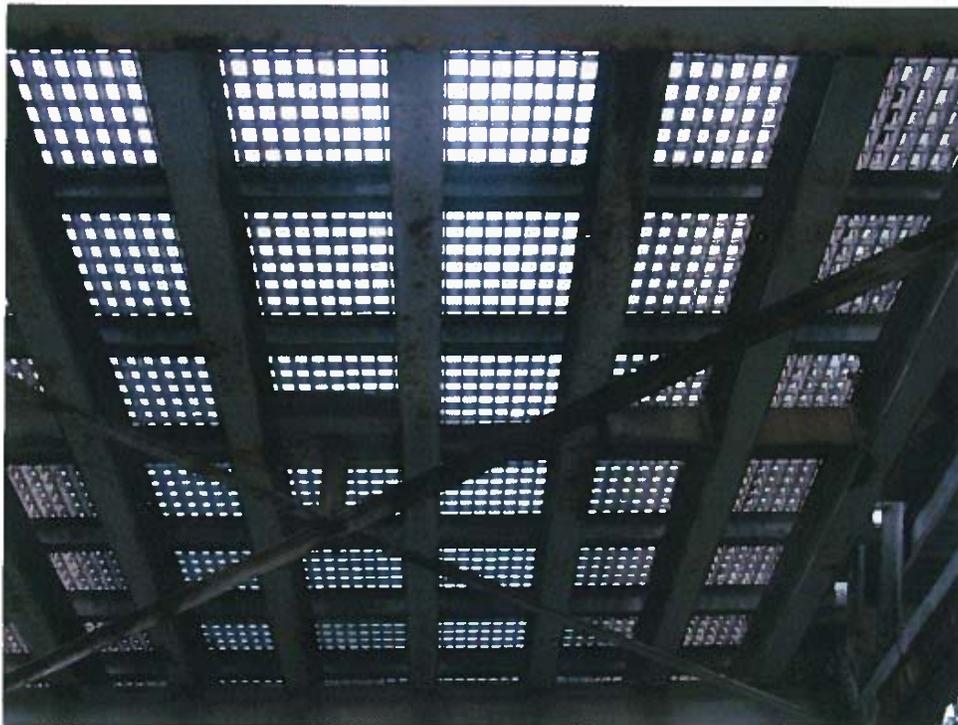
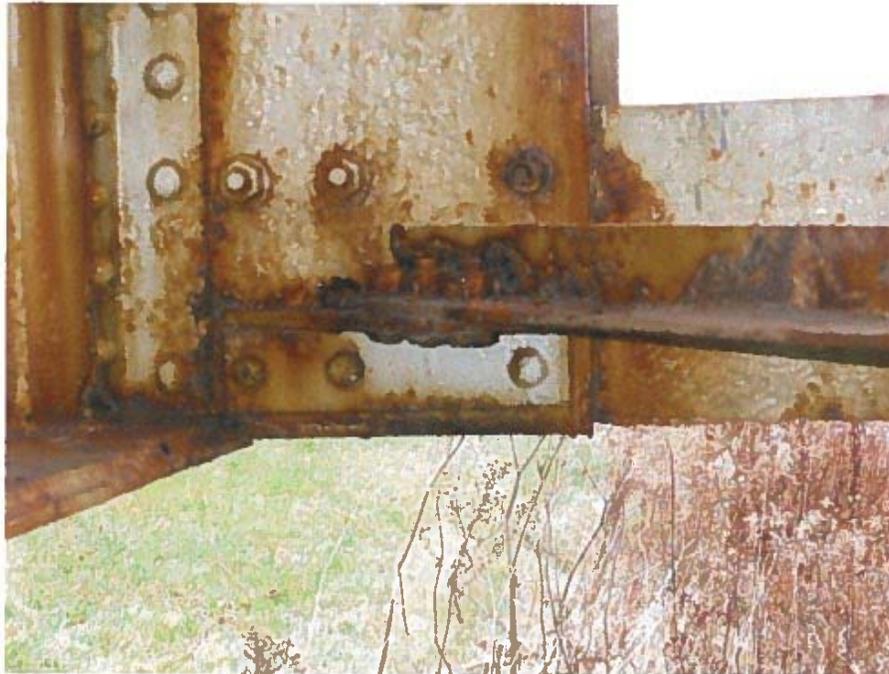
The horizontal/wind bracing was noted to be generally in fair condition as shown in Photographs 34 and 35. Typical medium to severe corrosion of the bracing was noted at the panel point connections. Coating breakdown was estimated at over 20% of the area of the bracing. Perforation and section loss was noted at the bracing connecting at panel point 5E at the south truss.

Photograph 34 – Typical condition of horizontal bracing.

Photograph 35 – Typical condition of horizontal bracing at panel point connection. Note: Medium to severe corrosion.
