Title - Sujet SWING BRIDGE REPLACEMENT	
Solicitation No. - N° de l'invitation EB144-150508/A	Amendment No. - N° modif. 002
Client Reference No. - N° de référence du client EB144-15-0508	Date 2014-09-17
GETS Reference No. - N° de référence de SEAG PW-\$PWA-115-5118	
File No. - N° de dossier PWA-4-72016 (115)	CCC No./N° CCC - FMS No./N° VME
Solicitation Closes - L'invitation prend fin at - à 02:00 PM on - le 2014-10-06	Time Zone Fuseau horaire Atlantic Daylight Saving Time ADT
F.O.B. - F.A.B. Plant-Usine: <input type="checkbox"/> Destination: <input checked="" type="checkbox"/> Other-Autre: <input type="checkbox"/>	
Address Enquiries to: - Adresser toutes questions à: Allen (PWA), Tanya	Buyer Id - Id de l'acheteur pwa115
Telephone No. - N° de téléphone (902) 496-5142 ()	FAX No. - N° de FAX (902) 496-5016
Destination - of Goods, Services, and Construction: Destination - des biens, services et construction:

ST. PETERS CANAL SWING BRIDGE
CAPE BRETON ISLAND

Mechanical and Electrical Inspection

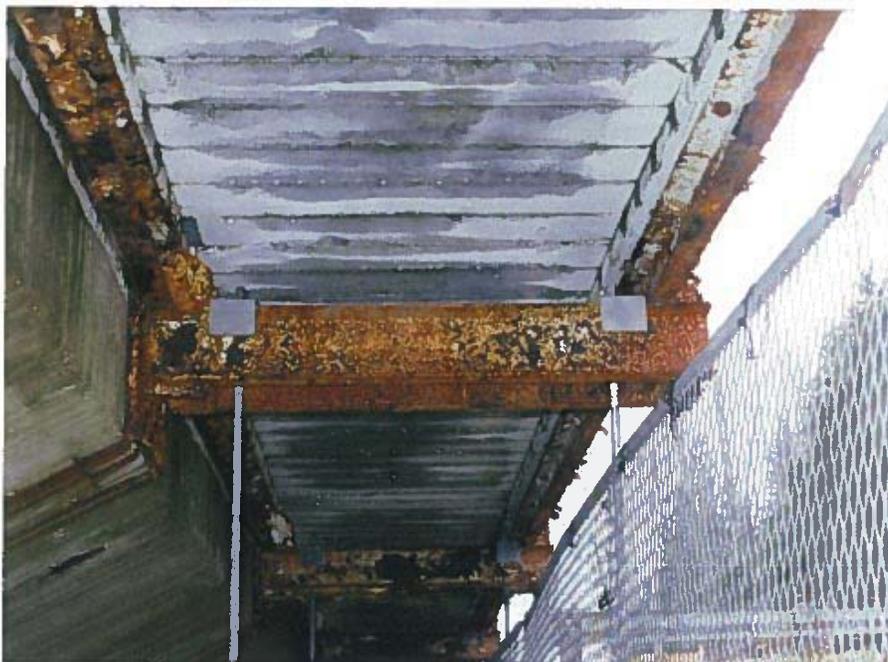
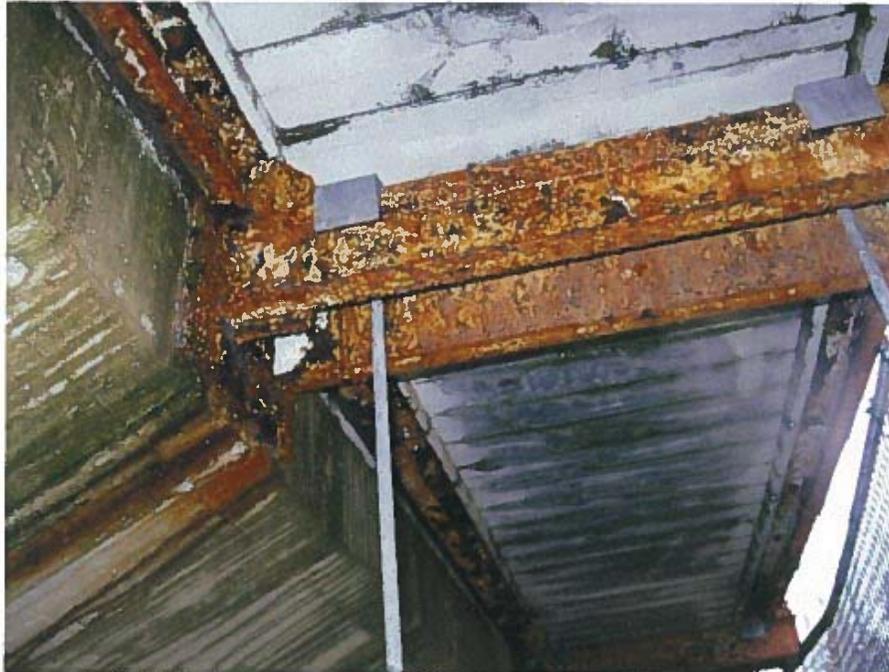
The sidewalk structural steel at the east abutment was noted to be in poor condition with medium to severe corrosion as shown in Photographs 36 and 37. The transverse and the longitudinal steel channels supporting the timber sidewalk have perforations and section loss. At one transverse support location it was noted that a hollow structural section (HSS) was welded to the existing steel anchorage as shown in Photograph 38 and 39. The HSS is supported by a column on the existing ground.

Photograph 36 – Typical condition of structural steel at sidewalk overhang at east approach.

Photograph 37 – Typical condition of structural steel at sidewalk overhang at east approach. Note: Medium to severe corrosion

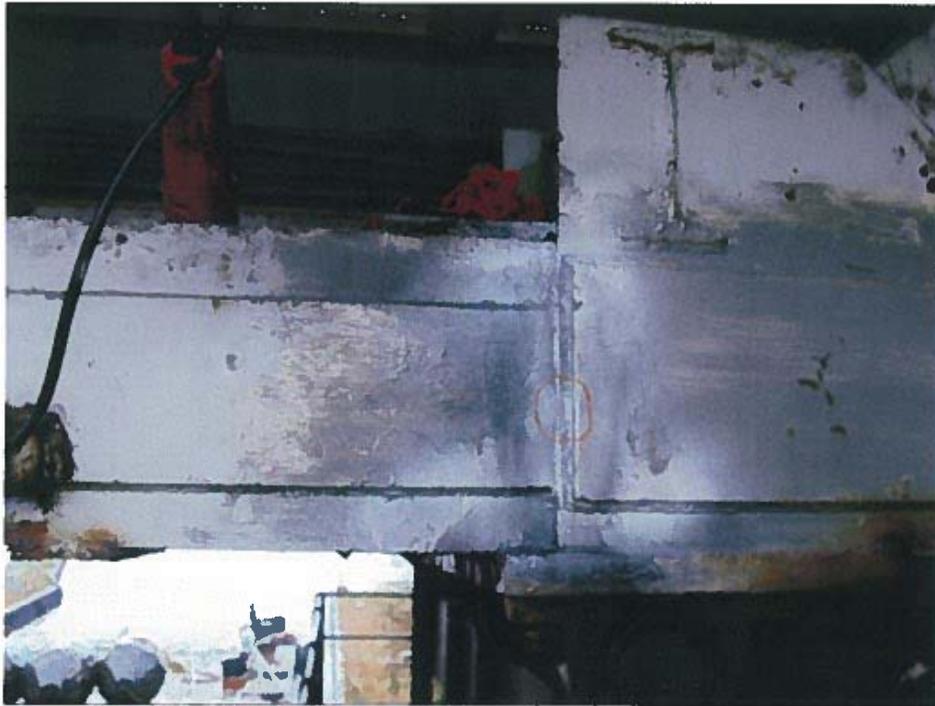
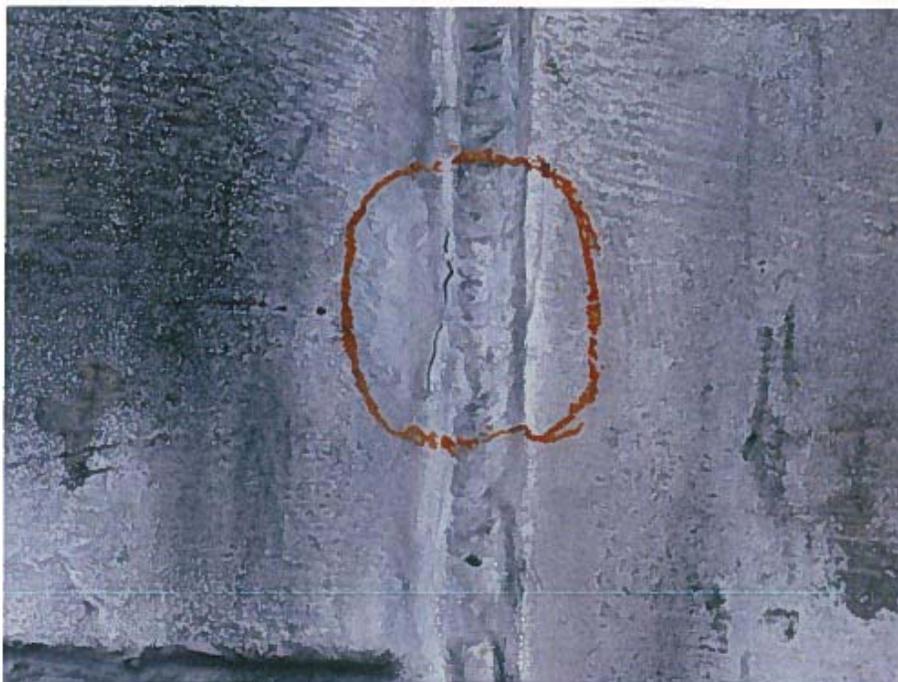
The magnetic particle testing of the welded reinforcements for below deck structural steel components did not show any cracks in welds except at one location (south truss bottom chord at panel point 5E) where a crack in the weld was noted. This is shown in Photograph 43 and 44.

Photograph 43 – Crack in weld at welded reinforcement at panel point 5E south truss bottom chord.

Photograph 44 – Crack in weld at welded reinforcement at panel point 5E south truss bottom chord.

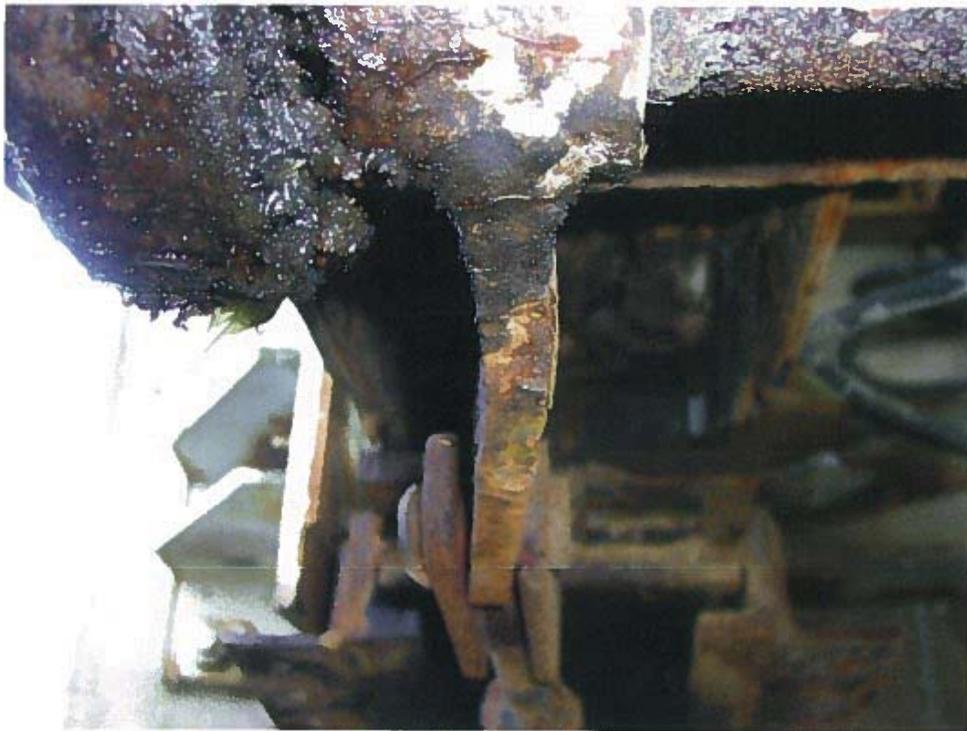
- The end wedges located at the east end were functional but the components were noted to be corroded with some mechanical damage to the wedge components.
- The main drive machinery consisting of two hydraulic cylinders mounted to the centre pier with the rod yoke attached to the bridge structure was in good condition.

Photograph 4 – South east wedge bent crank arm

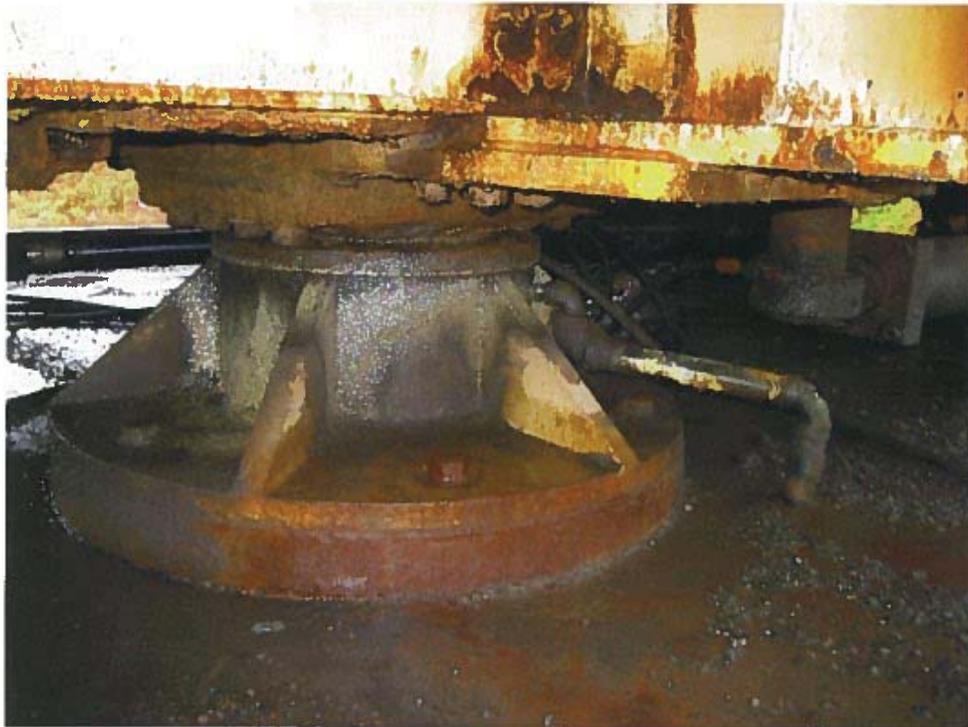
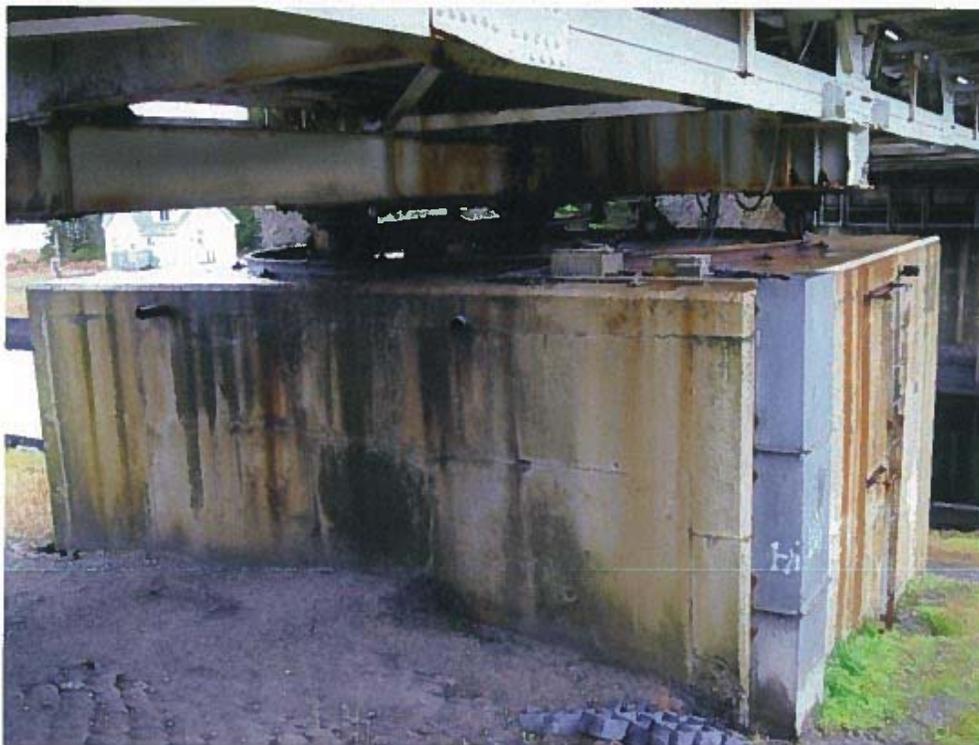
-
- The centre bearing was noted to be in good condition. The bearing housing retains oil and no leaks were noted. The oil overflow line draining on the west side of the pier was noted to be not contained and could present an environmental issue.

Photograph 7 – Center bearing oil drain line

Photograph 8 – Center bearing oil drain line (pipe on the left side)

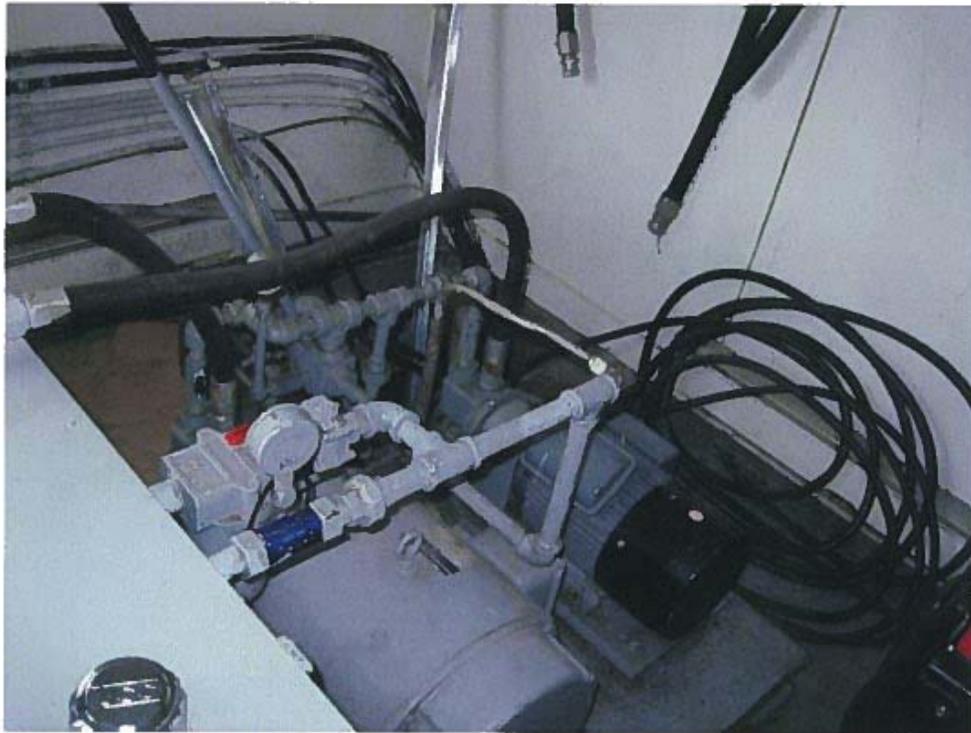
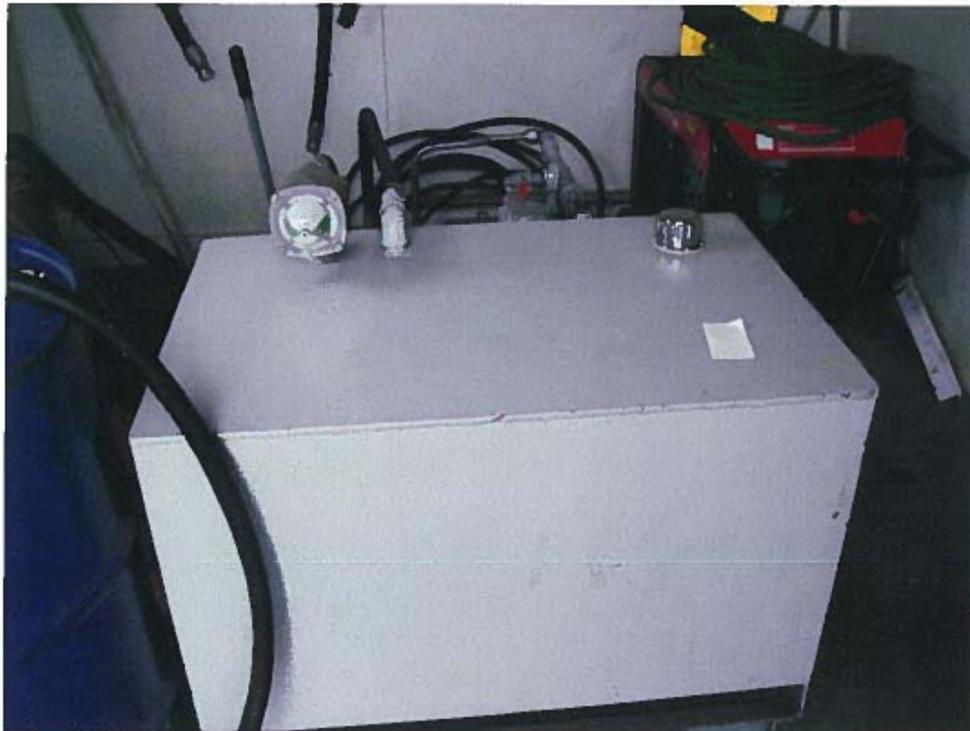
- The hydraulic power unit located in the machinery house was noted to be in good working condition. It was noted that there was no fluid drip tray installed underneath the power unit, as is current practice.

Photograph 9 – Hydraulic power unit 1

Photograph 10 – Hydraulic power unit 2
