Pavement Management Update

# National Parks in Eastern Canada 2010/2011

Dr. D.R. MacLeod P.Eng.

September 2011

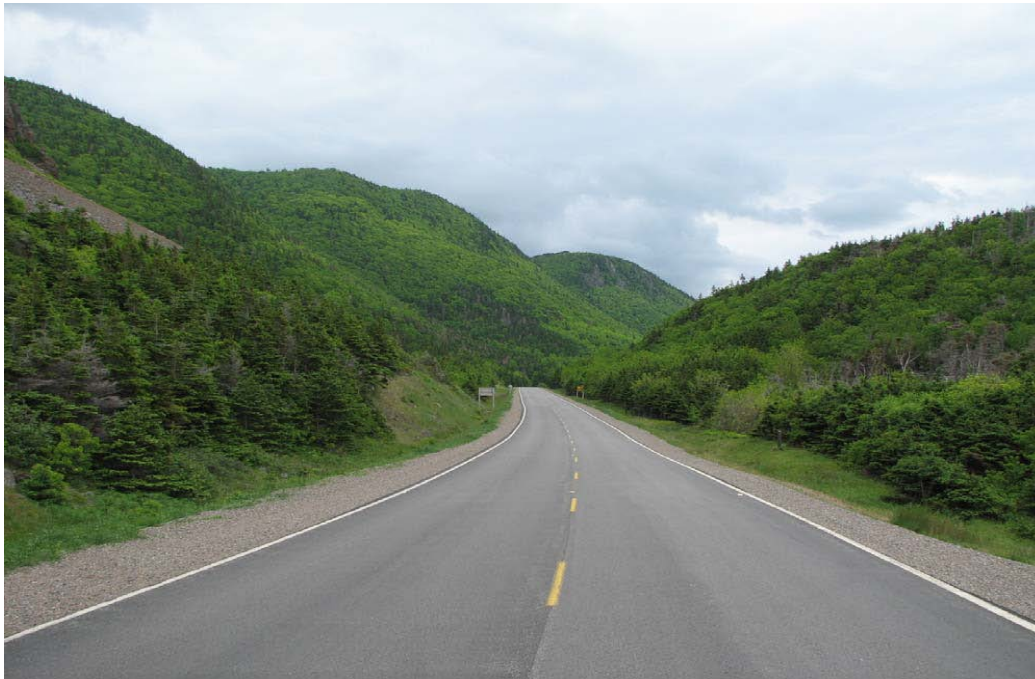
**Photo 1: Pavement in Very Good Condition PCI 75**

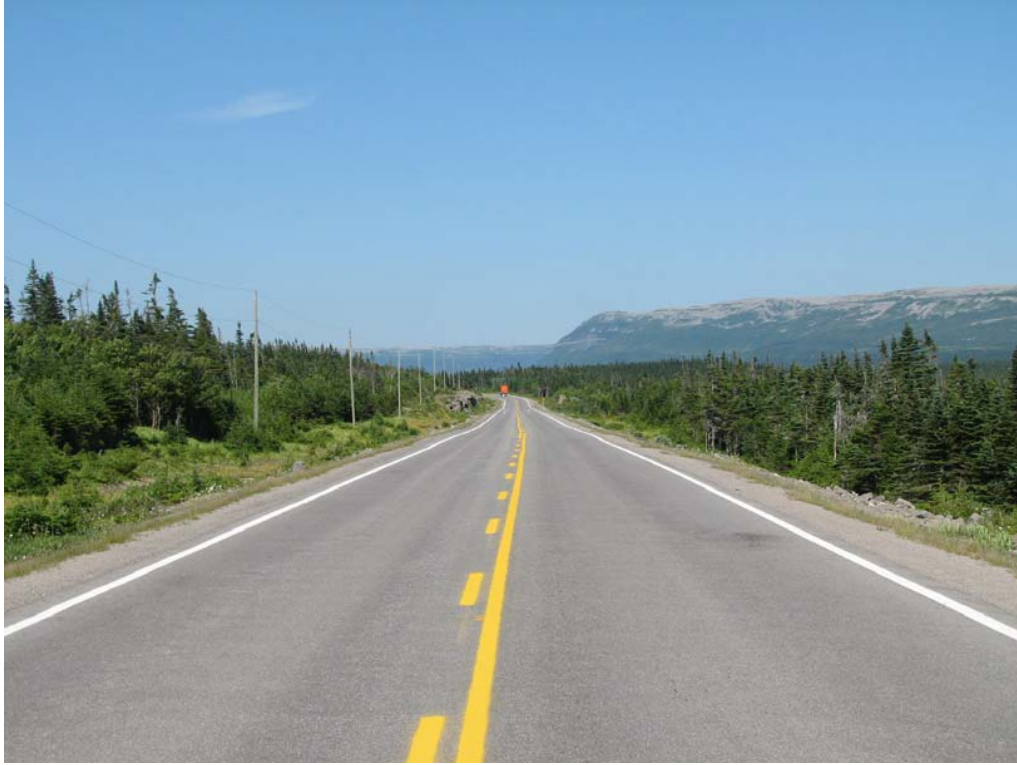
**Photo 2: Pavement in Good Condition PCI 71**

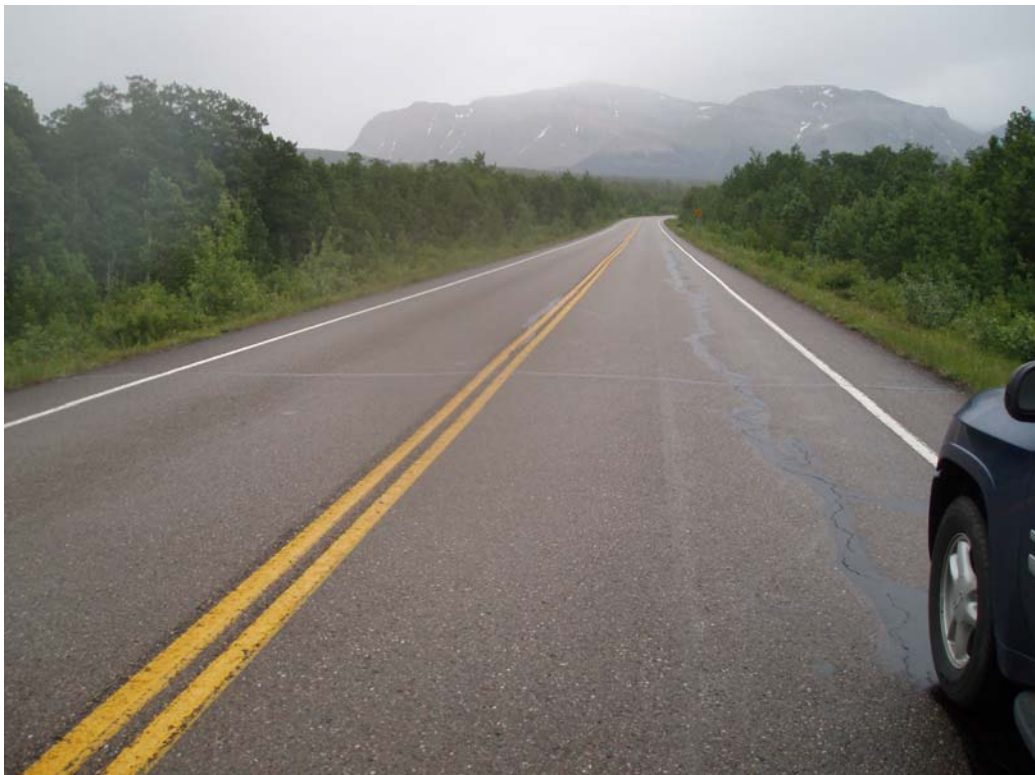
**Photo 3: Pavement in Fair Condition PCI 64**

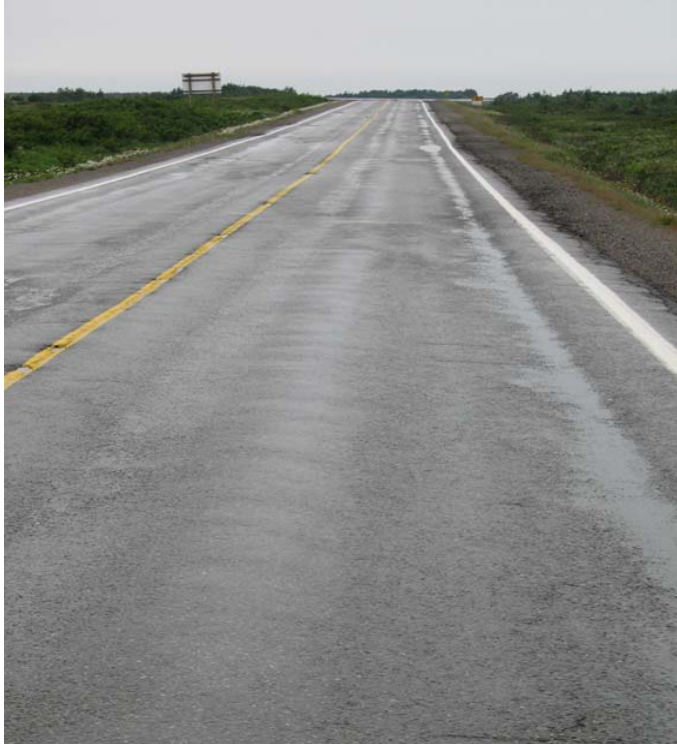
**Photo 4: Pavement in Poor Condition PCI 58**

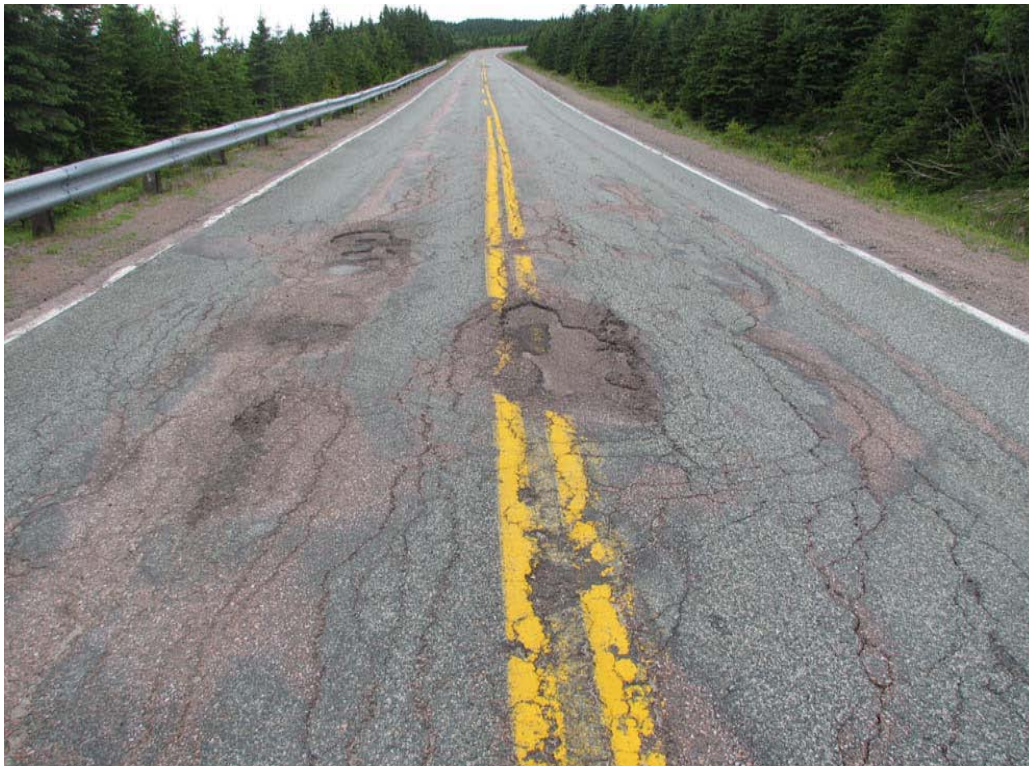
**Photo 5: Pavement in Very Poor Condition PCI 43**

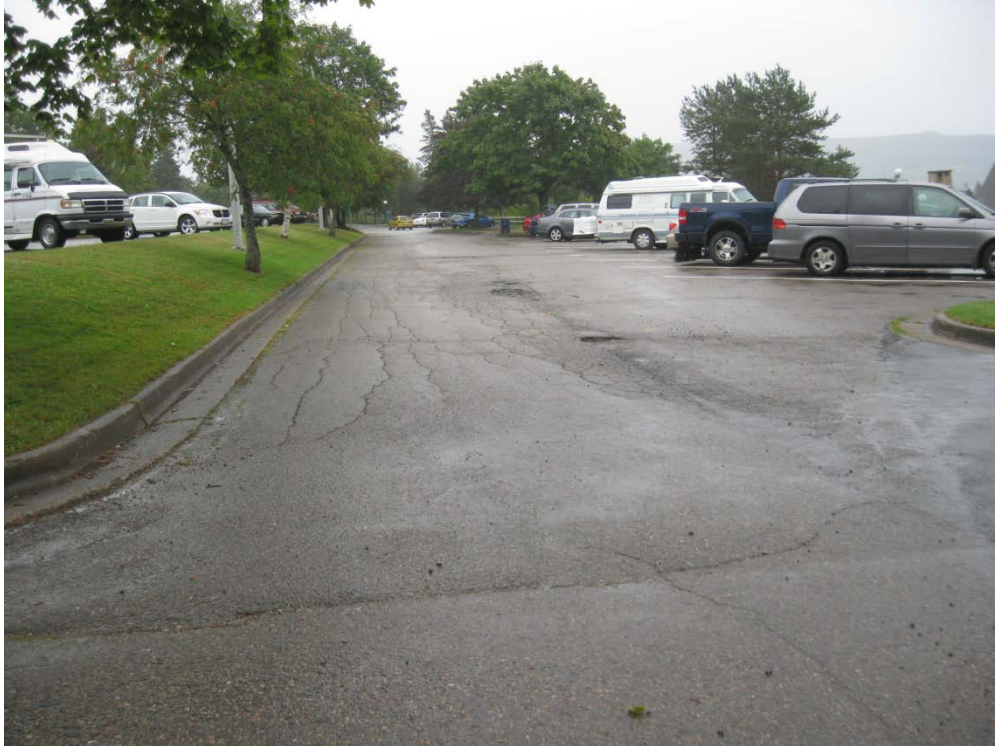
Photo D1: Meander, Transverse, Longitudinal and Very Severe Wheel Track Alligator Cracking –A.G. Bell Museum.

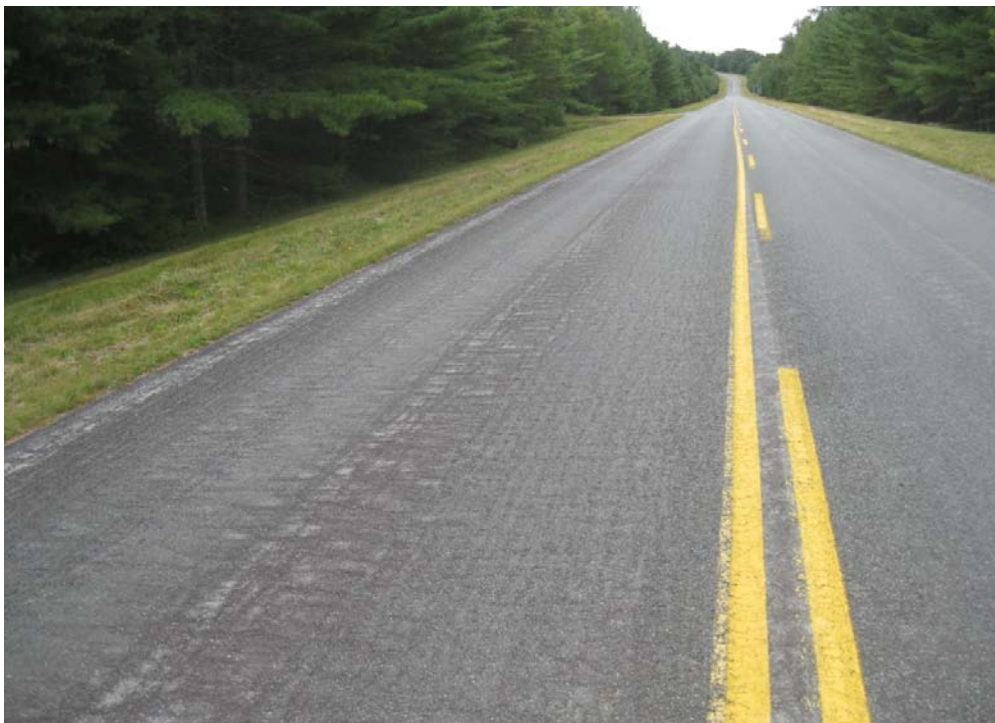
Photo D2: Moderate Ravelling of Micro-surfacing – Kejimikujik

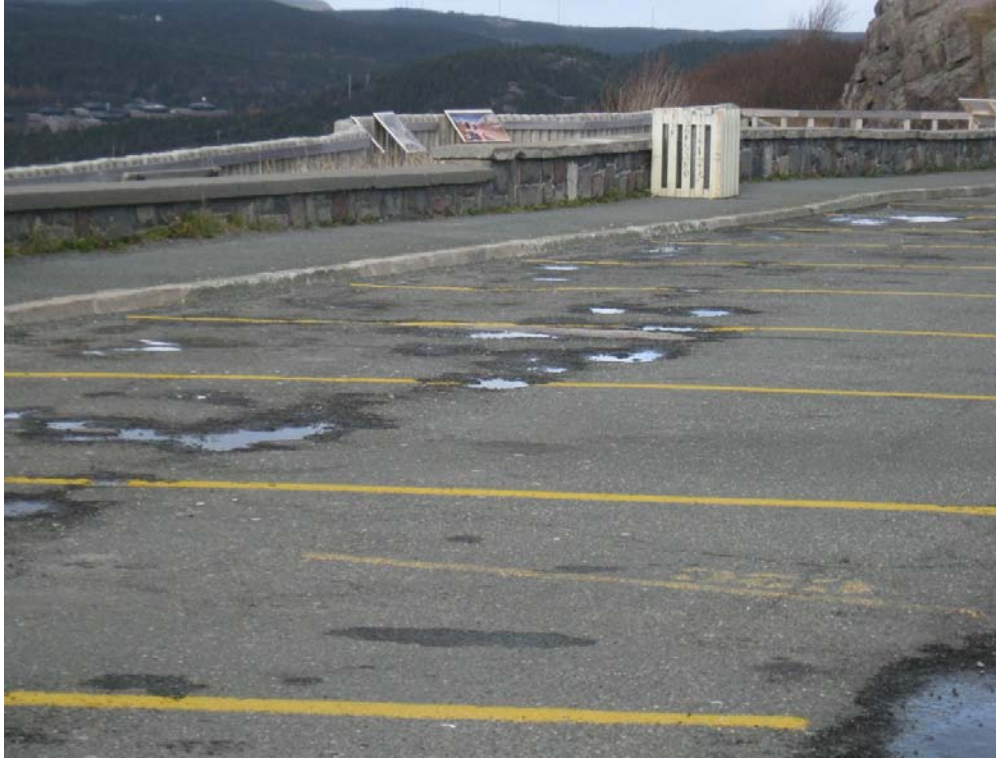
Photo D3: Distortion, Potholes – Signal Hill, Newfoundland

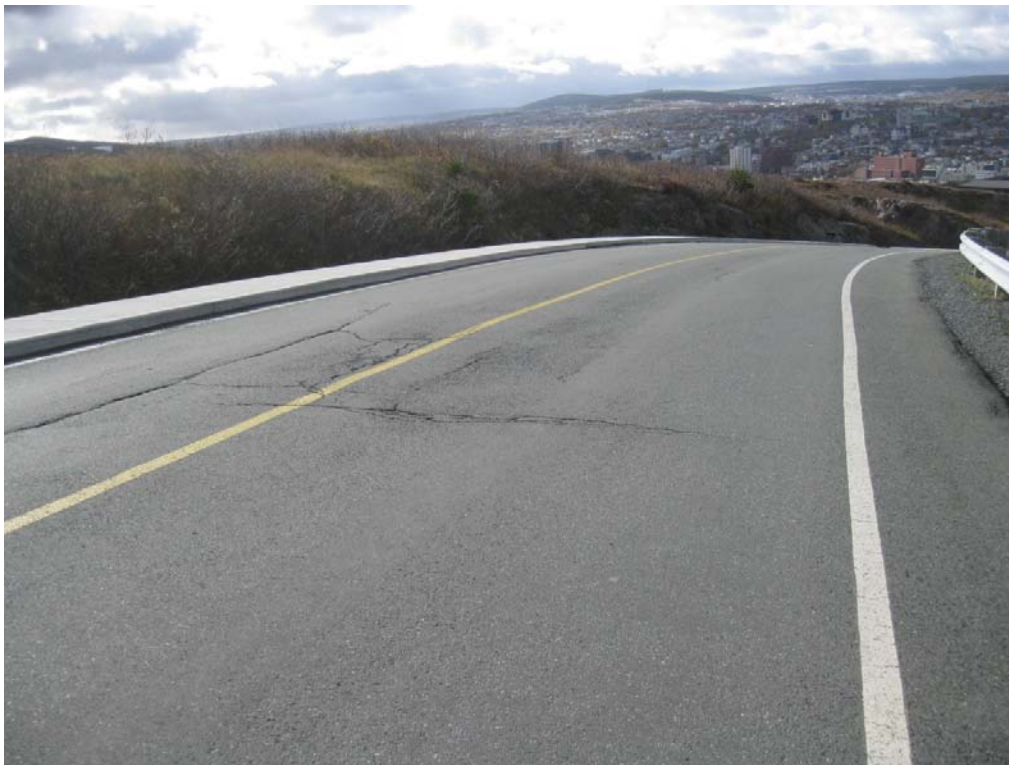
Photo D4: Rutting, Wheel Track Alligator Cracking, Transverse Alligator Crack – Signal Hill Newfoundland

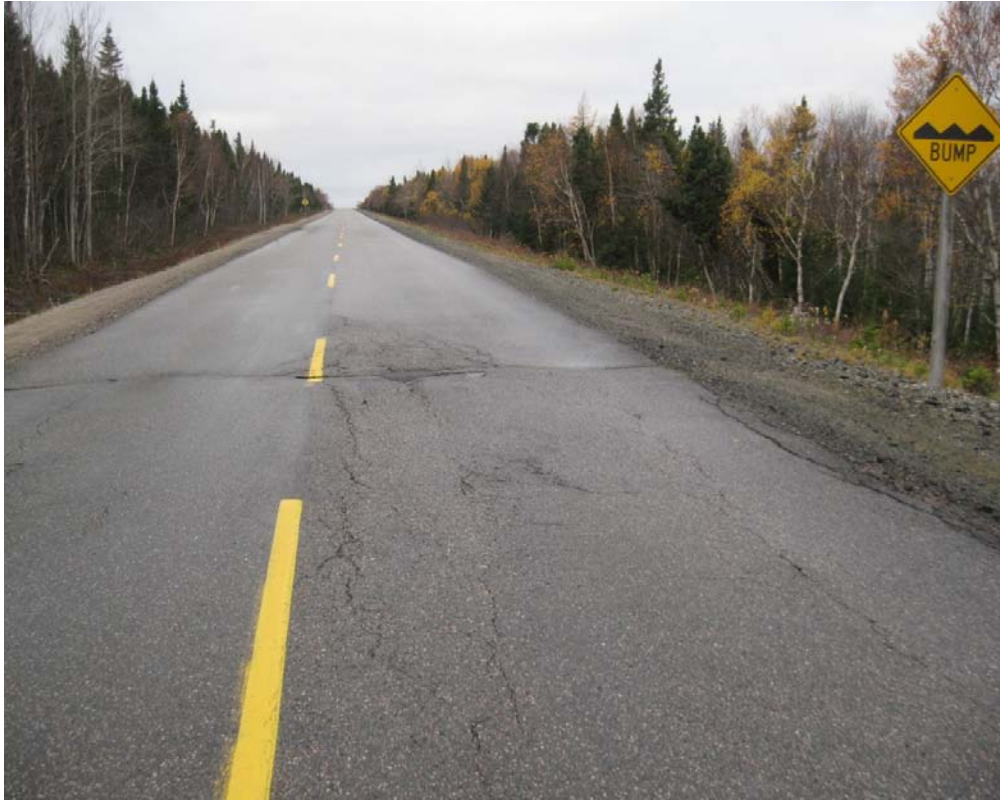
Photo D5: Distortions, Alligator Transverse and Wheel Track Cracking – Eastport Road, Terra Nova NP

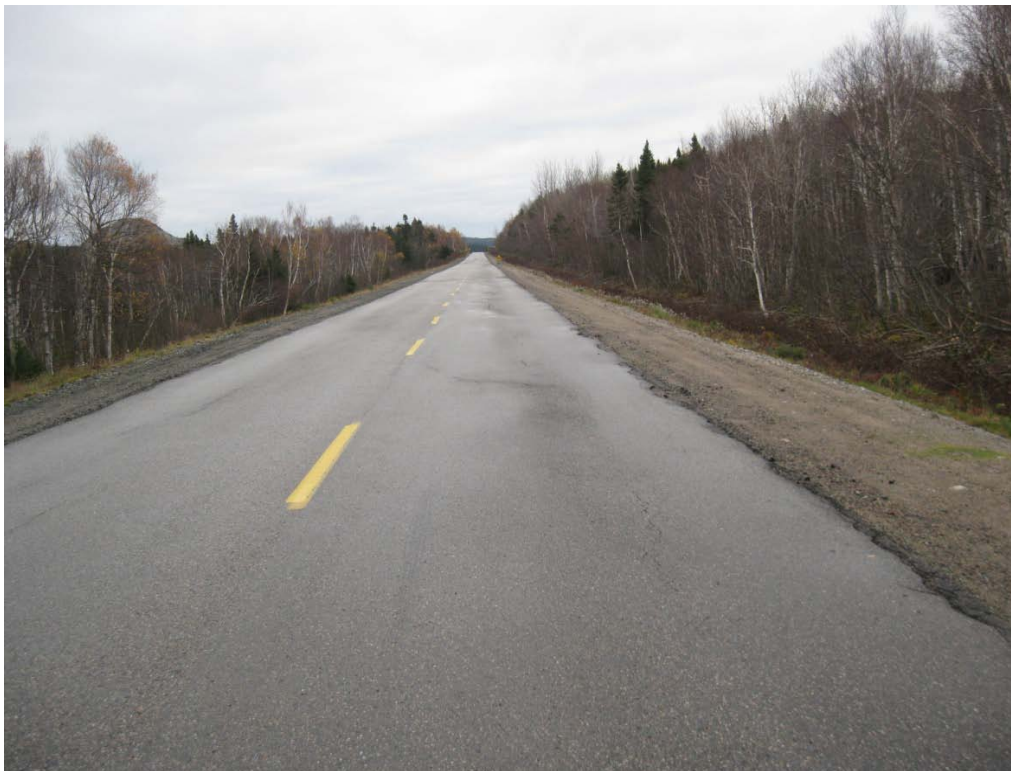
Photo D6: Distortions, Rutting, Edge Cracking - Eastport Road, Terra Nova NP

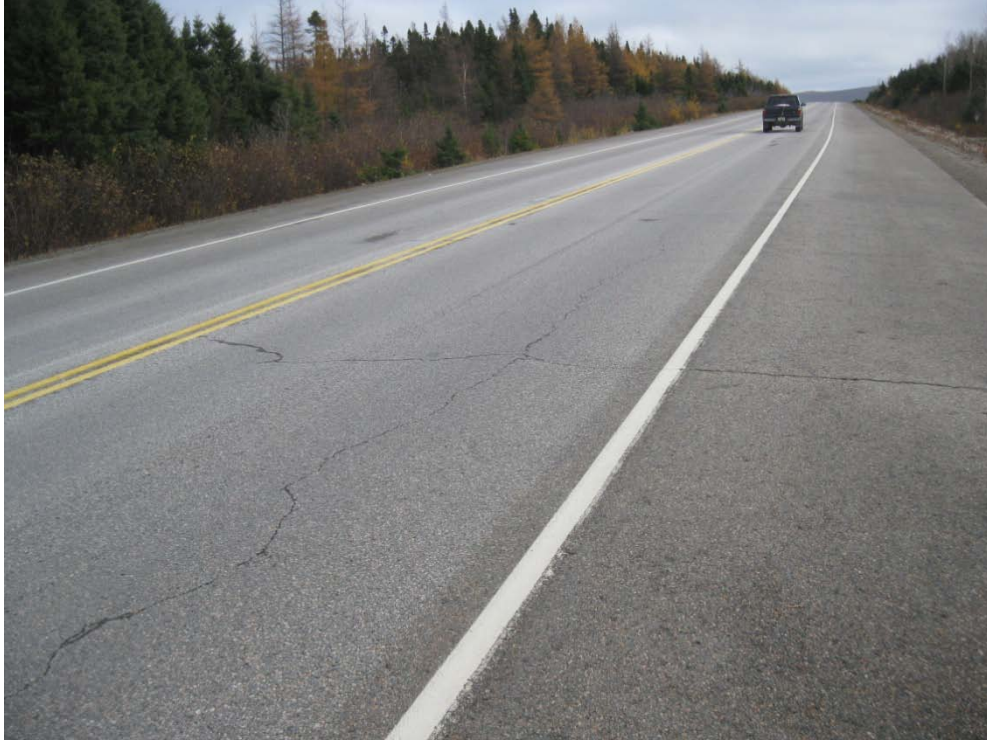
Photo D7: Block, Transverse, and Longitudinal Cracking. Note severe ravelling in left lane, TCH, Terra Nova NP

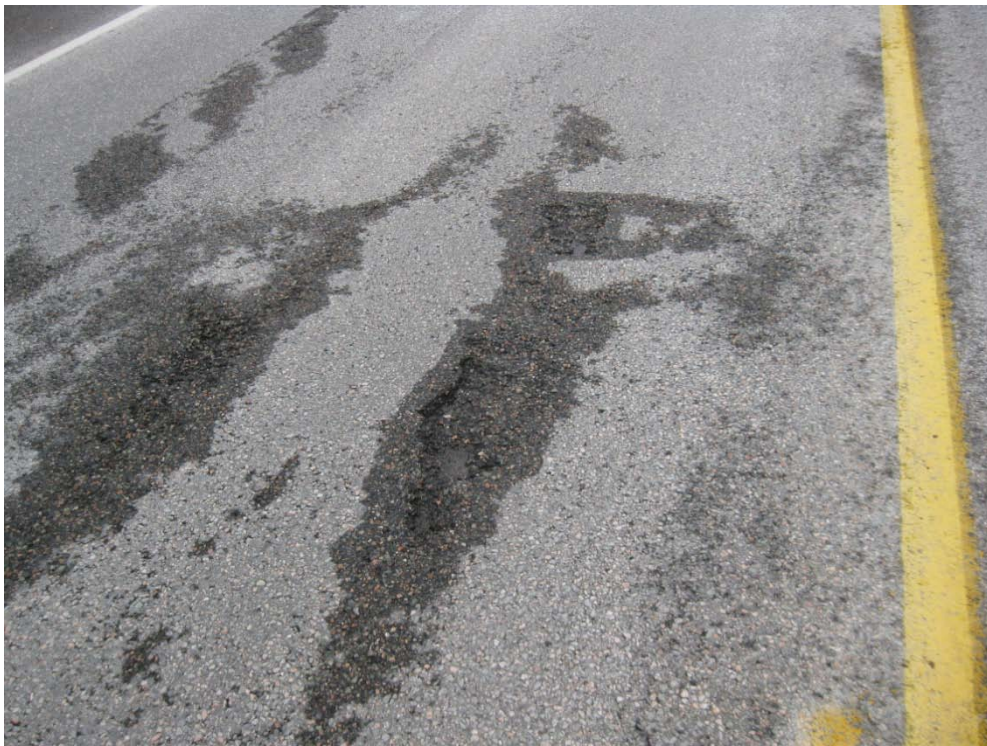
Photo D8: Severe ravelling, TCH, Terra Nova National Park

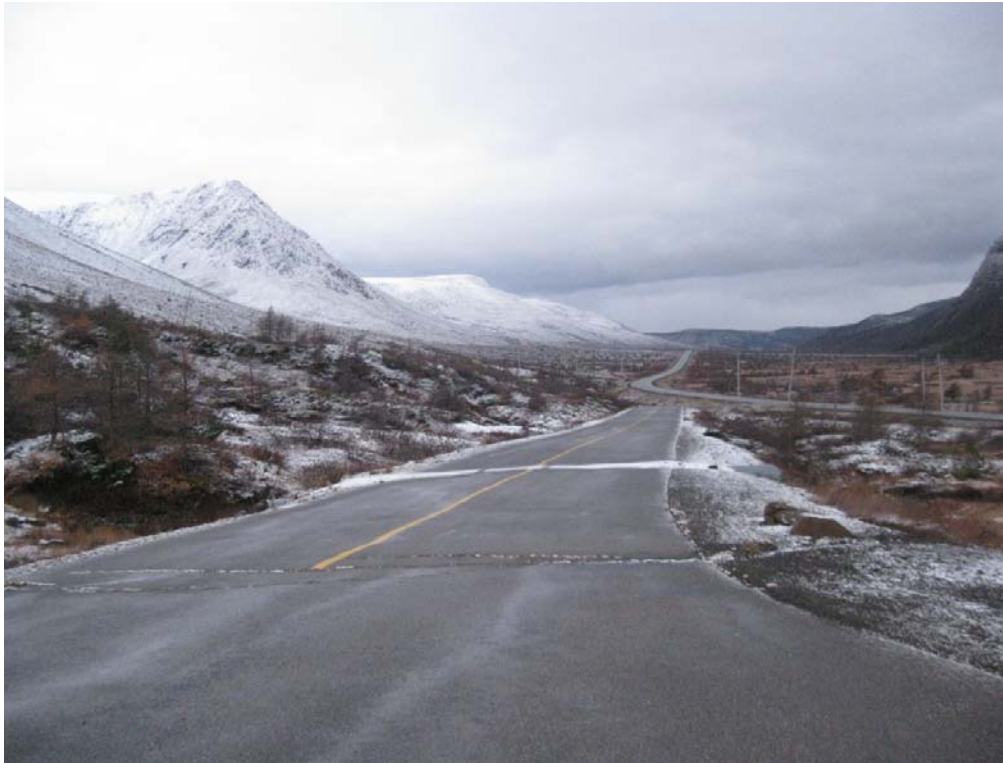
Photo D9: Culverts Freeze First, Gros Morne National Park

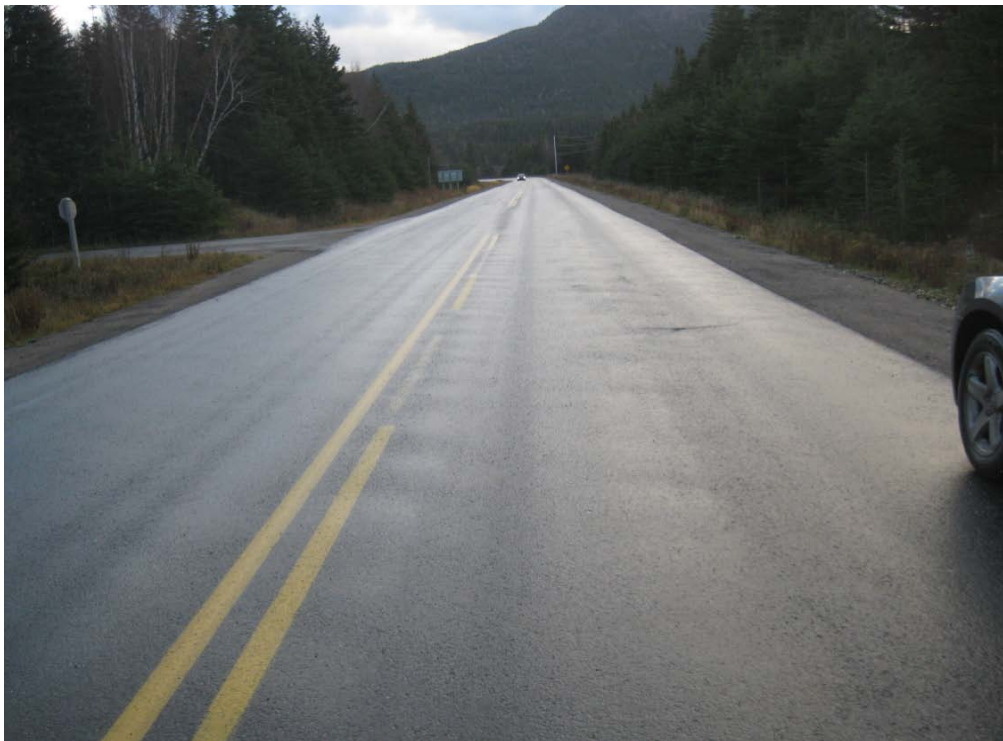
A common problem on this highway is ravelling. At present most sections are showing moderate ravelling throughout but there are sections with severe localized ravelling. On the provincial sections of highway between Gros Morne and L'Anse aux Meadows, various stages of ravelling distress were quite evident depending on the age of the pavement

Photo D10: Moderate Ravelling foreground, Severe Ravelling mid-photo –Gros Morne National Park

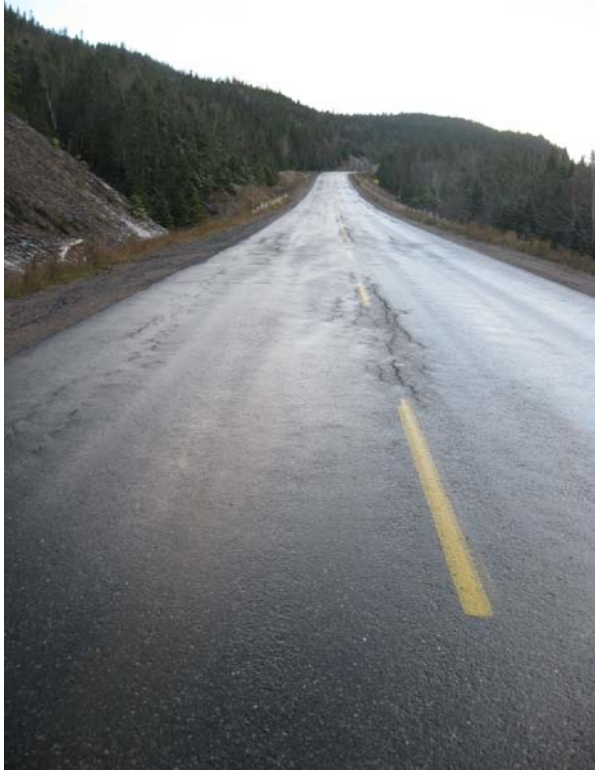
Photo D11: Severe Centreline Crack, Highway 431, Gros Morne National Park

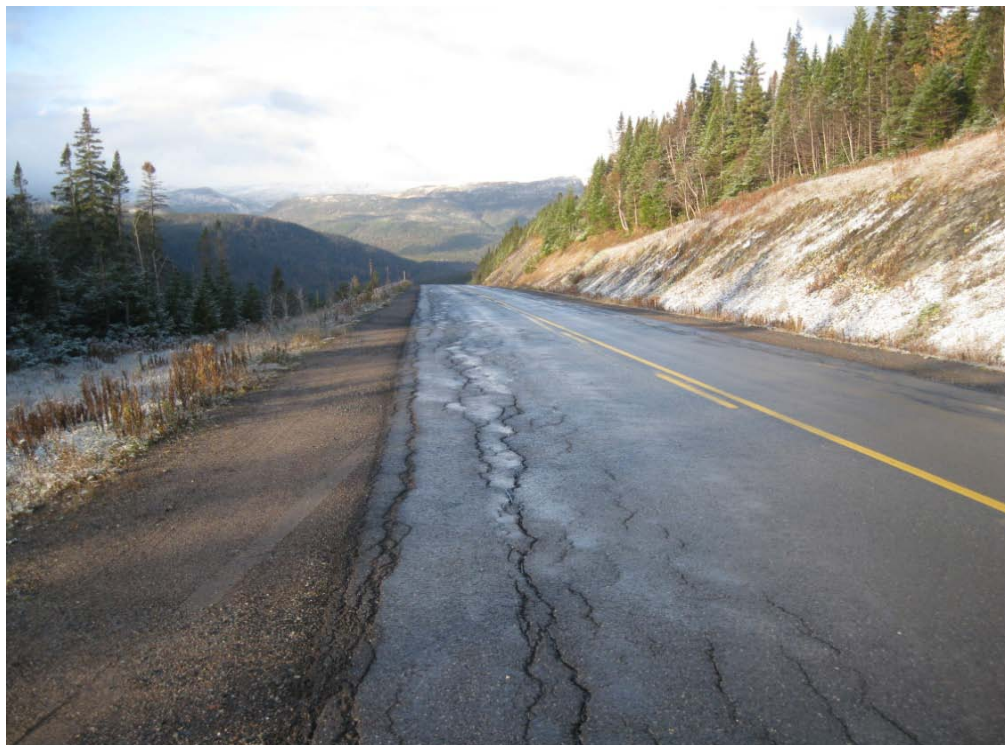
Photo D12: Severe Edge Cracking, Highway 431, Gros Morne National Park

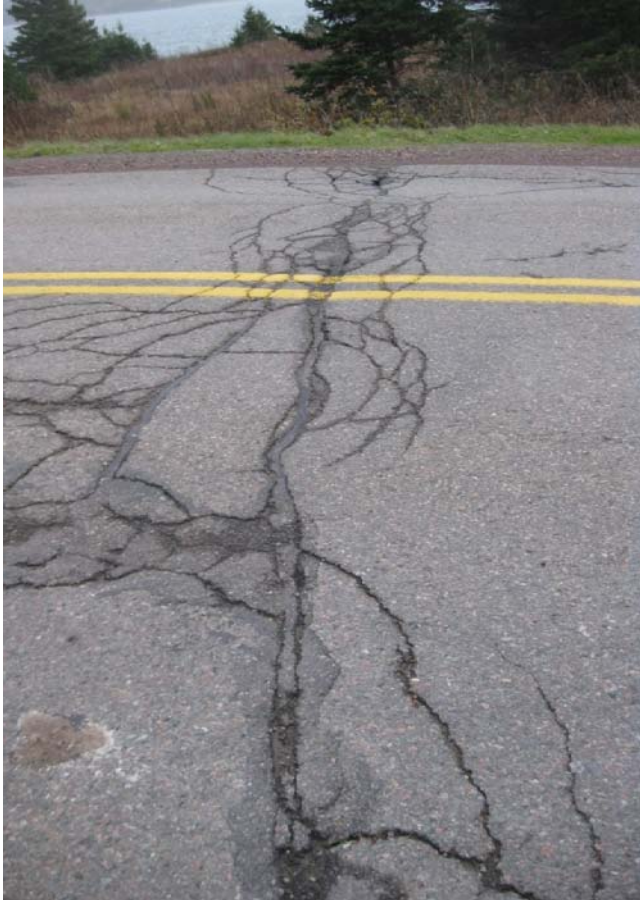
Photo D13: Very Severe Transverse Crack and alligator cracking, Fort Louisbourg

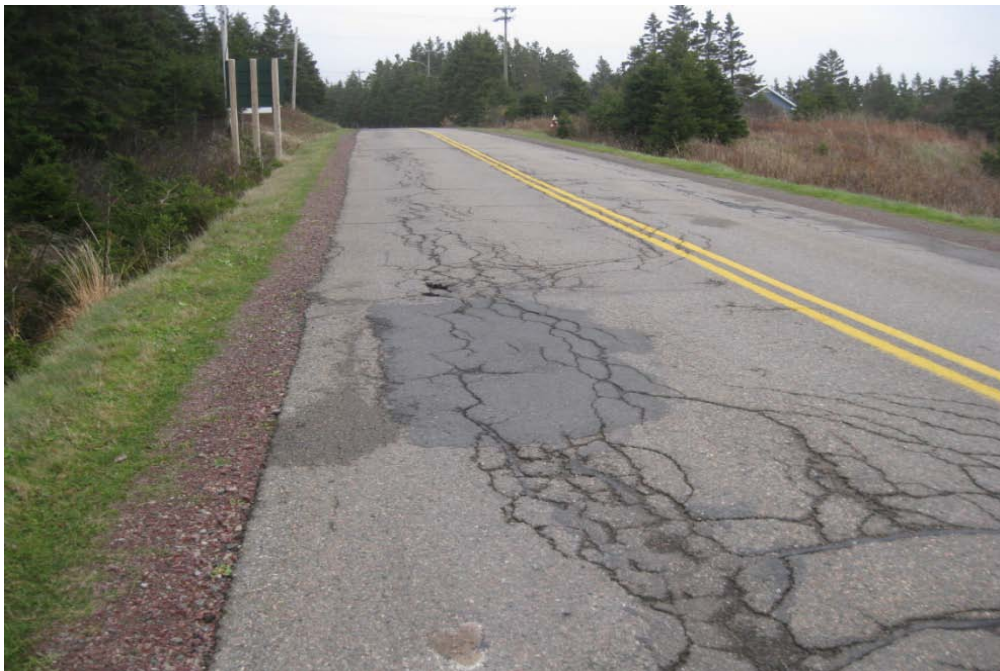
Photo D14: Very Severe Alligator Wheel Track Cracks – Fort Louisbourg

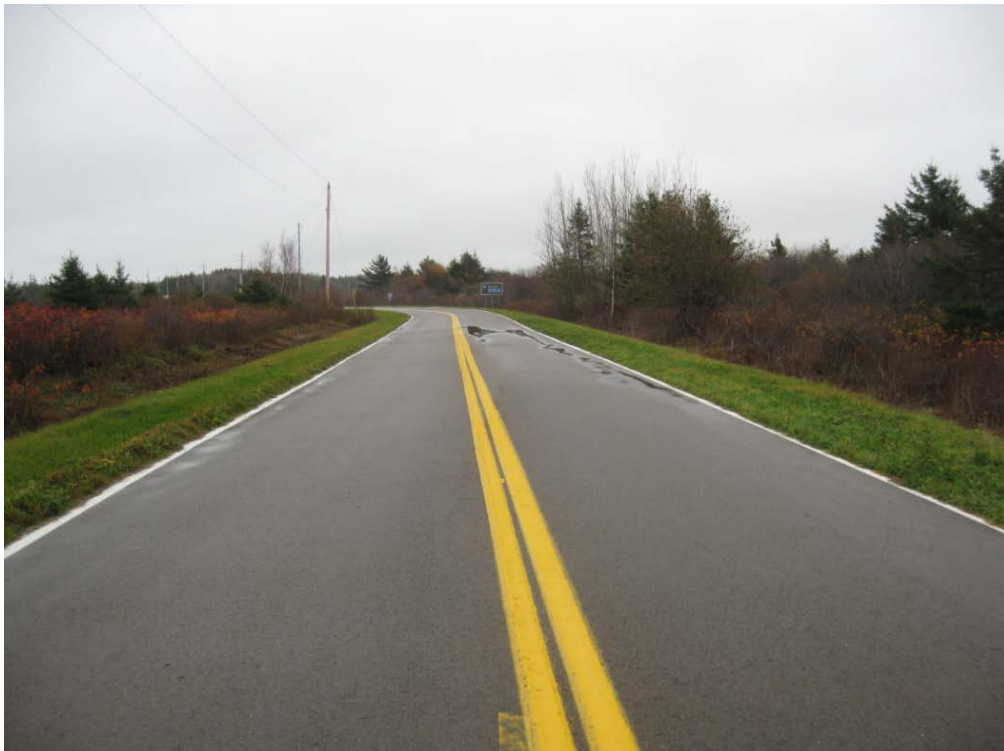
Photo D16: Rutting – Greenwich National Park

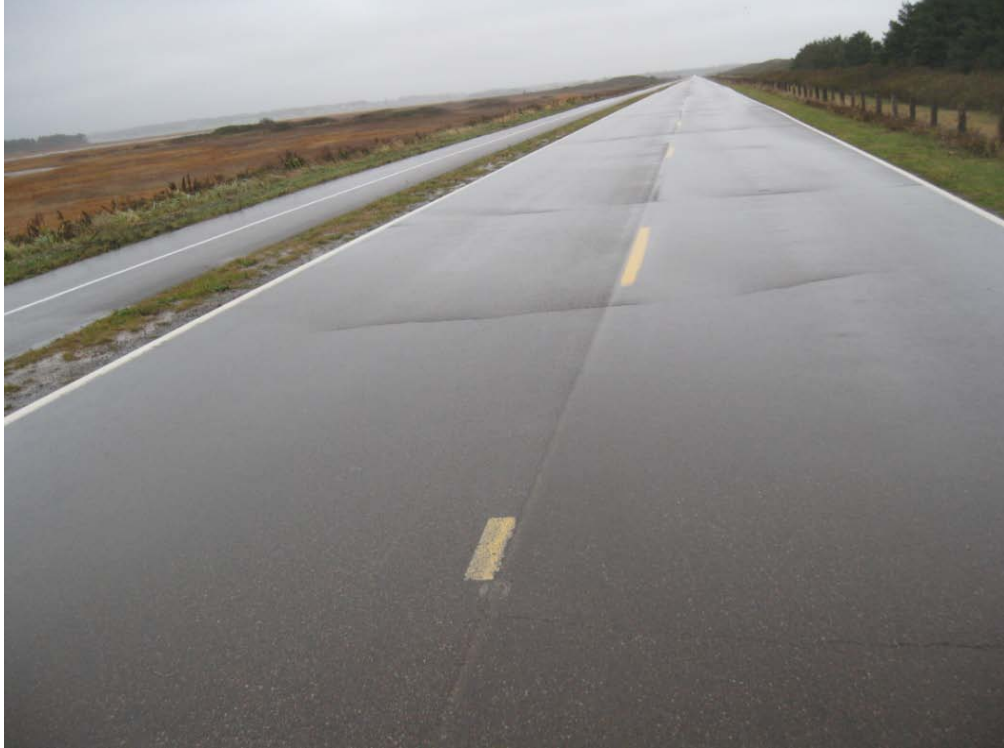
Photo D17: Reflective Transverse Crack on an a Recent Overlay Gulf Shore Highway, PEI National Park

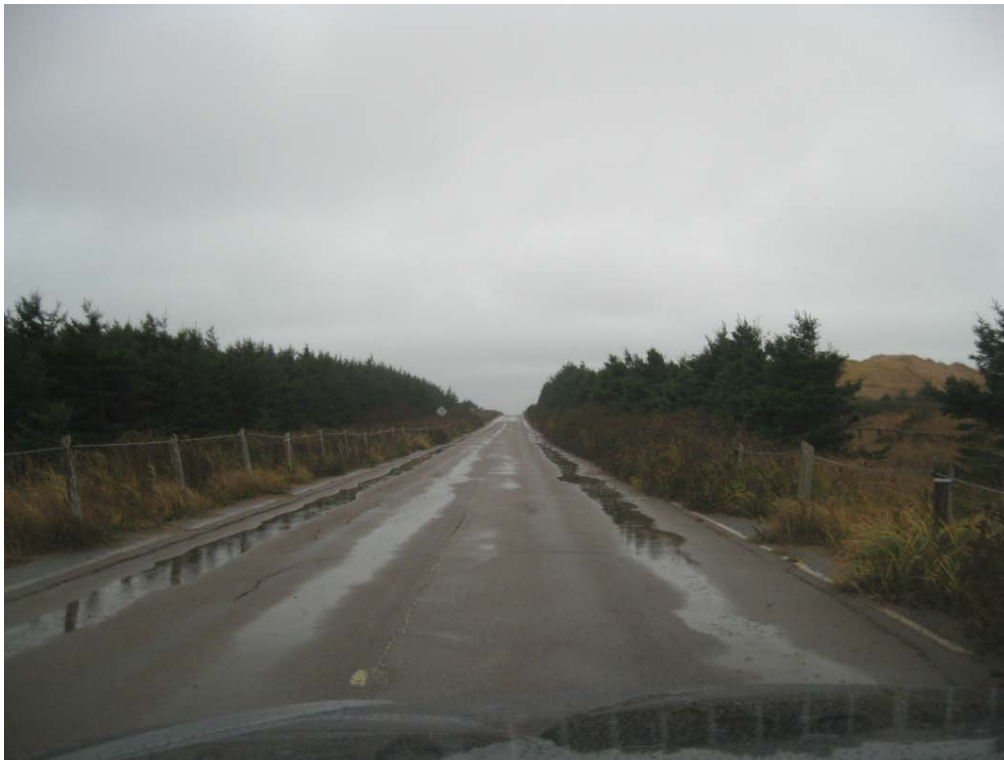
Photo D18: Very Severe Rutting – PEI National Park

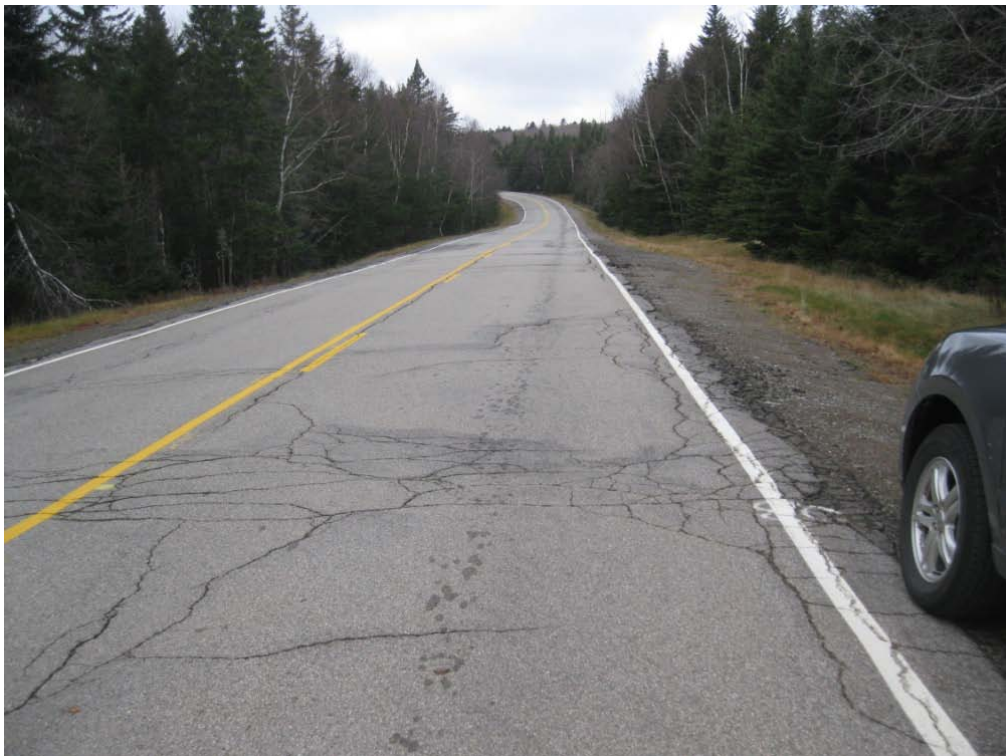
Photo D20: Severe Edge Cracking, Severe Transverse Alligator Cracking – Fundy National Park

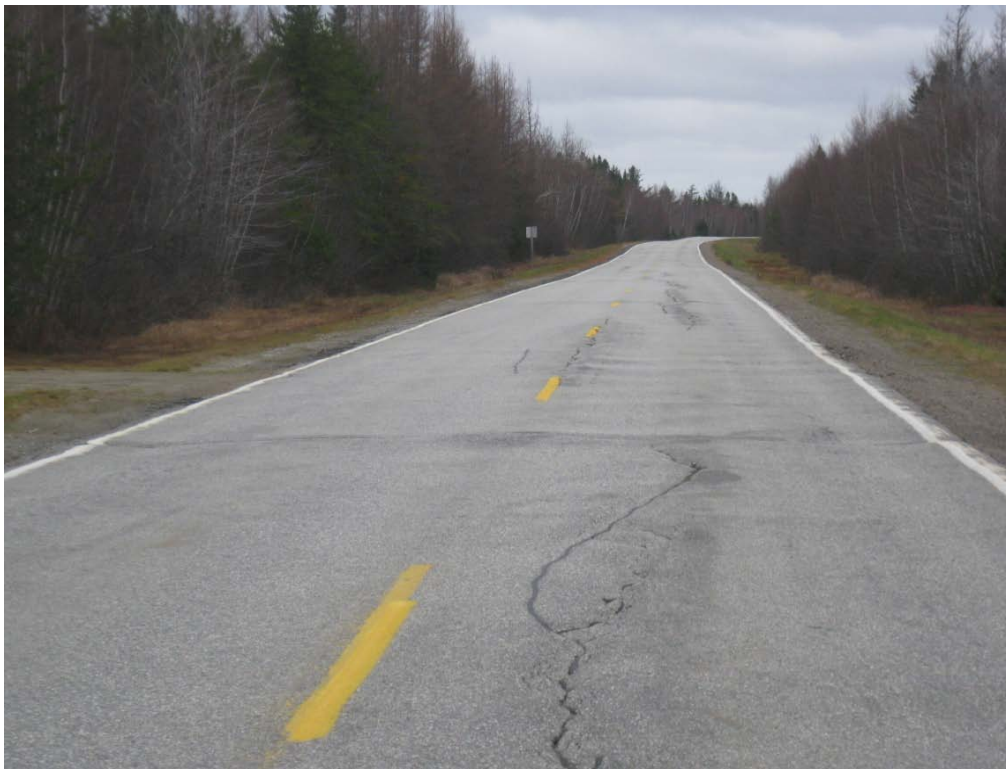
Photo D22: Severe Transverse and Meander Cracking – Kouchibouguac National Park

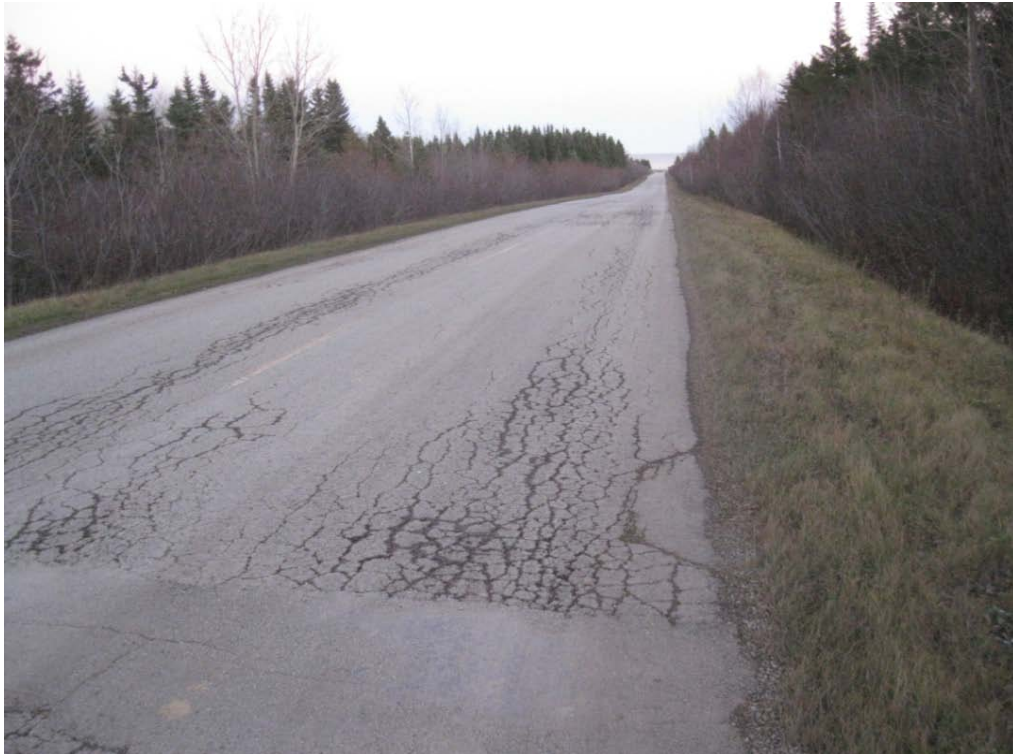
Photo D23: Severe Wheel Track Alligator Cracking – Forillon National Park

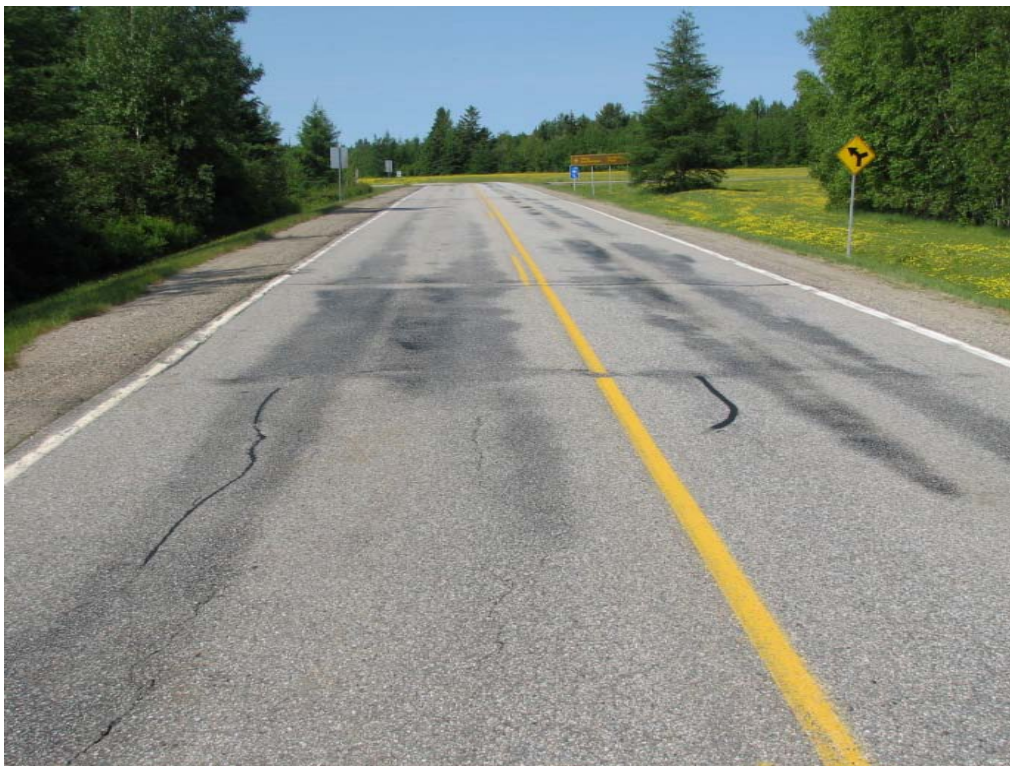
Photo D24: Severe & extensive Bleeding, Kouchibouguac

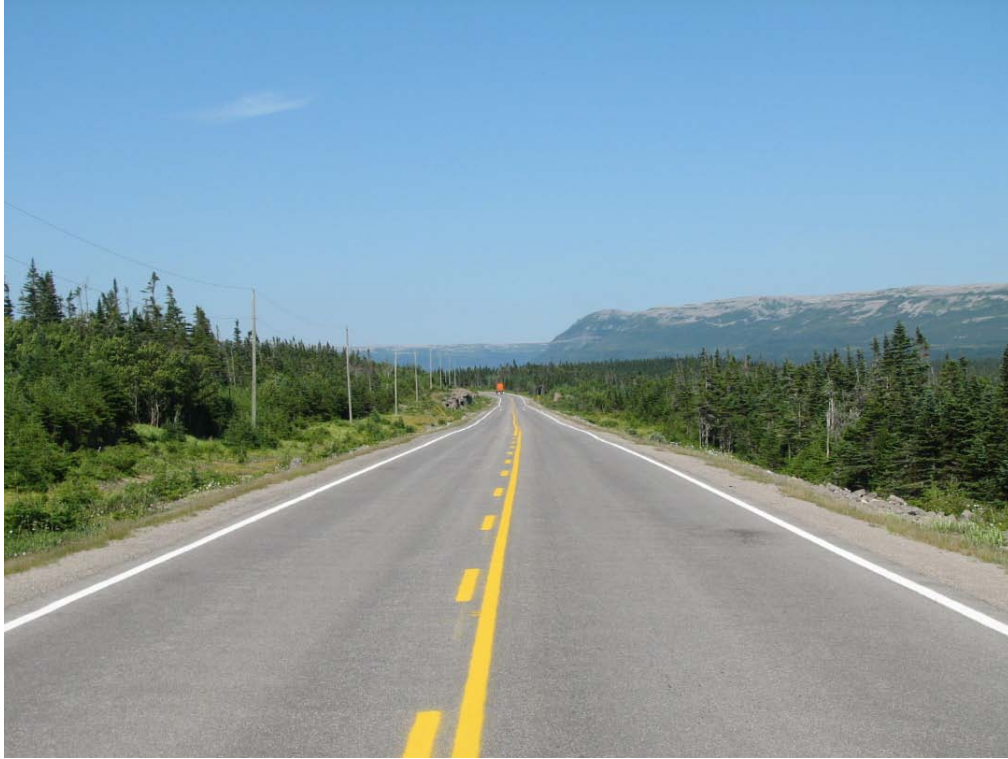
Photo D25: Start of Raveling Highway 430 Newfoundland (2007 Photo)

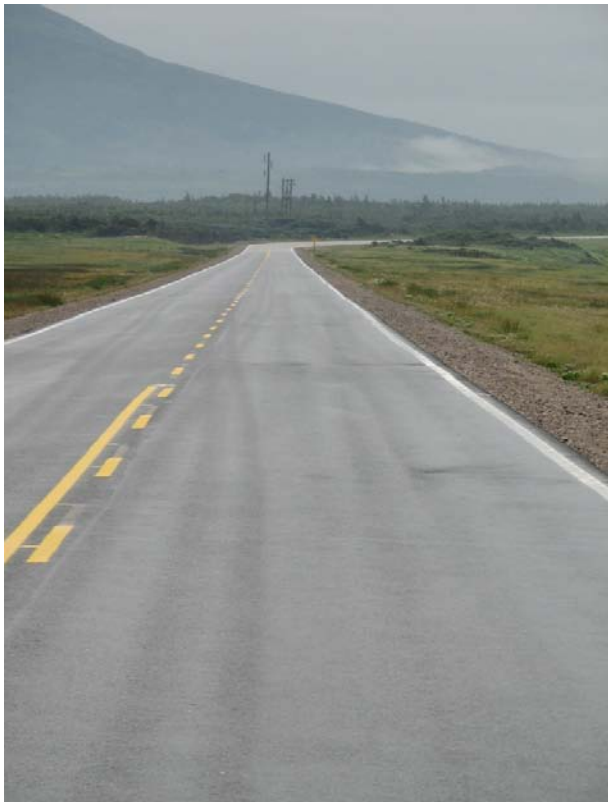
Photo D26: Progression of Ravelling Highway 430 Newfoundland (2007 Photo)

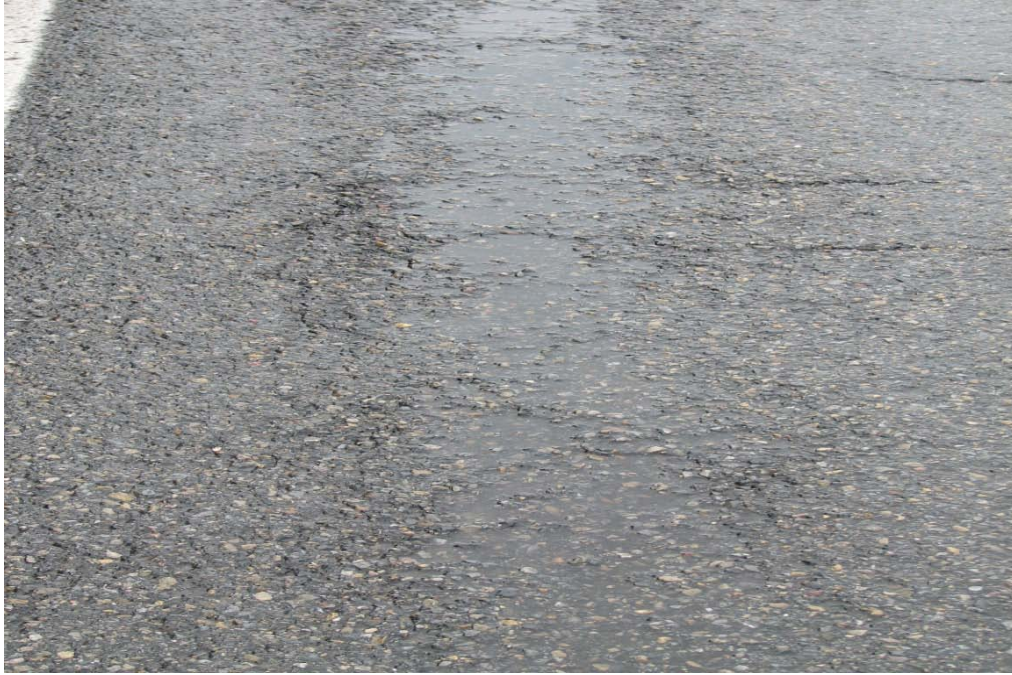
Photo D27: Start of severe ravel leading to alligator cracking (2007 Photo)

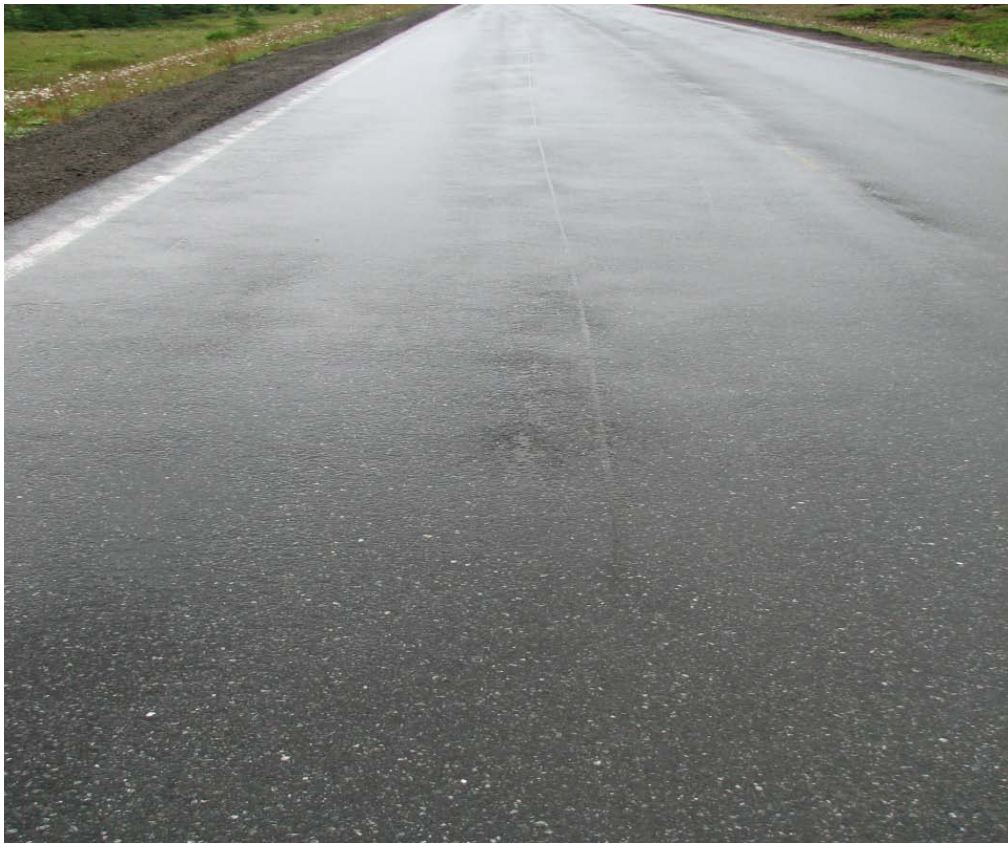
Photo D28: Start of Severe Ravelling Highway 430 Newfoundland (2007 Photo)

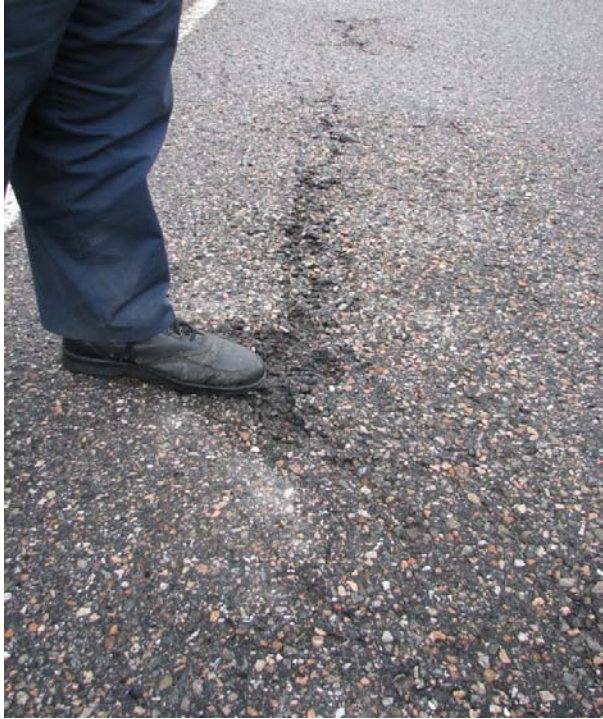
Photo D29: Severe Ravelling Highway 430 Newfoundland (2007 Photo)

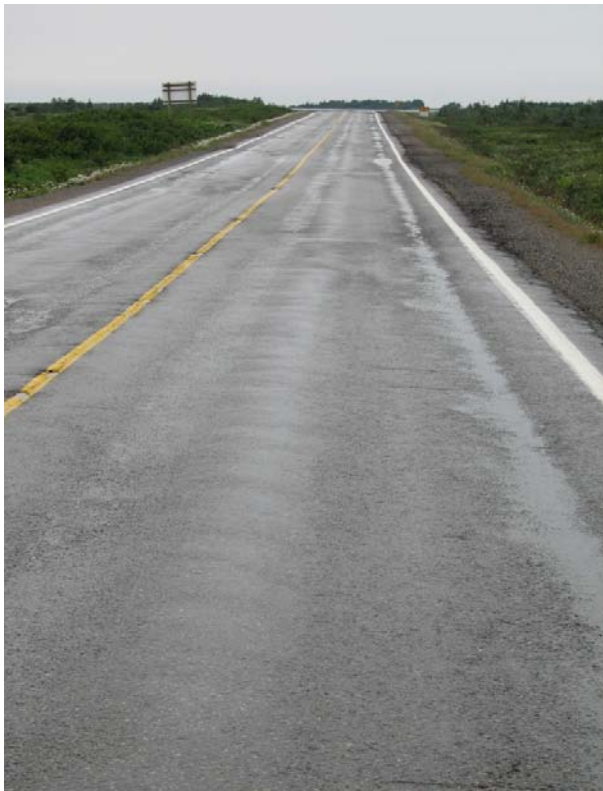
Photo D30: Severe ravelling leading to ruts and alligator cracking Highway 430 Gros Morne National Park (2007 Photo)
