Pavement Management Update

# National Parks in Eastern Canada 2010/2011

Dr. D.R. MacLeod P.Eng.

September 2011

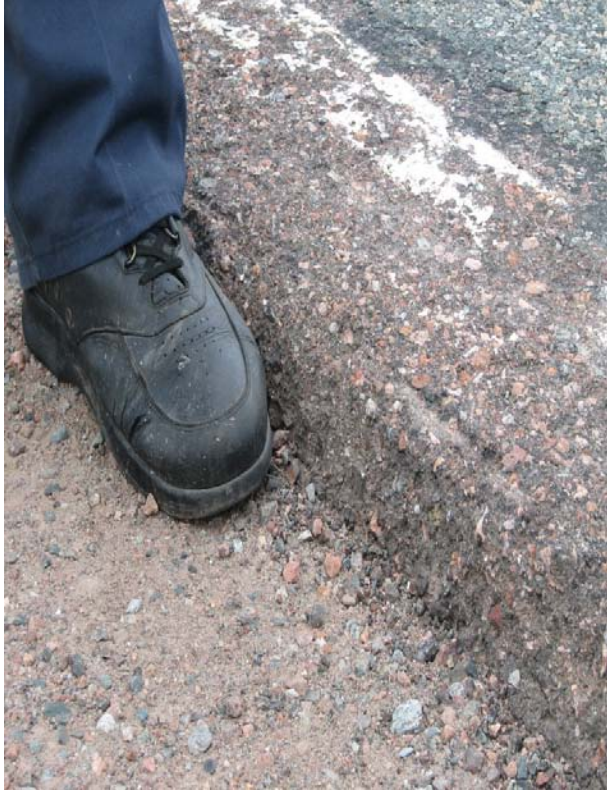
Photo D31: Sharp Drop of Pavement Edge – Cabot Trail, Cape Breton National Park

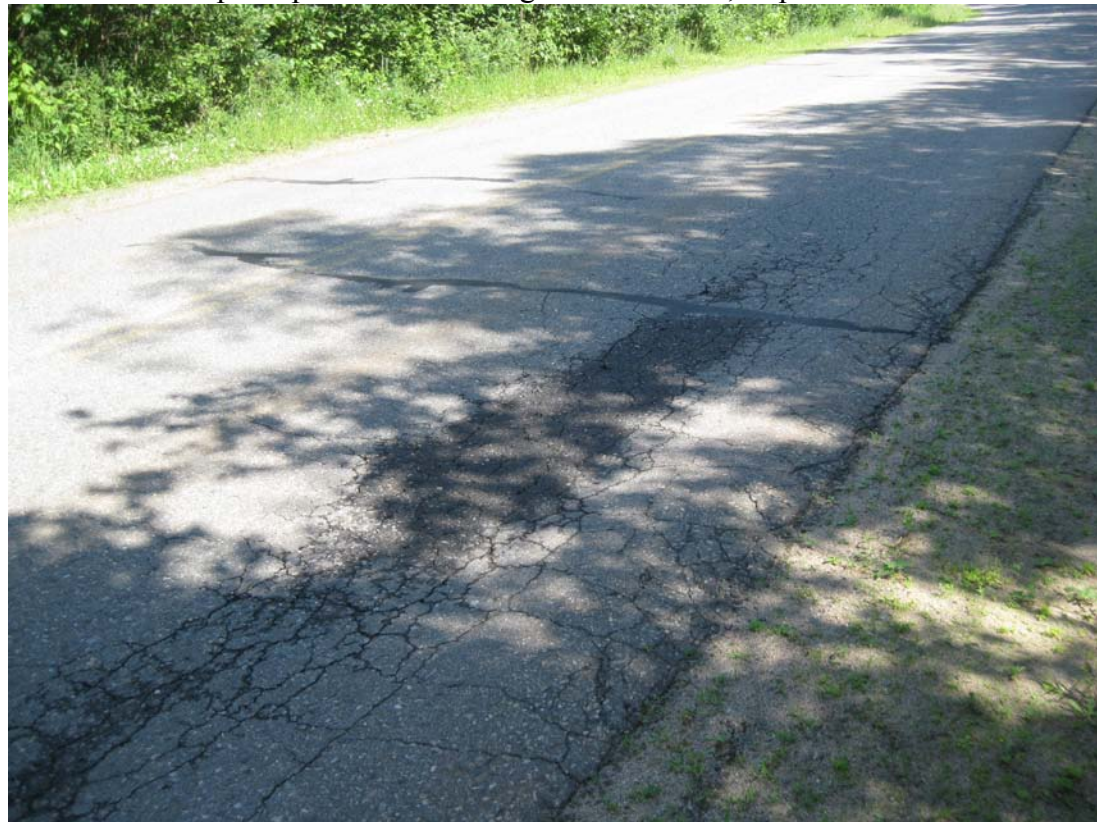
Very severe rutting and single and alligator wheel cracking characterize this section indicating that the pavement needs to be strengthened. There are also moderate transverse, centerline, longitudinal and block cracking throughout. These conditions have resulted in a poor ride score. Given the extent and severity of these distresses, a simple overlay will not correct these problems and a more extensive rehabilitation strategy that will strengthen the pavement is required.

Photo D32: Very Severe Rutting and Alligator Wheel Track Cracking Km 2, La Mauricie National Park

- f. Severe rutting and wheel track alligator cracking between km 0 and km 5.4 and between km 58.3 and 62.8 in La Mauricie National Park requires a major rehabilitation as these distresses are indications of a lack of structural strength.

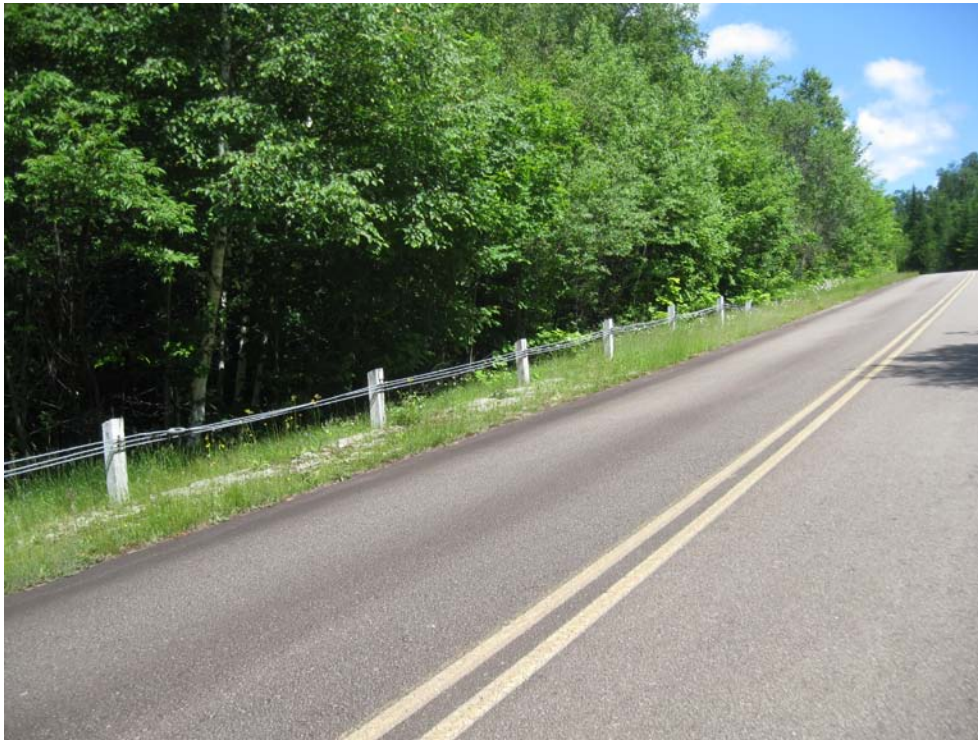
Photo D 34: 3-Strand Guard Rail – loose cables and hence ineffective guardrail La Mauricie National Park
