**PUBLIC WORKS AND
GOVERNMENT SERVICES
CANADA**

**Electrical, Mechanical and
Structural Steel Inspection of the
St. Peters Canal Bridge**

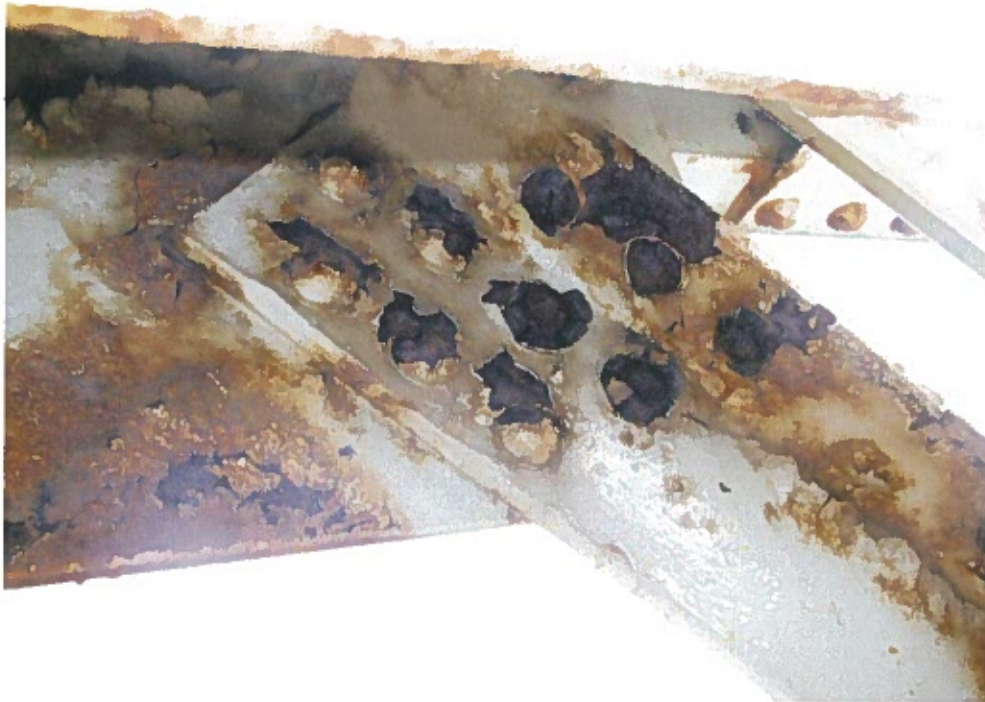
Photograph 5 – Condition of rivets at top chord (node 2W) on north truss. Note: Section loss and corrosion.

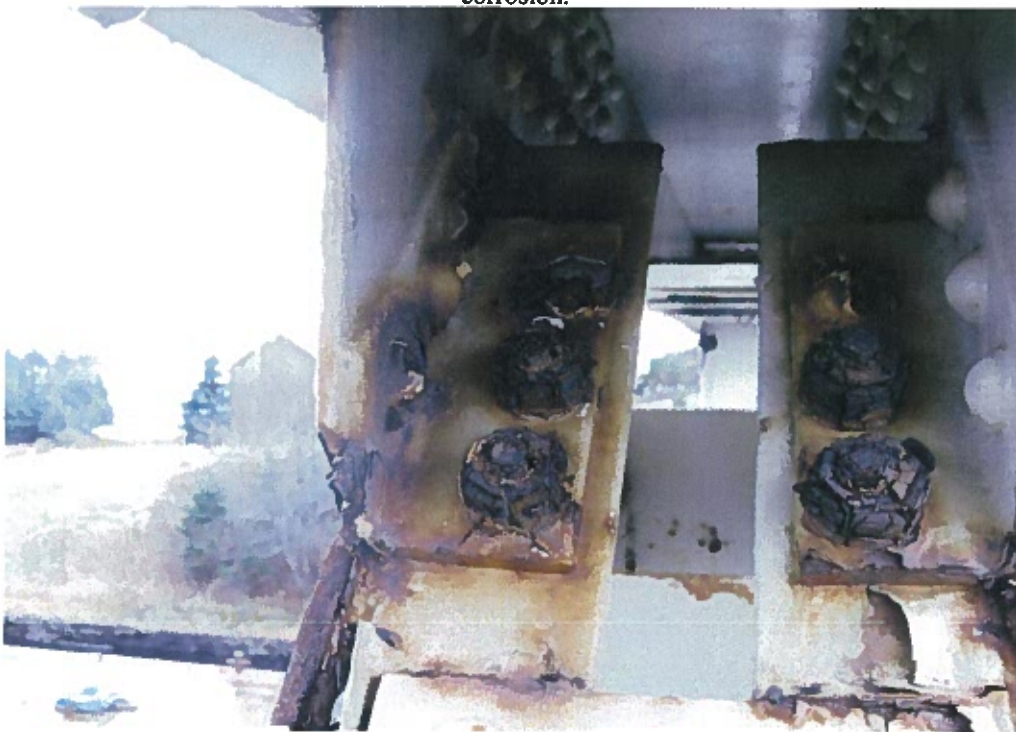
Photograph 6 – Condition of bolts at top chord (node 1W) on north truss. Note: Section loss and corrosion.

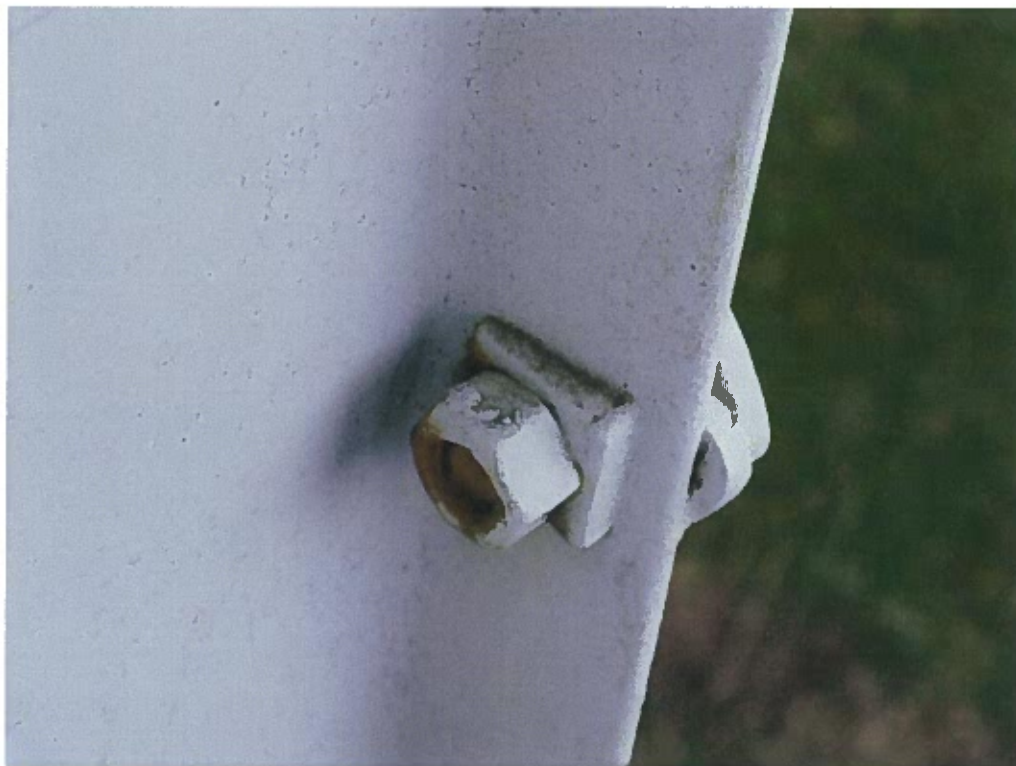
Photograph 7 – Insufficient bolt thread (typical).

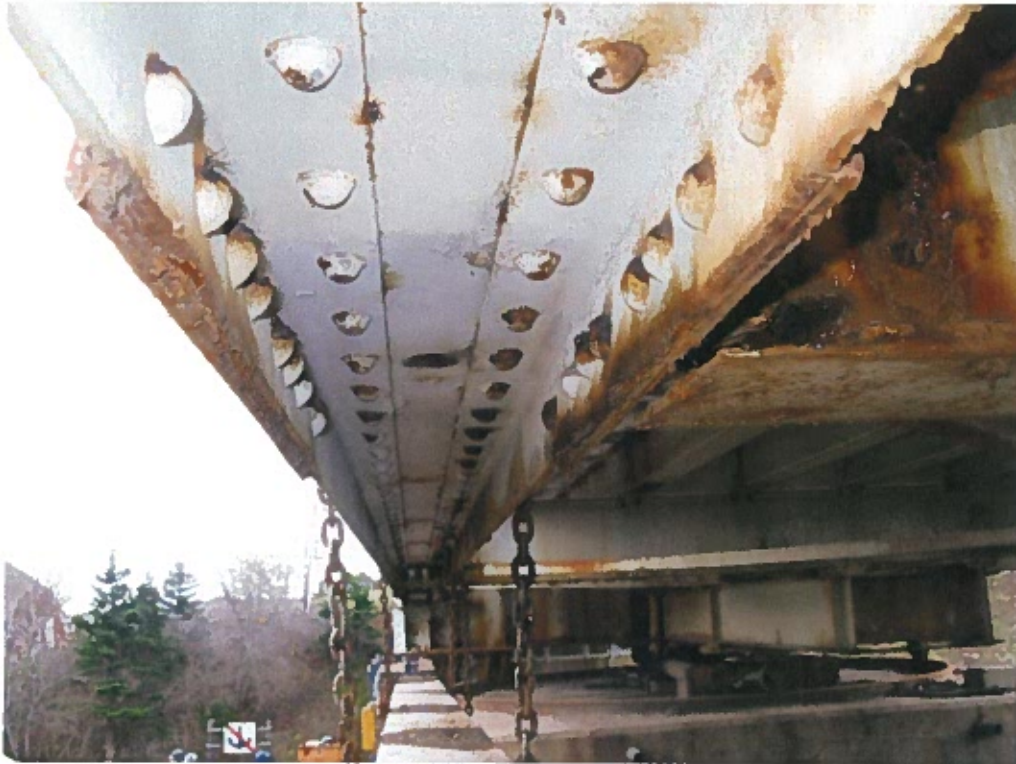
Photograph 9 – Condition of bottom chord along north truss. Note: Medium to severe corrosion.

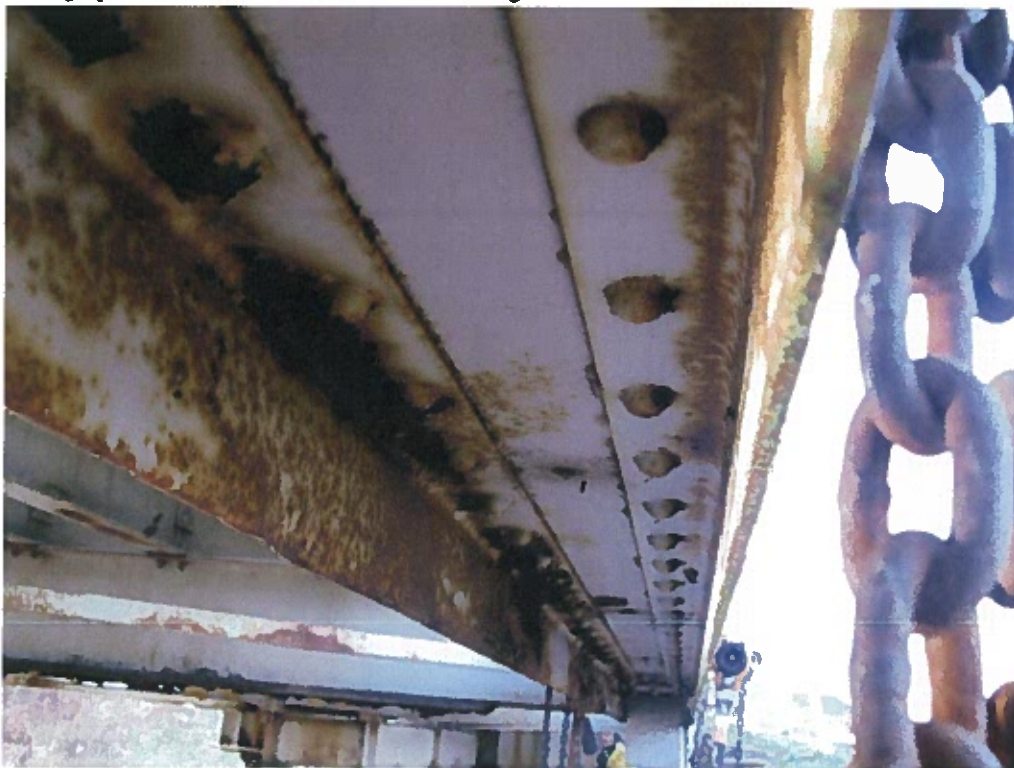
Photograph 10 - Condition of bottom chord along north truss. Note: Medium to severe corrosion.

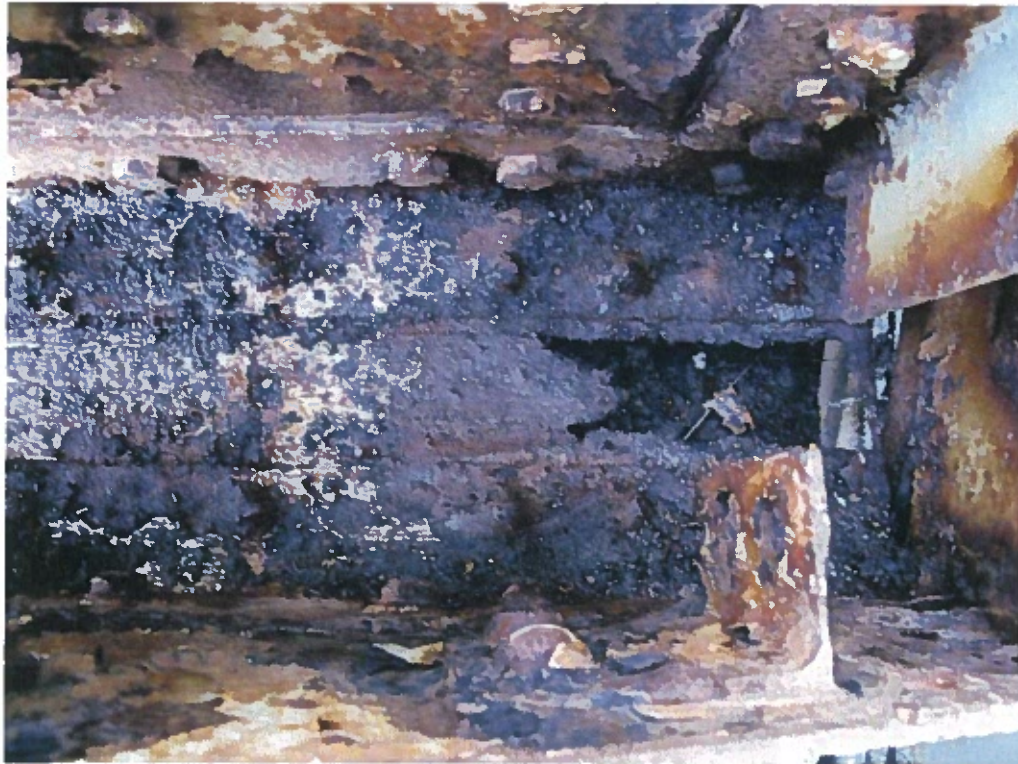
Photograph 11 – Perforation at north truss bottom chord at panel point 3W.

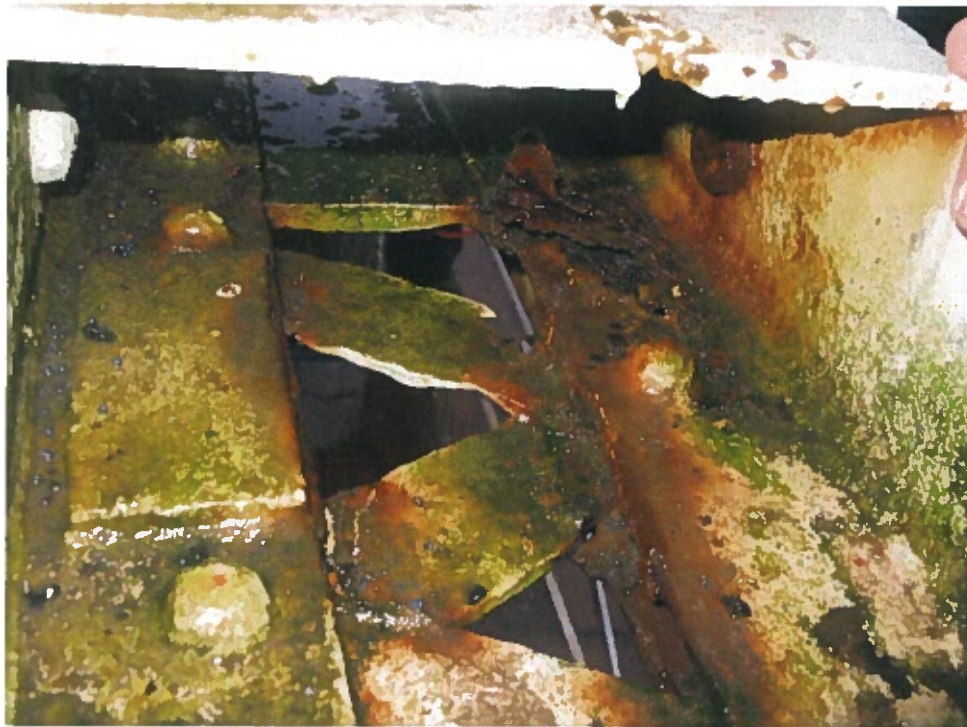
Photograph 13 – Perforation / section loss and corrosion at lacing bars at north truss bottom chord.

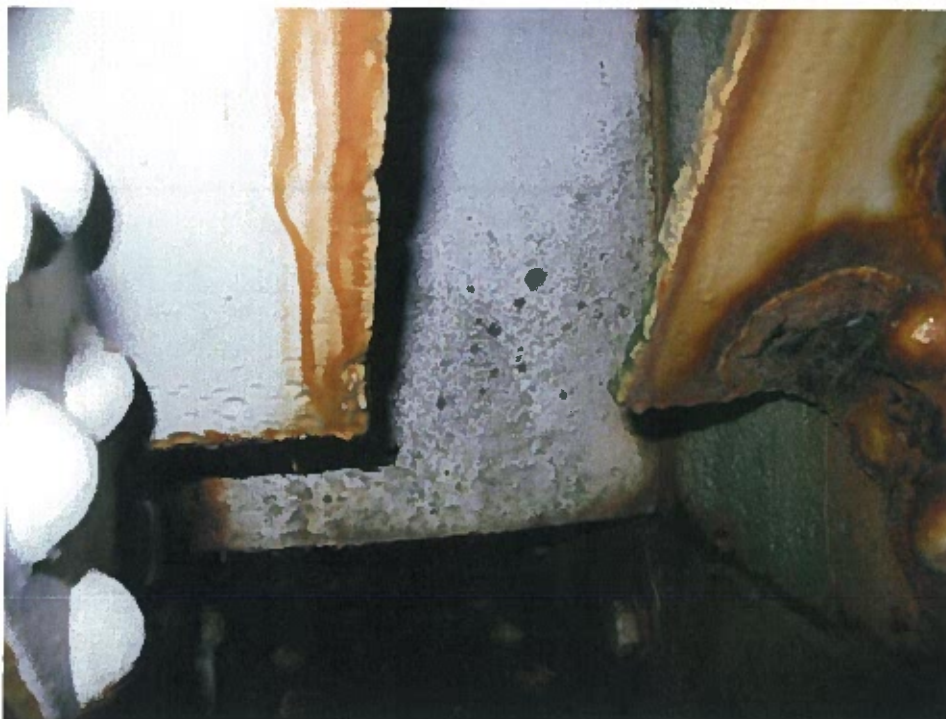
Photograph 14 – Section loss and perforation of the vertical member at panel point location along north truss bottom chord.

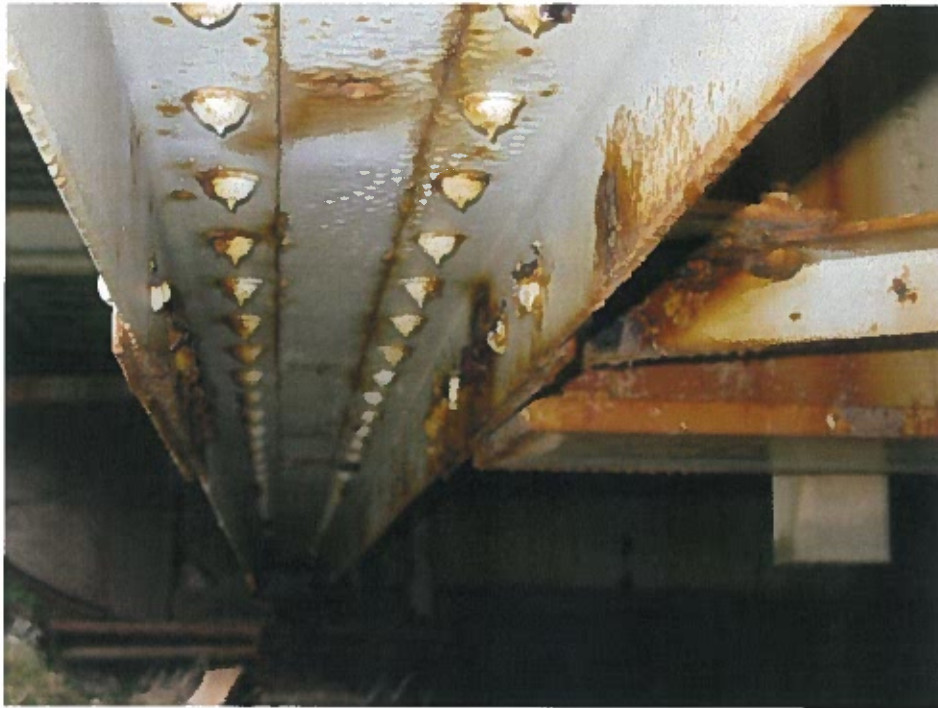
Photograph 21 – Condition of bottom chord along south truss. Note: Medium to severe corrosion.

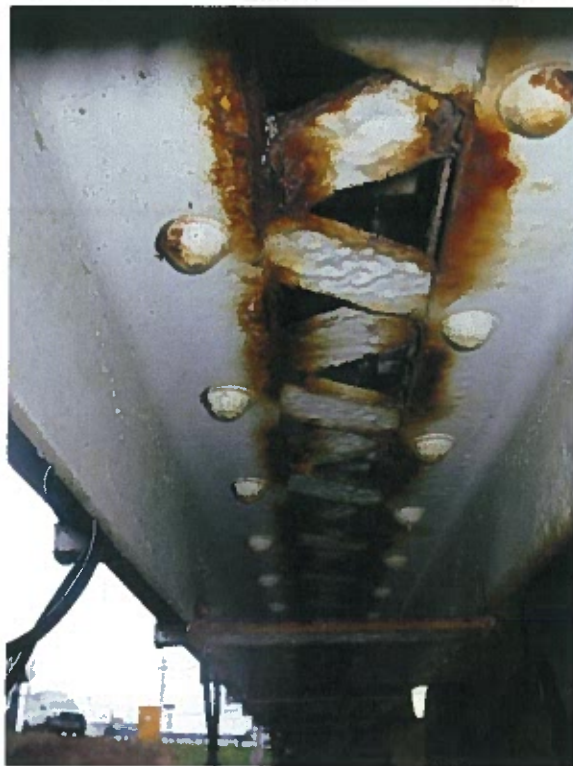
Photograph 22 – Condition of lacing bars along south truss bottom chord between panel points 3E and 5E.

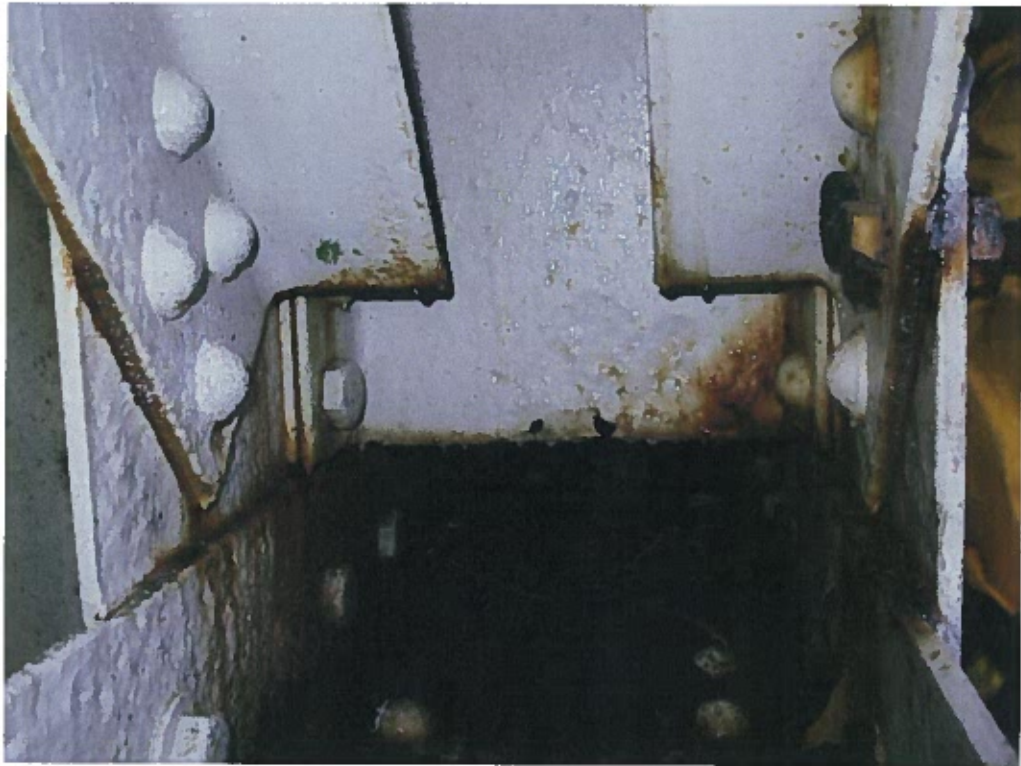
Photograph 23 – Perforation and section loss at vertical member at panel point 4E on south truss.

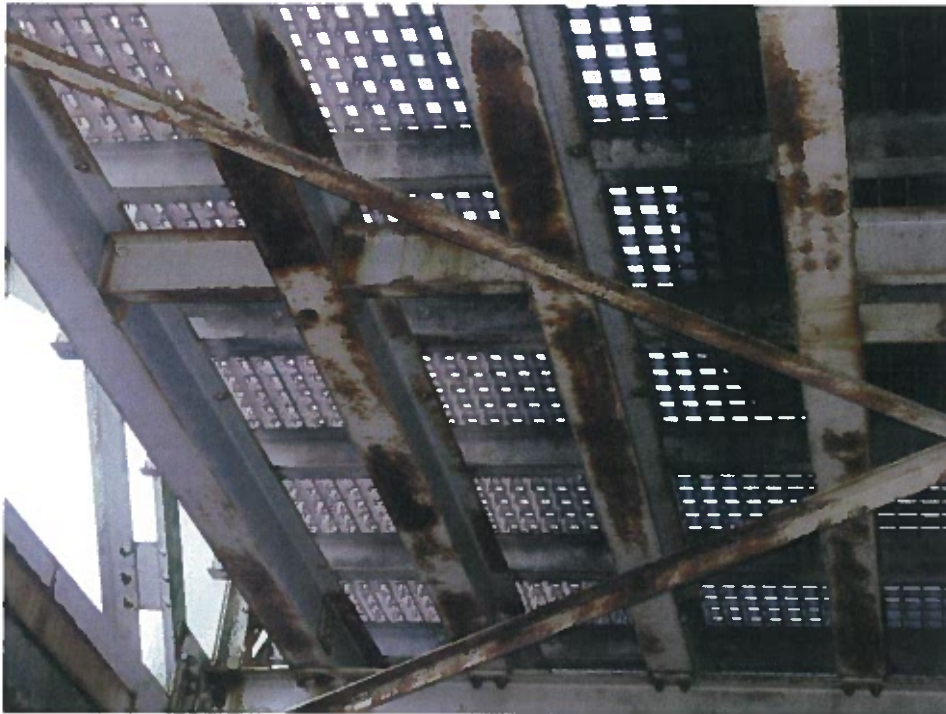
Photograph 29 – Typical condition of stringer/decking beams and grating. Note: coating break down and light to medium corrosion.

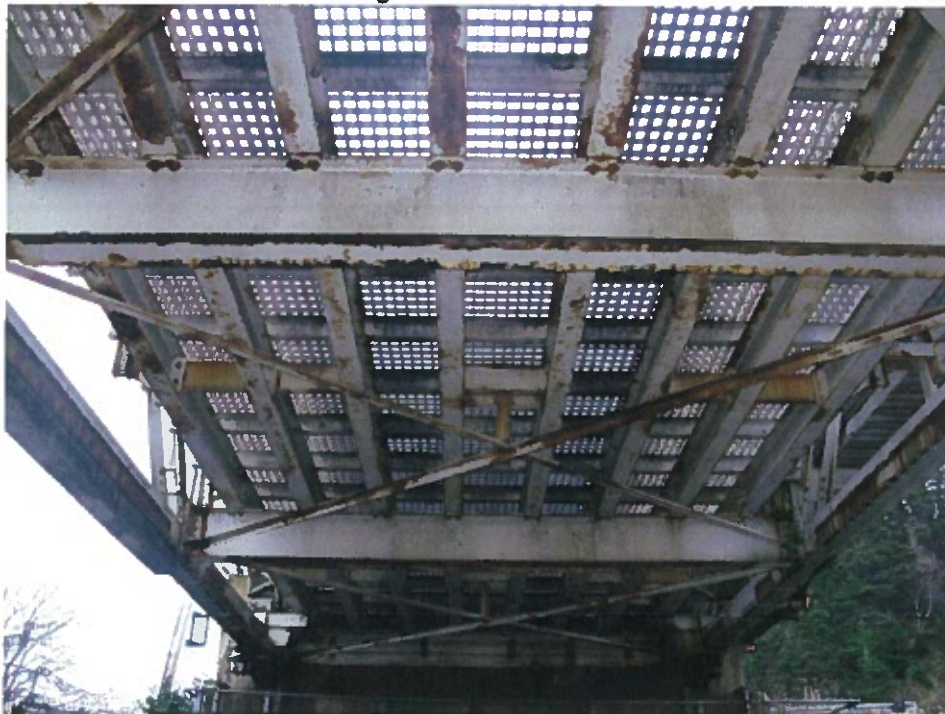
Photograph 30 – Typical condition of stringer/deck beams and grating. Note: the welded reinforcement to the bottom flange of the floor beam.

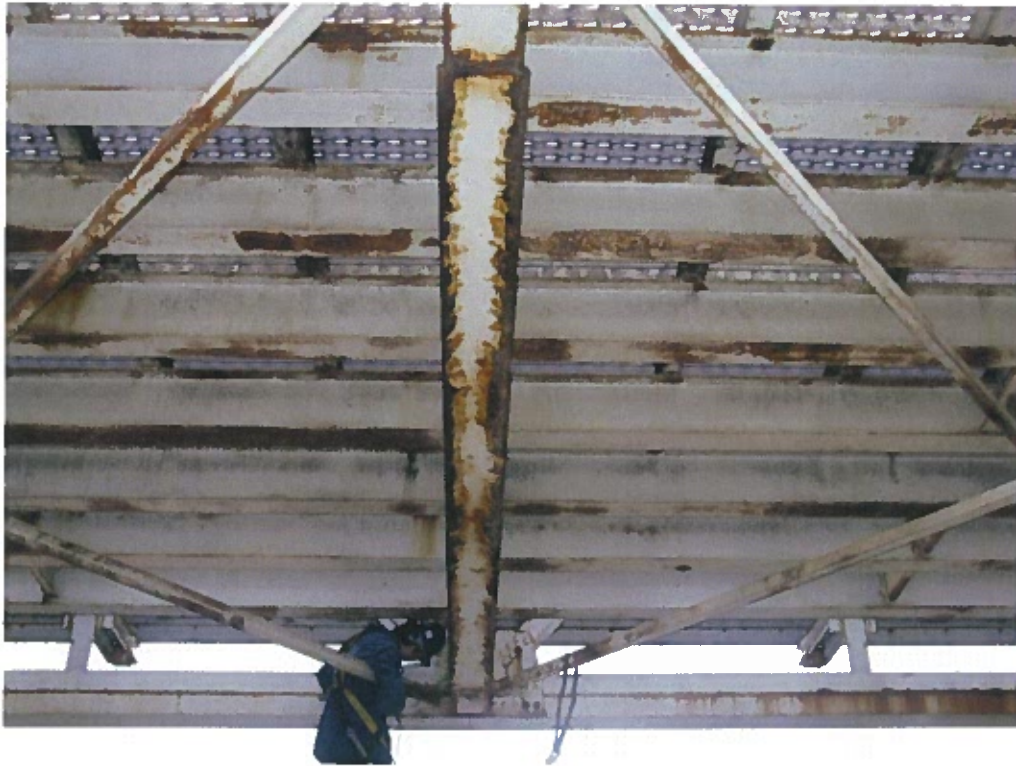
Photograph 31 – Typical condition of floor beams. Note: Welded reinforcement at the bottom flange.

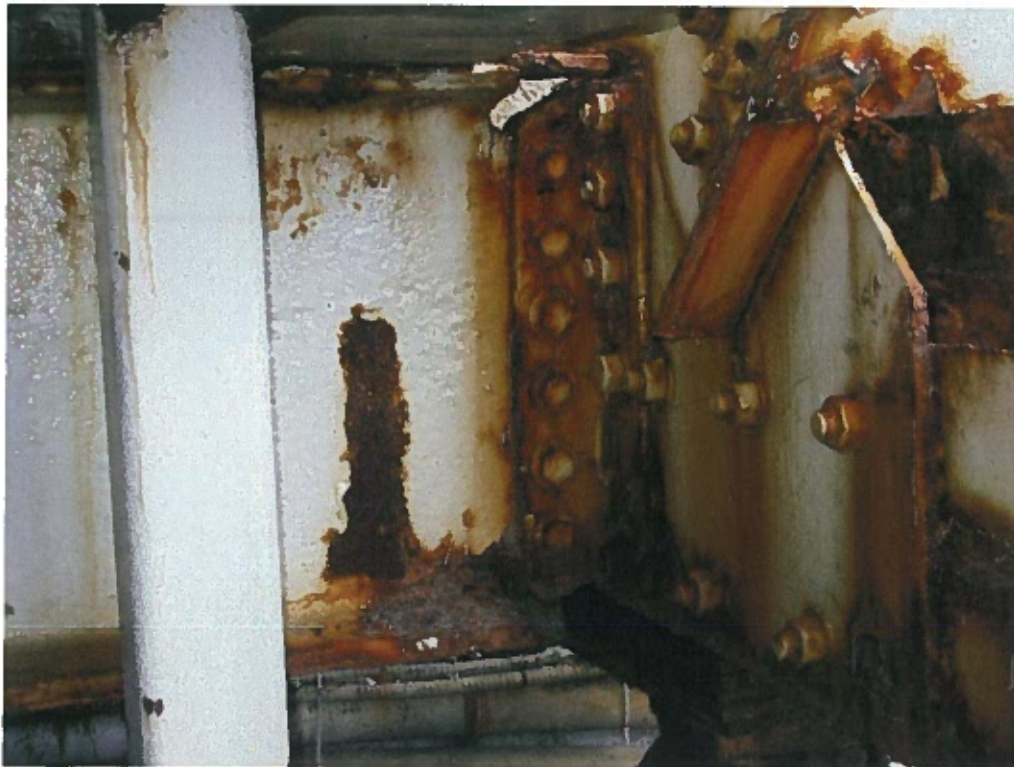
Photograph 32 – Typical condition of connection angles of the floor beam to the lower chord.

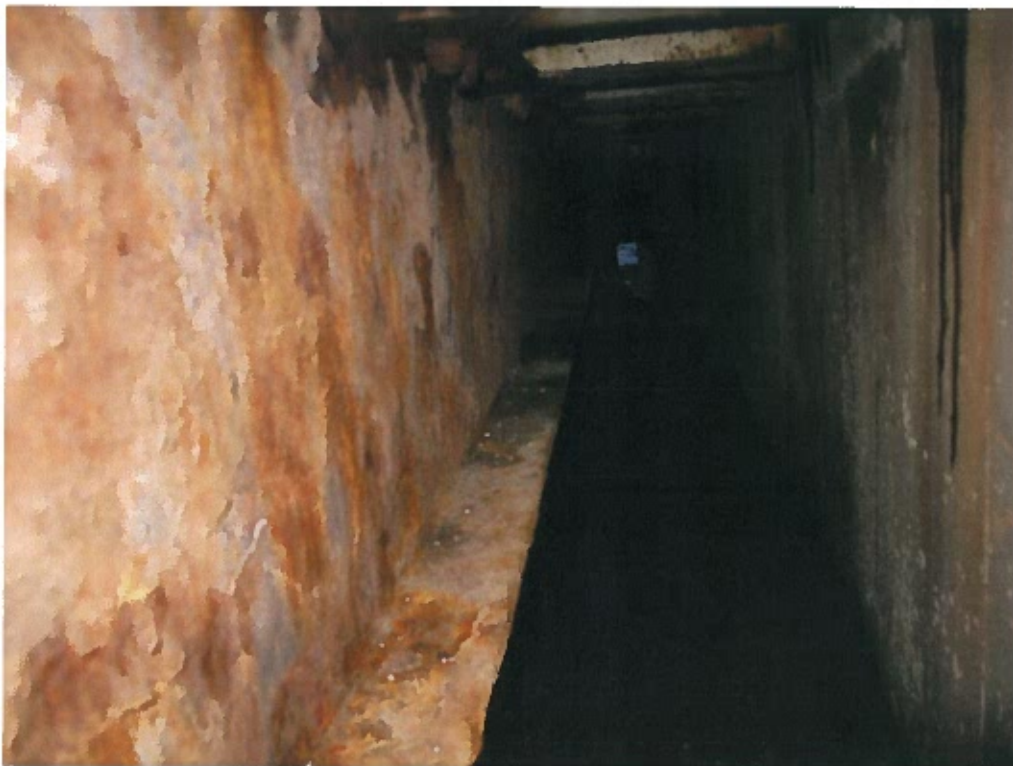
Photograph 33 – Inside face of the end floor beam at east abutment.

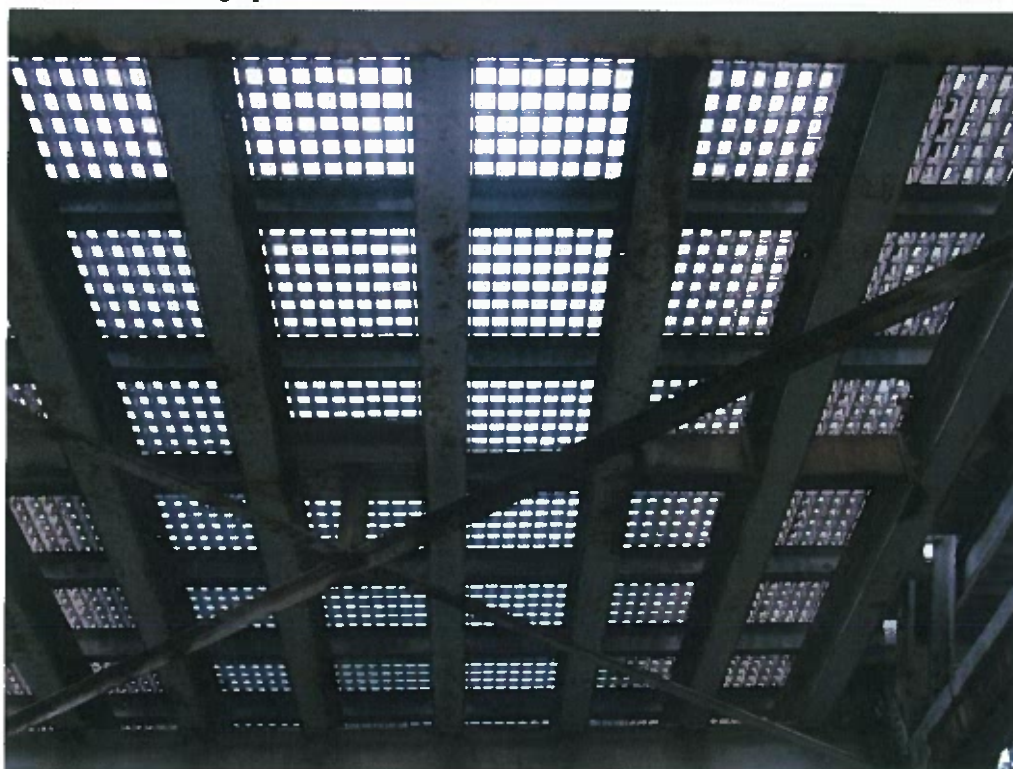
Photograph 34 – Typical condition of horizontal bracing.

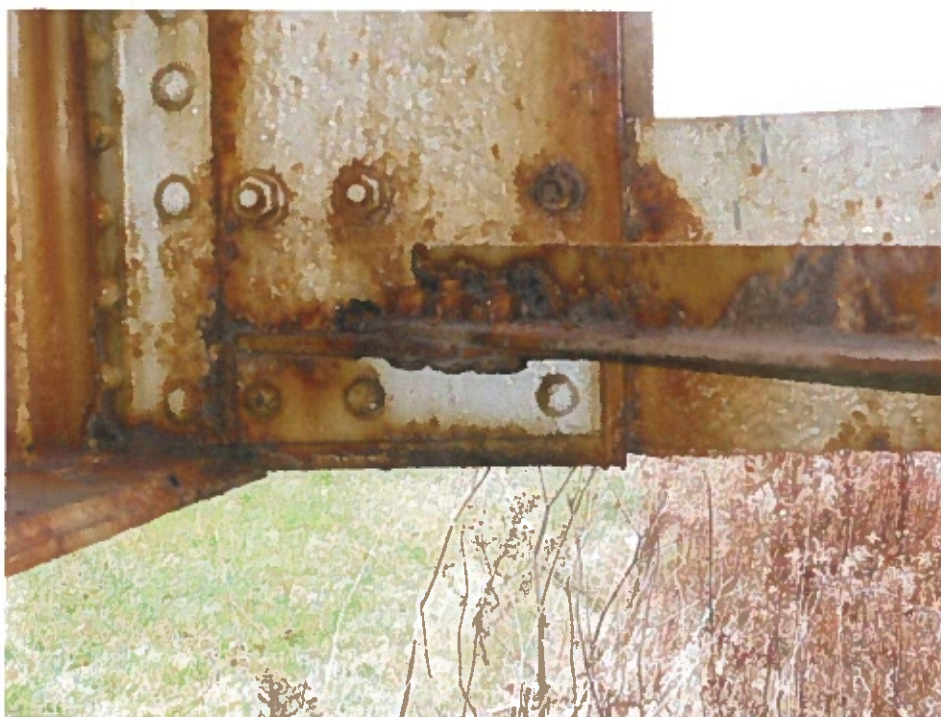
Photograph 35 – Typical condition of horizontal bracing at panel point connection. Note: Medium to severe corrosion.

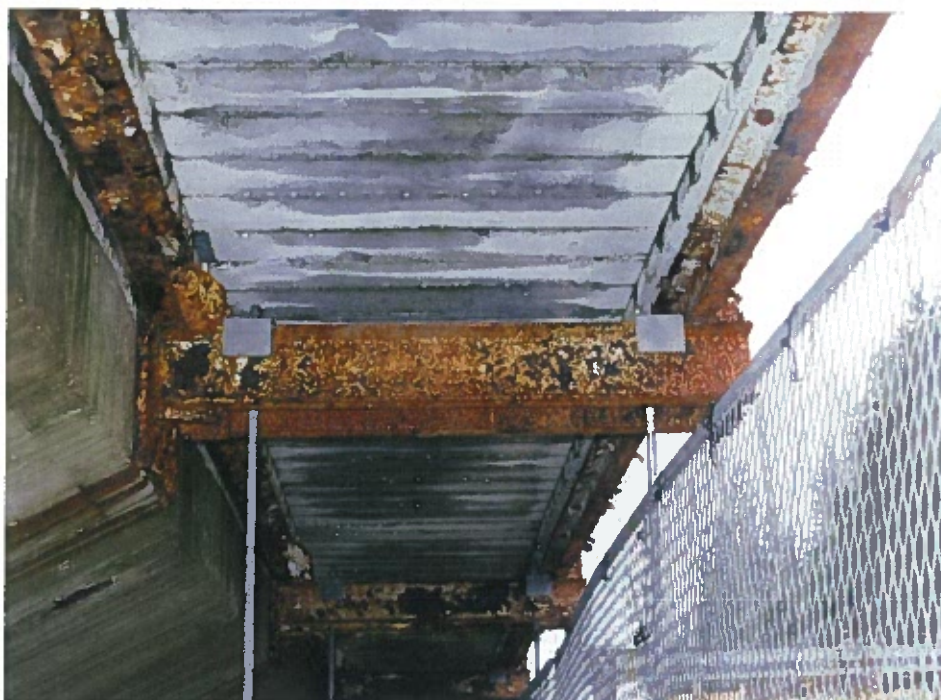
Photograph 36 – Typical condition of structural steel at sidewalk overhang at east approach.

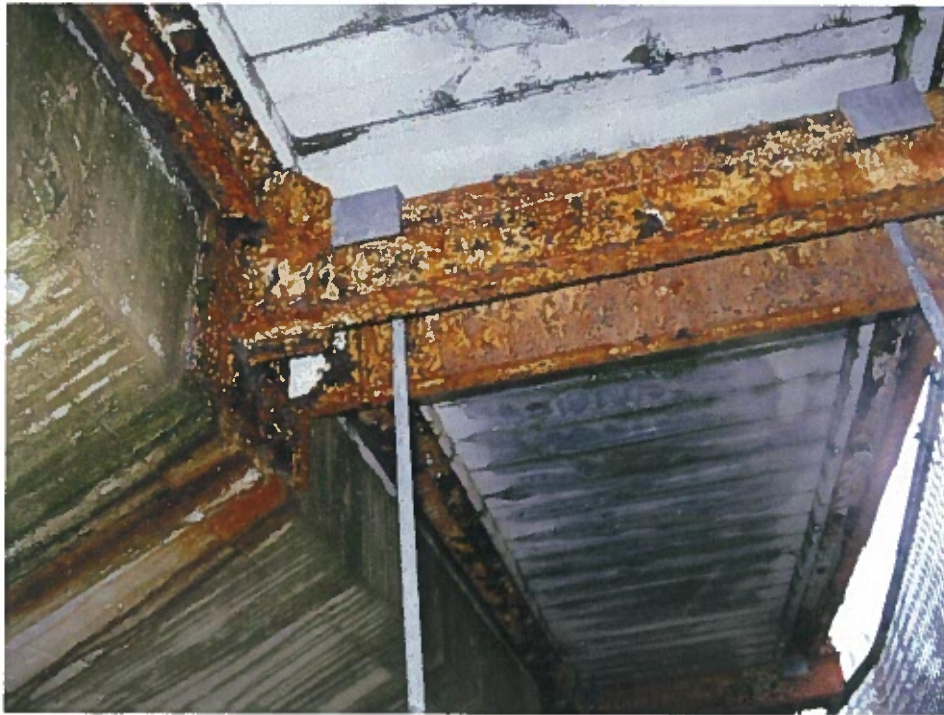
Photograph 37 – Typical condition of structural steel at sidewalk overhang at east approach. Note:
Medium to severe corrosion

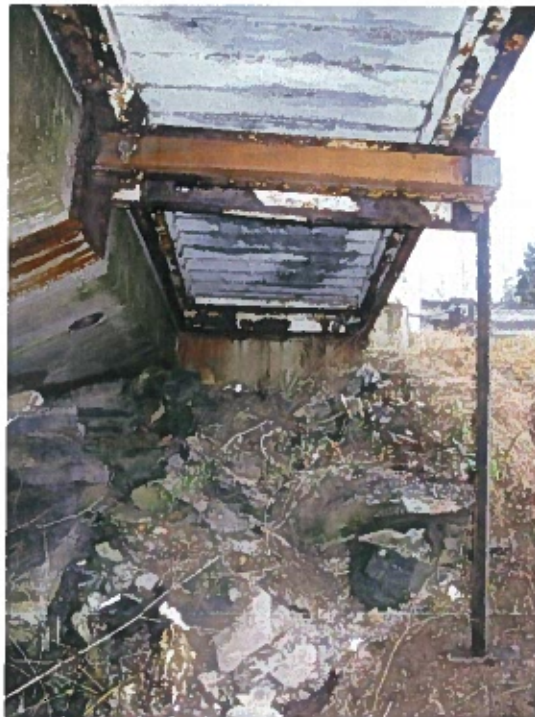
Photograph 38 – Welded reinforcement to existing transverse steel member at the sidewalk near the
east abutment.

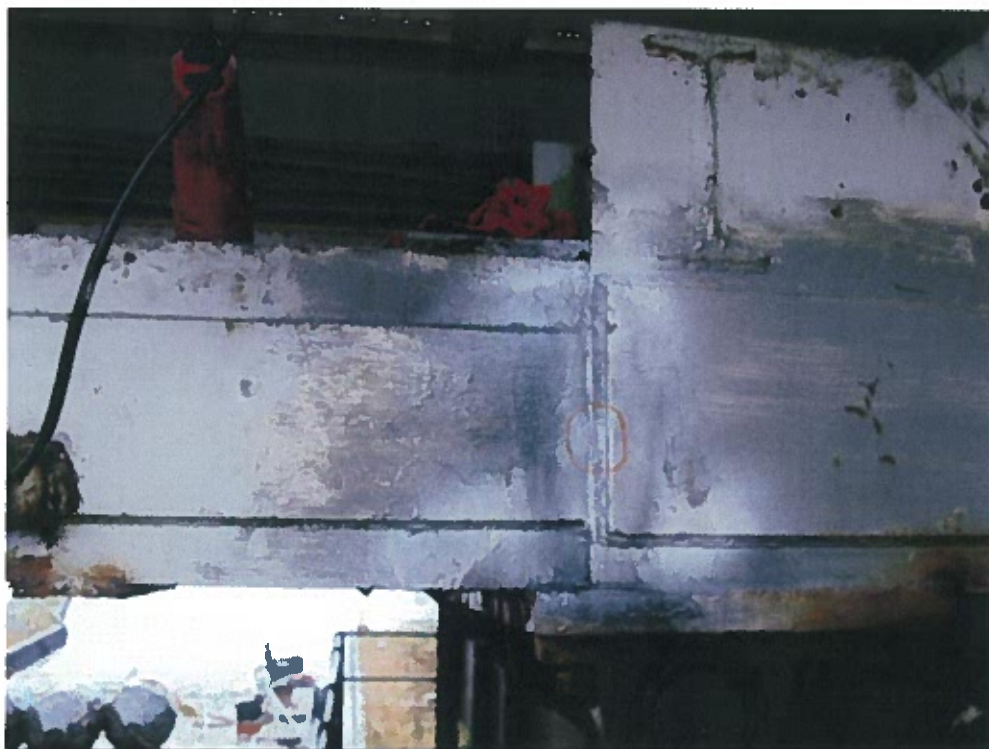
Photograph 43 – Crack in weld at welded reinforcement at panel point 5E south truss bottom chord.

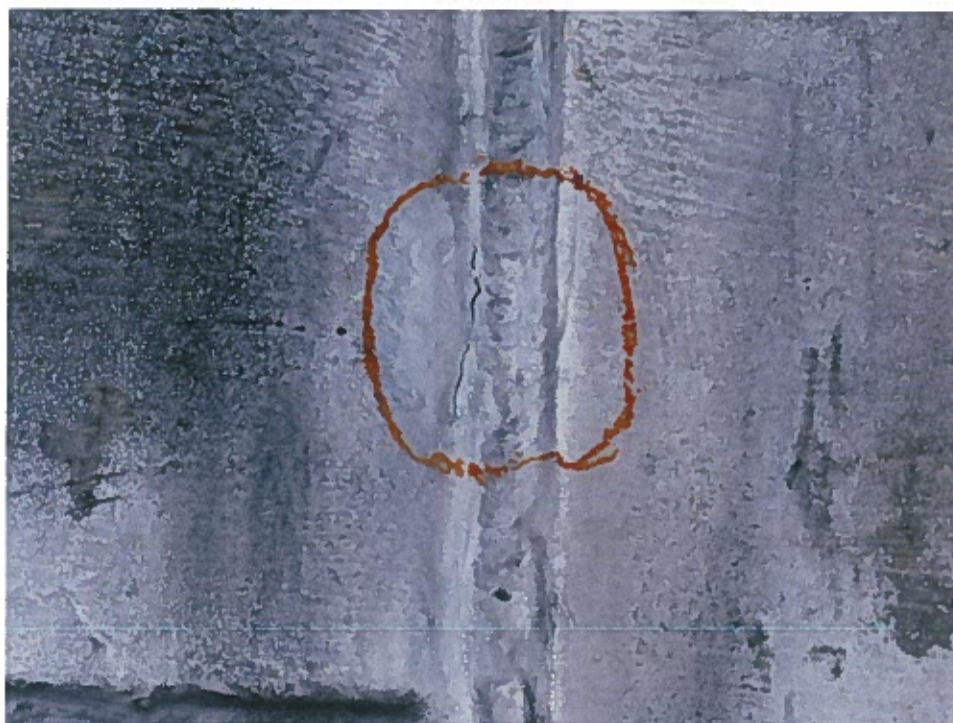
Photograph 44 – Crack in weld at welded reinforcement at panel point 5E south truss bottom chord.

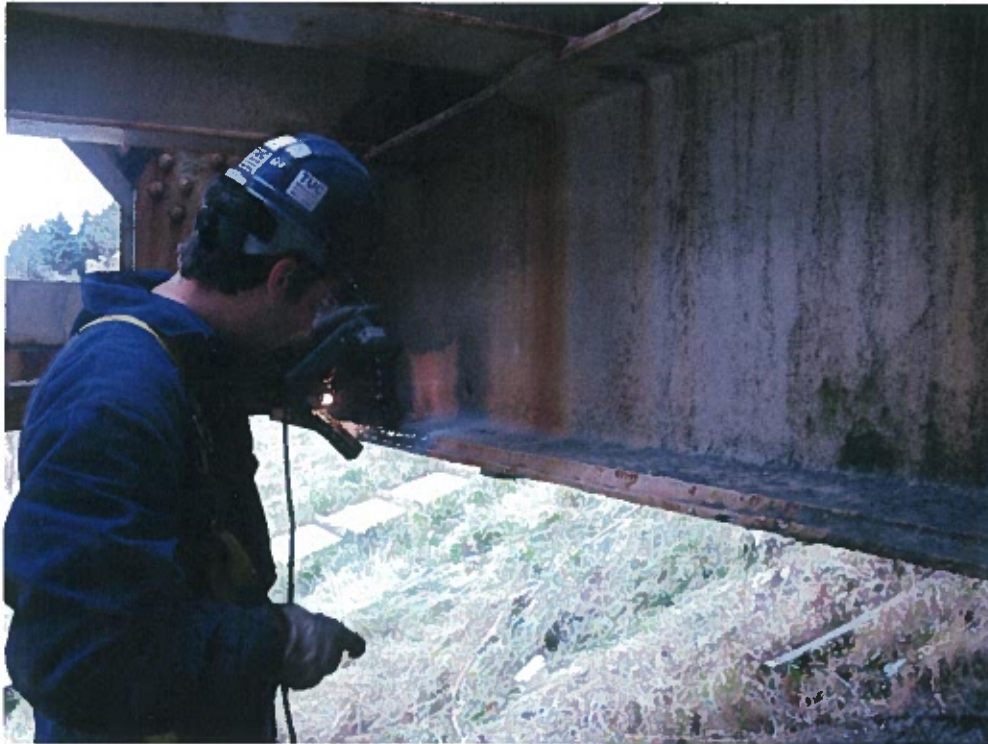
Photograph 45 – Magnetic particle testing of welded reinforcement at bottom flange of floor beam at panel point 2W

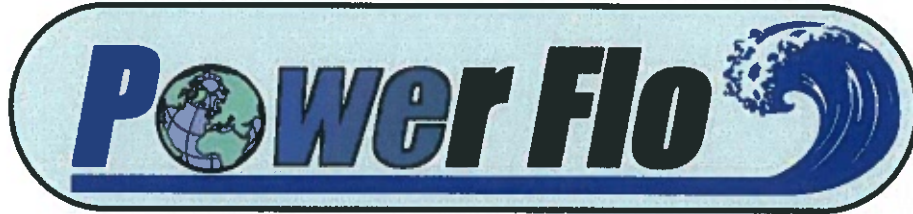
Environmentally Approved Hydraulic Fluid
