<b>Title - Sujet</b> Mise Hors Service et Démolition de	
<b>Solicitation No. - N° de l'invitation</b> EJ192-150405/A	<b>Amendment No. - N° modif.</b> 002
<b>Client Reference No. - N° de référence du client</b> 20150405	<b>Date</b> 2014-09-25
<b>GETS Reference No. - N° de référence de SEAG</b> PW-\$\$\$FG-353-65646	
<b>File No. - N° de dossier</b> fg353.EJ192-150405	<b>CCC No./N° CCC - FMS No./N° VME</b>
<b>Solicitation Closes - L'invitation prend fin</b> <b>at - à 02:00 PM</b> <b>on - le 2014-09-30</b>	
<b>F.O.B. - F.A.B.</b> <b>Plant-Usine:</b> <input type="checkbox"/> <b>Destination:</b> <input checked="" type="checkbox"/> <b>Other-Autre:</b> <input type="checkbox"/>	
<b>Address Enquiries to: - Adresser toutes questions à:</b> Searchwell, Suzette	<b>Buyer Id - Id de l'acheteur</b> fg353
<b>Telephone No. - N° de téléphone</b> (819) 956-6645 ( )	<b>FAX No. - N° de FAX</b> (819) 956-8335
<b>Destination - of Goods, Services, and Construction:</b> <b>Destination - des biens, services et construction:</b> Agriculture Canada Ferme Expérimentale Central 78 Promenade Prince of Wales Ottawa, Ontario

**ADDENDA NO. 02**

# Designated Substances Survey for the Central Experimental Farm Centr

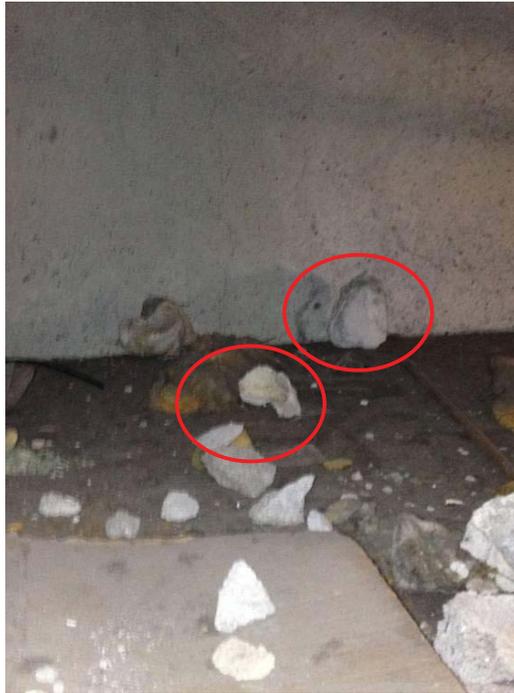
- Minor debris on top of the ceiling slab of the Steam Tunnel entrance in the Basement is suspected to consist of asbestos-containing pipe fitting insulation (poor condition);
- Metal clad cap insulation (**Sample 015686-05**) on a header in the Basement (good condition);
- End cap insulation on the High Temperature Hot Water pipe run (**Sample 015686-09**) (good condition);
- Grey pipe elbow insulation on domestic water pipes (good condition);
- Select pipe elbow insulation (painted red) (good condition);
- Antisweat insulation on domestic water pipes and drain pipes (good/fair condition);
- Grey parging insulation over white non-asbestos insulation on Emergency Generator Pipe elbows and hangers (fair condition);
- Insulation on middle section of induced fan units (3 units) (good condition);

**Photograph 1 – Basement, on top of ceiling slab of Steam Tunnel entrance, Debris on top of the ceiling slab of the Steam Tunnel entrance in the Basement is suspected to consist of asbestos-containing pipe fitting insulation.**

The removal or disturbance of one square metre or less of friable asbestos-containing materials (pipe insulation, Emergency Generator Pipe elbows and hangers, induced fan unit insulation) must be conducted using a minimum of Type 2 asbestos work procedures. The removal or disturbance of more than one square metre of friable asbestos-containing materials must be conducted using Type 3 asbestos work procedures. Type 3 asbestos abatement operations performed in occupied buildings require daily asbestos air monitoring outside of each asbestos work area, as per PWGSC DP 057. It should be noted that the removal of good condition asbestos-containing pipe insulation and pipe fitting insulation can be conducted using Type 2 glove bag procedures, provided the material is in good condition, and a proper seal can be maintained.

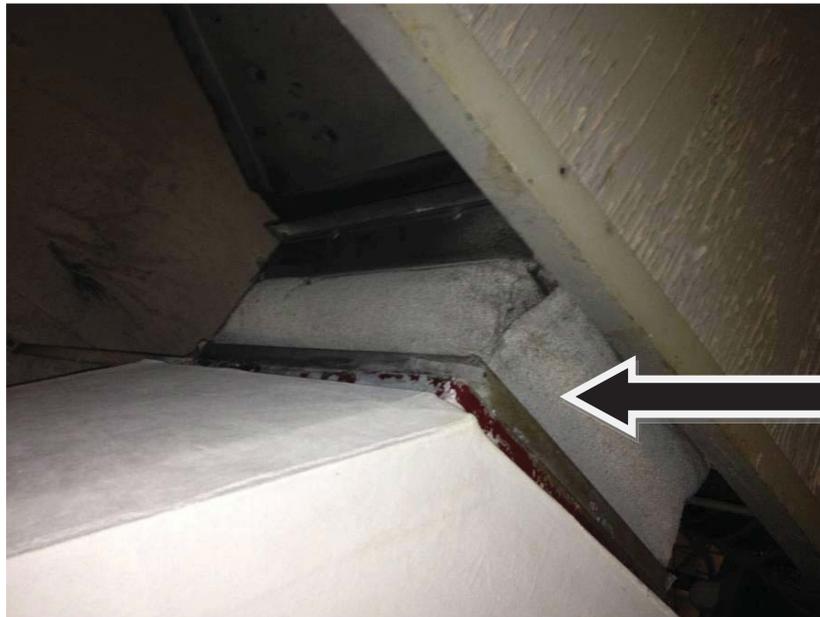
**Photograph 2 – Mechanical ventilation dampeners in the Basement and on the 5<sup>th</sup> Level are suspected to contain asbestos.**

The removal or disturbance of non-friable asbestos-containing drain pipe joint caulking, ventilation dampeners, gasket material, light heat shielding, exterior white caulking, fire doors, and transite panels (and tile remnants) can be conducted using a minimum of Type 1 asbestos work procedures, provided the material is wetted to control the spread of dust or fibres, and the work is done only by means of non-powered hand-held tools. If these conditions cannot be met, then more stringent (Type 2 or Type 3) work procedures are required.

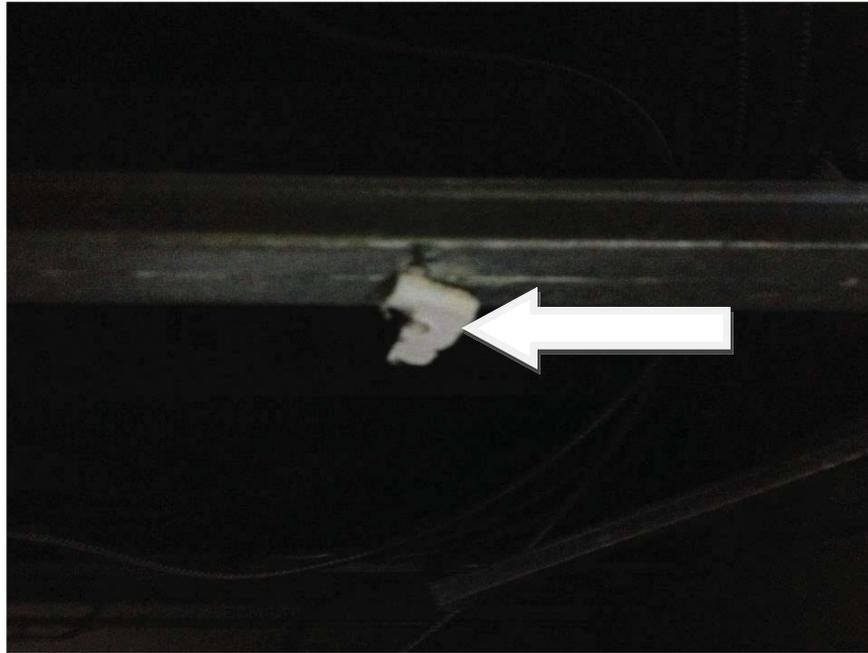
**Photograph 3** – Transite ceiling tile remnants (suspect) were noted on concealed ceiling tracking in ceiling space of Ground Floor Kitchen and Front Office.

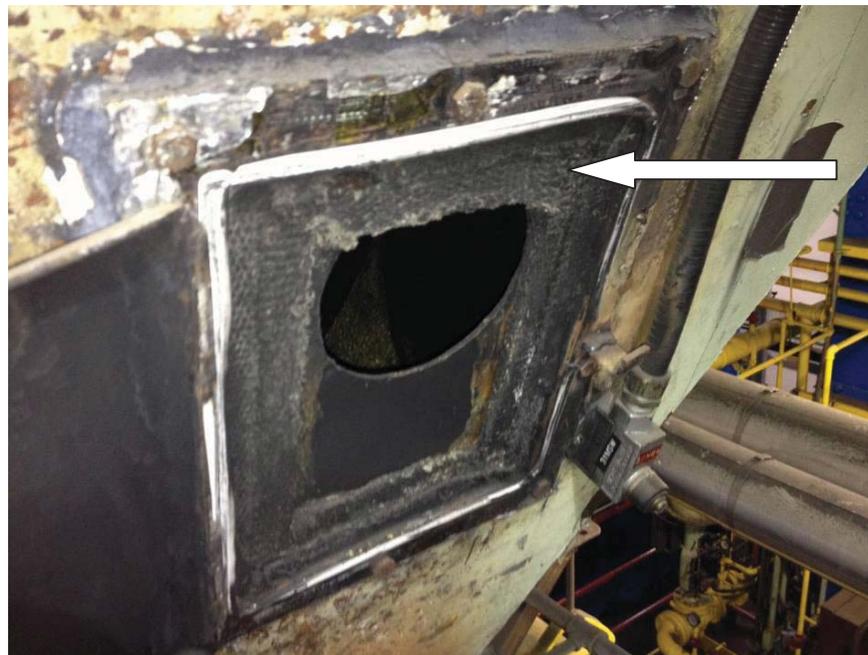
**Photograph 4** – Mezzanines Floor Level, Gasket material on soot (“heavies”) collectors are suspected to contain asbestos.

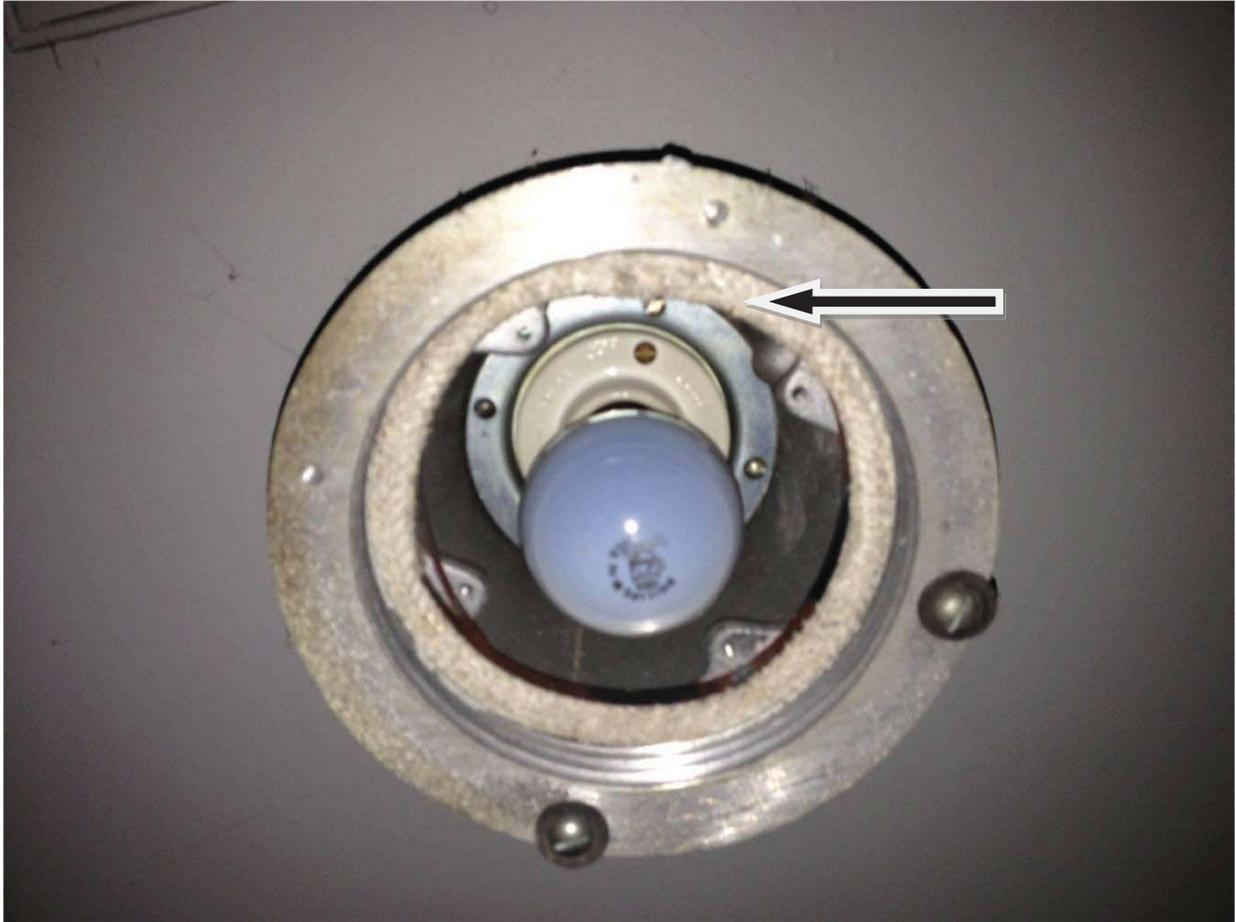
**Photographs 5 – Ground Floor Storage Room off Garage, Light heat shielding suspected to contain asbestos.**

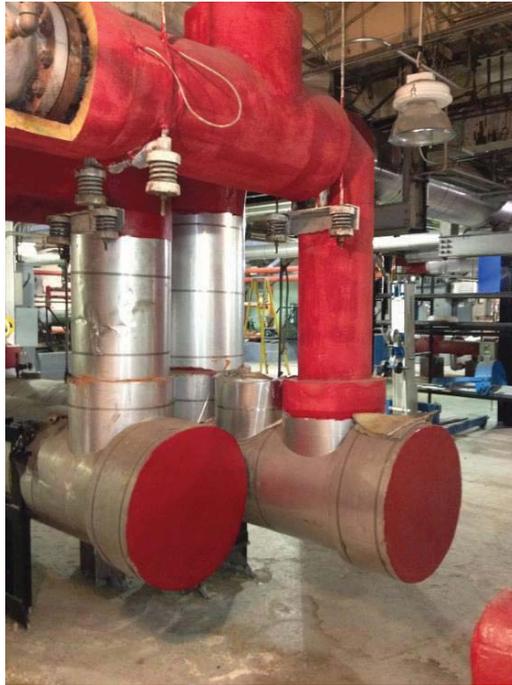
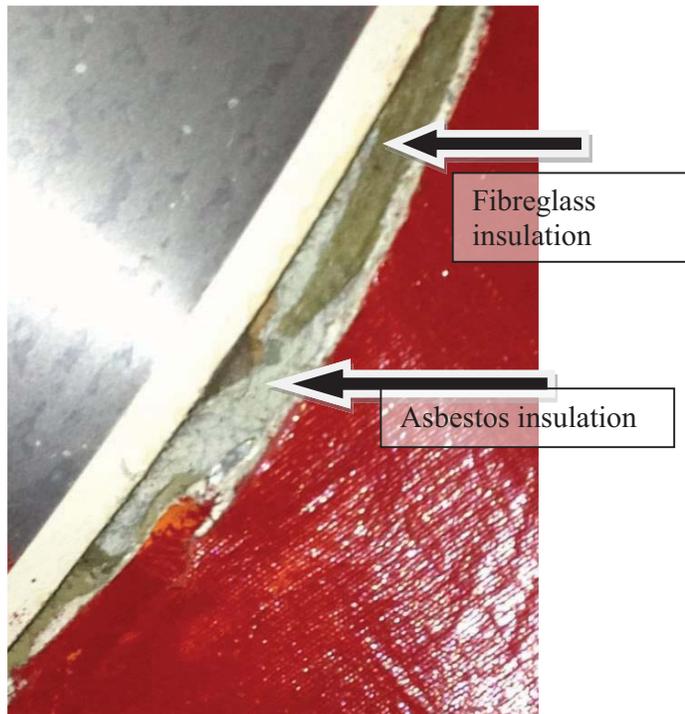
Much of the pipe insulation in the Basement is non-asbestos (e.g. fiberglass, non-asbestos white insulation, etc.). However, pipe fitting insulation type was inconsistent and varied between asbestos and non-asbestos applications, and in some cases both applications present on the same fitting. As intensive destructive testing would be required to delineate fitting insulation type in the Basement, it may be more practical to consider all pipe fitting insulation as asbestos-containing for abatement purposes. There are approximately 110 of these fittings throughout the Basement. One (1) asbestos-containing elbow was noted associated with the heater in the Diesel Room. One (1) suspect asbestos-containing elbow was noted associated with a pipe beneath the North most make-up tank at the make-up tank level. Approximately four (4) elbows insulated with suspect asbestos-containing material at the Return Header at the boiler base are associated with each Boiler.

**Photographs 6 & 7 – Basement,** Pipe fitting insulation type is inconsistent and varies between asbestos and non-asbestos applications, and in some cases both applications present on the same fitting

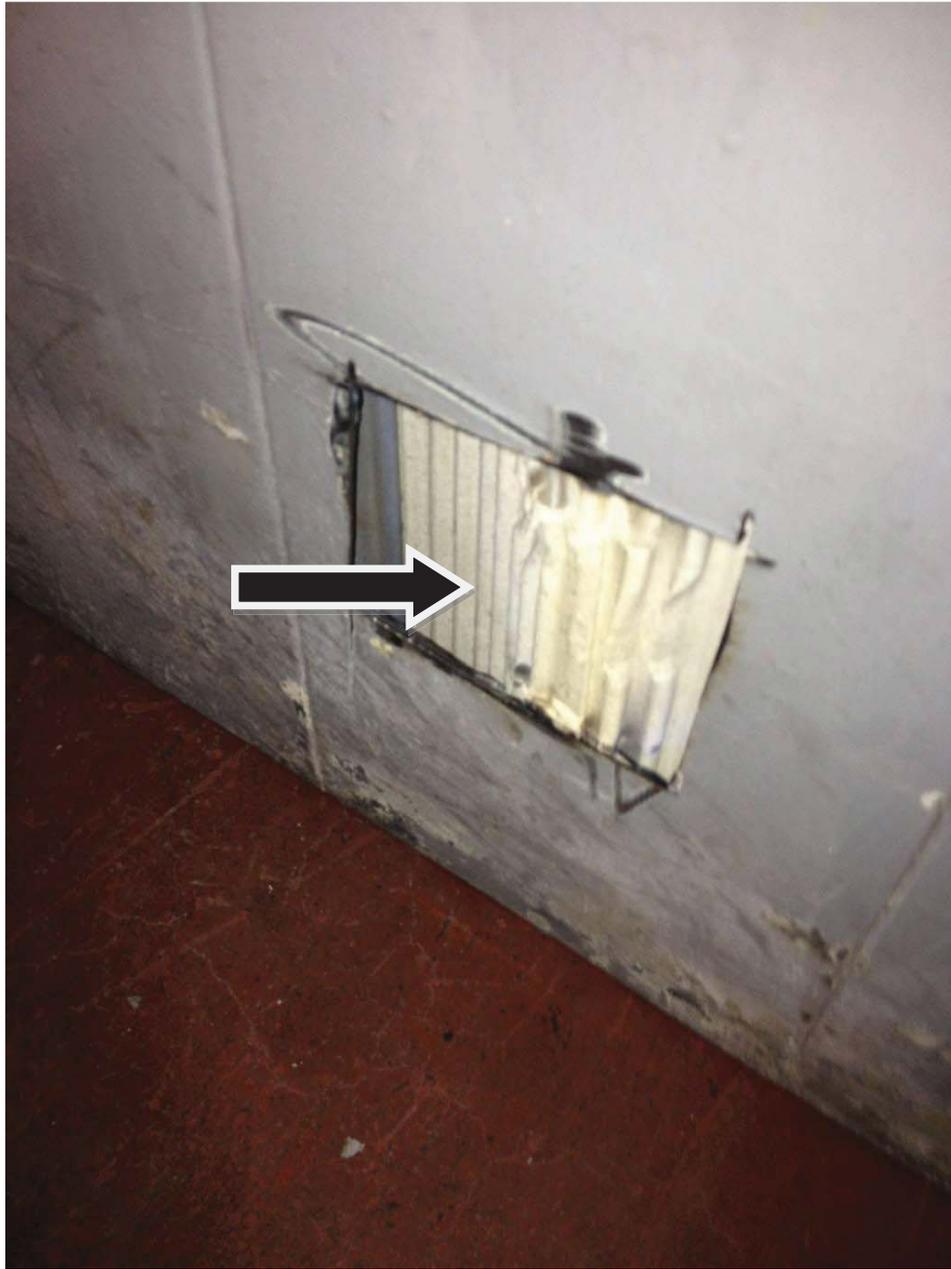
**Photograph 8 – Ground Floor, Electrical Room, Metal Fire Doors on the Ground Floor have an “aircell” insulation core which is assumed to contain asbestos**

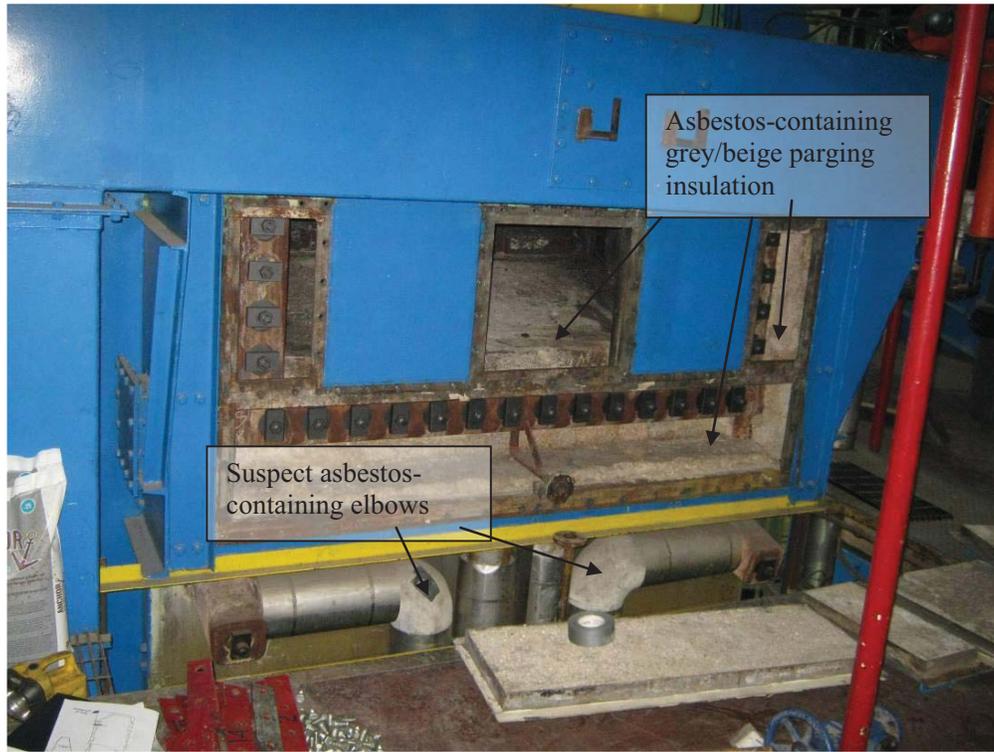
- Grey/beige parging insulation on the floor and sides of the Return Header of Boiler #1 (**Sample B01-A**) (good condition). This material is also suspected present in the same areas of Boiler # 2 & 3;
- Grey/beige castable parging insulation in the Fire Box side wall of Boiler #1 (**Sample B07-A**) (good condition). This material was not seen in the same areas of Boiler # 2 & 3;
- Parging insulation on the upper side walls of Boiler #1, #2 & #3 (**Samples B08-A-C**) (good condition);
- Brown insulation concealed beneath the floor of Boiler #1 (**Sample B09-A**) (good condition). This material is also suspected present concealed beneath the floors of Boiler # 2 & 3.

**Photograph 9 – Ground Floor, Base of Boiler #1,** Grey/beige parging insulation on the floor and sides of the Return Header of Boiler #1 (Sample B01-A) contains asbestos. Pipe elbows at the base of the boiler are assumed to contain asbestos.

Given that the boiler materials at the base of the boilers, Fire Box side wall of Boiler #1, and at the upper levels of the boilers contain asbestos, DST recommends that it would be more practical to treat all boiler materials as asbestos-containing for abatement purposes. Repairing, altering or demolishing all or part of a kiln, metallurgical furnace or similar structure (e.g. Boiler) that is made in part of refractory materials that are asbestos-containing materials must be conducted using Type 3 asbestos work procedures. Waste segregation and cleaning of non-asbestos refractory materials for disposal as non-hazardous should be considered.

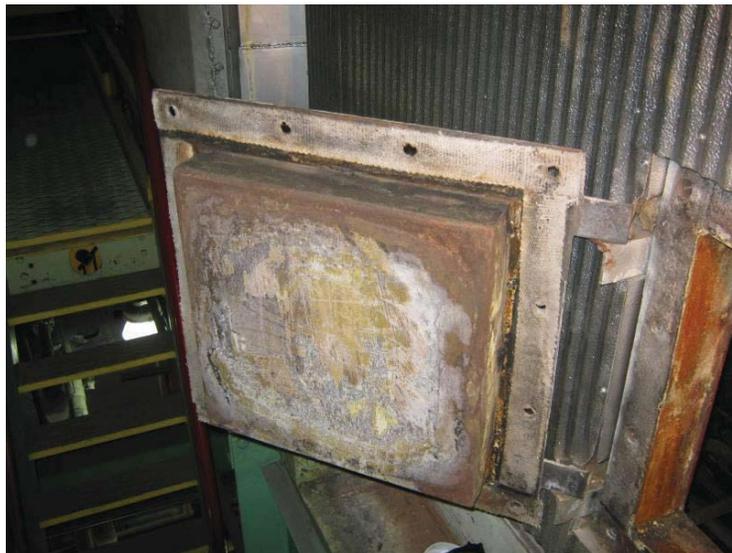
**Photograph 10 – Upper Level, Boiler #2,** Hatch gasket is assumed to contain asbestos.
