**DATE** March 26, 2014**PROJECT No.** 13-1122-0120**TO** Martin Bouwma  
PWGSC**FROM** Stefano Marconetto**EMAIL** Stefano\_Marconetto@golder.com**THUNDER BAY INTERNATIONAL AIRPORT FIREFIGHTING TRAINING AREA (FTA)  
DESCRIPTION OF WASTE AND DEBRIS FOR REMOVAL AT ABANDONED DUMP SITE**

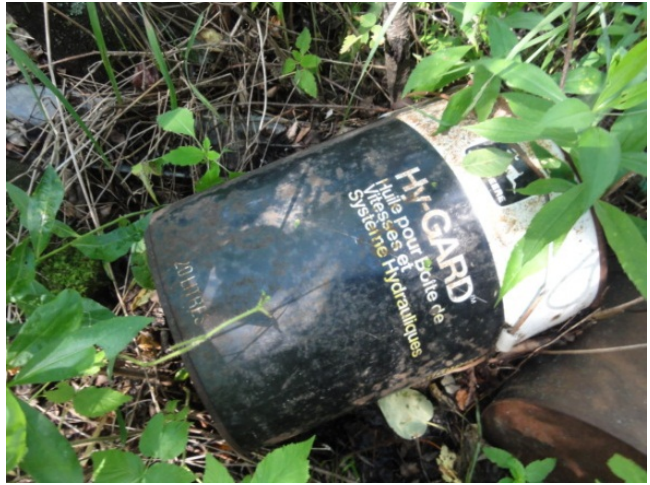
Product Name	Comment	
Deere and Company, Hy-GARD hydraulic oil	Patented in 1976 and renewed in 2006.

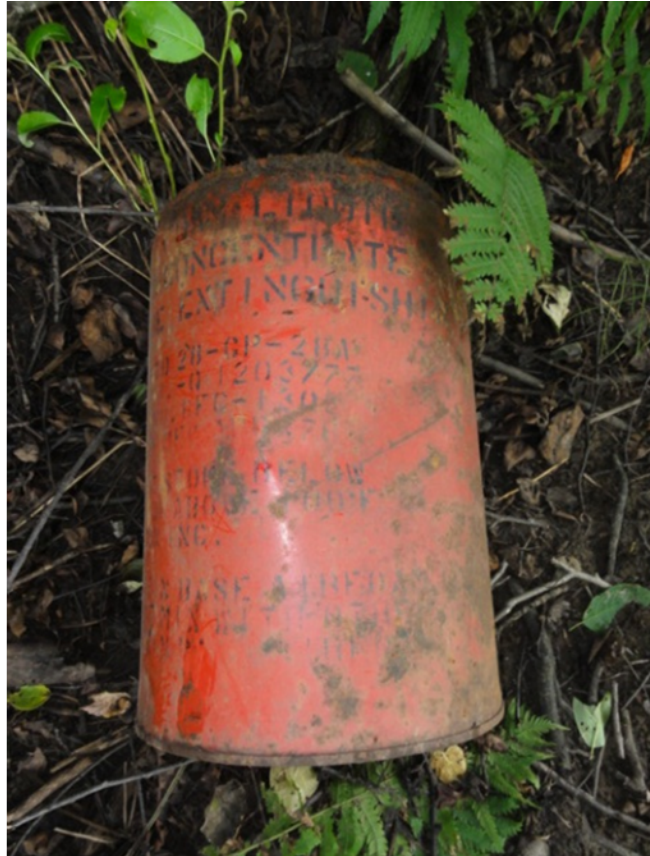
Foam liquid concentrate, protein-based fire extinguishing chemicals, standard 28-GP-28A	Standard 28-GP-28A was published in 1977 by the Canadian General Standards Board. This standard was reportedly cancelled in 1999.

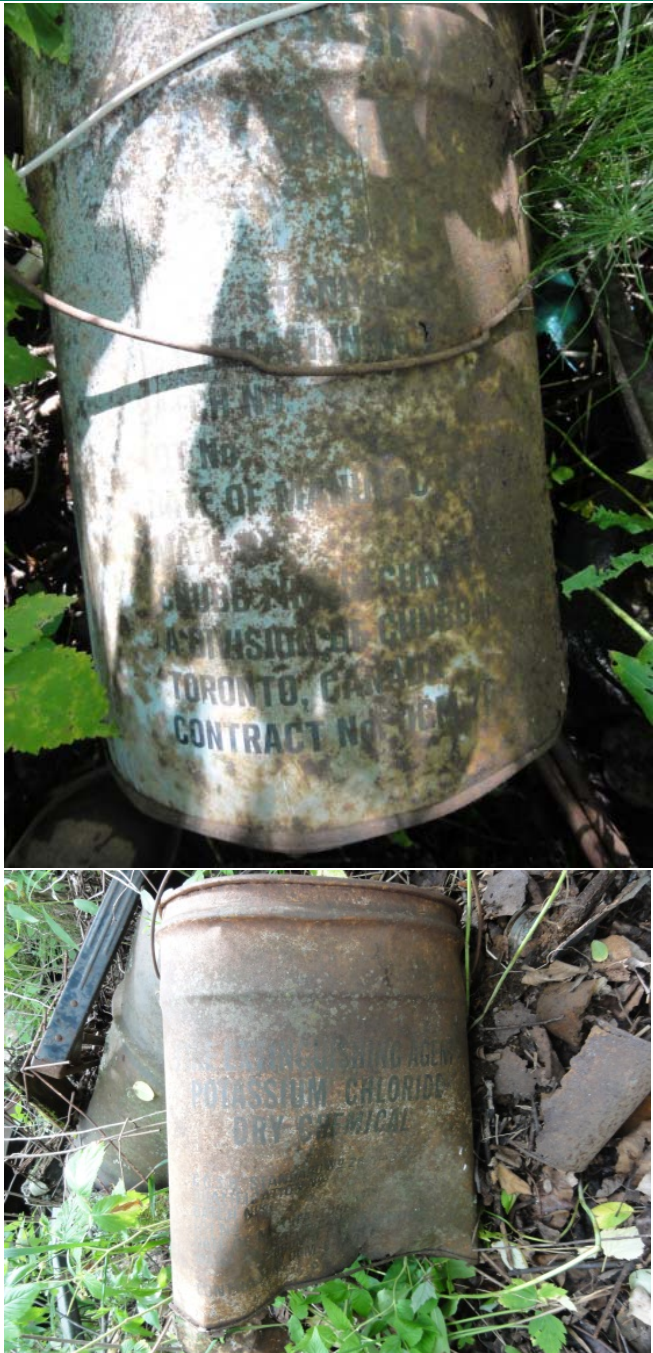
Product Name	Comment	
<p>Potassium chloride dry chemical fire extinguishing agent, standard 28-GP-73(M)</p>	<p>This standard for fire extinguishing agents was previously registered with the Standards Council of Canada and its status now appears as “withdrawn” – published in 1975 then superseded by 28-GP-73 (M) which was canceled in June 1989 and replaced by CAN/ULC-S514-M88.</p>

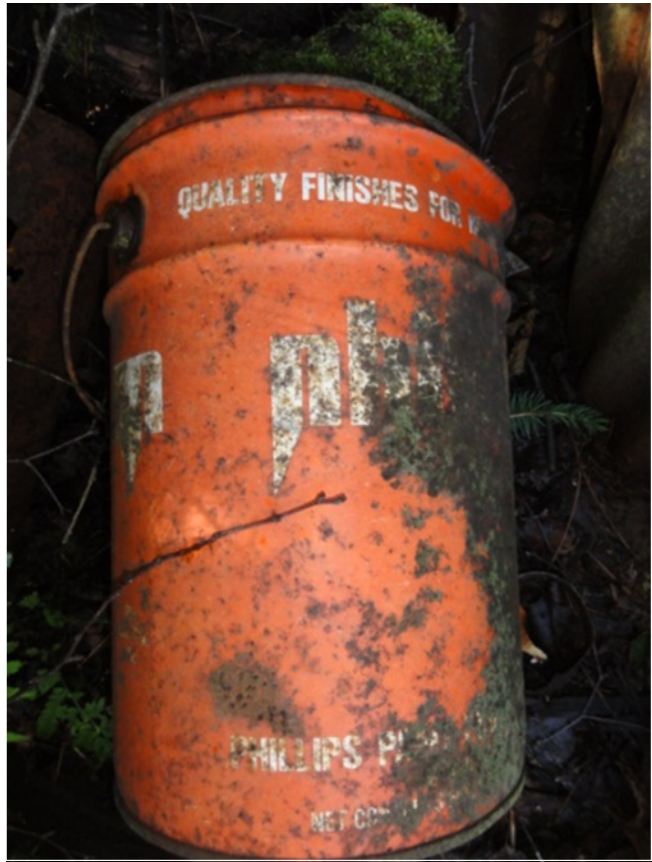
Product Name	Comment	
Phillips brand industrial oils, finishes for machined parts	Phillips merged with Conoco in 2002. The label on this drum only indicates the Phillips brand and may have been produced prior to the ConocoPhillips merge.

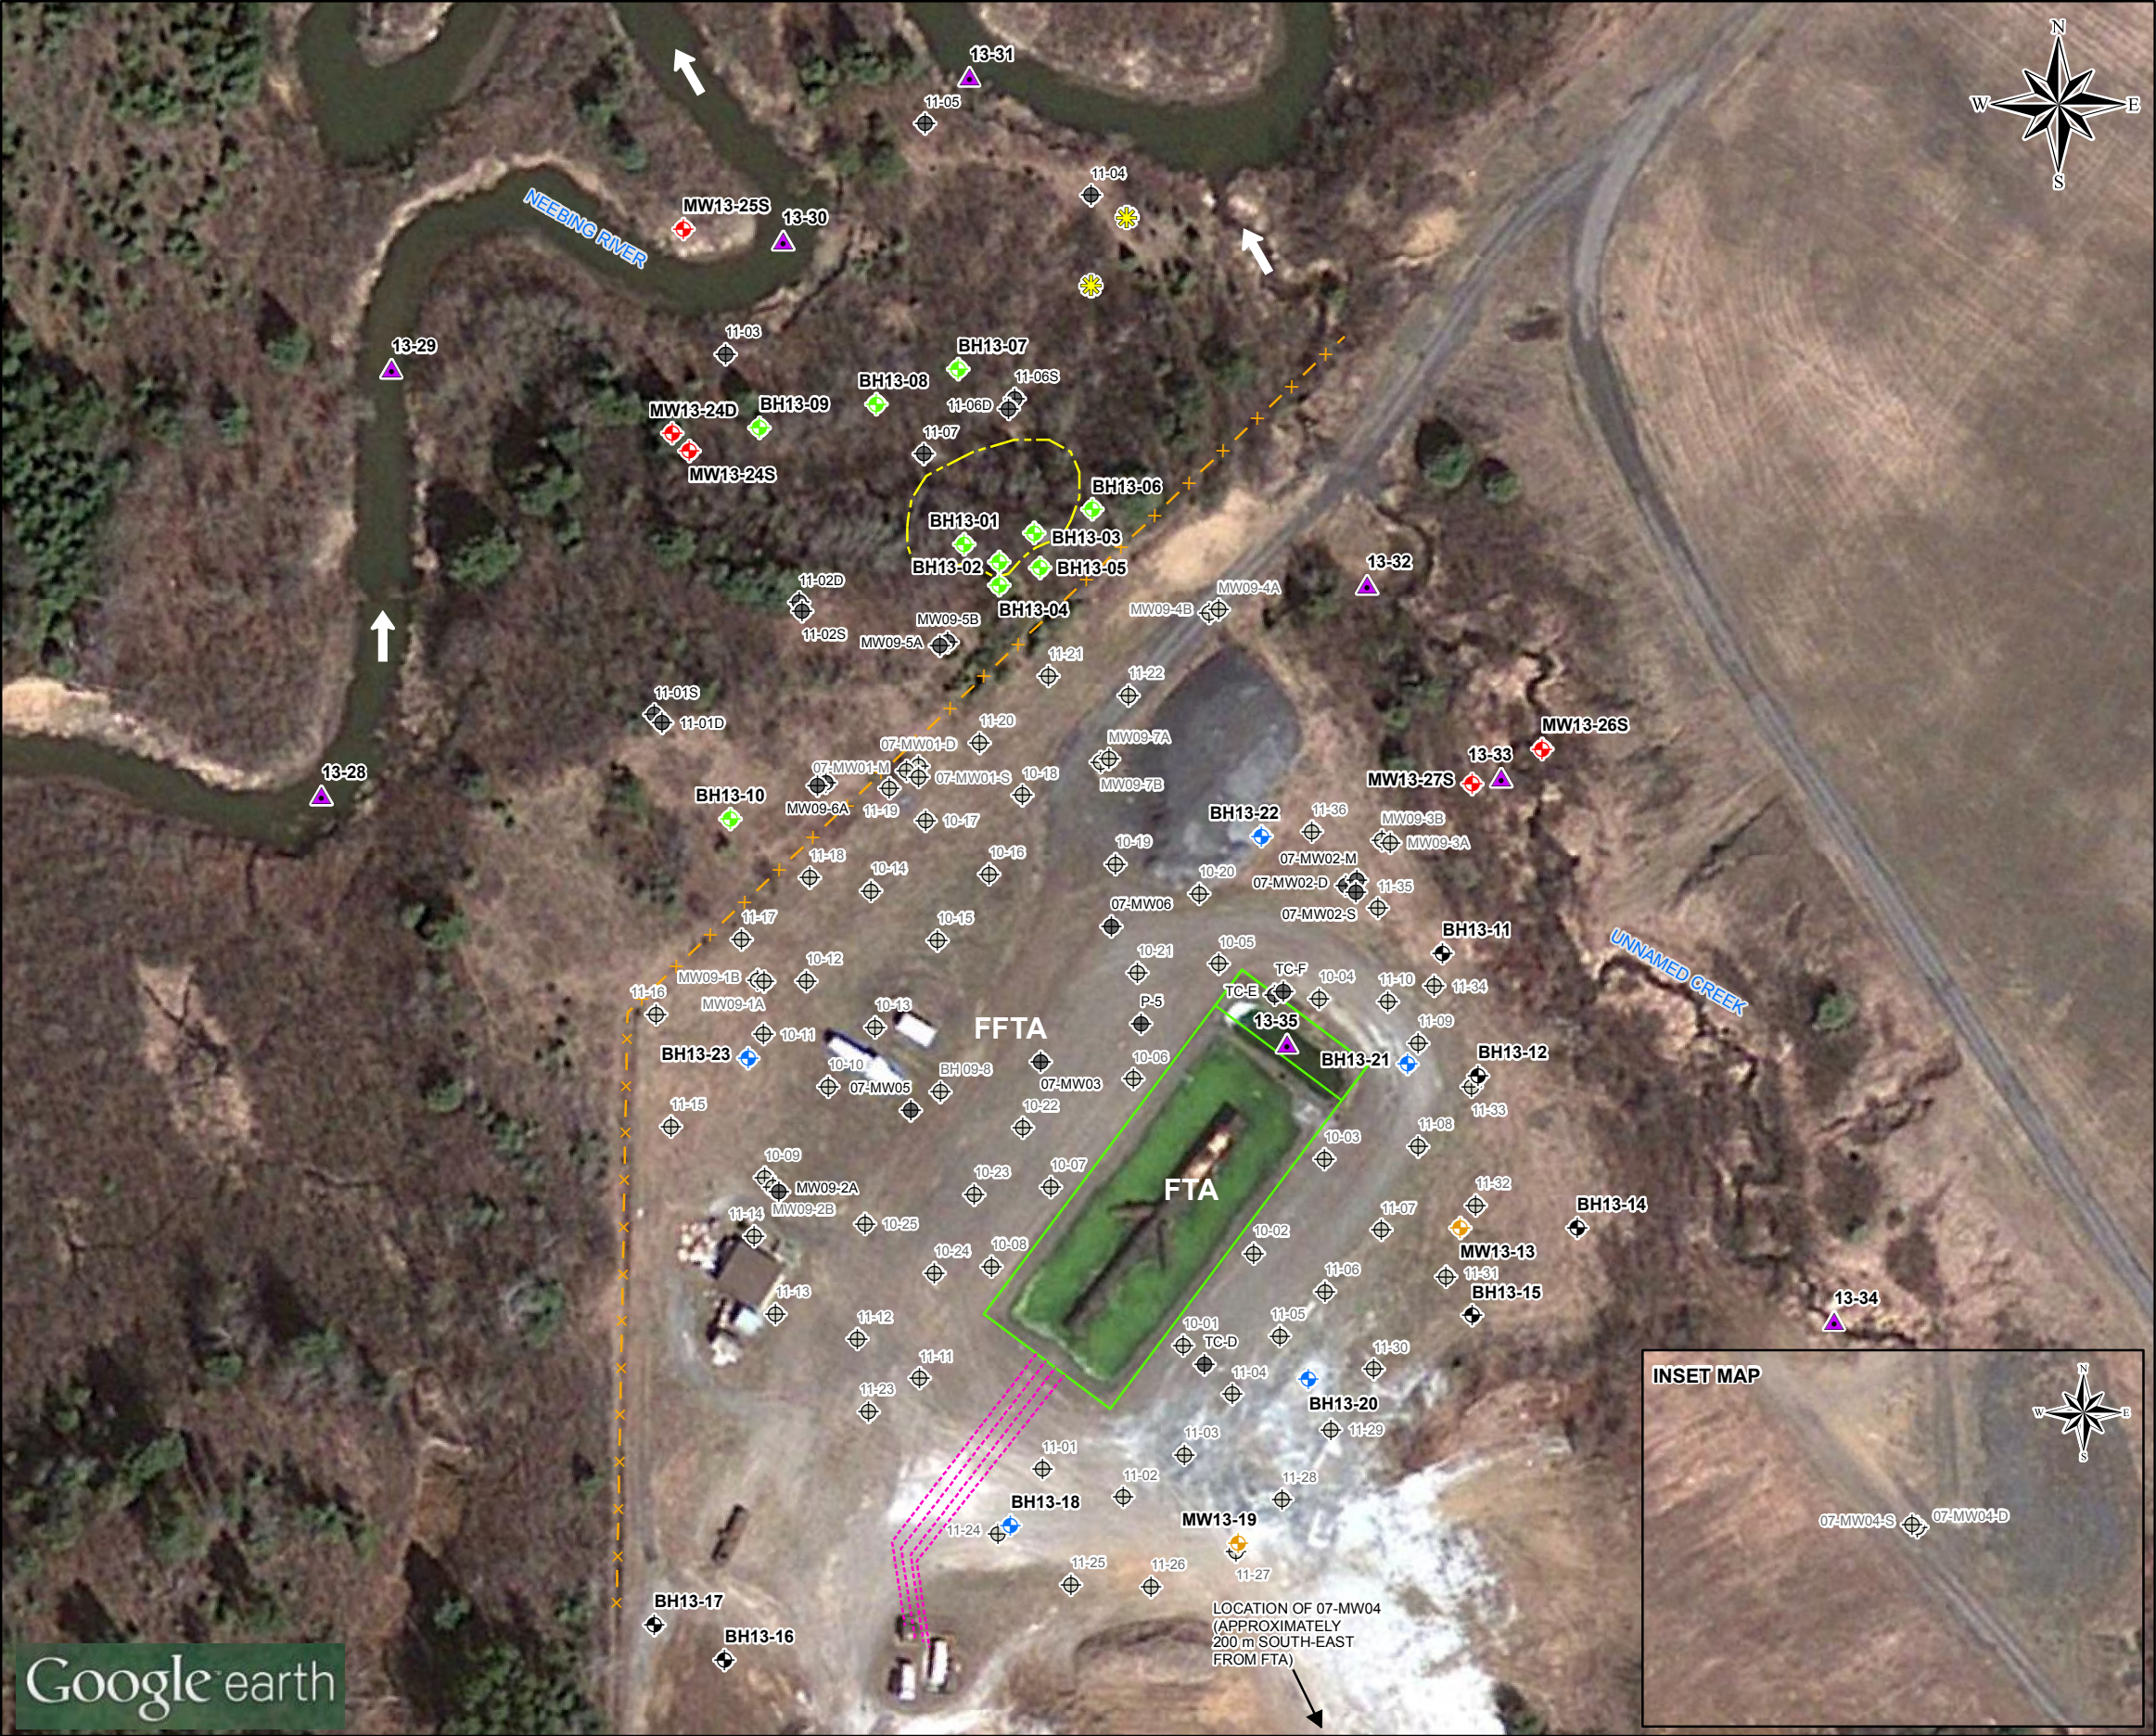
SITE PLAN

During the site visit of August 7<sup>th</sup> and the field work activities carried out between August 19<sup>th</sup> and August 30<sup>th</sup>, debris was observed in the vegetated area located northwest of the fence and the FFTA. The debris visible at ground surface only represented an area of approximately 500 to 800 m<sup>2</sup> in size, located along a northwest facing slope which appeared to vary from 40 to 60 degrees from the horizontal, likely due to the accumulation of more debris in certain areas. The approximate limits of the debris observed at ground surface in August 2013, labeled as the abandoned dump site are shown on Figure 2.

Evidence of waste materials was observed at depth in boreholes 13-01 to 13-03, which were advanced along the slope, within the visible waste footprint (Figure 2). The maximum depth to which waste and fill materials were observed was 3.2 mbgs at borehole BH13-01. The depth of waste and fill materials observed in BH13-02 and 13-03 was 0.91 mbgs and 0.2 mbgs, respectively. Borehole BH13-01 is located along the slope, where a portion of the waste on the slope has appeared to slump down or was pushed downslope, forming a relatively flat area, along the slope, and this may account for the thicker accumulation of waste and fill or re-worked materials. The trees growing in this area, downslope of borehole BH13-01, appear to be growing around the debris which has slumped down the slope. The fill material recovered from boreholes BH13-01 to BH13-03 within the waste footprint consisted of silty sand intermixed with roots, wood, ash and a granular blue/green/white synthetic material. The nature and depth of soil materials observed in the shallow test-pits advanced next to boreholes BH13-01 to BH13-03 were similar to the observations reported for these boreholes. In addition, fragments of metal, glass and plastics were noted in the shallow test pits. Based on the results of the waste characterization analysis on soil samples recovered from boreholes and test pits advanced within the waste footprint, the soil fill within the abandoned dump site is considered non-hazardous under Ontario Regulation 347 Waste Management. Environmental Protection Act, R.R.O. 1990 (Table 1).

No evidence of buried waste was observed during the advancement of boreholes 13-04 to 13-06, which are located at the top of the slope, outside of the southeast margin of the waste footprint visible at ground surface.

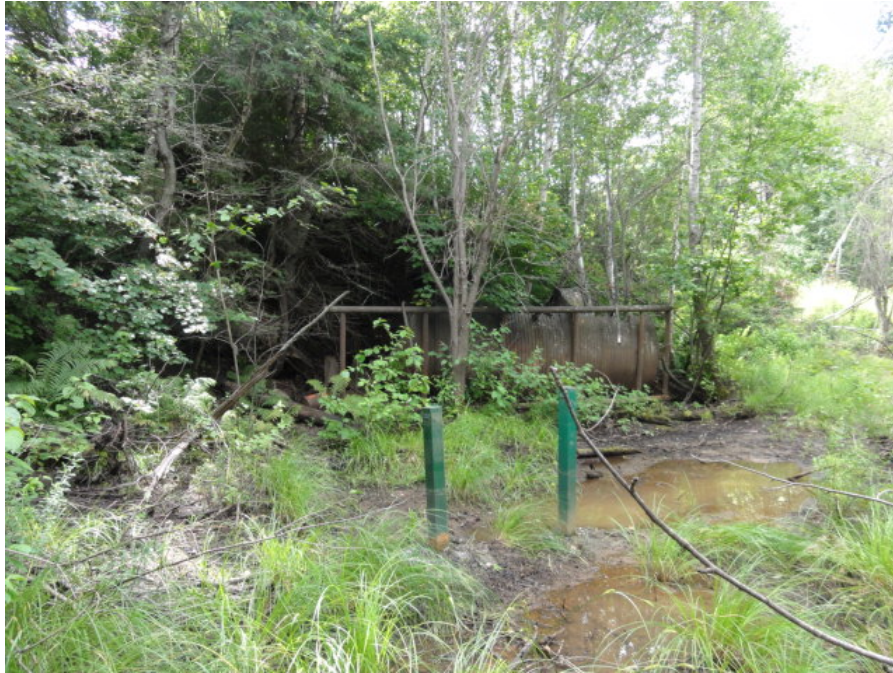
This debris is visible along the slope and at the base of the slope, near monitoring wells MW11-07 and MW11-06S/D. Limited amounts of debris and waste are present at the top of the slope. The largest pieces of debris consisting of parts of metal appliances and a portion of a culvert are located at the base of the slope. Additional photographs are provided in Attachment A.

Photograph 1: View of culvert at the base of the slope and the abandoned dump site with monitoring wells MW11-06S/D in the foreground.

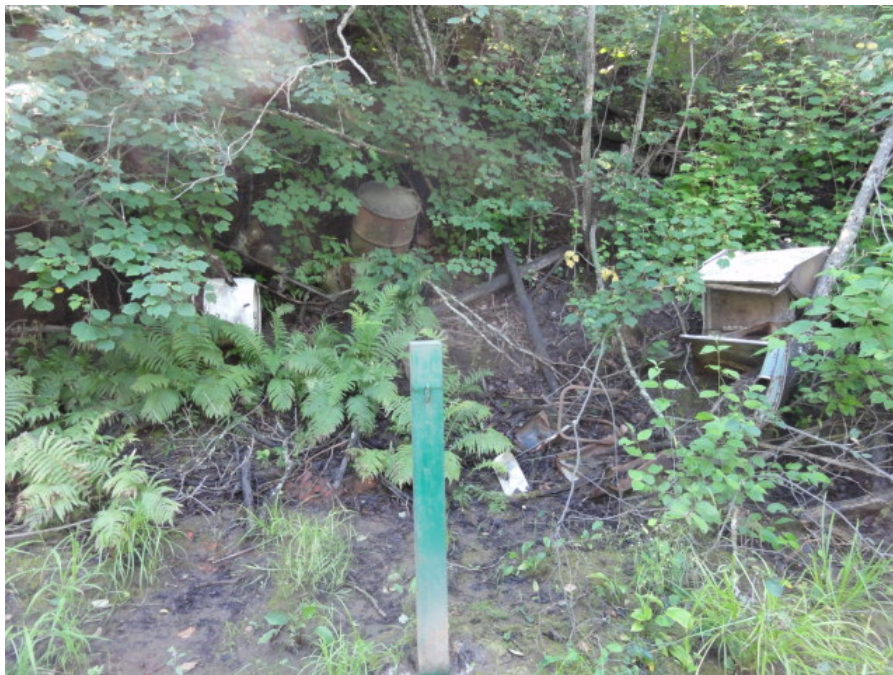
Photograph 2: Metal drum and parts of a washer and dryer at the base of the slope and the abandoned dump site, with monitoring well MW11-07 visible in the foreground.

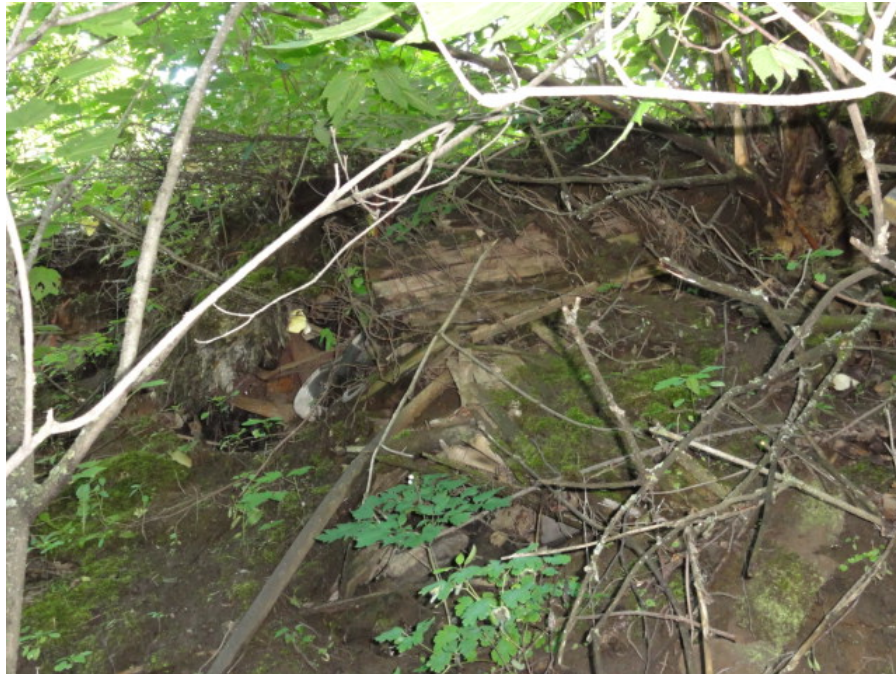
Photograph 3: Metal and wood fencing located along the slope, within the abandoned dump site.

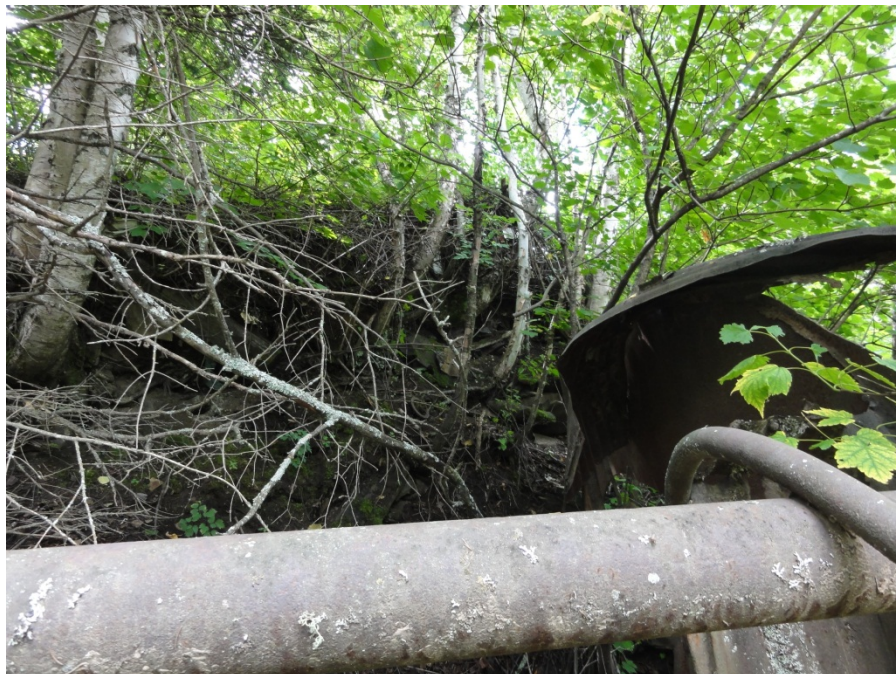
Photograph 4: Portion of the metal culvert visible with trees growing around the waste located along the slope.

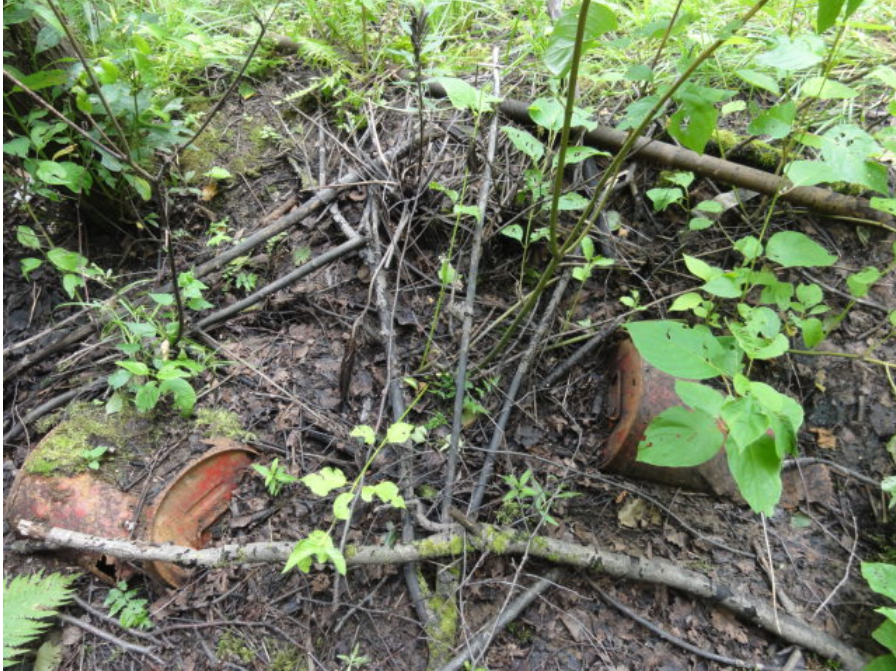
Individual, empty orange steel drums labelled "liquid foam concentrate" (pictured below) which were observed at the dump site were also found partially buried and sporadically placed between MW11-06D/S and MW11-04.

Photograph 5: Orange drums previously containing fire extinguishing agents (liquid foam concentrate) which were observed in the main abandoned dump site. Up to 5 of these drums were also observed sporadically along an overgrown path between monitoring wells MW11-06D/S and MW11-04.

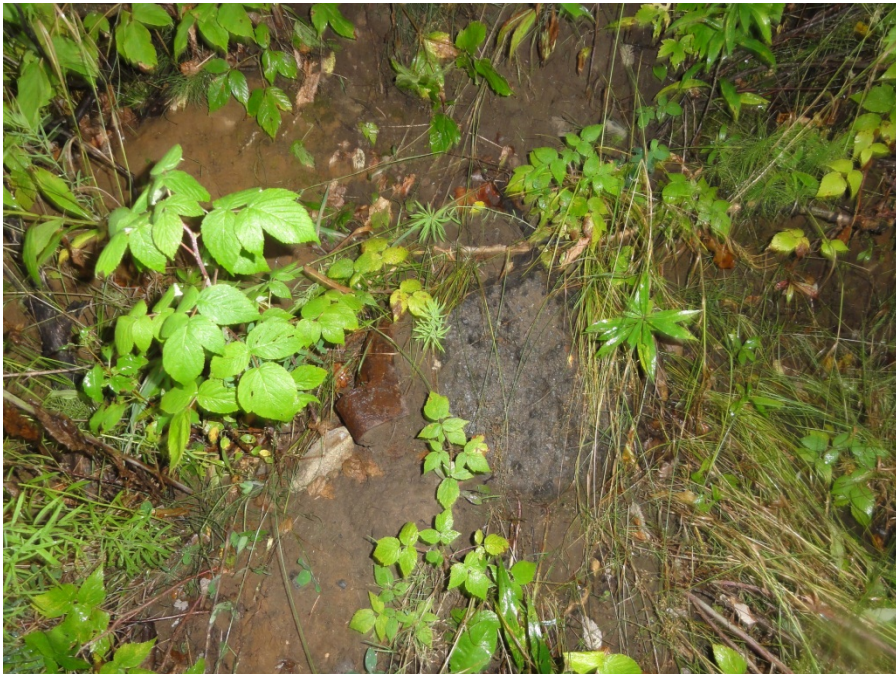
On August 29, 2013, broken asphalt overgrown with vegetation was observed in the area northwest of MW11-02, within 10 metres of this monitoring well.

Photograph 6: Partially buried fragments of asphalt overgrown with vegetation observed in the area northwest of MW11-02, within 10 metres from this monitoring well.
