# Bedrock Condition Assessment Thompson Bay Dam Peterborough, Ontario

Cambium Reference No.: 3420-001

August 27, 2014

Prepared for: Public Works and Government Services  
Canada

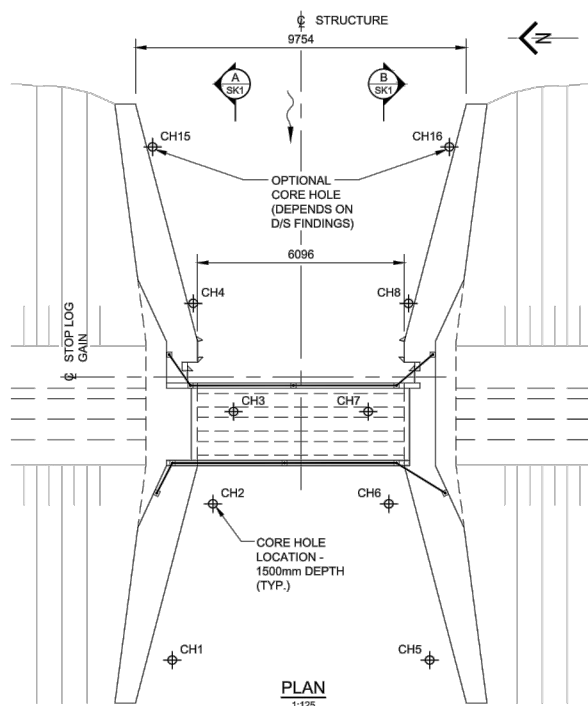
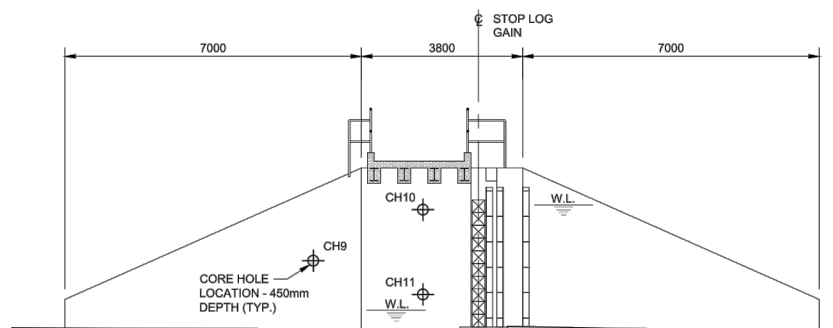
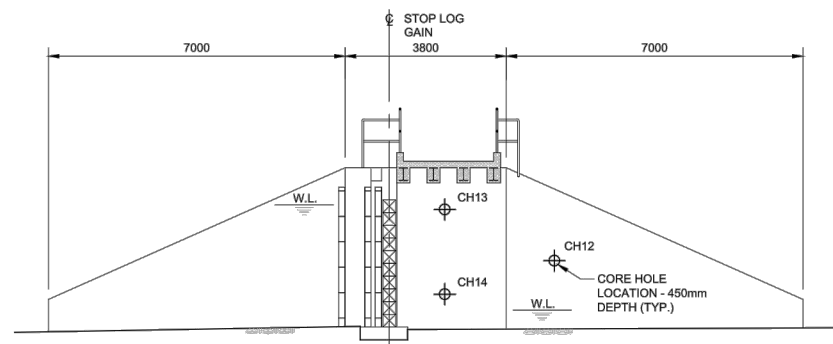
Core Hole Locations Plan

Horizontal cores into the concrete structure on the downstream side of the dam and vertical cores through the structure and into the underlying bedrock on both the upstream and downstream side of the dam were completed as part of the investigation. Upon completion of the bedrock coring, the modified Lugeon test (Packer test) was completed at each hole to determine the permeability of the bedrock. A turbidity curtain was maintained downstream of the dam to minimize siltation and turbidity to the downstream water course during the coring. Turbidity measurements (total suspended solids (TSS)) were taken twice a day throughout the investigation to ensure that TSS levels did not exceed the project specifications or applicable Provincial guidelines. The core locations are shown in Figure 1 of this report.

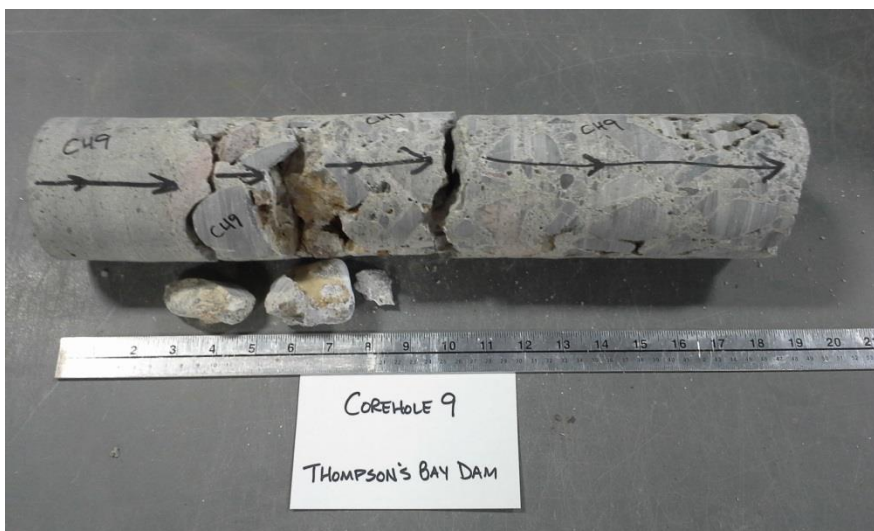
### CH9

CH9: 457 mm long, 89 mm diameter, angular to subangular aggregate, maximum aggregate size 76 mm, approx. 100 mm new concrete facing at surface, significant voids and breaks at 100 mm to 250 mm depth.

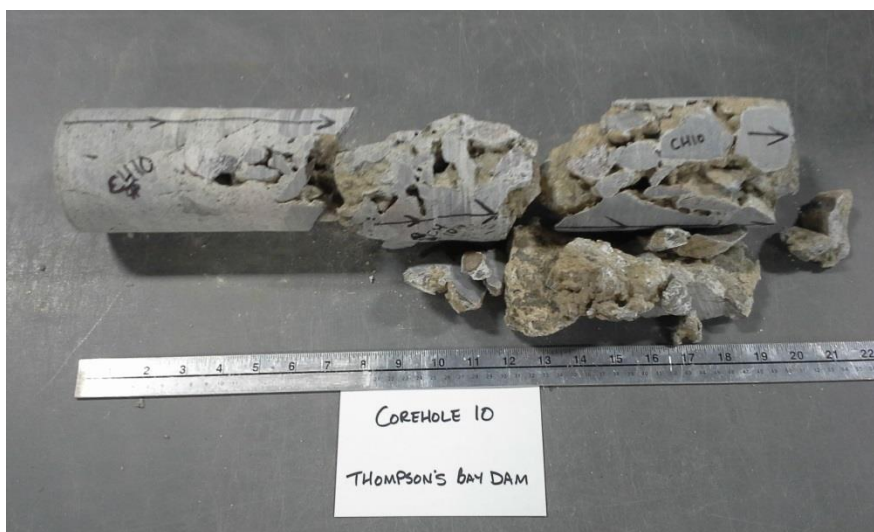
### CH10

CH10: 457 mm long, 89 mm diameter, angular to subangular aggregate, maximum aggregate size 89 mm, approx. 100 mm new concrete facing at surface, significant voids and breaks at 150 mm to 457 mm depth.

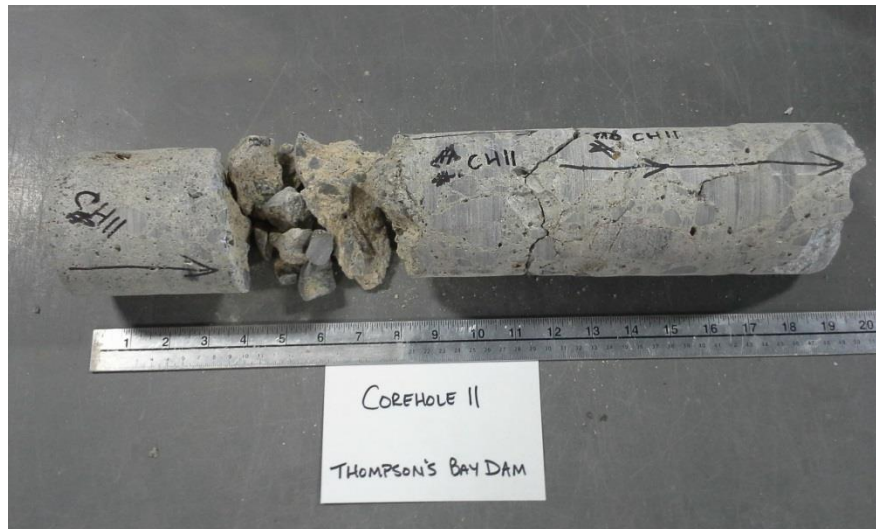
### CH11

CH11: 457 mm long, 89 mm diameter, angular to subangular aggregate, maximum aggregate size 89 mm, approx. 100 mm new concrete facing at surface, significant voids and breaks at 180 mm to 250 mm depth, large crack at 300 mm, minor voids at 355 mm.

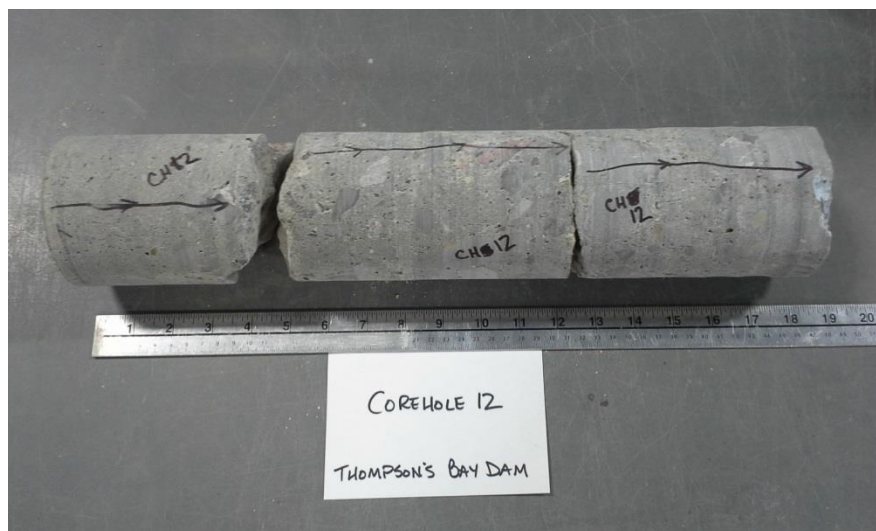
### CH12

CH12: 470 mm long, 89 mm diameter, angular to subangular aggregate, maximum aggregate size 89 mm, approx. 100 mm new concrete facing at surface, no significant voids, breaks at 127 mm and 305 mm depth.

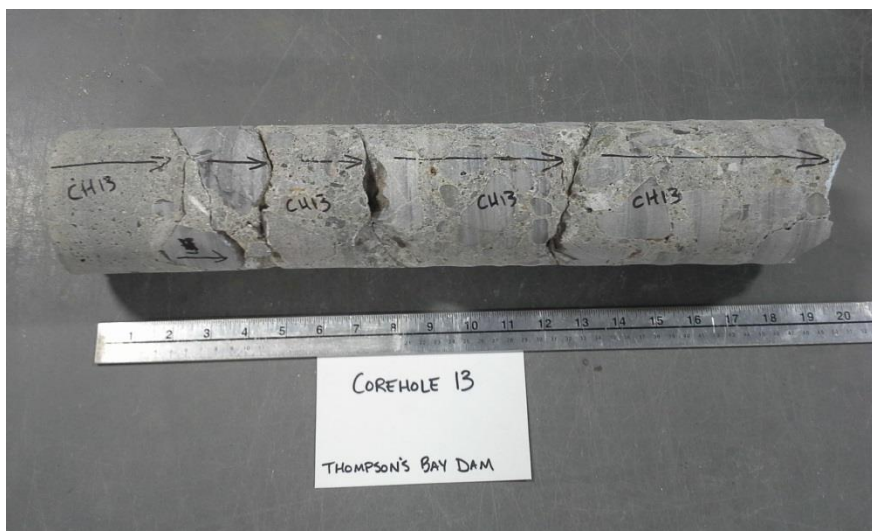
### CH13

CH13: 490 mm long, 89 mm diameter, angular to subangular aggregate, maximum aggregate size 64 mm, approx. 100 mm new concrete facing at surface, significant breaks at 100 mm, 220 mm & 310 mm depth.

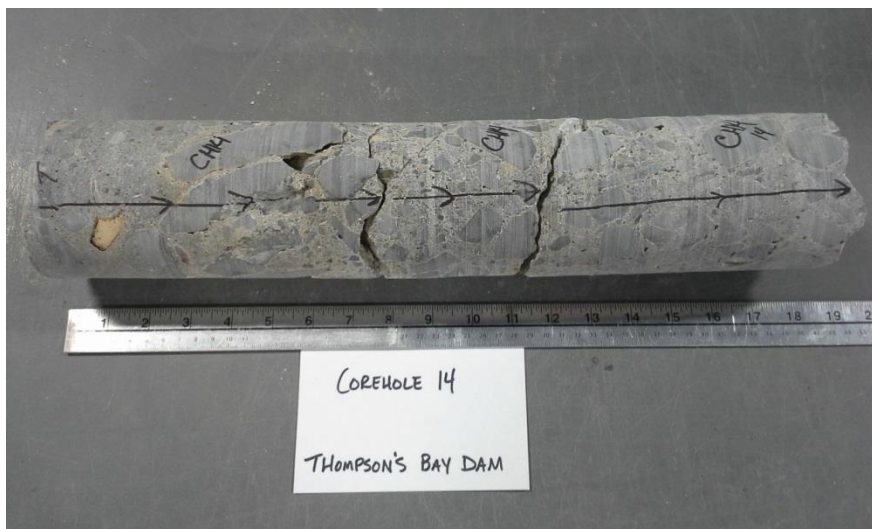
### CH14

CH14: 460 mm long, 89 mm diameter, angular to subangular aggregate, maximum aggregate size 76 mm, approx. 100 mm new concrete facing at surface, significant breaks at 190 mm and 280 mm depth, minor voids at 160 mm depth.

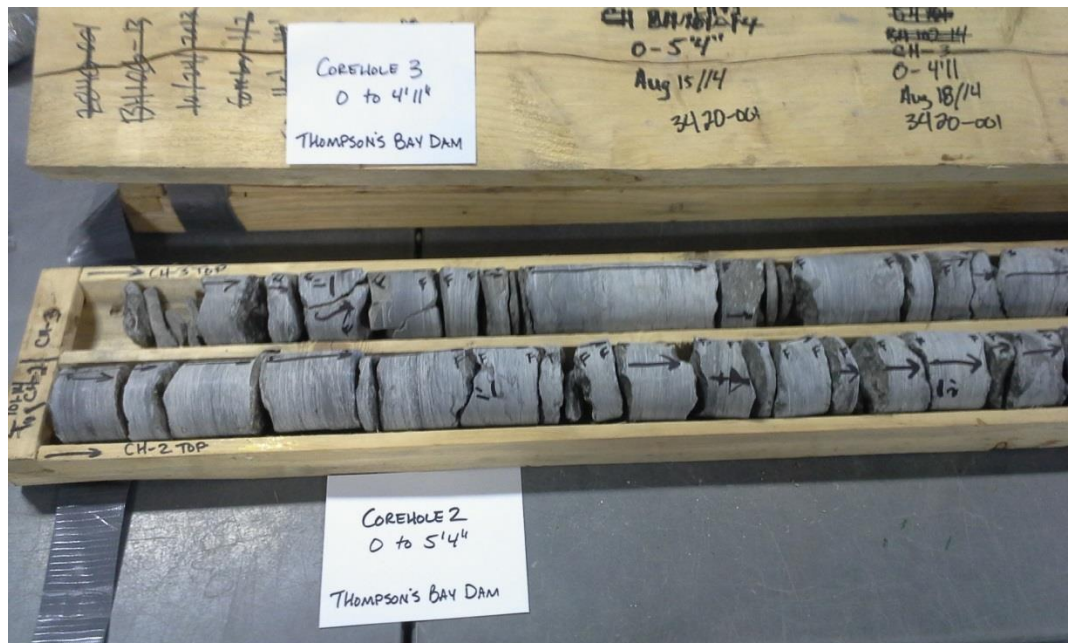
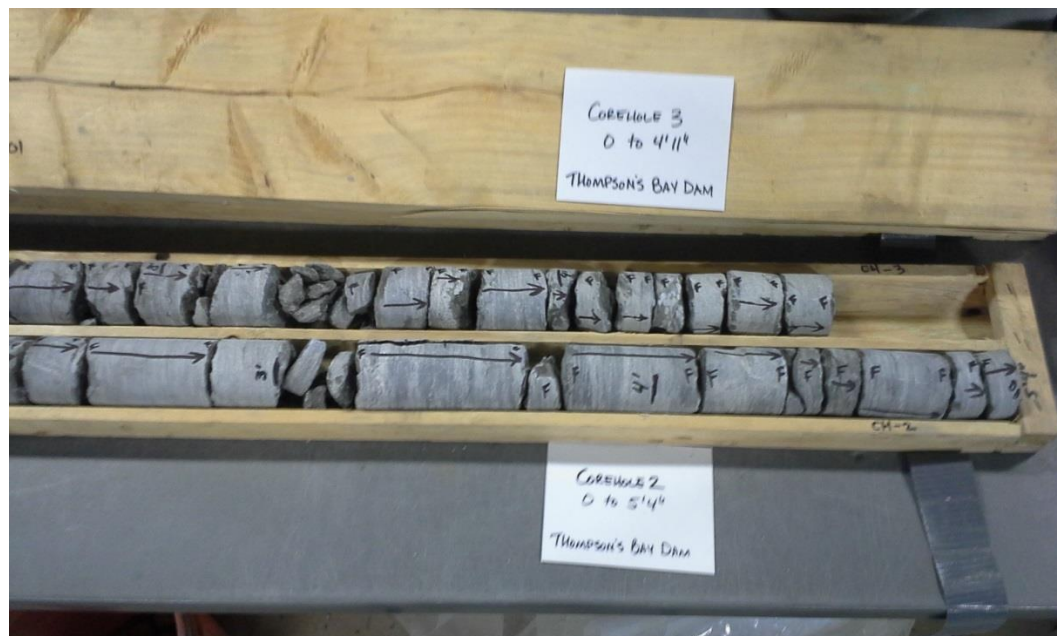
Photo 1: Bedrock core CH2 (below) and CH3 (above)

Photo 2: Bedrock core CH2 (below) and CH3 (above)

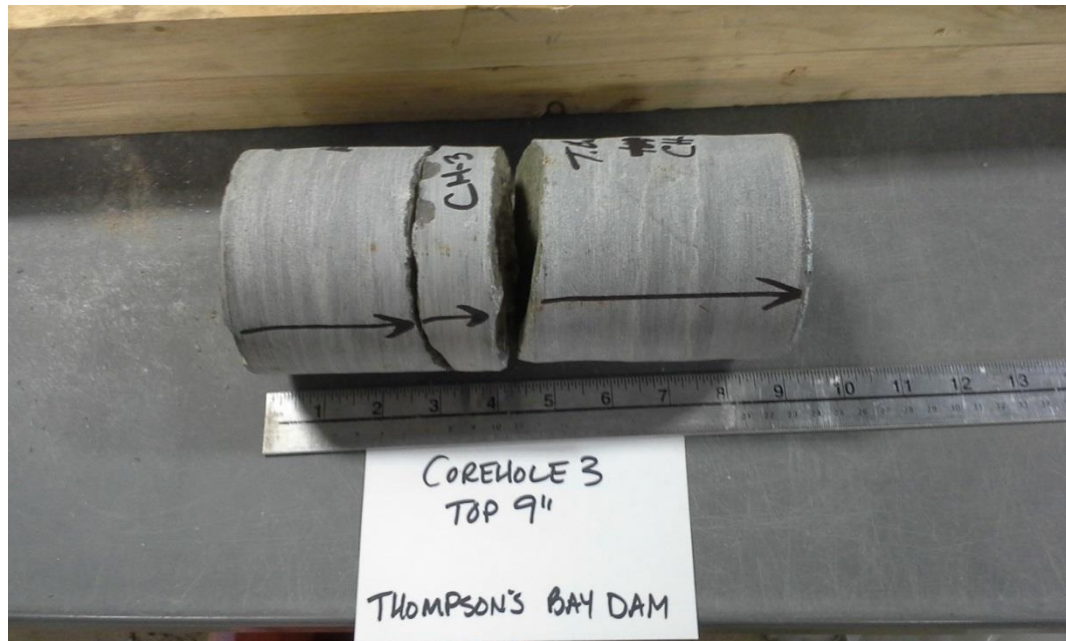
Photo 3: Bedrock core CH3 (top 228 mm)

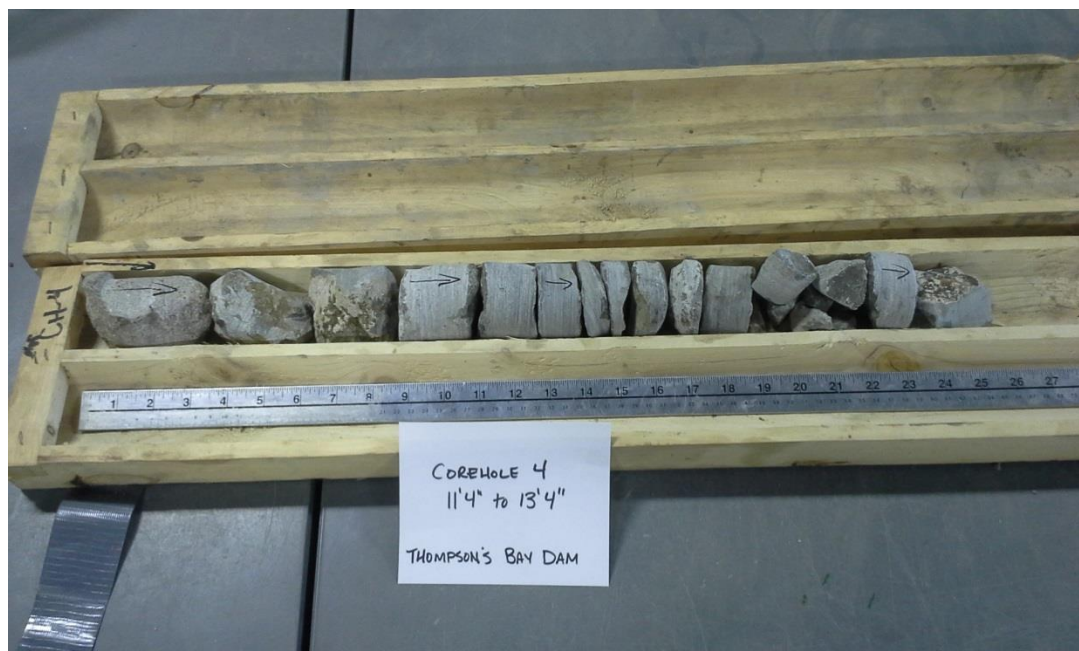
Photo 4: Bedrock core CH4

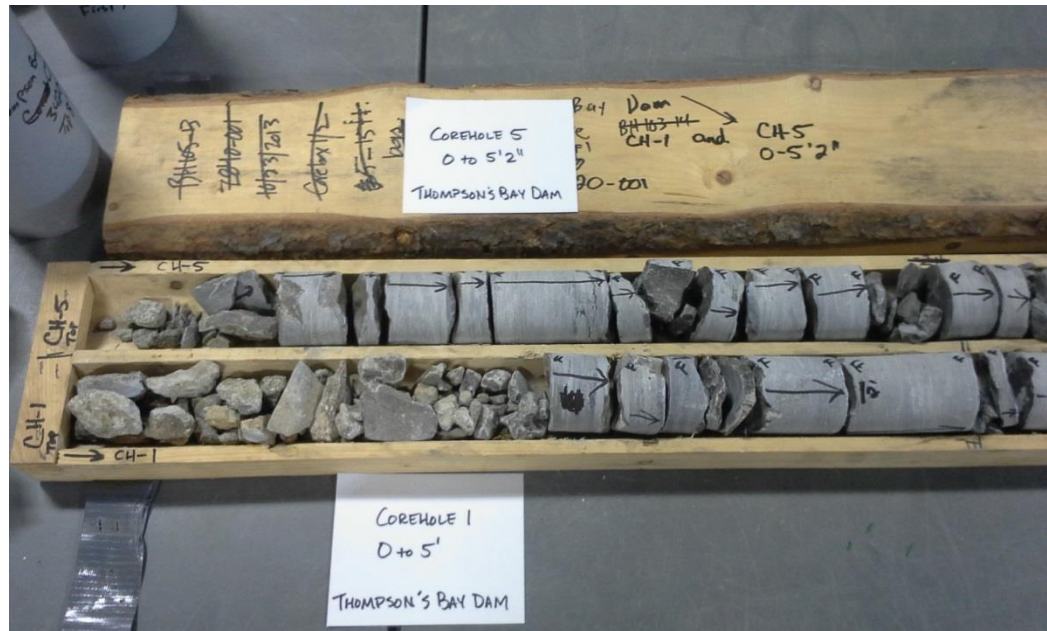
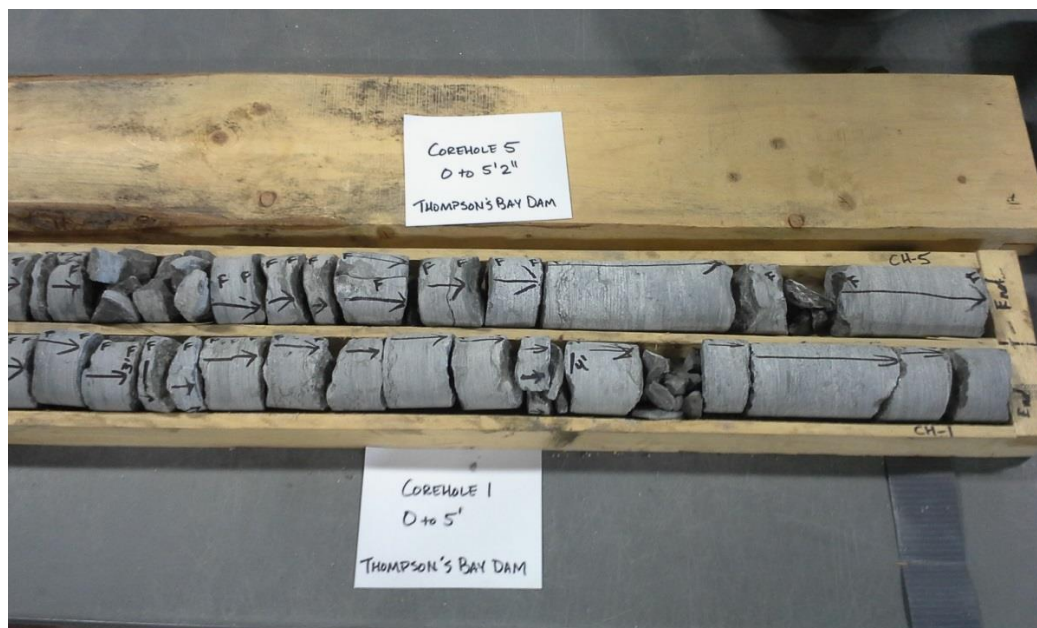
Photo 5: Bedrock core CH1 (below) and CH5 (above)

Photo 6: Bedrock core CH1 (below) and CH5 (above)

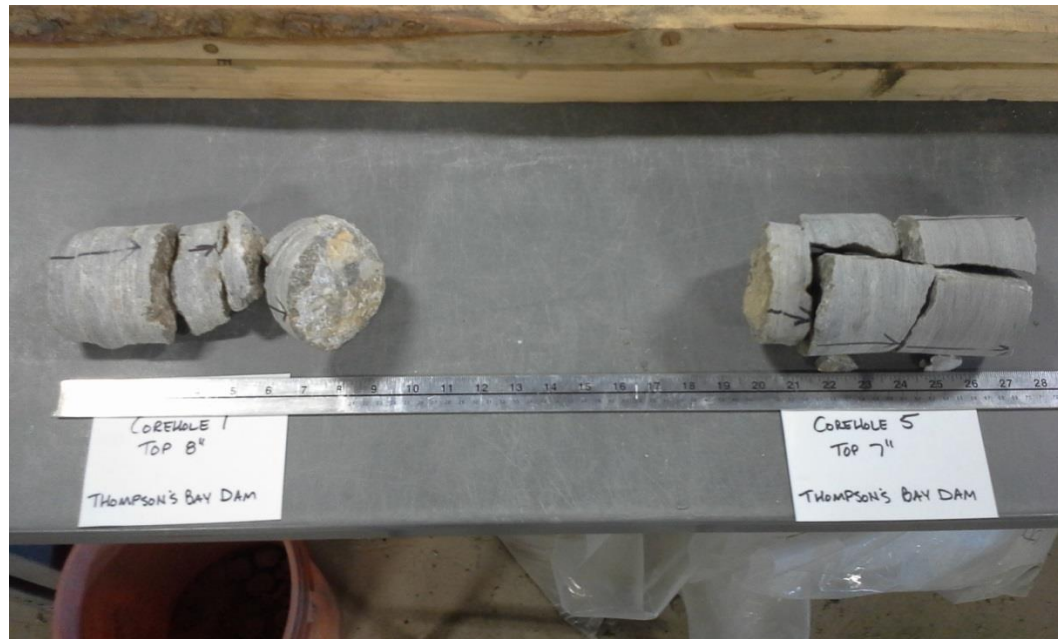
Photo 7: Bedrock core CH1 (top 203 mm) and CH5 (top 178 mm)

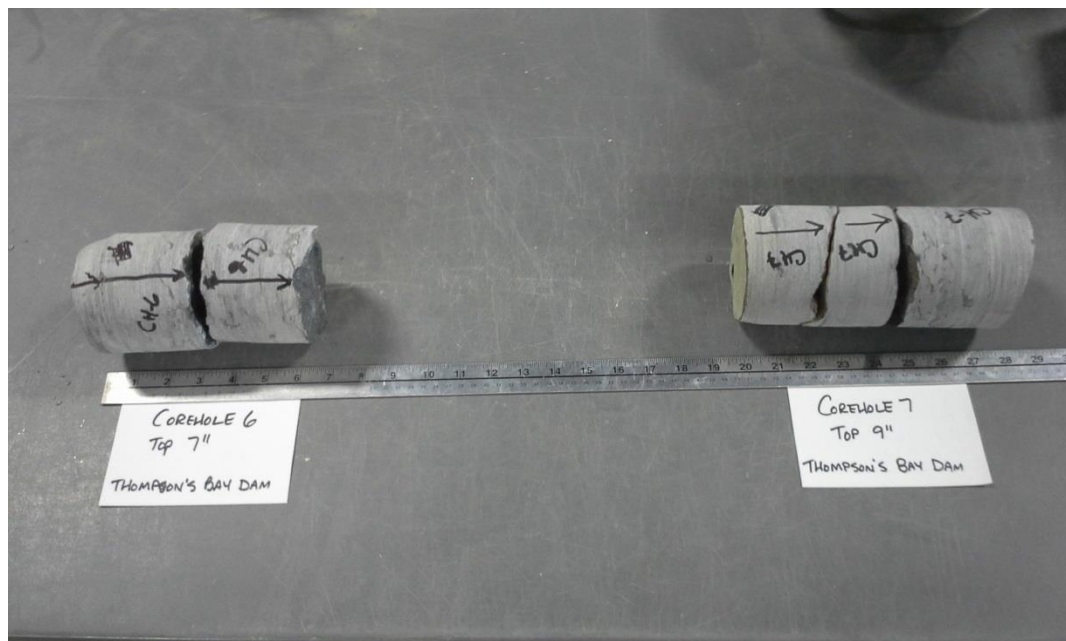
Photo 8: Bedrock core CH6 (top 178 mm) and CH7 (top 228 mm)

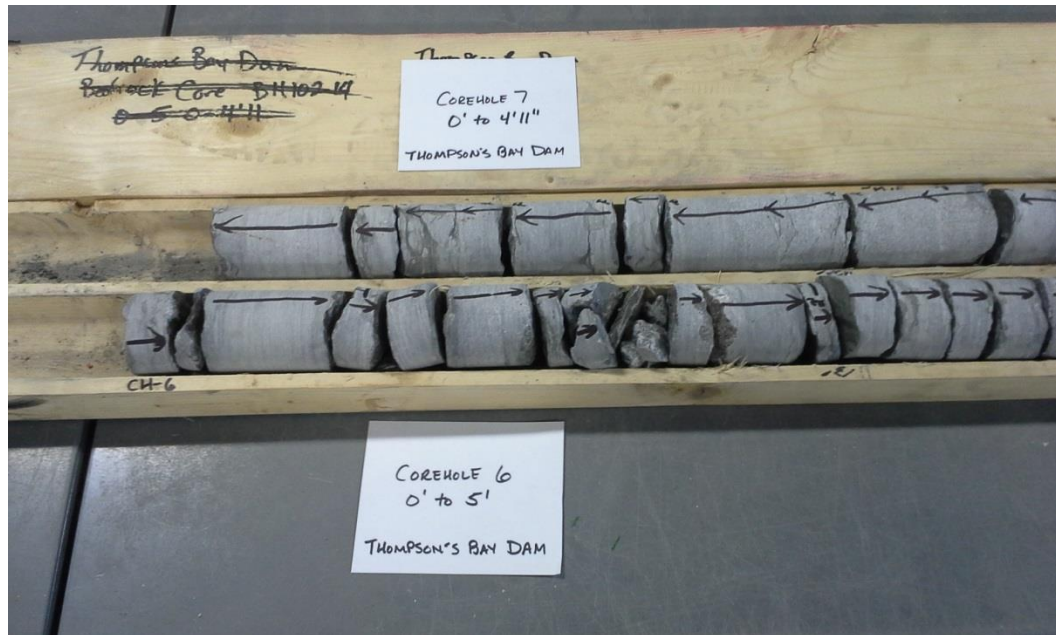
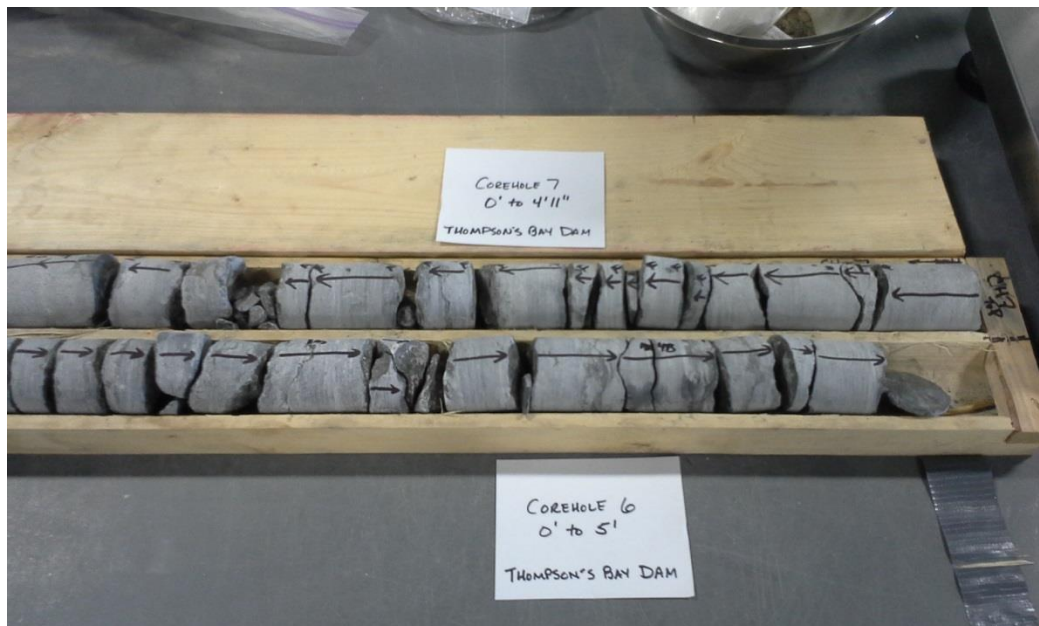
Photo 9: Bedrock core CH6 (below) and CH7 (above)

Photo 10: Bedrock core CH6 (below) and CH7 (above)
