SECTION 9.0 EXECUTIVE SUMMARY

9.0 SITE EXTERIOR

| | Public Works and Government Services Canada Travaux publics et Services gouvernementaux Canada | DWN BY: H. Ryan | PROJECT DEMOLITION HAZARDOUS BUILDING MATERIALS ASSESSMENT AND INVENTORY, BACALHAO ISLAND LIGHTSTATION BACALHAO ISLAND, NL | DATE February 2014 |

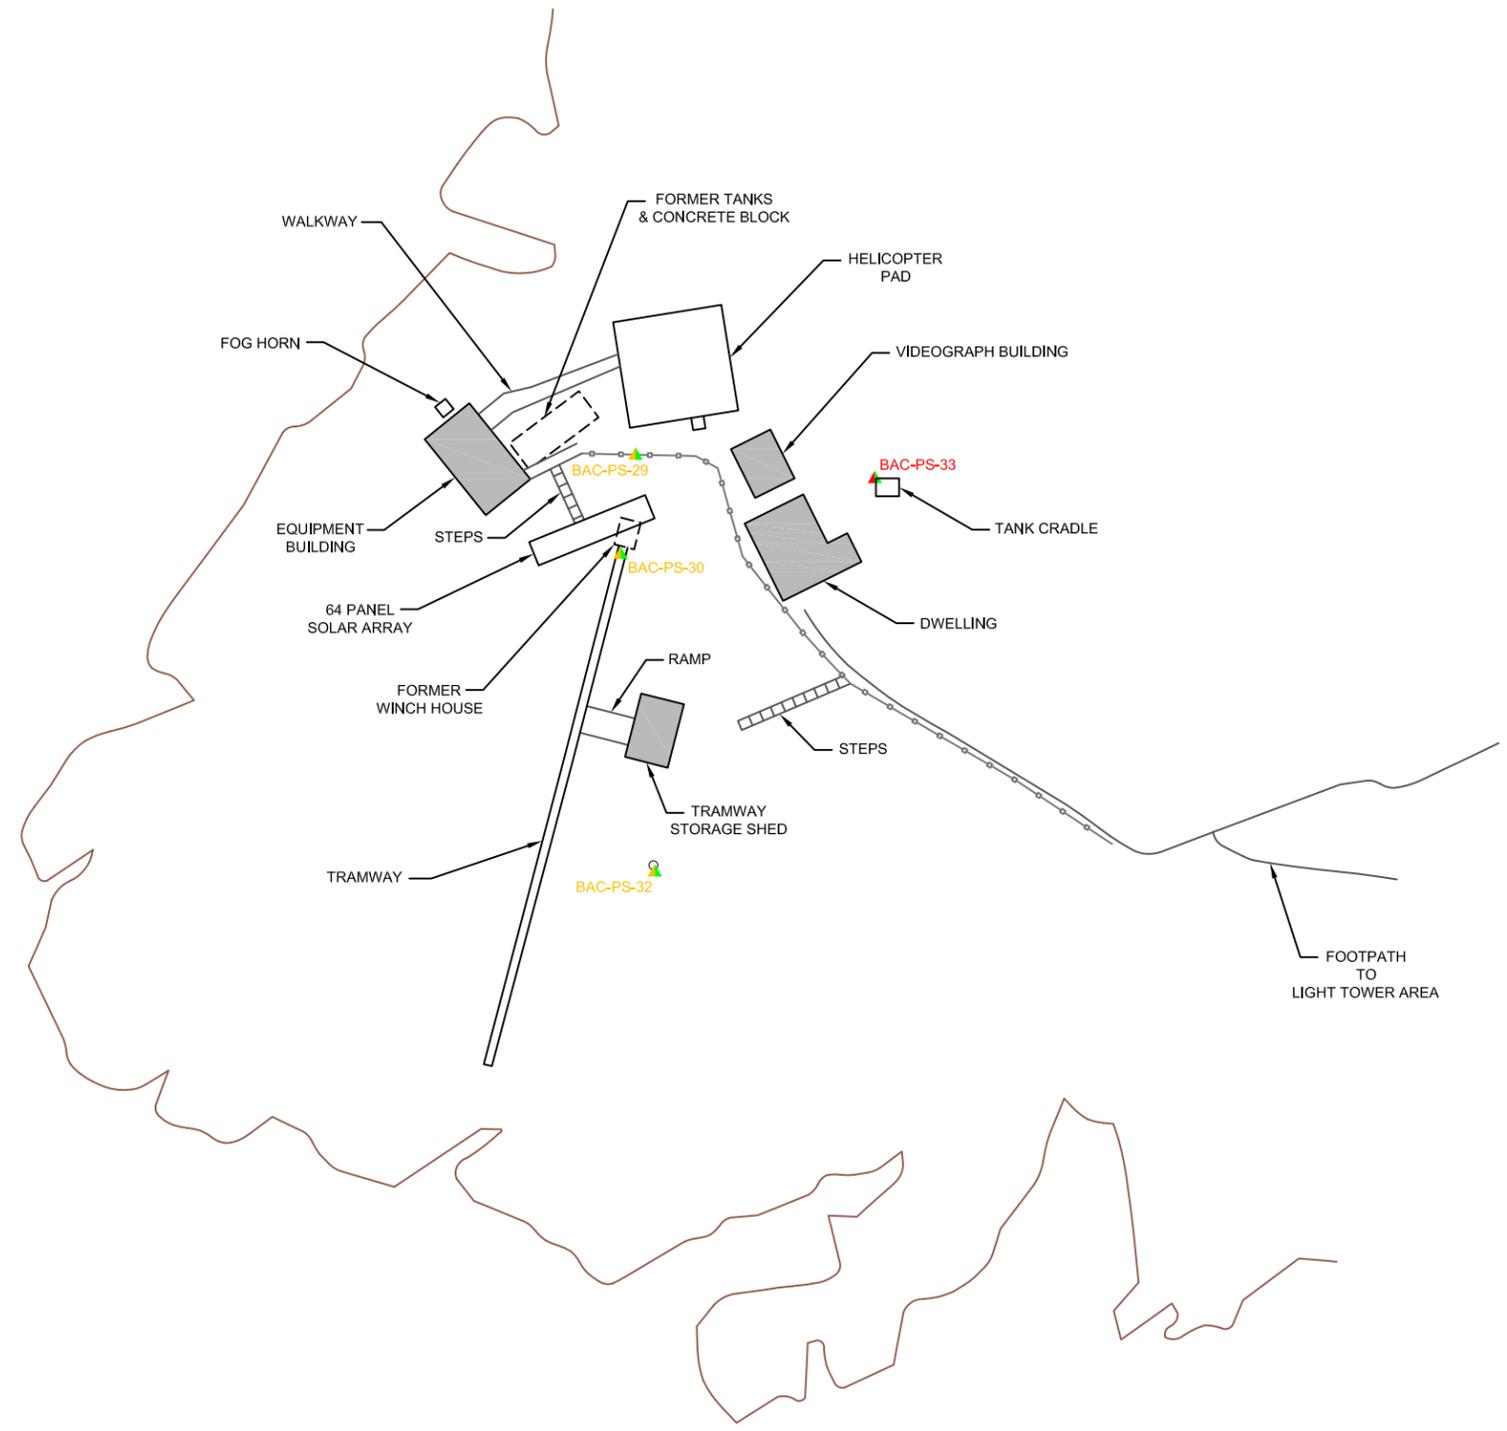
| | | | | FIGURE No. 9.1 |

A total of four (4) paint samples (BAC-PS-29, BAC-PS-30, BAC-PS-32 and BAC-PS-33), including substrates, were collected from the Site exterior structures and analyzed for lead and mercury content (refer to Photos 23 to 26, Appendix B9). One (1) paint sample (BAC-PS-30) was also analyzed for PCB content (refer to Photo 24, Appendix B9). Sample descriptions and analytical results are summarized in Tables C9-1 to C9-3, Appendix C9. Sample locations and analytical results are graphically illustrated in Figure 9.1, Appendix A9.

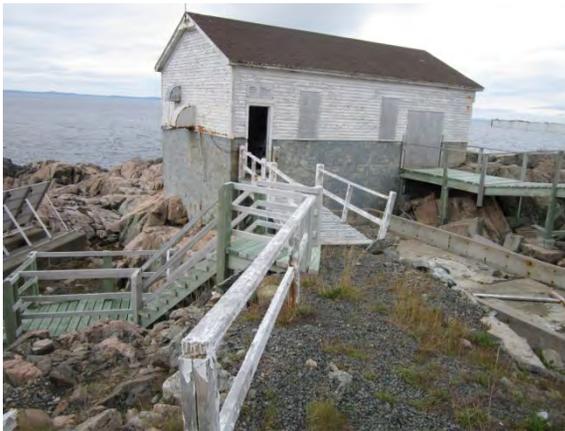
The condition of the paint visible on the Site exterior structures was generally in poor condition. Peeling and flaking paint was observed on the stairs, ramps, tramway, tank cradle, fence and posts (refer to Photos 4 to 7, 17 to 20 and 23 to 26, Appendix B9).

Photo 4: View of walkways, stairs, tank pad and ramp to equipment building.

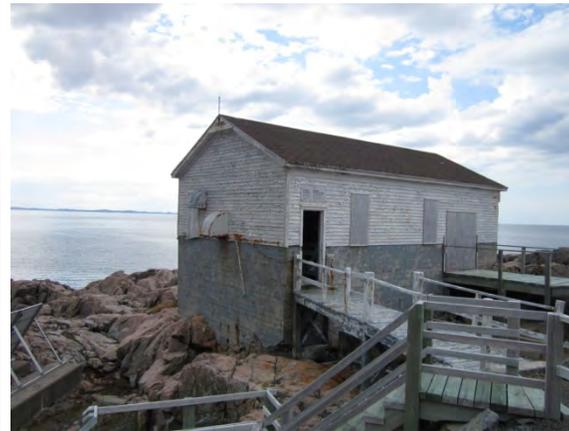
Photo 5: View of ramp and walkway to equipment building.

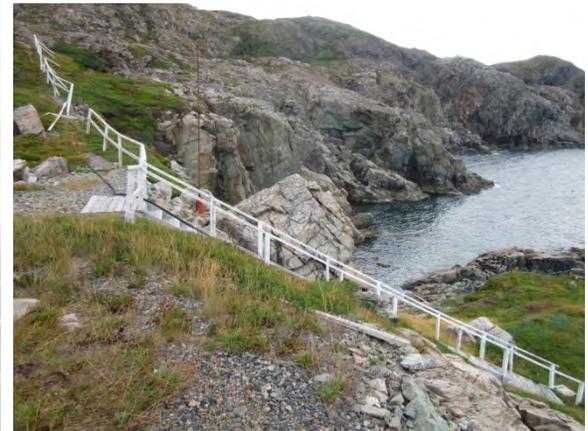
Photo 6: View of stairs to tramway storage shed.

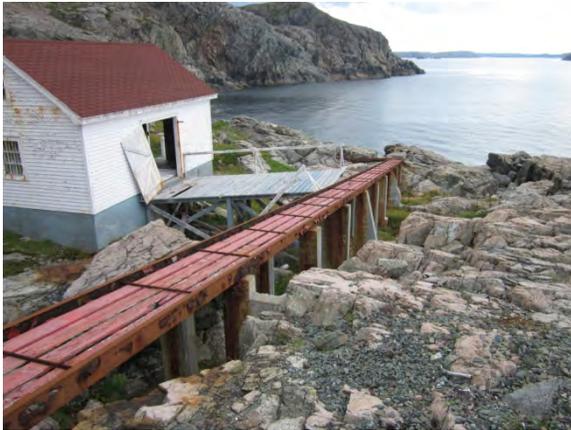
Photo 7: View of tramway and ramp to tramway from storage shed.

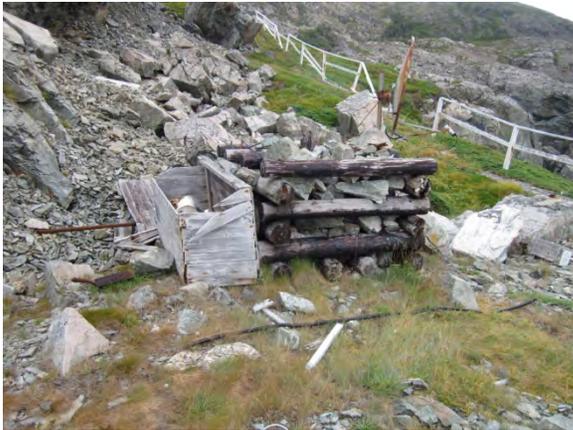
Creosote appears to have been used as a wood preservative on the timber used to construct the cribwork foundation for a former utility pole located on the south side of the dwelling on the main site area.

Photo 13: View of crate, cribwork foundation, satellite dish and fence.

- Creosote wood preservative is expected to be present in the timber used to construct the cribwork foundation of a former utility pole located south of the dwelling on the main site area. These materials (creosote timber cribwork), if removed from the Site, must be disposed of at a hazardous waste treatment facility.

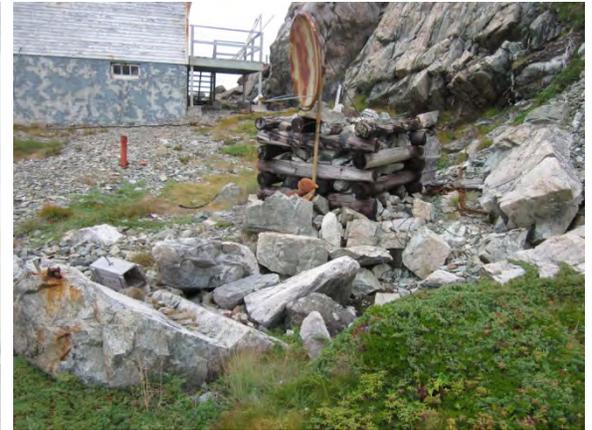
Photo 15: View of septic vent, cribwork foundation and satellite dish.

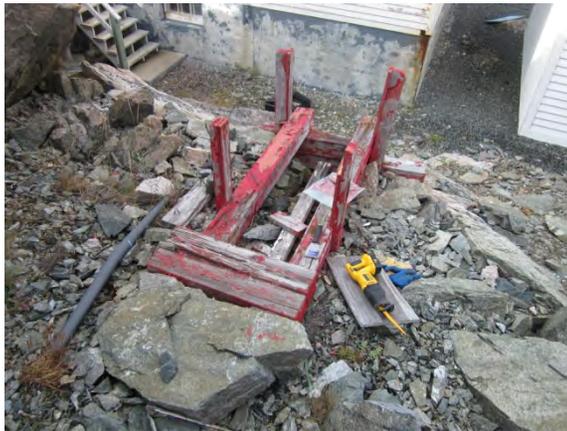
Photo 17: View of tank cradle.

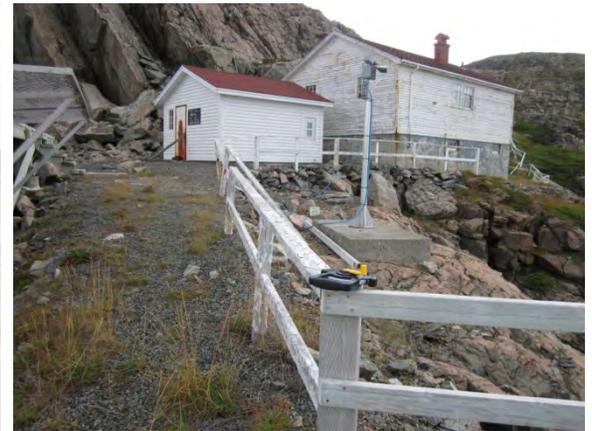
Photo 18: View of fence and videograph equipment pole.

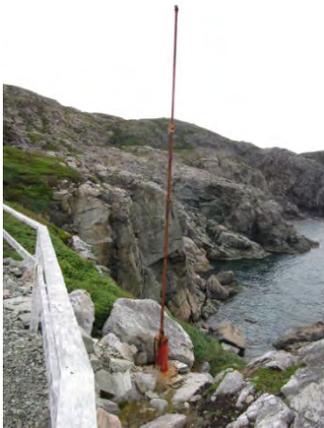
Photo 19: View of antenna.

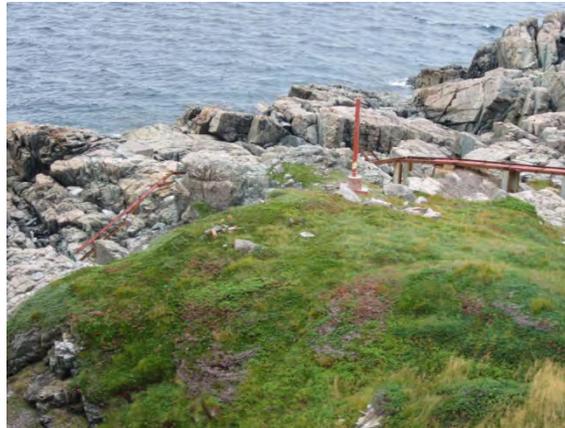
Photo 20: View of post near end of tramway.

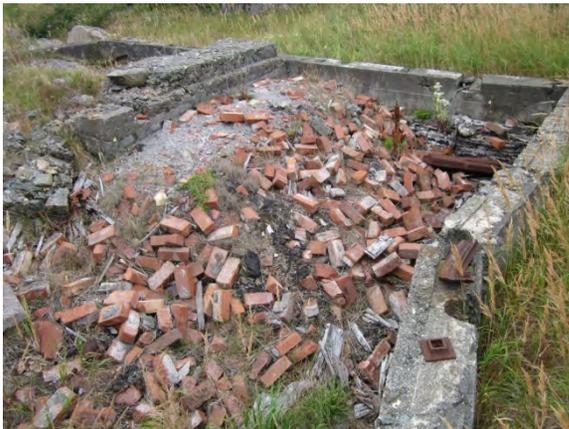
- Potential ACMs were observed and these materials included, but are not limited to, remnants of mortar on brick debris in the area of the former dwelling foundation ruins and in other smaller areas of brick debris throughout the Site, and electrical components and insulators such as wiring, gaskets and cables associated with the solar arrays, fog horn and videograph equipment at the Site.

Photo 22: View of brick debris in former dwelling foundation ruins.

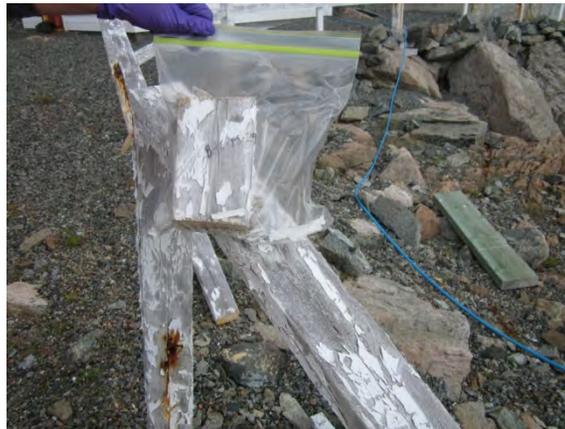
The concentration of leachable lead in paint and wood substrate sample BAC-PS-29 (6.2 mg/L) was above the Schedule II leachate criterion for lead (5.00 mg/L) provided in the provincial guidance document for leachable toxic waste (GD-PPD-26.1) (refer to Table C9-4, Appendix C9). Paint (white paint) and wood substrate sample BAC-PS-29 was collected from the fence between the dwelling and equipment building. The paint on the fence (approximately 100 m long) was generally in poor condition and flaking. Since the concentration of leachable lead in the paint and wood substrate sample is at a level considered to be hazardous, these materials (painted wooden fence), if removed from the Site, must be disposed of at a hazardous waste treatment facility.

Photo 23: View of paint sample BAC-PS-29.

| Sample ID | Colour Description | Substrate | Sample Location (Room No.) | RDL (mg/kg) | Total Lead (mg/kg) |
|---|---|---|---|---|---|
| BAC-PS-29 | White | Wood | Fence between Dwelling and Equipment Building | 5.0 | 1,100 |

| Sample ID | Colour Description | Substrate | Sample Location (Room No.) | RDL (mg/kg) | Total Mercury (mg/kg) |
|---|---|---|---|---|---|
| BAC-PS-29 | White | Wood | Fence between Dwelling and Equipment Building | 1.0 | 7.1 |

- The white paint exceeding the lead leachate criterion is deteriorated (i.e. peeling and flaking) therefore in order to help prevent impacts to the environment, priority should be given to the removal of this deteriorated paint.

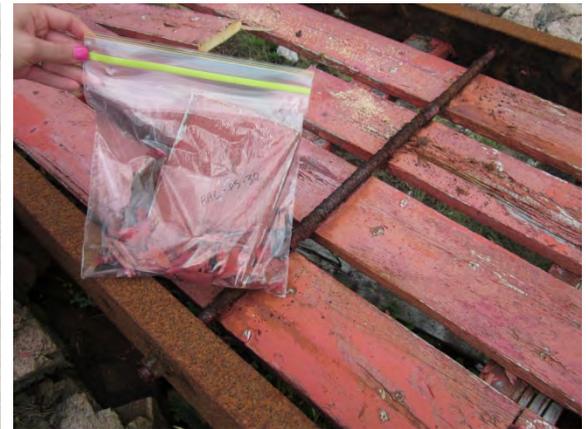
The concentrations of leachable lead in paint and wood substrate samples BAC-PS-30 (0.920 mg/L), BAC-PS-32 (2.0 mg/L) and BAC-PS-33 (2.5 mg/L) were below the Schedule II leachate criterion for lead (5.00 mg/L) provided in the provincial guidance document for leachable toxic waste (GD-PPD-26.1) (refer to Table C9-4, Appendix C9). Paint (weathered red paint and red paint) and wood substrate samples BAC-PS-30, BAC-PS-32 and BAC-PS-33 were collected from the tramway, a pole located southeast of the tramway storage shed and a tank cradle located northeast of the dwelling on the main site area. Since the concentrations of leachable lead in the paint and wood substrate samples are at levels that are not considered to be hazardous, these materials (painted wooden/metal tramway, painted wooden pole and painted wooden tank cradle), if removed from the Site, can be disposed of at an approved landfill facility, pending regulatory and landfill operator approval.

The paint sample (BAC-PS-30) analyzed for PCBs was non-detect (<5.0 mg/kg) and therefore did not exceed the CCME CSQG of 33 mg/kg for PCBs in soil at a commercial site or the criterion of 50 mg/kg for PCB solid provided in the provincial guidance document for leachable toxic waste (GD-PPD-26.1) (refer to Table C9-3, Appendix C9).

Photo 24: View of paint sample BAC-PS-30.

| Sample ID | Colour Description | Substrate | Sample Location (Room No.) | RDL (mg/kg) | Total Lead (mg/kg) |
|---|---|---|---|---|---|
| BAC-PS-30 | Weathered red | Wood | Tramway | 5.0 | 1,300 |

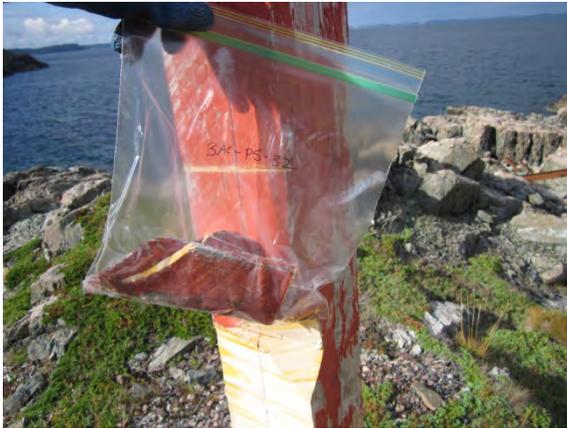
Photo 25: View of paint sample
BAC-PS-32.

| Sample ID | Colour Description | Substrate | Sample Location (Room No.) | RDL (mg/kg) | Total Lead (mg/kg) |
|---|---|---|---|---|---|
| BAC-PS-32 | Weathered red | Wood | Pole southeast of Tramway Storage Shed | 5.0 | 1,700 |

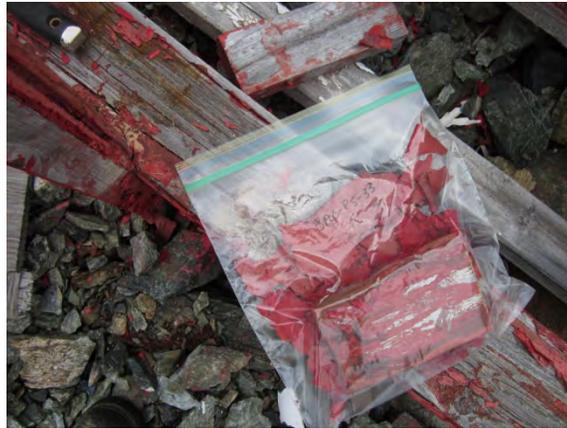
Photo 26: View of paint sample
BAC-PS-33.

| Sample ID | Colour Description | Substrate | Sample Location (Room No.) | RDL (mg/kg) | Total Lead (mg/kg) |
|---|---|---|---|---|---|
| BAC-PS-33 | Multiple layers of red | Wood | Tank Cradle northeast of Dwelling | 5.0 | 8,400 |
