## SECTION 8.0 EXECUTIVE SUMMARY

## 8.0 SOLAR SHED 2

Project: DEMOLITION HAZARDOUS BUILDING MATERIALS  
ASSESSMENT AND INVENTORY,  
BACALHAO ISLAND LIGHTSTATION  
BACALHAO ISLAND, NL

SOLAR STORAGE SHED 2 SAMPLE LOCATION PLAN

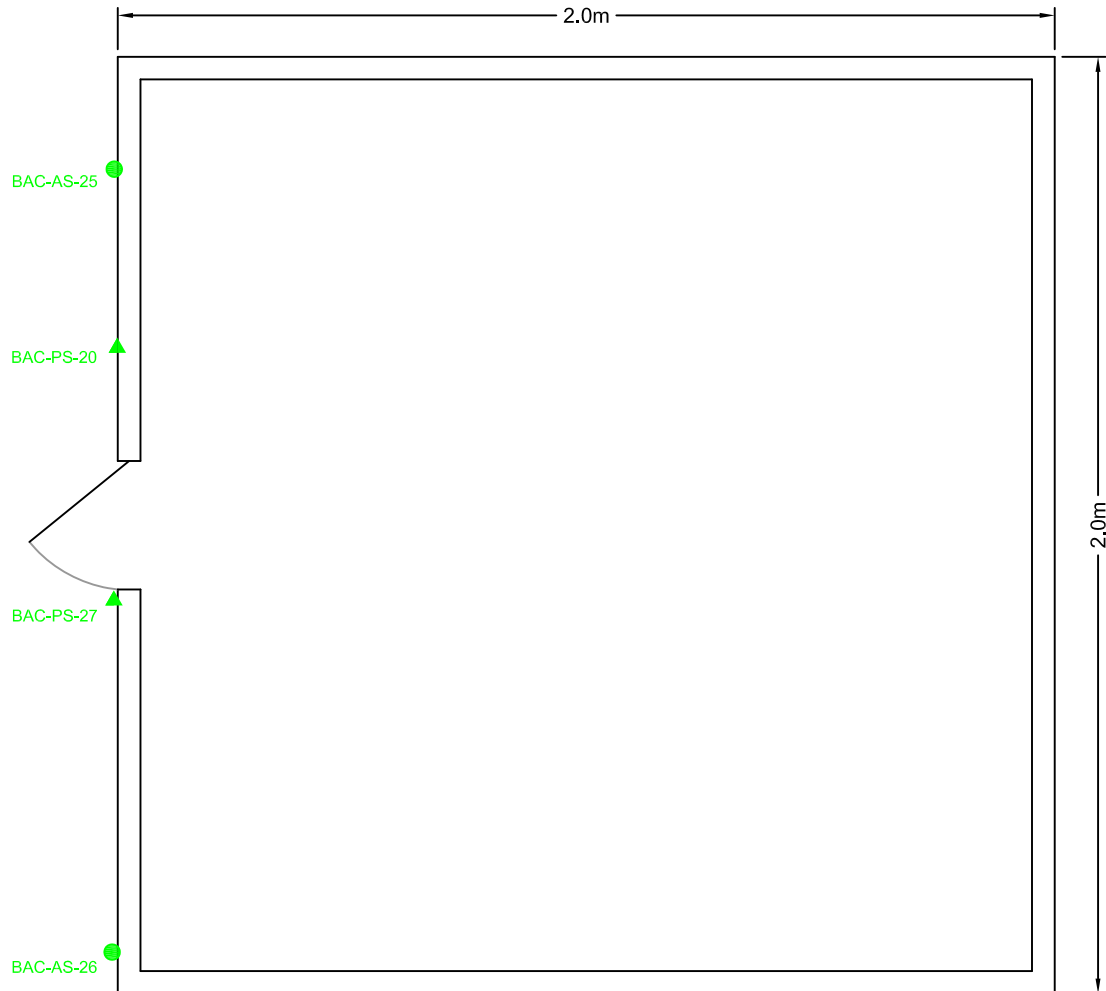
8.1

A total of three (3) building material samples (BAC-AS-25, BAC-AS-26 and BAC-AS-27), plus one (1) field duplicate sample (BAC-AS-DUP-3; duplicate BAC-AS-25), were collected from solar shed 2 and analyzed for asbestos content (refer to Photos 5, 6 and 7, Appendix B8). Sample descriptions and analytical results are summarized in Table C8-1, Appendix C8. Sample locations and analytical results are graphically illustrated in Figure 8.1, Appendix A8.

One (1) sample of waterproofing membrane material (BAC-AS-25), plus one (1) field duplicate sample (BAC-AS-DUP-3; duplicate BAC-AS-25), and one (1) sample of vapour barrier material (BAC-AS-27) were collected from the exterior of solar shed 2 and analyzed for asbestos content (refer to Figure 8.1, Appendix A1 and Photos 5 and 7, Appendix B8). Asbestos was not detected in the waterproofing membrane or vapour barrier material samples collected from solar shed 2.

One (1) sample (BAC-PS-20) was collected from painted surfaces of solar shed 2 and analyzed for lead and mercury content (refer to Photo 8, Appendix B8). Sample descriptions and analytical results are summarized in Tables C8-2 and C8-3, Appendix C8. Sample locations and analytical results are graphically illustrated in Figure 8.1, Appendix A8.

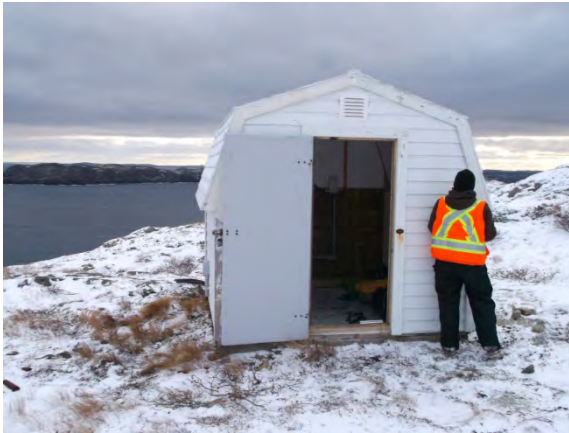
Photo 1: View of solar shed 2.

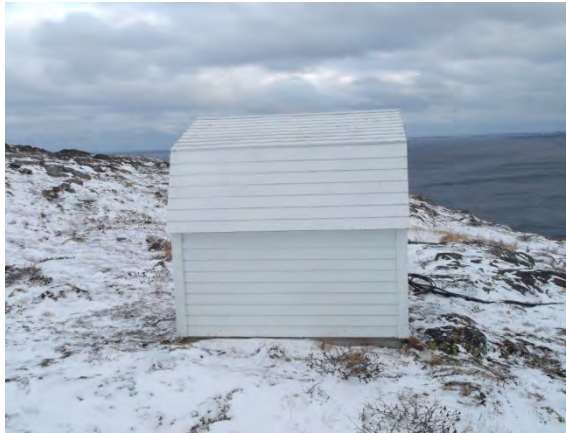
Photo 2: View of solar shed 2.

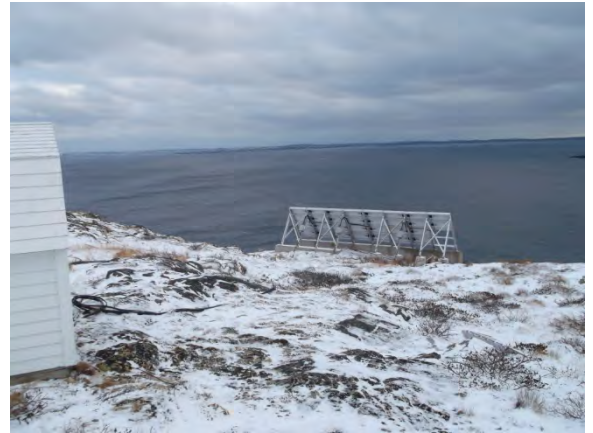
Photo 3: View of solar shed 2 and the solar array in the background.

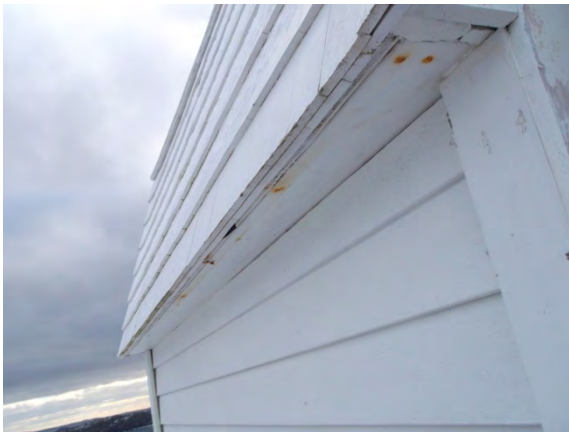
Photo 4: View of wooden shingles on solar shed 2.

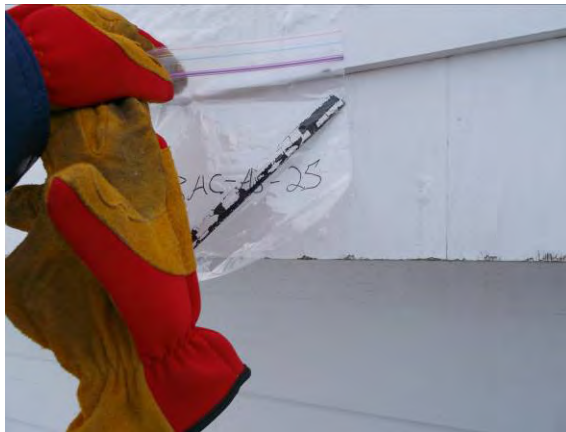
Photo 5: View of waterproofing membrane sample BAC-AS-25.

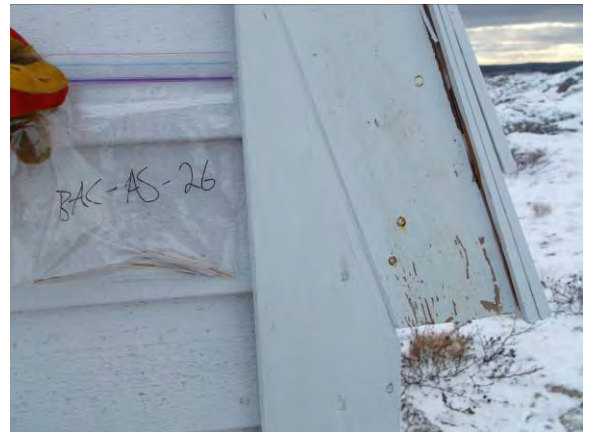
One (1) sample of caulking (BAC-AS-26) was collected from the exterior of solar shed 2 and analyzed for asbestos content (refer to Photo 6, Appendix B8). Asbestos was not detected in the caulking sample collected from solar shed 2.

Photo 6: View of caulking sample BAC-AS-26.

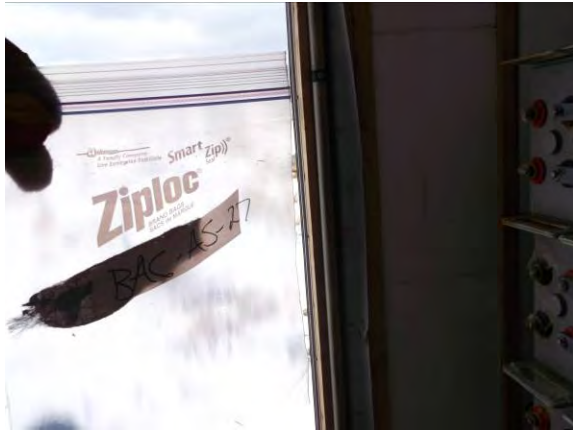
Photo 7: View of vapour barrier sample BAC-AS-27.

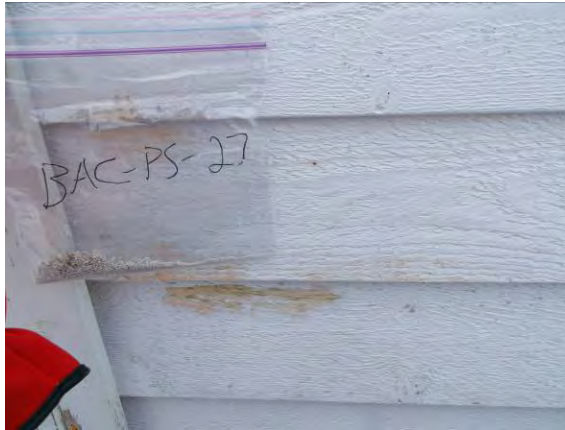
Lead was detected in the paint sample analyzed at a concentration of 6.4 mg/kg (refer to Table C8-2, Appendix C8). Therefore, the paint sample contained lead at a concentration below the Federal HPA criterion of 90 mg/kg and the former Federal HPA criterion of 5,000 mg/kg.

Mercury was not detected (<1.0 mg/kg) in the paint sample analyzed and therefore did not exceed the Federal HPA criterion of 10 mg/kg for mercury in paint or the CCME CSQG of 24 mg/kg for mercury in soil at a commercial site (refer to Table C8-3, Appendix C8).

Photo 8: View of paint sample BAC-PS-20.  
Note: This paint sample was re-labelled.

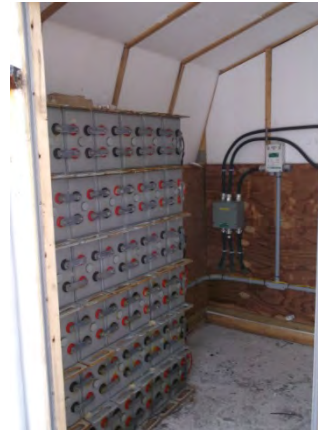
Several potential lead-acid batteries (i.e., solar batteries) were noted inside solar shed 2 at the time of the March 2013 HBMS Site inspection (refer to Photo 9, Appendix B8).

Photo 9: View of solar batteries in solar shed 2.

- Several potential lead-acid batteries (i.e., solar batteries) were noted inside solar shed 2 at the time of the March 2013 HBMS Site inspection.
- The disturbance, control or disposal of lead-containing material/equipment (e.g., batteries, etc.) should be carried out in accordance with applicable criteria/regulations (refer to Section 1.4). The presence/absence of lead in these materials should be confirmed through a contractor or consultant prior to disturbance or disposal of these materials. Typically these materials are sent to a recycling facility and not a landfill.

- If required, removal of lead-containing batteries should be completed in a manner that ensures structural integrity and no loss of fluid from the batteries. Should disposal be required, disposal of lead-containing batteries should be completed in accordance with hazardous waste procedures/guidelines (i.e. at an approved facility).
